OPEN-FILE REPORT O-00-03

Memorandum:
Cape Cove Landslide
Findings from Field Visit
February 10 and March 10, 2000

By
George R. Priest,
Oregon Department of Geology and Mineral Industries

SUBJECT: Cape Cove Landslide, findings from field visit on February 10 and March 10, 2000

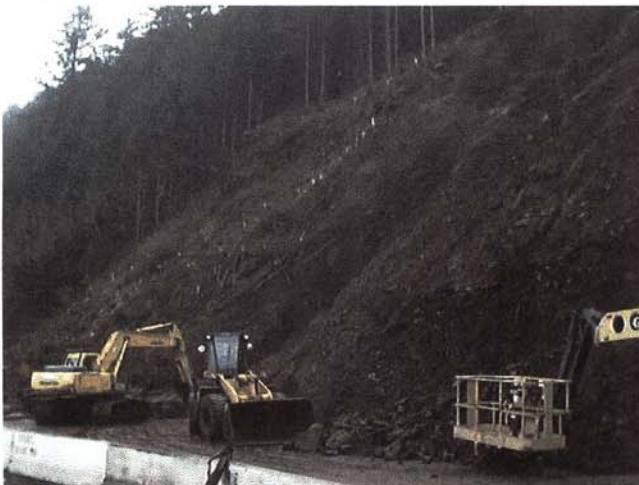
Figure 2. Cape Cove landslide scar above Highway 101, February 10, 2000.

The cause of the main slide was failure of a thin veneer of colluvium resting on a west-facing slope cut at about 36-37° in Yachats Basalt. Pore water pressure was apparently high enough in a zone about 15-20 feet above the Highway to weaken the oversteepened slope enough for failure. The steep highway cut and unusual rainfall combined to cause the failure.

Monitoring and detailed geotechnical analysis of all of these slopes should be considered. Draining water from the colluvium and underlying bedrock and buttressing it will increase slope stability. Buttressing is a challenge because loading slopes undercut by wave action could cause them to fail, so light, strong buttresses or reinforcing of the slopes by piles and rock bolts is preferable.

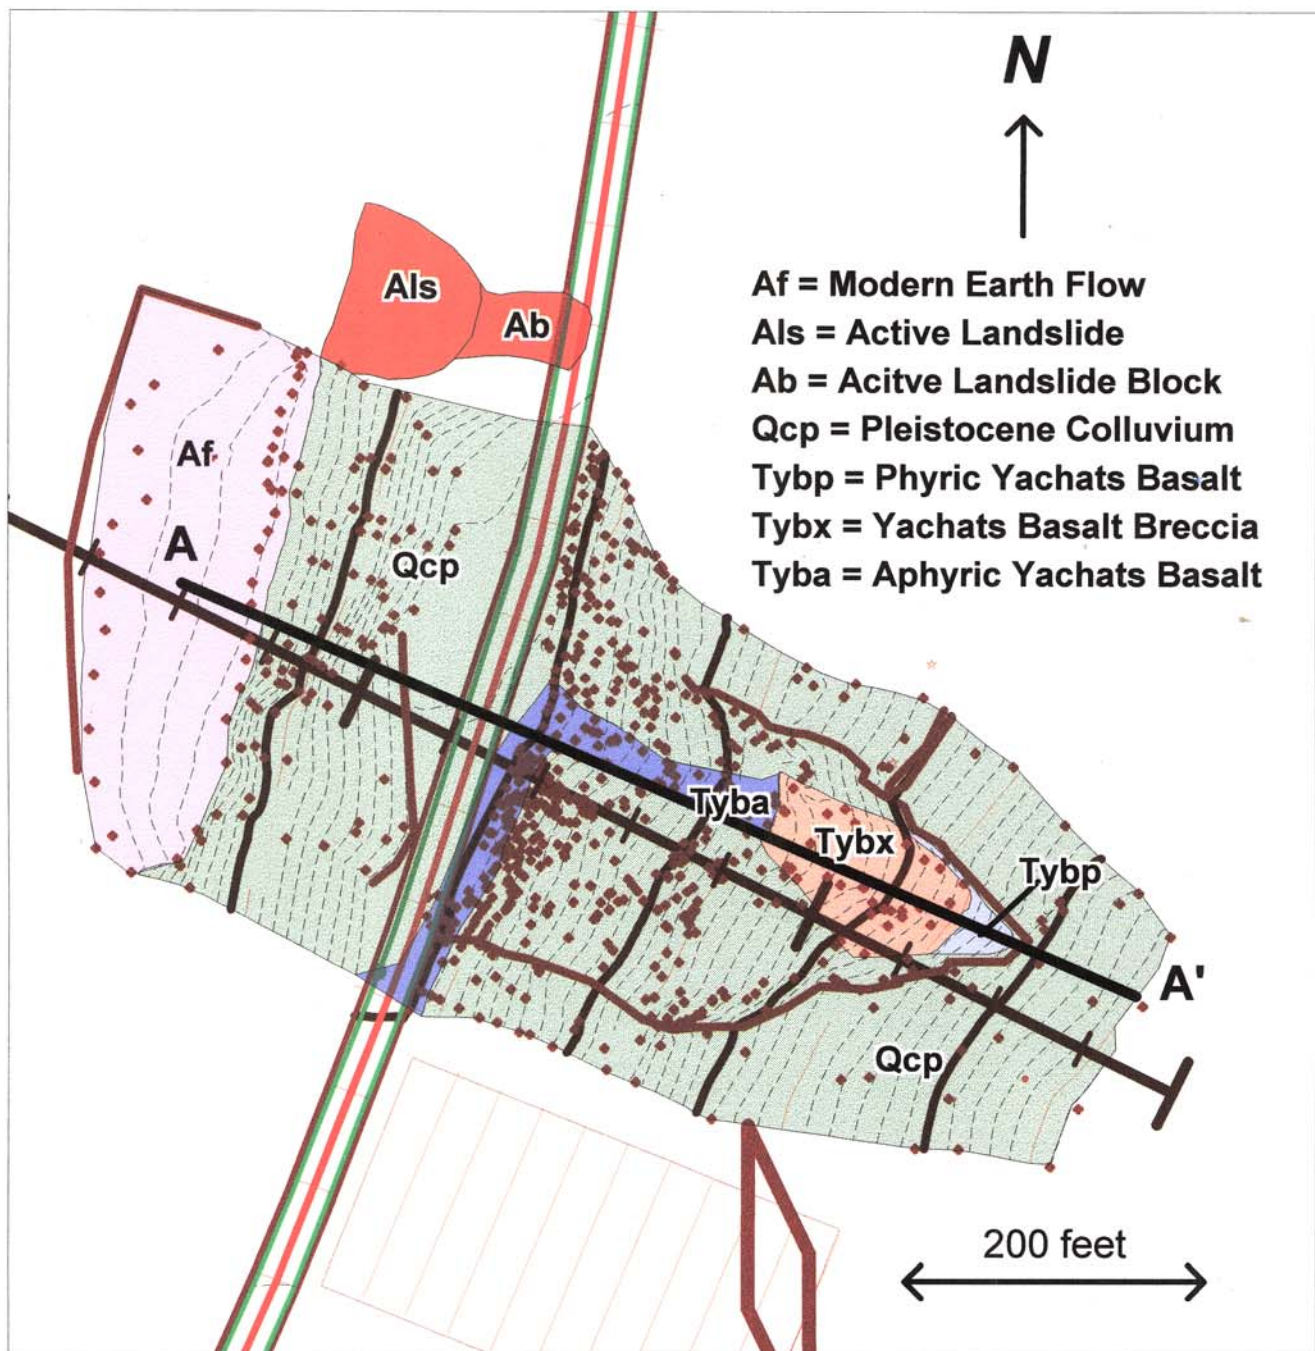
The stratigraphic sequence in the area is summarized in Table 1; Figures 3 and 4 show a detailed geologic map and cross section of the slide area. Also shown is a small active landslide immediately north of the main landslide scar. Depiction of geology in areas adjacent to the detailed topographic map of the slide was not possible because no base map of sufficient accuracy was available. The available US Geological Survey 1:24,000-scale quadrangle is in significant disagreement with topographic contours and the road location shown on the detailed base map of Figure 3.

Figure 3. Geologic map of the slide area with slide scar outlined in heavy brown lines plus 9.8 foot (3 m) contours. Other lines are Highway 101 and engineering notations. Depiction of geology in adjacent areas was not possible because no base map of sufficient accuracy was available. The available US Geological Survey 1:24,000-scale quadrangle is in significant disagreement with topographic contours and road location shown on this base map.

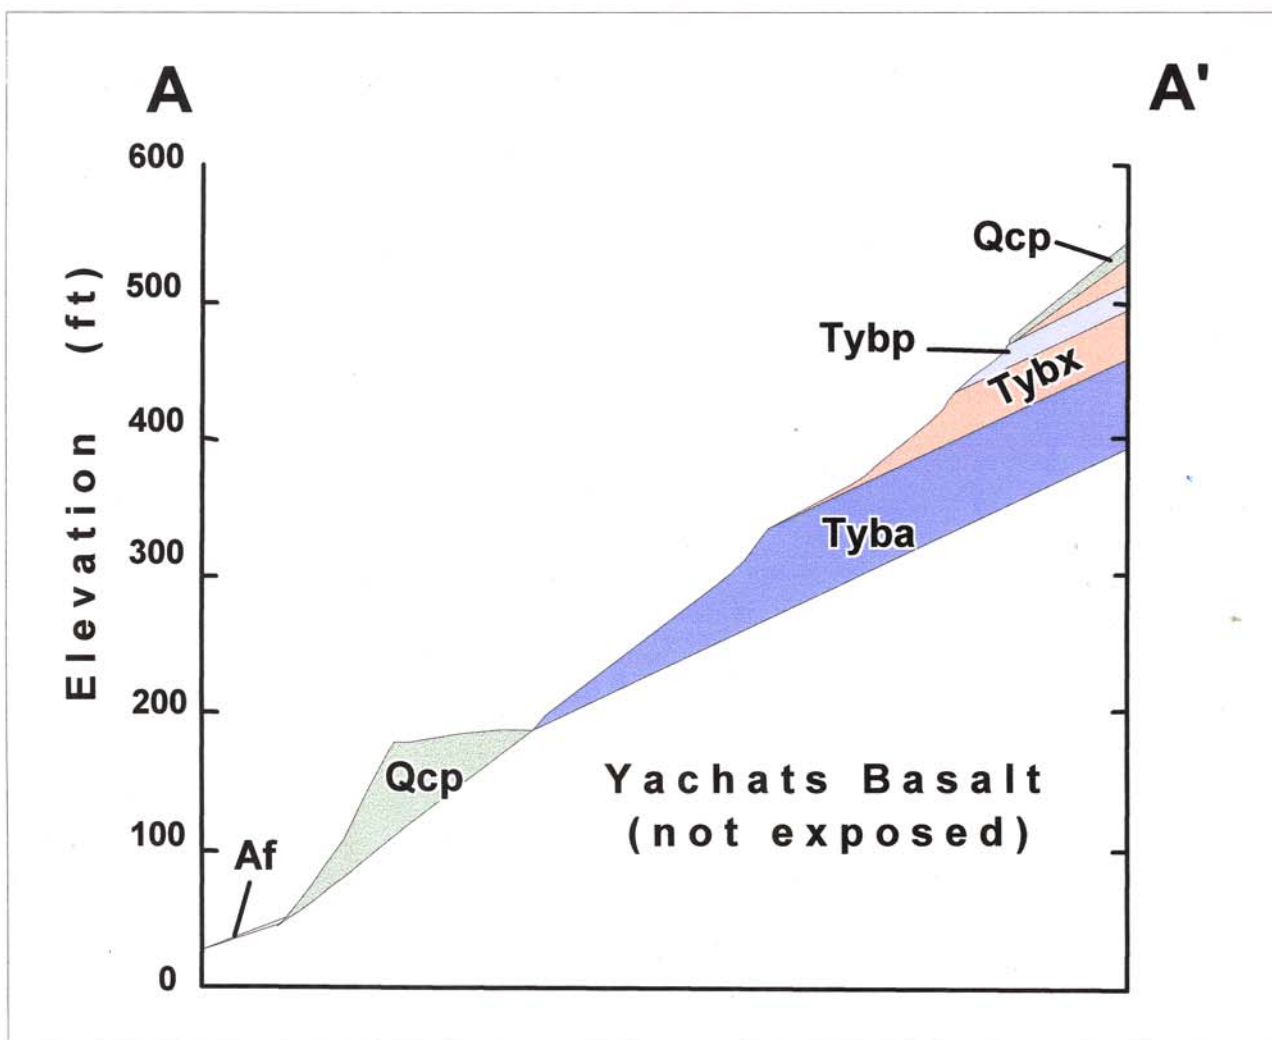
Figure 4. Cross section A-A' across the Cape Cove landslide scar. Note the thick apron of Pleistocene colluvium on the lower slope. Af is the fan of loose slide debris that poured onto the beach from the slide scar.

conditions prevailed. Slopes on the order of 53-78° occur from the beach to about 150 feet of elevation (about 40 feet below Highway 101). Slopes of about 40-50° occur from this point upward to the road where fill material and slide debris has been dumped over the side of the highway (Figures 4 and 12). As is apparent in Figures 6 and 12, natural slopes created by wave erosion approximate 55-78° even where underlain by Pleistocene colluvium. Road cuts above Highway 101 are generally 1:1 slopes (45°) with locally steeper spots near the headwalls of recent slide failures.

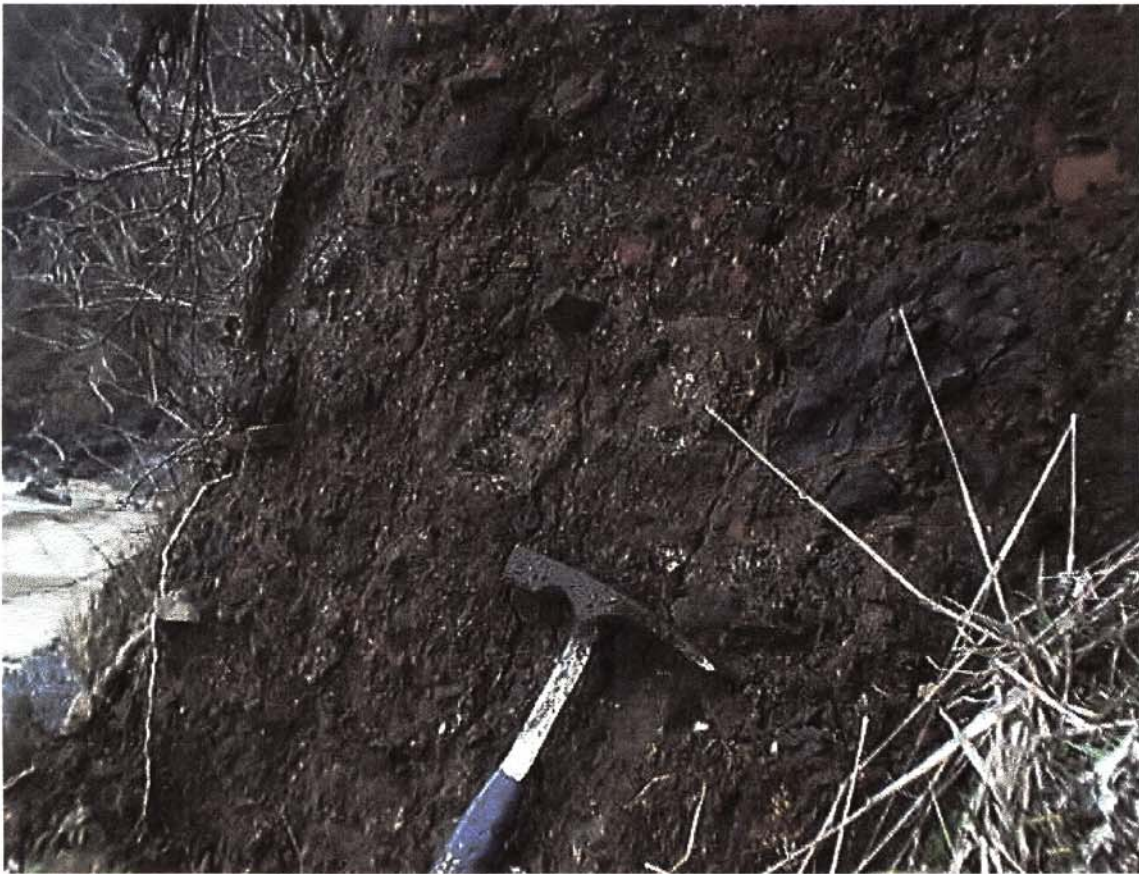
Figure 5. Pleistocene colluvium in sea cliff below Highway 101 on north side of Cape Cove slide scar.

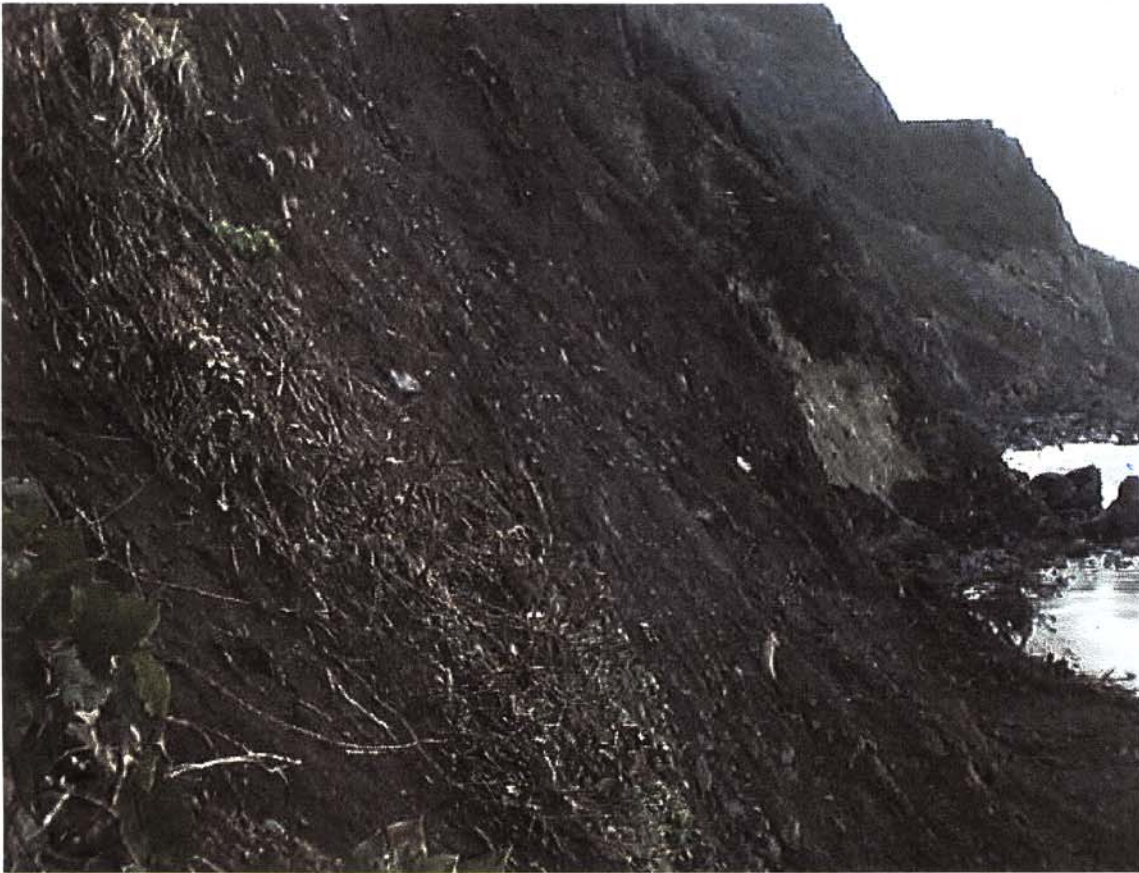
Figure 6. Steep slope composed of Pleistocene colluvium below Highway 101 at Cape Cove slide scar. Note apron of loose slide debris (unit Af on geologic map) that cascaded onto the beach on lower right.

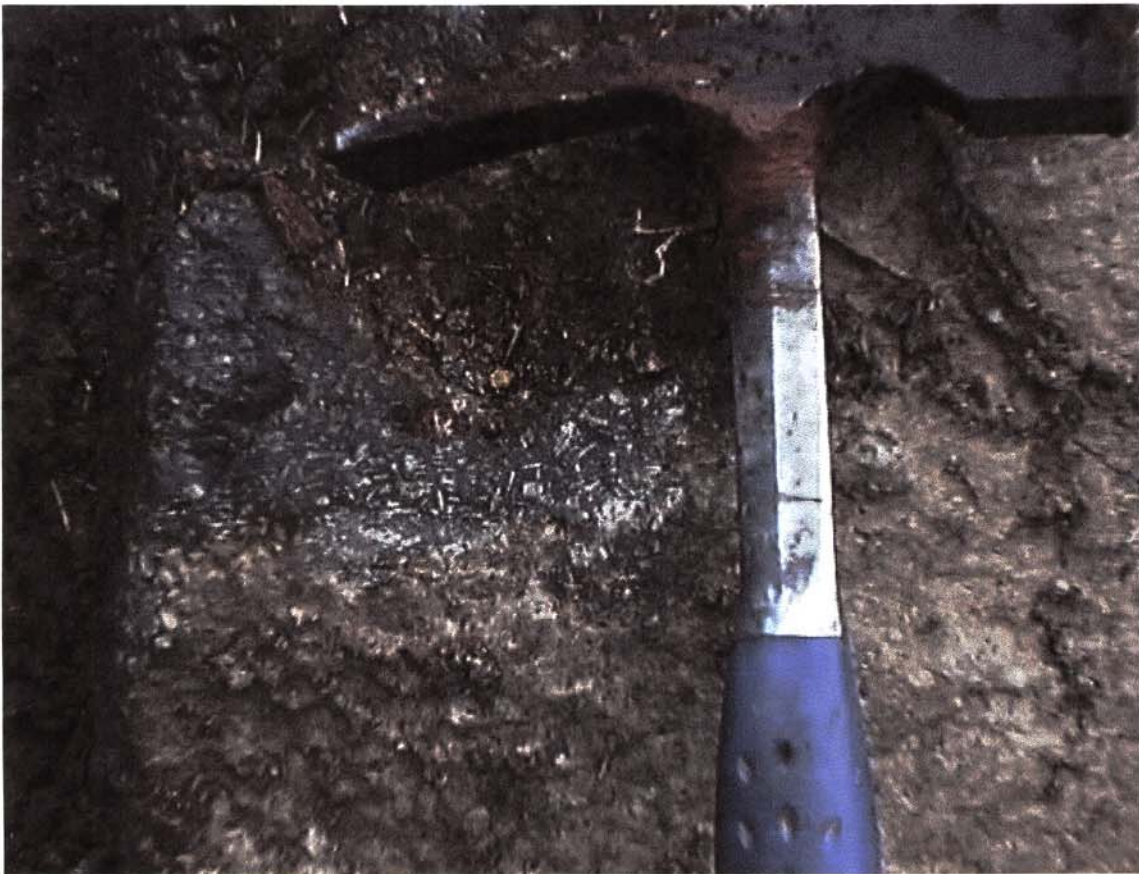
Figure 7. Highly phytic lava flow of upper Yachats Basalt at the head of the slide scar.

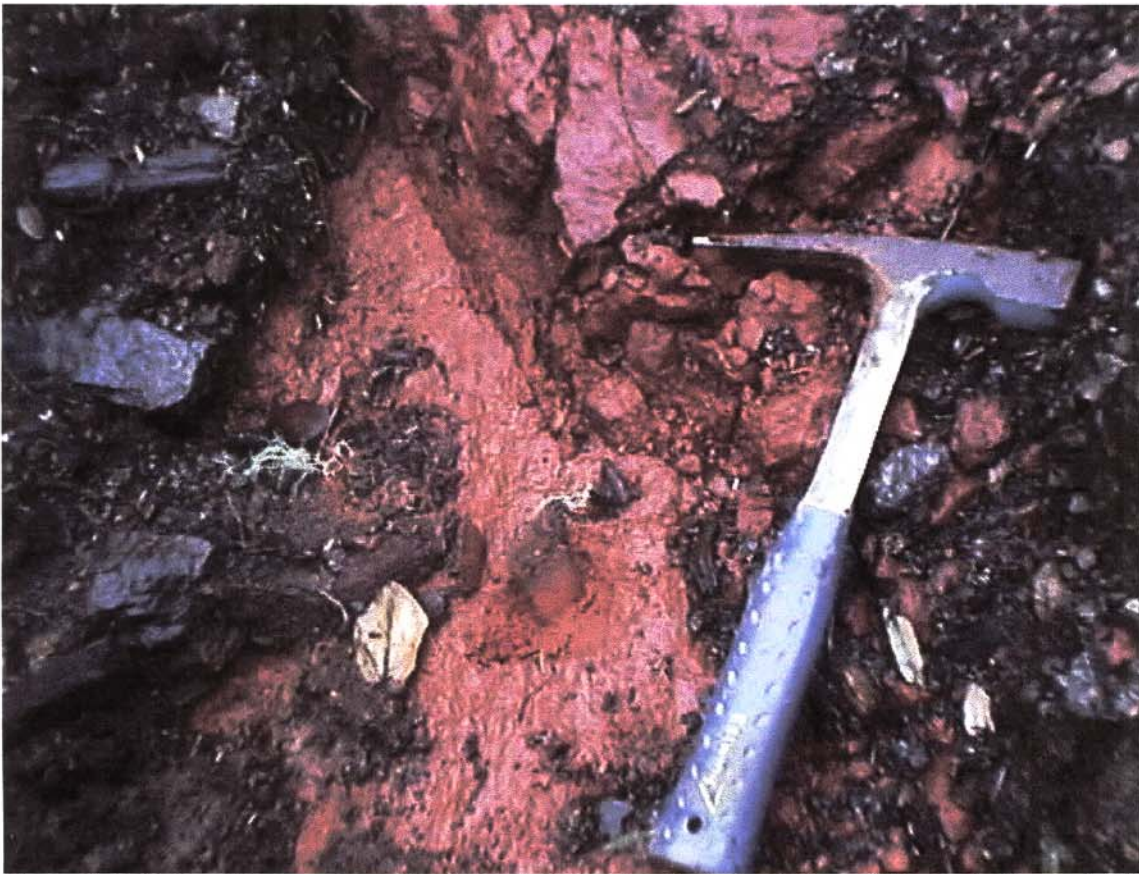
Figure 8. Soft clay-rich wet paleosol immediately below the phyric basalt flow of Figure 7 at head of slide scar. Mapped as part of the brecciated upper Yachats Basalt (Tybx). Colluvium from this red paleosol coats the slope below in red colors. This distinctive unit crops out in the small creek to the north and may be a major zone of weakness for translational block slides.

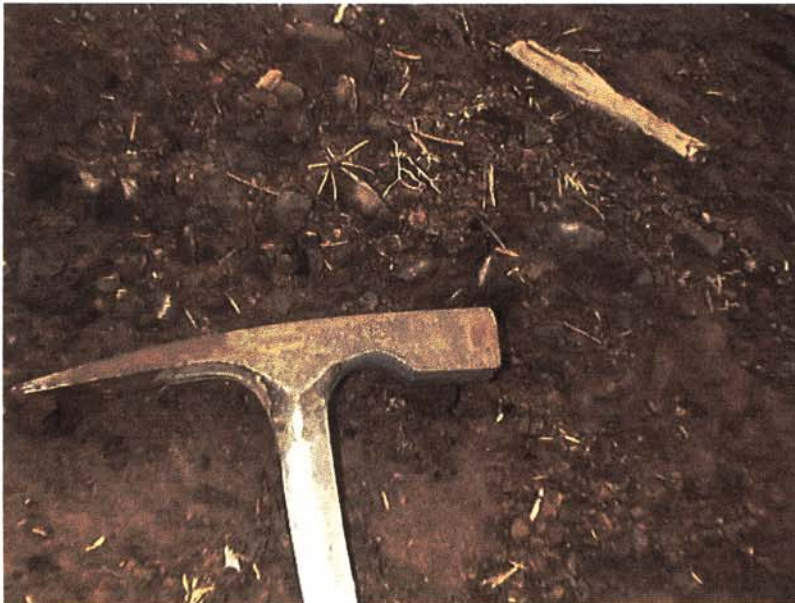
Figure 9. Pyroclastic breccia in upper part of the Yachats Basalt near contact with lower Yachats Basalt.

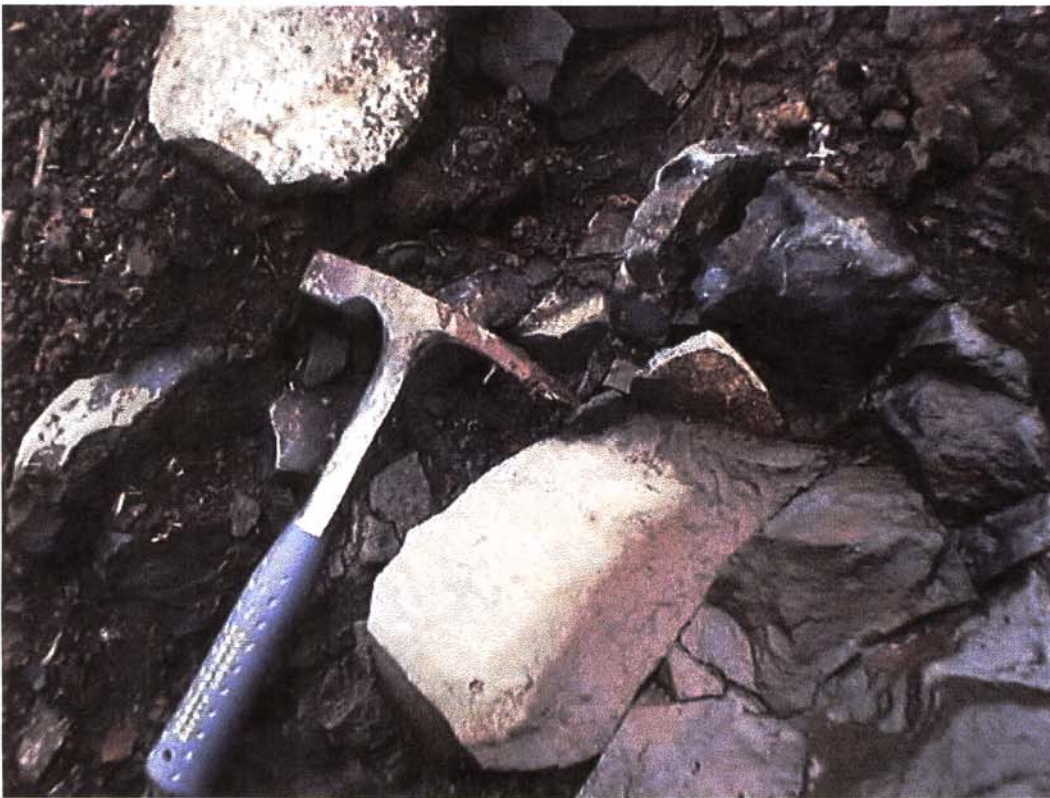
Figure 10. Lower Yachats basalt. This is a hard aphyric (lacking in large crystals) basalt flow. This outcrop is in the Cape Cove slide scar above Highway 101.

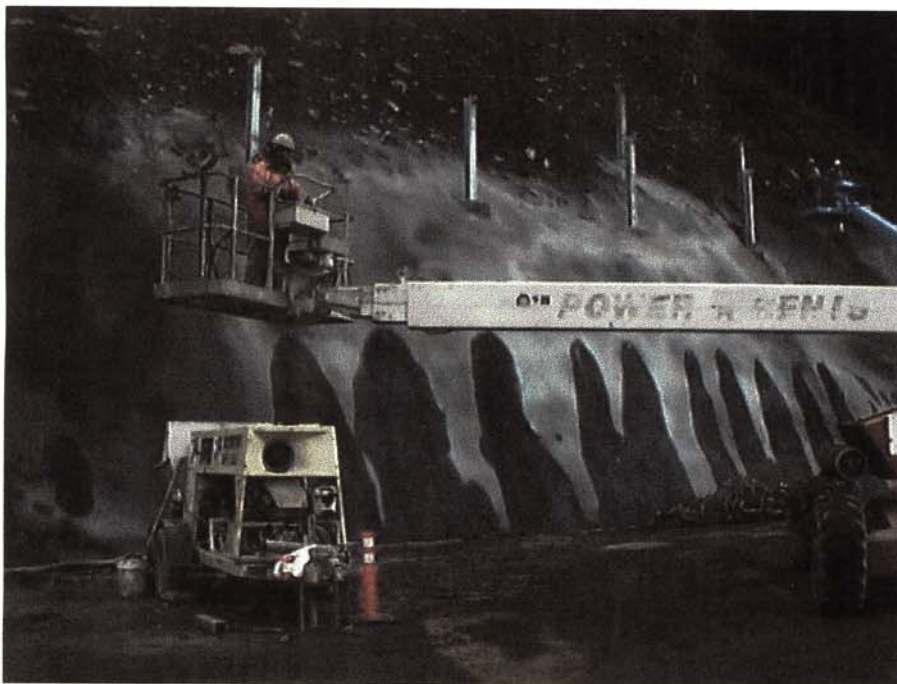
Persistence of the red paleosol as a colluvial layer at the base of the colluvium and abundance of clay and silt in the overlying colluvium has important geotechnical implications. This clay-rich material is of low permeability, so it could prevent free drainage of ground water from the fracture-dominated aquifers in the lower Yachats Basalt. The extreme weakness of the basal red paleosol colluvium combined with the potential increase in pressure head behind colluvial mantle probably contributed to the December, 1999 slope failure. Indeed, considerable ground water was encountered by horizontal drains penetrating the fractured lower Yachats Basalt at the central toe of the slide (Figure 11). Removal of buttressing colluvium by the highway cut was the other contributing factor.

Figure 11. Ground water table is intersected by horizontal drains in Highway 101 road cut near the center of the Cape Cove slide scar. Lower slope has been coated with shotcrete and reinforced in this March 10 photograph. This cut is in the lower Yachats Basalt with a thin residual layer of Pleistocene colluvium cropping out above the wall. This thin layer is left over from the slusher operation and thickens to south (treed area in upper right corner) where it could be vulnerable to slope failures like the present one.

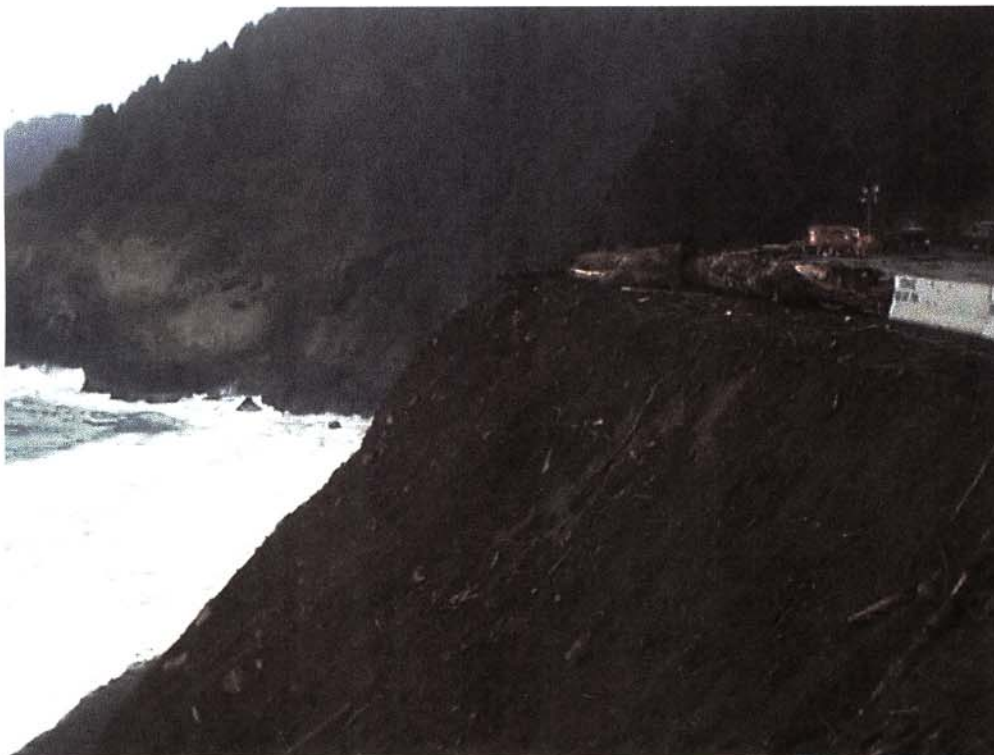
Figure 12. Leveled slope cut in Pleistocene colluvium with fill material and slide debris dumped over the edge of the bluff.
