OFR-03-07

**Reconnaissance Geologic Evaluation
for Building Suitability of a
Portion of the Moolack Beach Landslide,
Lincoln County, Oregon**

By
George R. Priest
Oregon Department of Geology and Mineral Industries

May 9, 2003

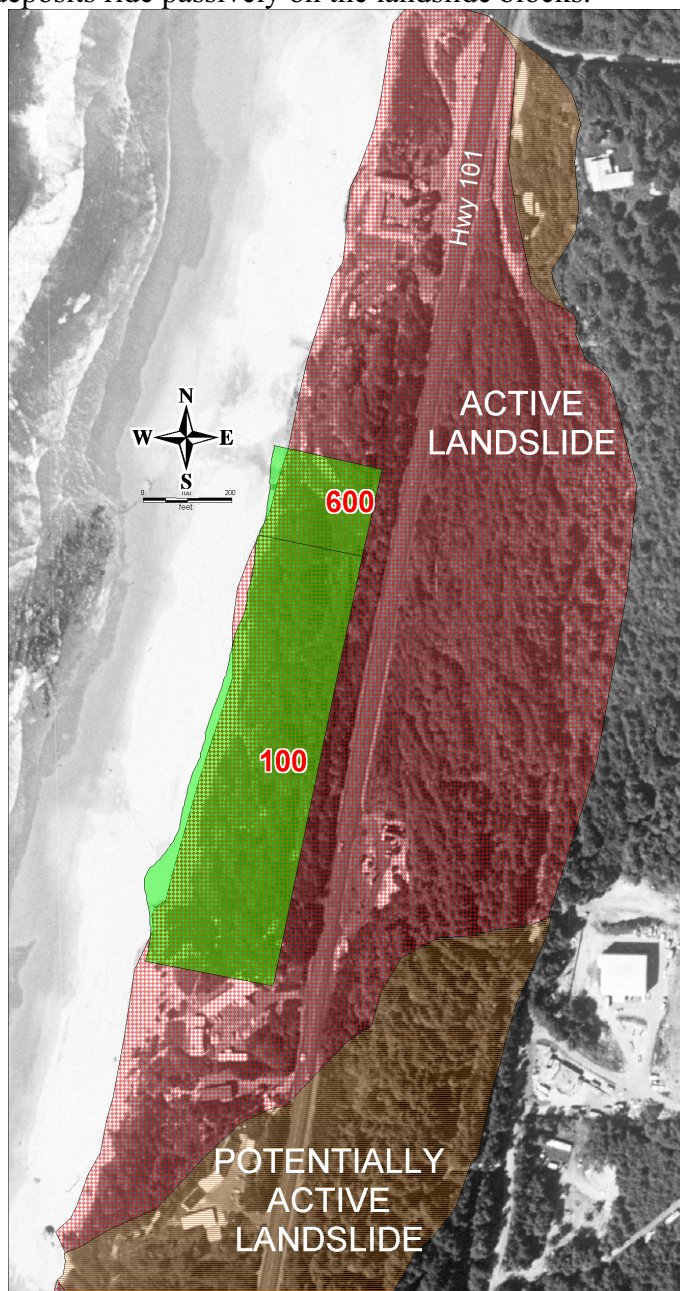
The property lies within one of the largest active landslides in Lincoln County (Figure 3). The slide is offsetting Highway 101 downward and westward on an annual basis, necessitating continual repairs. The slide has been named the Moolack Beach Landslide by the Oregon Department of Transportation (ODOT) and was previously mapped by Priest (1997). The slide is in westward-inclined sedimentary rock of the Astoria Formation. Capping Quaternary marine terrace sand deposits ride passively on the landslide blocks.

Figure 3. Study area is shown in green and lies in the active Moolack Beach Landslide. Mapped landslide boundaries are modified from Priest (1997).

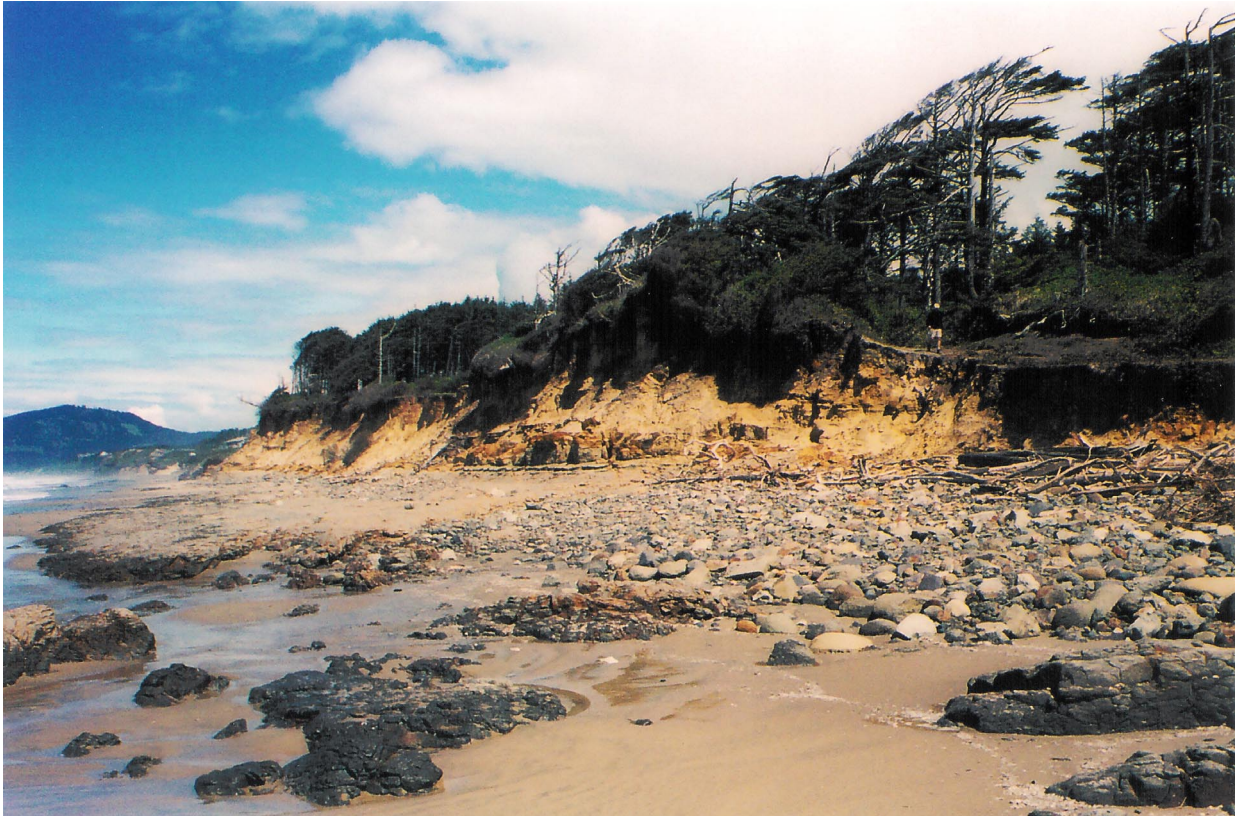
The landslide is eroded back from the toe by wave erosion, forming a sea cliff composed of fractured Astoria Formation and overlying marine terrace sand (Figure 4). Mathiot (1973) obtained an erosion rate of -0.49 ft/year by monitoring bluff toe change during a 250-day (September 1972 to May 1973) period using a semi-permanent survey marker. This measurement was done on the Moolack Beach Landslide 410 feet north of the study area. Priest and Allan (2002) concluded that overall erosion rate for this general area (Beverly Beach littoral cell) is on the order of -0.5 ft/yr with a conservative rate of -0.8 ft/yr, but these estimates have high uncertainties.

Figure 4. Eroded landslide forms a sea cliff. Toe of the slide is probably west of the photo (left) in or near the surf zone. Astoria Formation forms wave cut terrace in foreground and is partially covered with beach sand and gravel. Sea cliff is composed of Astoria Formation siltstone (dark gray to dark orange unit) in the lower 6-9 feet overlain by 10-30 feet of Quaternary marine terrace sand (light-colored unit).

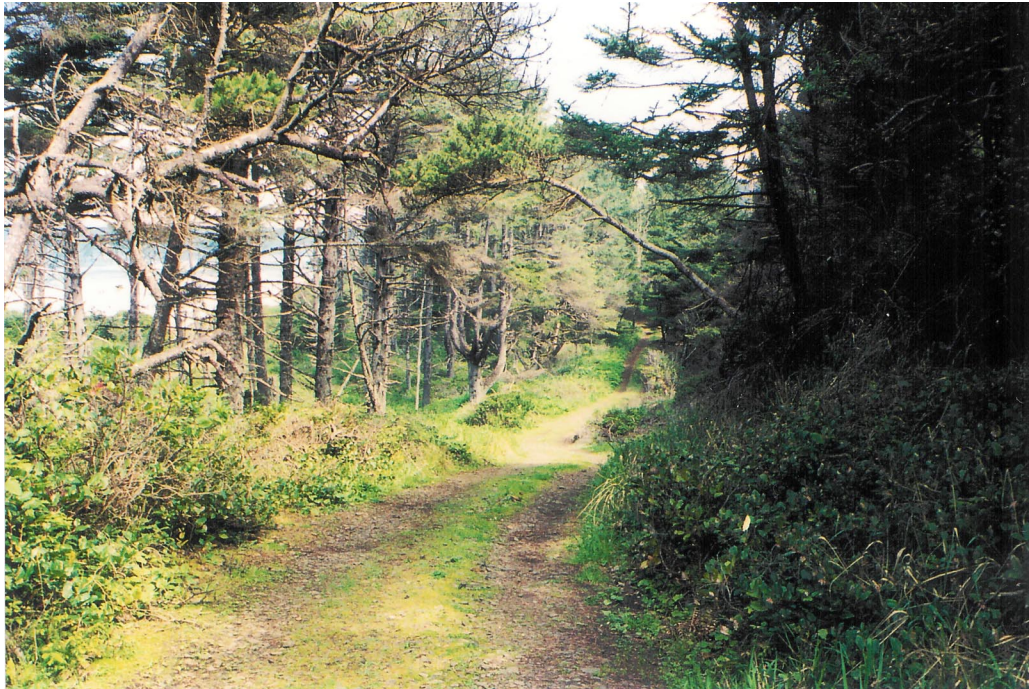
Most of the study area is forested and has rolling topography typical of active landslide terrain (Figure 5). The coastal bluff near the toe of the landslide is about 40-52 feet high (Figure 4) over most of the length of study area, rising to an elevation of 68 feet at the south edge of the area. Elevations are somewhat higher east of the coastal bluff, but in several places there are small closed basins formed by down-dropped blocks within the landslide (Figure 6). These basins trap meteoric water.

Figure 5. Looking north along an entry road into the property; note the landslide scarp on the right and down-dropped block (small basin) in the left background. Property is heavily forested.

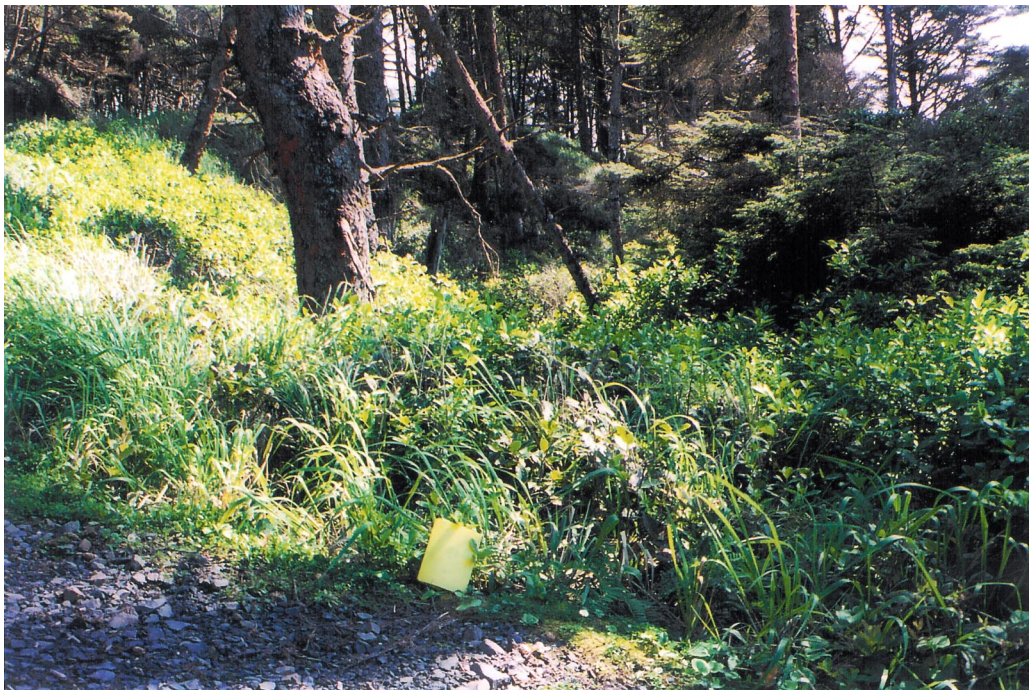
The highly fractured nature of the landslide material probably promotes infiltration of water. Fractures are probably closely spaced in these basins, based on observations in exposures of in analogous landslides.

Figure 6. Small down-dropped block in the slide here forms a closed basin that traps surface runoff water.

Again, it is not recommended, but if any grading is done, care should be taken to avoid depressions within the slide (graben and colluvial-filled fissures) and slide scarps. Grading and filling of these active structures should also be avoided. Such modification will obscure the structures, making any site development decisions more difficult. Adding fill to depressions within the landslide may add driving force to the slide.

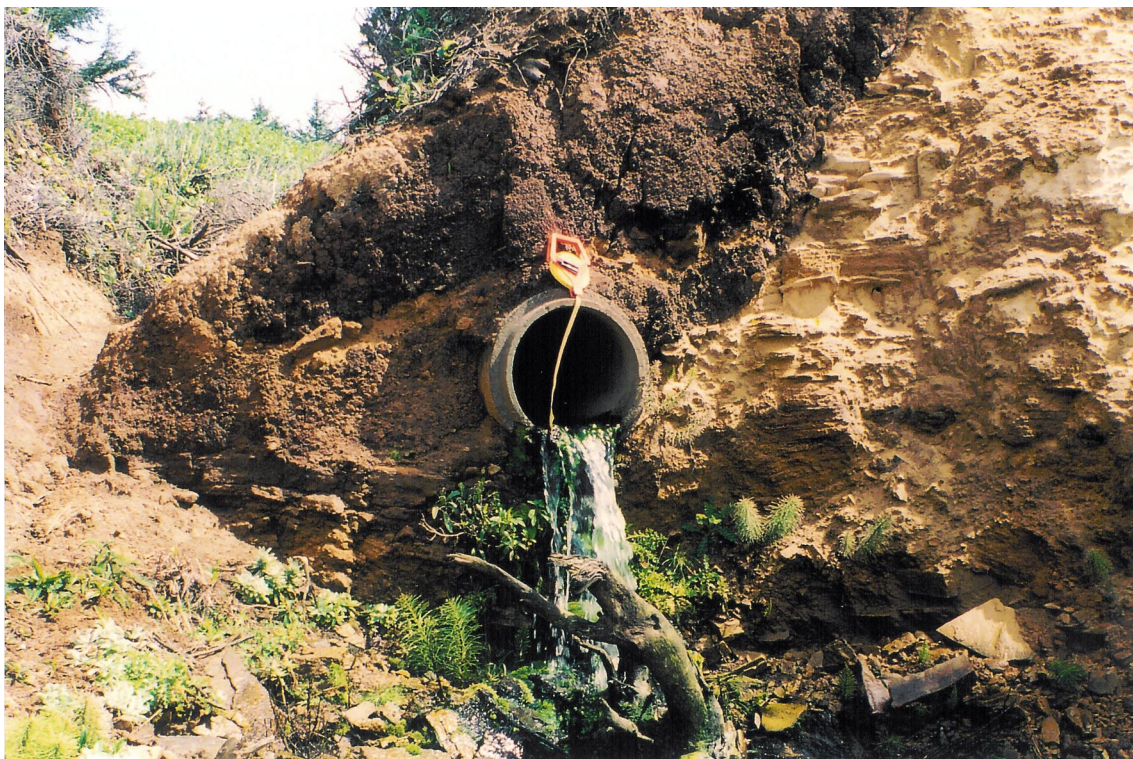
One small creek runs underground through the northern edge of the property and was flowing at the time of the field work. This creek emerges at the sea cliff from a 1.6-foot diameter concrete pipe (Figure 7). The eastward extent of this pipe is not known. The flowing water appears to cause enhanced erosion of the sea cliff at this point. Evidence is the reentrant in the cliff and broken pieces of the pipe lying about in the reentrant. The fill material above the pipe is also eroding more rapidly than surrounding material, probably in response to runoff. This subaerial erosion has created a small dry gulch extending east-southeast of sea cliff for about 60 feet (Figure 7).

Figure 7. Looking east at reentrant in sea cliff where a small creek emerges from a 1.6-ft diameter concrete pipe buried in a trench excavated in Quaternary marine terrace sand (tan unit on right) and buried by fill (dark unit). Pipe is located 70 feet south of the north property boundary and appears to run east-southeast. Note the dry gulch just visible on the left where surface runoff has eroded the fill..

Likewise, the dry gulch that is developing over the buried creek on the northern margin of the study area (Figure 7) would need to be studied to determine why and how this erosion is occurring and how to stop it. Remediation of the apparent rapid erosion of the sea cliff in front of the buried creek would also need to be evaluated.

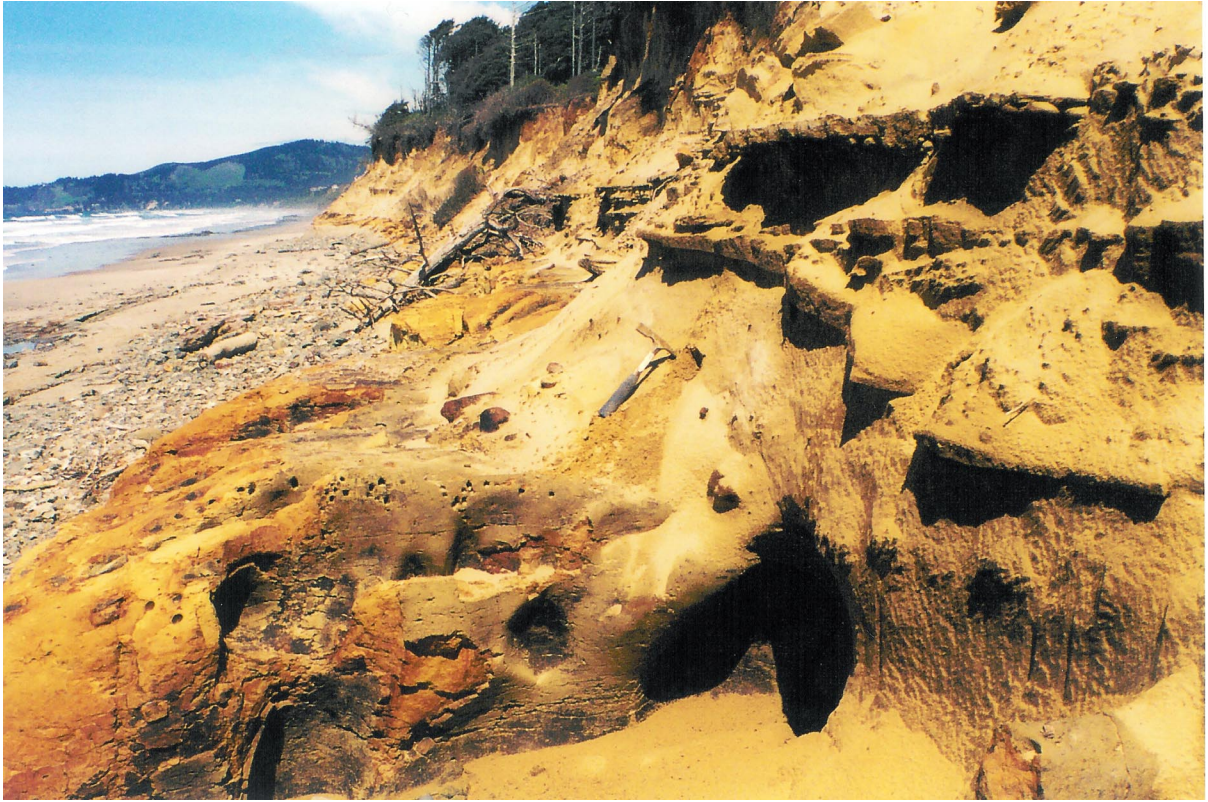
Groundwater in this region generally flows more easily in the permeable marine terrace sand than the relatively impermeable siltstone of the Astoria Formation. Movement of oxygenated ground water at the terrace sand-siltstone contact (Pleistocene wave cut platform) has probably caused the siltstone to have a rust-colored stain (Figure 8); alternatively, the stain could be from Pleistocene weathering (i.e. a paleosol), but this would be unlikely on a wave cut platform. Ground water can also flow in fractures. Mass movement has locally caused heavy fracturing of rock in the landslide mass, so groundwater flow may be heavily influenced by fractures. Swanson (1974) observed two springs issuing from the base of the sea cliff in the southern half of the study area (see his Figure 1). Swanson also noted that some creeks in the main landslide mass east of the study area disappear into the fracture system.

Figure 8. Heavy iron oxide stain in Astoria Formation siltstone (dark orange material forming a low slope) at the contact with the overlying Quaternary marine terrace sand (lighter colored unit forming steep slope). Note the near horizontal bedding in the terrace sand. The Astoria Formation is dipping west at about 15 degrees at this locality (south central part of the study area); Pleistocene wave cut platform appears to dip $\sim 7^\circ$ east, the likely dip of the marine terrace sequence as a whole.

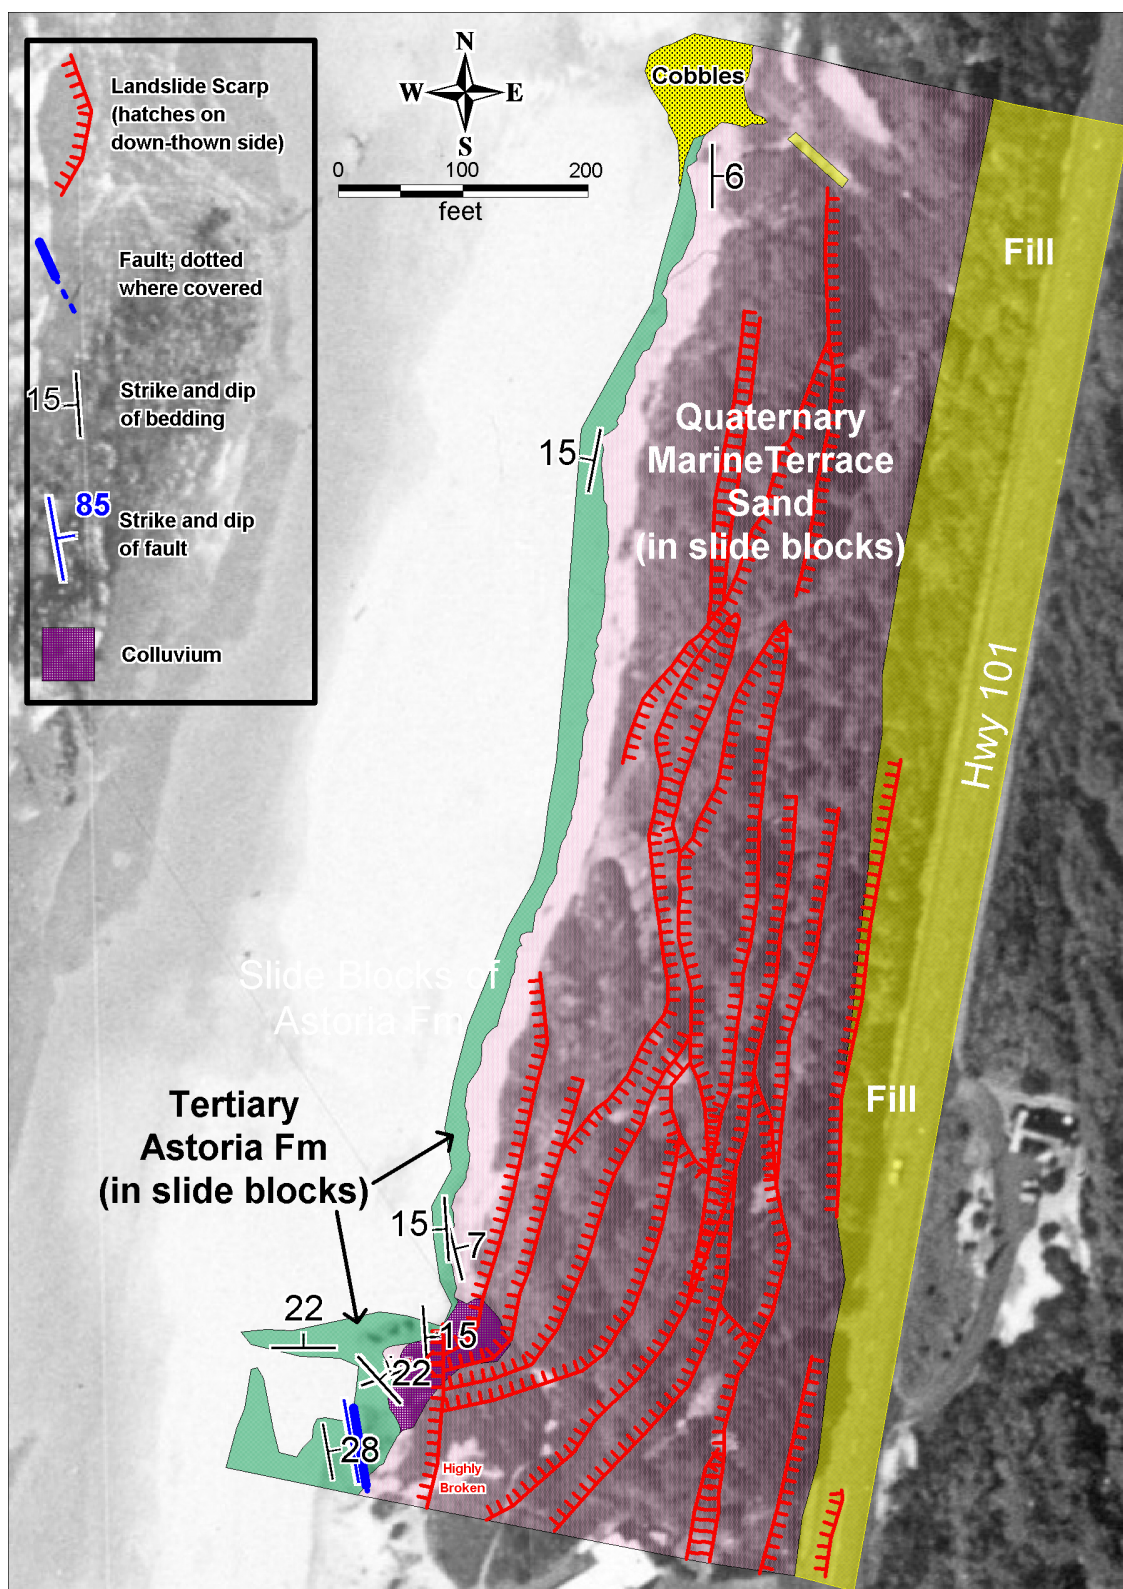
Slides in the area generally form in seaward-dipping weak siltstone or mudstone units in the Astoria Formation, as coastal erosion cuts sea cliffs into these weak layers. These same geological conditions pertain in the study area. Seaward-dipping fine-grained silty sandstone, siltstone, and mudstone of the Astoria crop out along the sea cliff and in the modern wave-cut platform. Intensity of landslide deformation increases from north to south in the study area becoming most intense at the southwest corner. In this southwest corner landslide scarps are too numerous and closely spaced to map separately. Some of the complexity of the transition between this area and the more intact, lower elevation block to the north is illustrated in Figure 10.

Figure 9. Geologic map of the study area. Uncolored area west of colored areas is chiefly beach sand and minor gravel. Areas surrounded by inward pointing hatches are down-thrown slide blocks in fissures; areas surrounded by outward pointing hatches are uplifted blocks relative to surrounding areas.

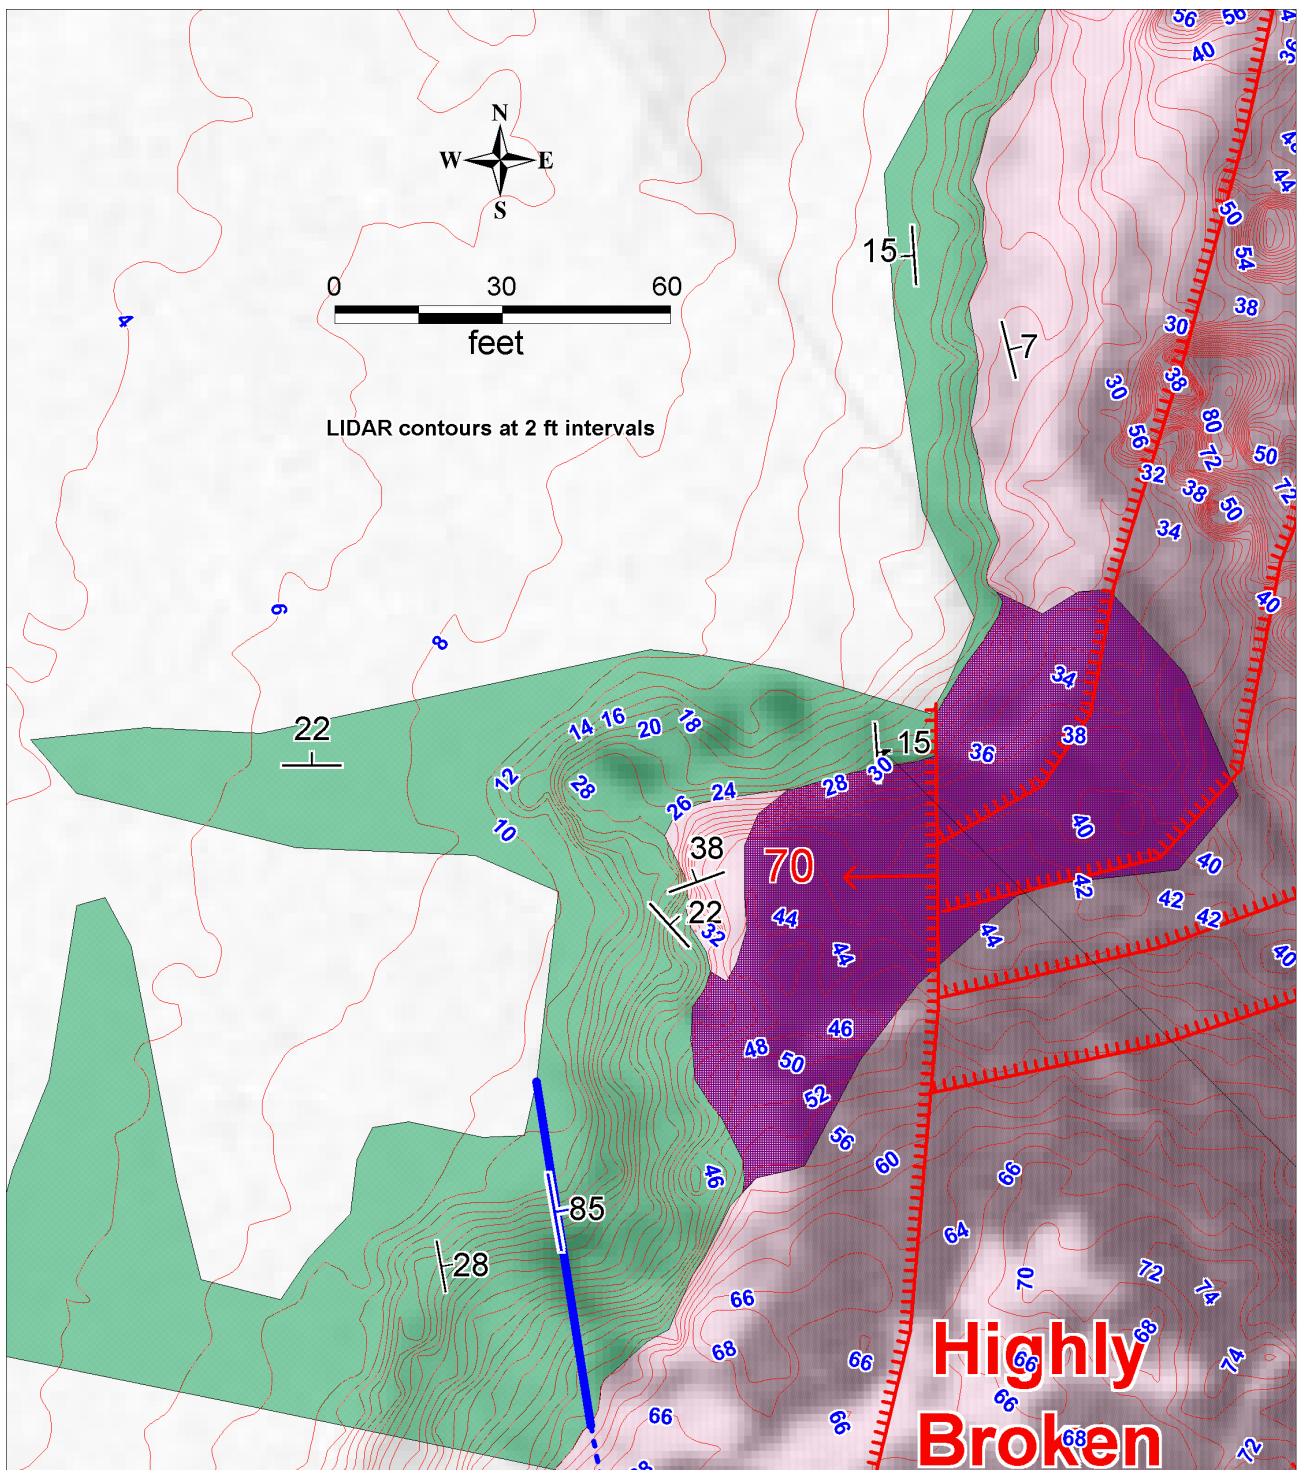
Figure 10. Close up of southwest part of the geologic map with topographic contours (thin red lines with blue elevation labels) derived from a 1998 LIDAR survey by USGS and NOAA. A black and white 1993 orthophotograph is the base map. LIDAR is most accurate in areas free of vegetation (white patches on the base map). Red arrow and number on scarp show amount and direction of dip. See Figure 9 map legend for explanation of other symbols. Note changes in dip of the Astoria Formation (blue green) across slide block and fault boundaries.

Exposures on the sea cliff reveal the complexity of the interplay between landslide and tectonic deformation. In the northern slide block pre-landslide dip of the Astoria is estimated to be at 21-22° west based on the 6-7° east dip of the formerly flat Quaternary marine terrace and 15° west dip of the underlying Astoria (Figures 9 and 10). Preexisting tectonic structure and modern landslide deformation in the southwestern corner of the study area cause the Astoria exposed at the sea cliff to dip 22° north to 28° east northeast (Figures 10 and 11). The overlying Quaternary marine terrace sand there is tilted 38° to the north-northwest, while Astoria formation directly underlying the steeply dipping marine terrace sand dips 22° northeast. The sharp northward flexure of the marine terrace sand in the southwestern part of the area brings the lower contact from an elevation of ~58 feet at the south edge of the study area to ~22-24 feet over a north-south distance of only 120 feet (Figure 10). This flexure is most likely due to landslide deformation.

Sea cliff exposures of the Quaternary marine terrace sand provide a convenient way of estimating overall vertical displacement at the western margin of the study area. The landslide causes the lower Quaternary marine terrace sand contact to be displaced from original elevations of ~80-95 feet to elevations of 20-22 feet at the sea cliff along most of the length of the study area; hence vertical displacement is 58-75 feet. The top of the terrace deposits is relatively flat, although there is some topography from former dunes, so the top surface can also be used as a marker to estimate vertical displacement. Elevation at the top of the headscarp of the landslide is ~120 feet, whereas the top of the terrace sand in the north slide block is at about 50 feet of elevation, where not deeply eroded; this gives 70 feet of vertical displacement. Vertical displacement decreases to 22-37 feet in the southwestern edge of the study area where the marine terrace contact lies at an elevation of ~58 feet (Figure 10).

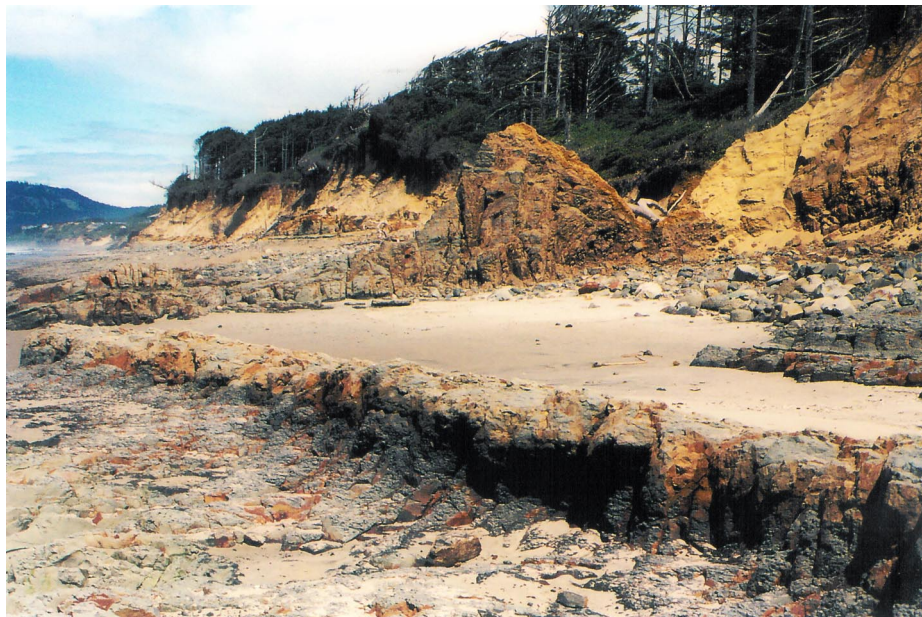
Figure 11. Looking north northeast at southwest part of the study area. Linear outcrop in foreground is Astoria Formation sandstone dipping 28° east. Linear outcrop at left center is Astoria Formation sandstone dipping 22° north. Light tan unit in upper right is Quaternary marine terrace sand dipping 38° northwest and lying on Astoria Formation (dark red brown) dipping 22° northeast. The main north block of the slide is in the background upper left.

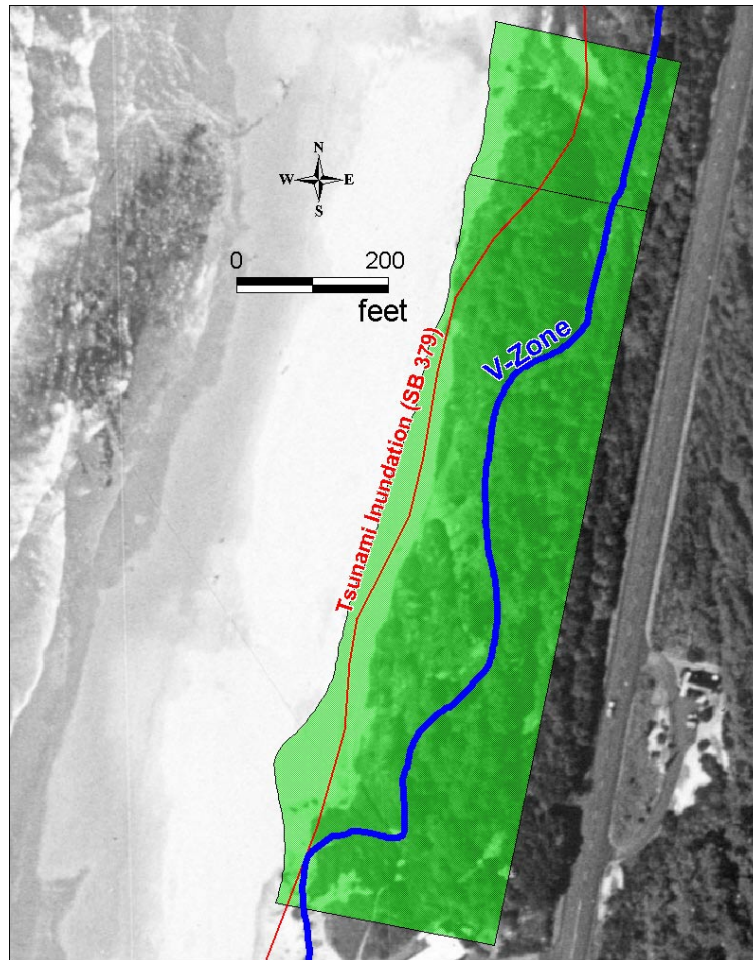
The 100-year coastal flood zone with wave action velocity (V-zone) taken from digital files of the Federal Emergency Management Agency (FEMA) Flood Insurance Rate Map (FIRM) and projected onto a 1993 orthophotograph is shown in Figure 12. No V-zone elevation is listed on the published FIRM for this area, but a V-zone elevation of 31 feet is listed 1 mile south of the study area. LIDAR data from 1998 show that the coastal sea cliff reaches elevations of ~40-50 feet over much of the study area, so the digitally projected V-zone inundation line in Figure 12 may be too far inland for most of the study area. Inaccurate digitizing of the original published line may be the cause.

Figure 12. Flood hazard boundaries. V-zone = ocean velocity zone (flooding from waves); SB 379 = Oregon Senate Bill 379.

In summary, the area is partially in the published FIRM V-zone, but it is not known with precision how much of the area is in the zone. The FIRM boundary shown in Figure 12 may extend too far inland, possibly because of a digitizing error. The study area is also subject to flooding from rare but catastrophic Cascadia subduction zone tsunamis.

The FEMA V-zone needs to be more accurately plotted to see how much of the area falls in the zone. Likewise, more accurate coastal erosion rates need to be calculated by monitoring erosion and analyzing bluff change on rectified historical aerial photography.
