OFR O-04-05

**GEOTECHNICAL INVESTIGATION
JOHNSON CREEK LANDSLIDE
LINCOLN COUNTY, OREGON**

Landslide Technology

2004

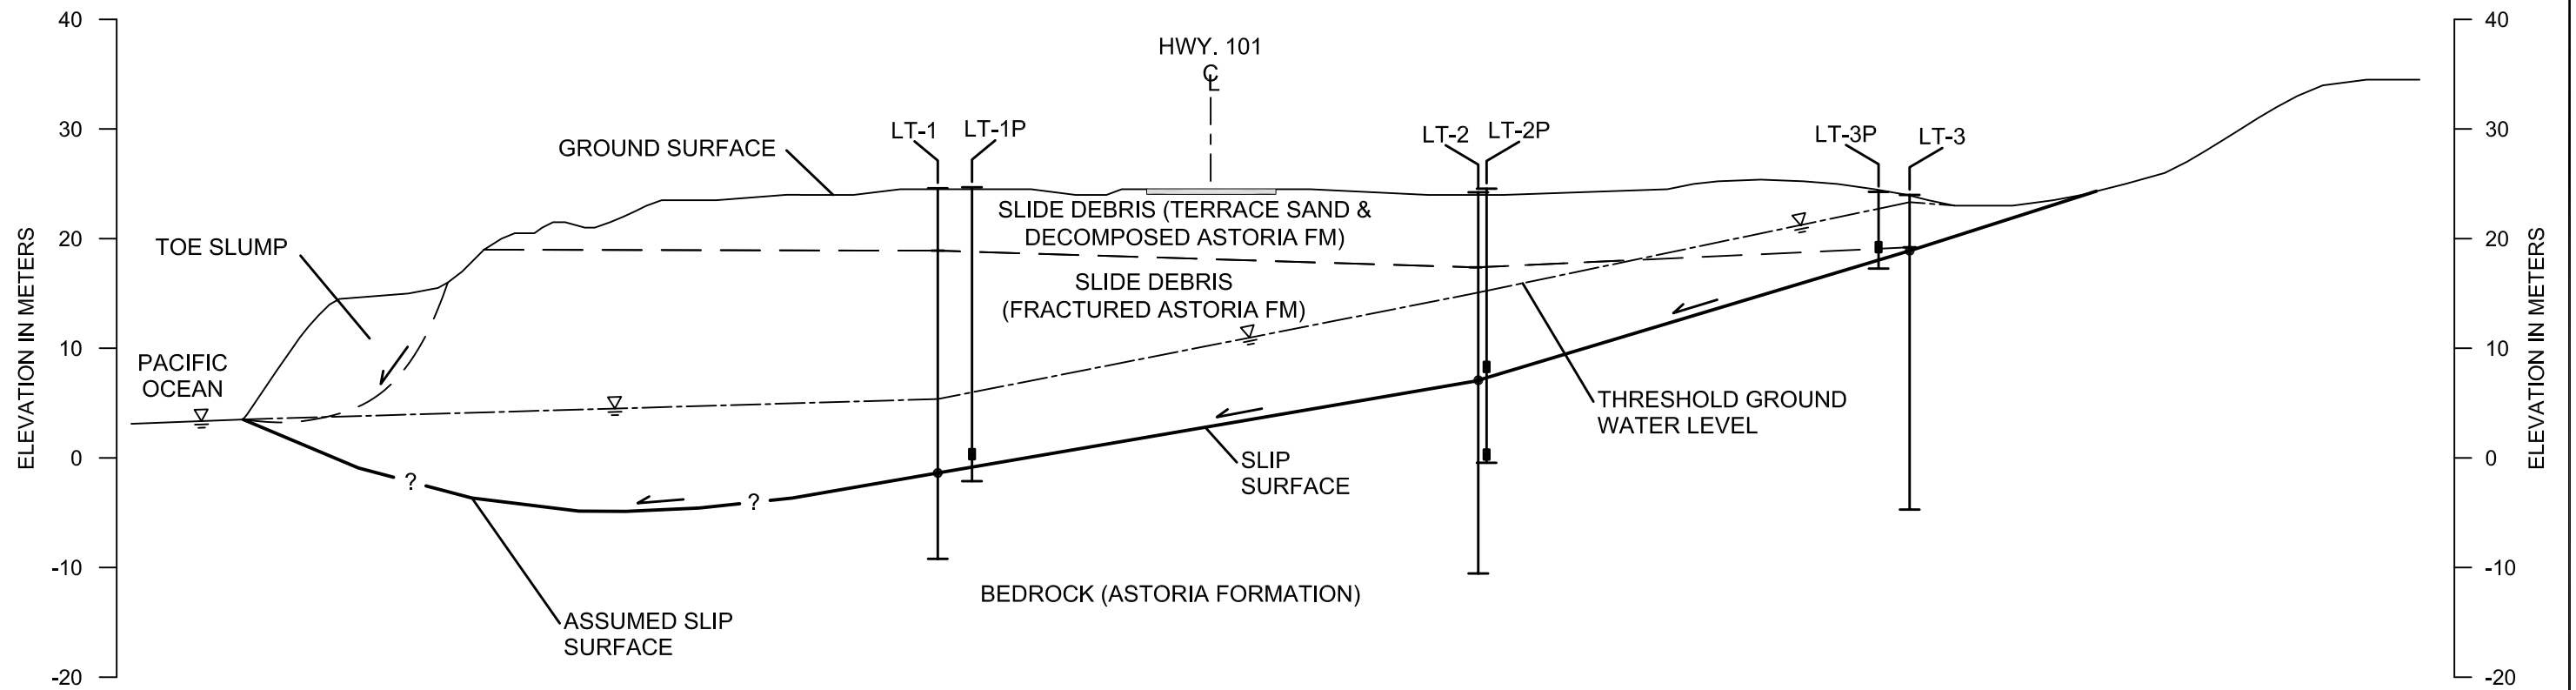
FIG. 18

Shear Zone. The location of the shear zone is estimated based on the known depth of movement in inclinometers LT-1, LT-2 and LT-3, the location of cracks observed upslope from the instrumentation, interpreted topography, and observations from the test pit at the slide toe. The analyzed slip surface is shown in Figure 18.

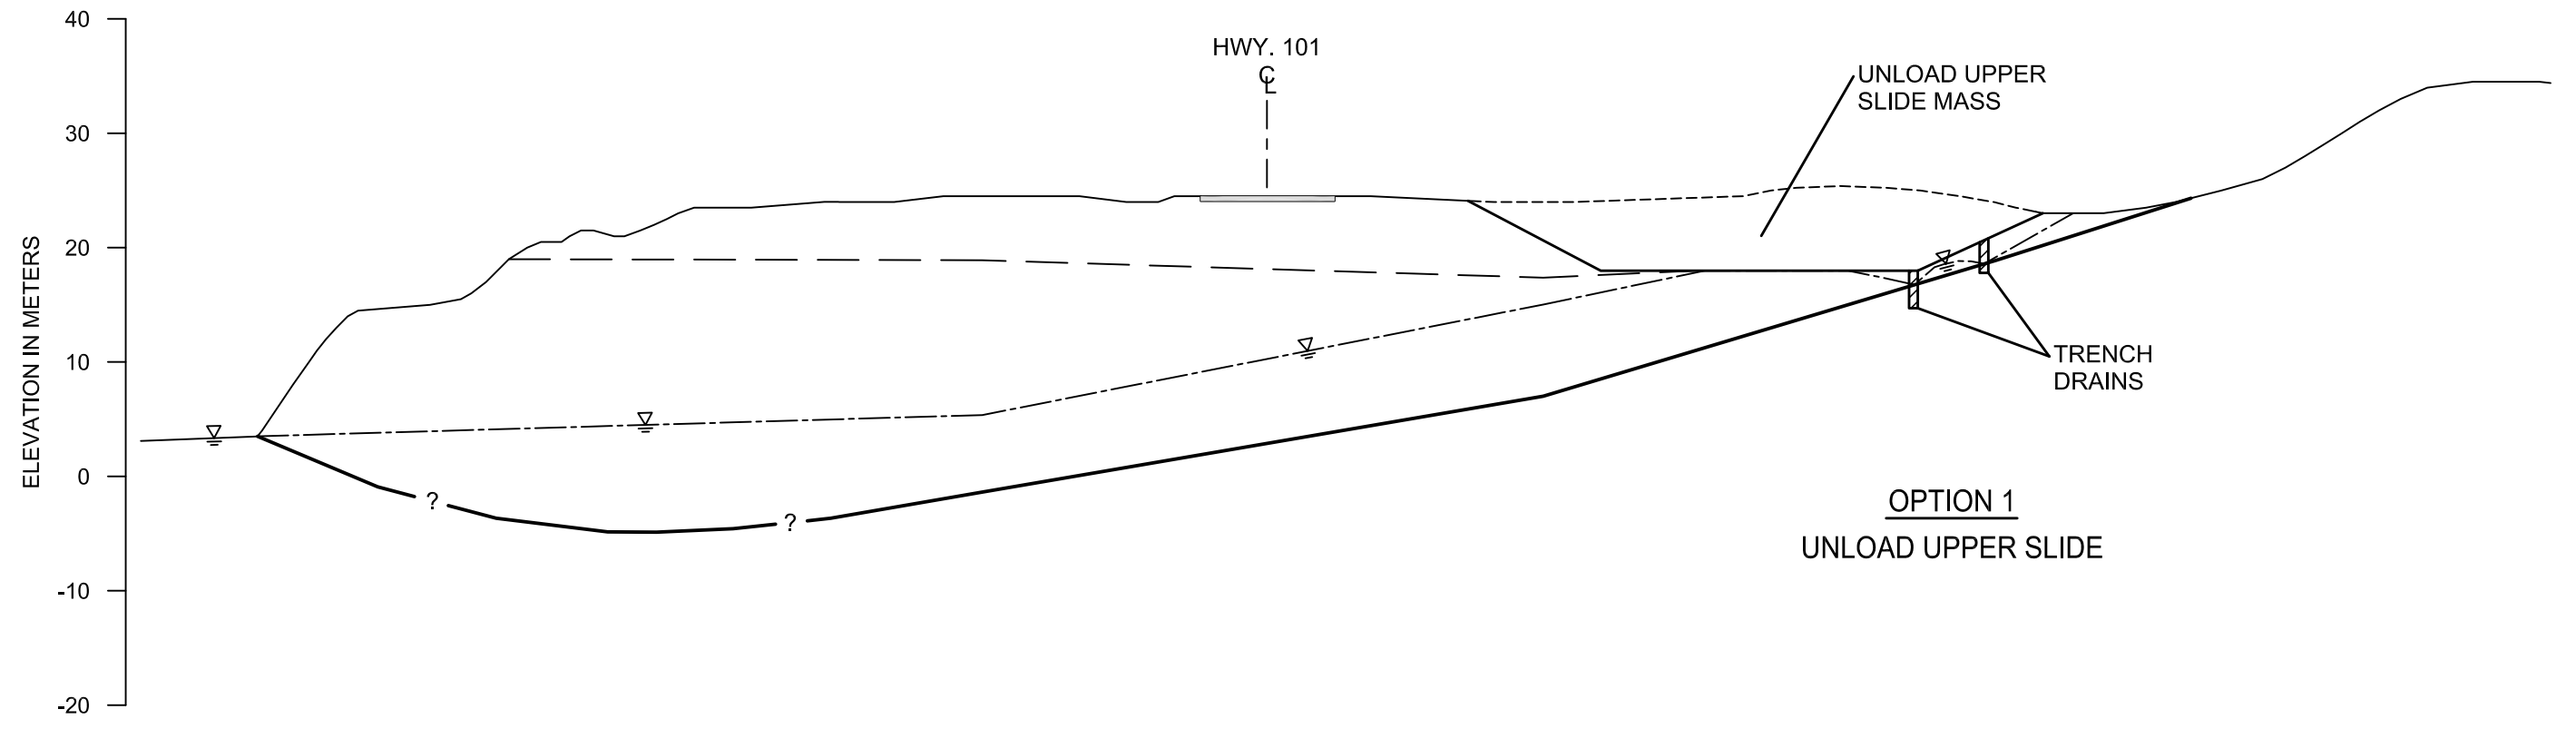
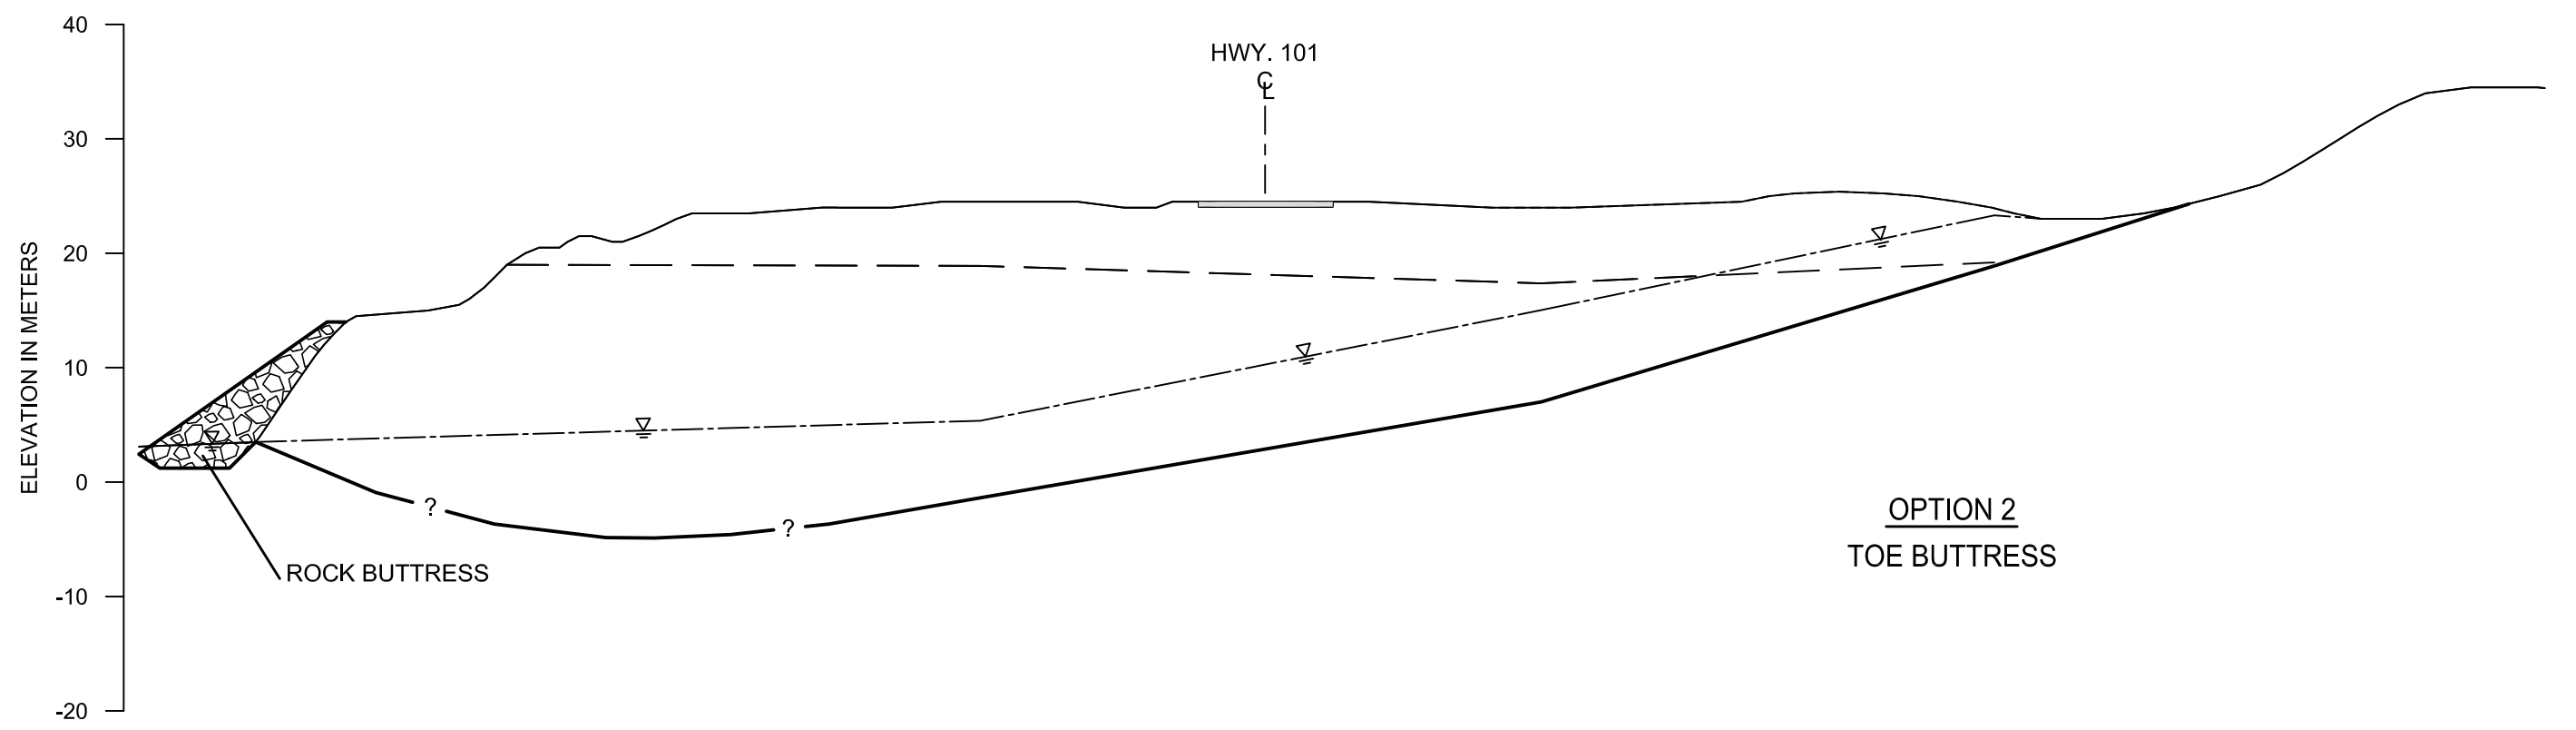
JUN 2003
PROJ. 1460
FIG. 20

**CONCEPTUAL
OPTIONS 1 AND 2**
JOHNSON CREEK LANDSLIDE INVESTIGATION
LINCOLN COUNTY, OREGON

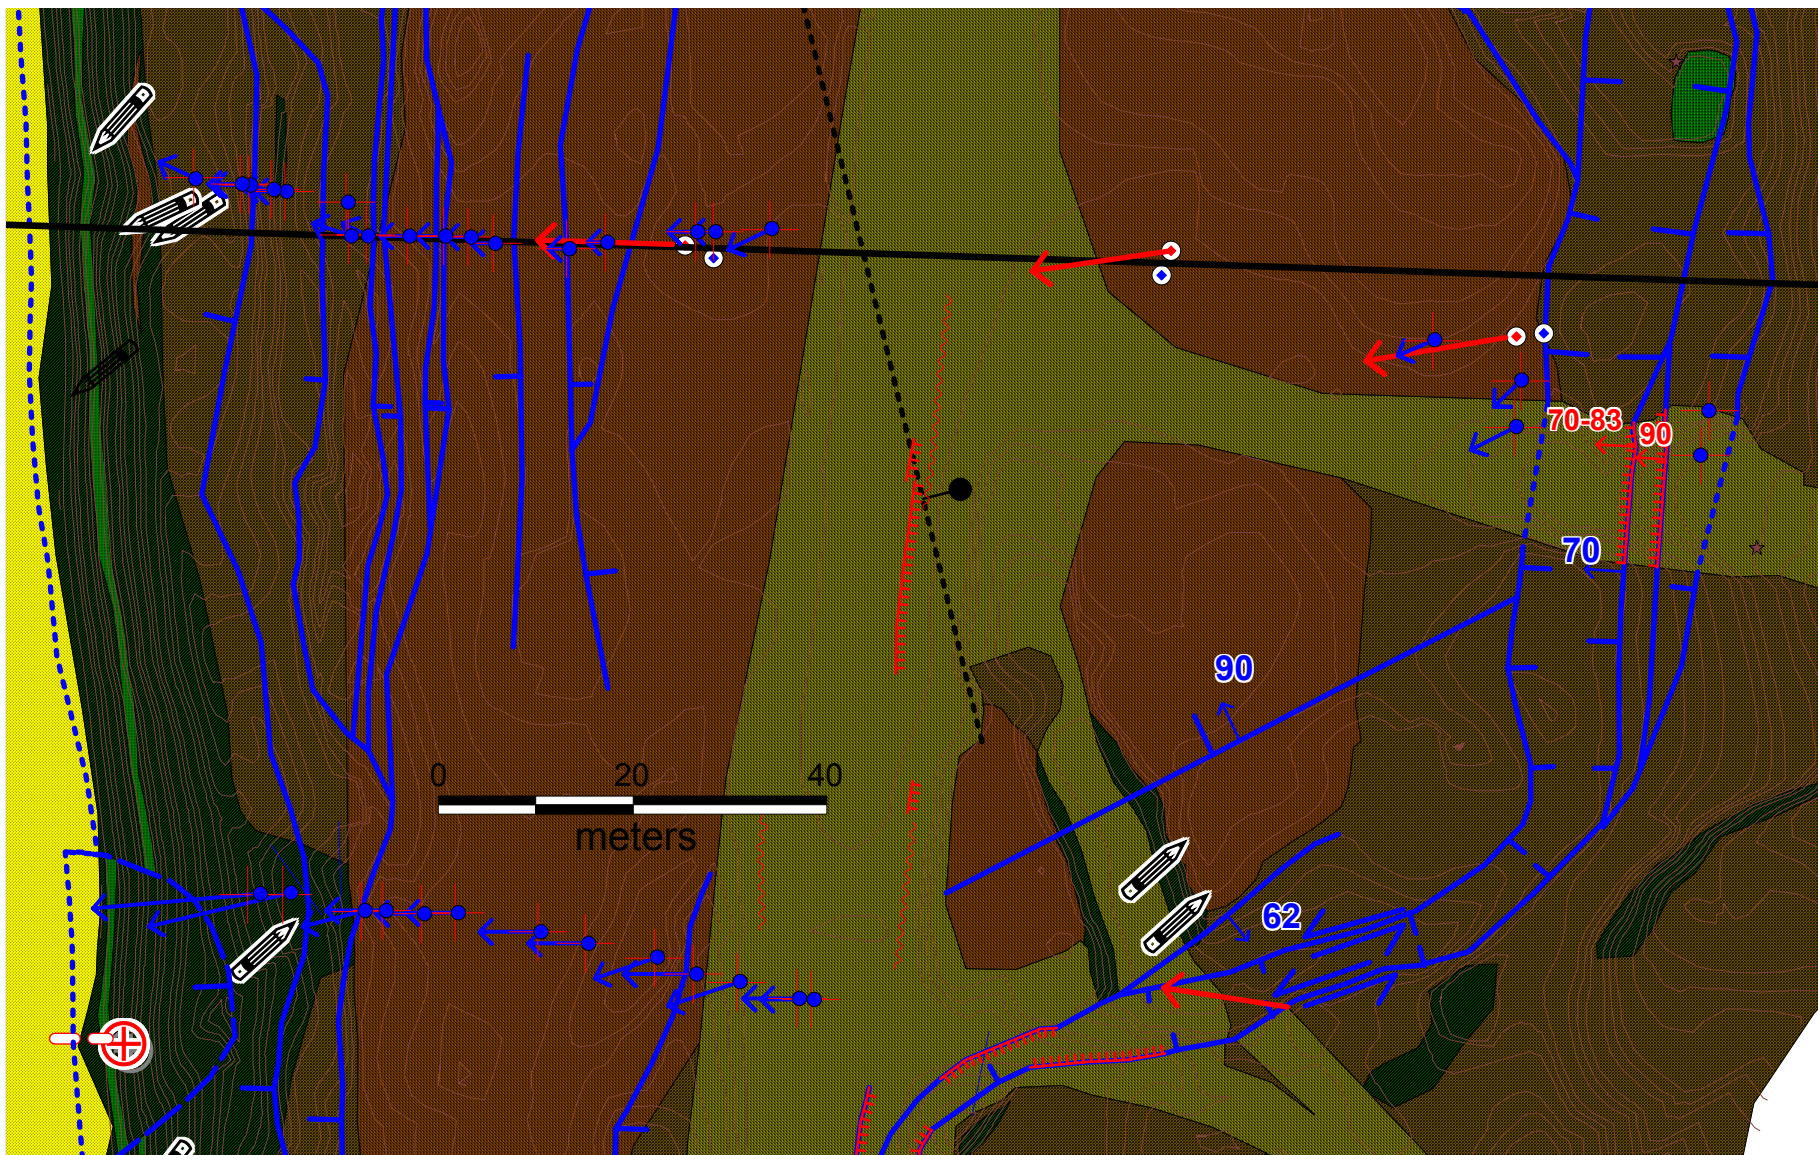
Qualitative overview of slide vectors from change in survey points between October, 2002 and April, 2003 (blue arrows). Red arrows at inclinometer holes are bearings from inclinometer data. Red arrow at south margin is qualitative displacement direction of old coast highway.

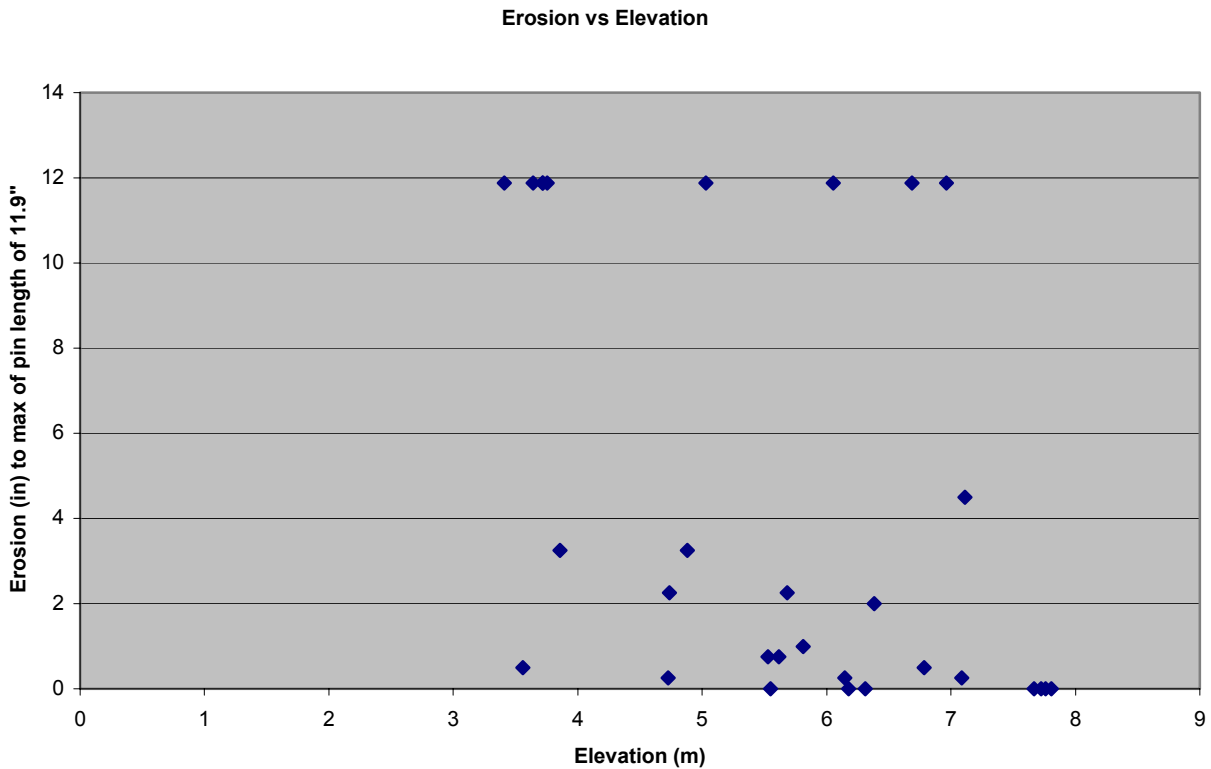
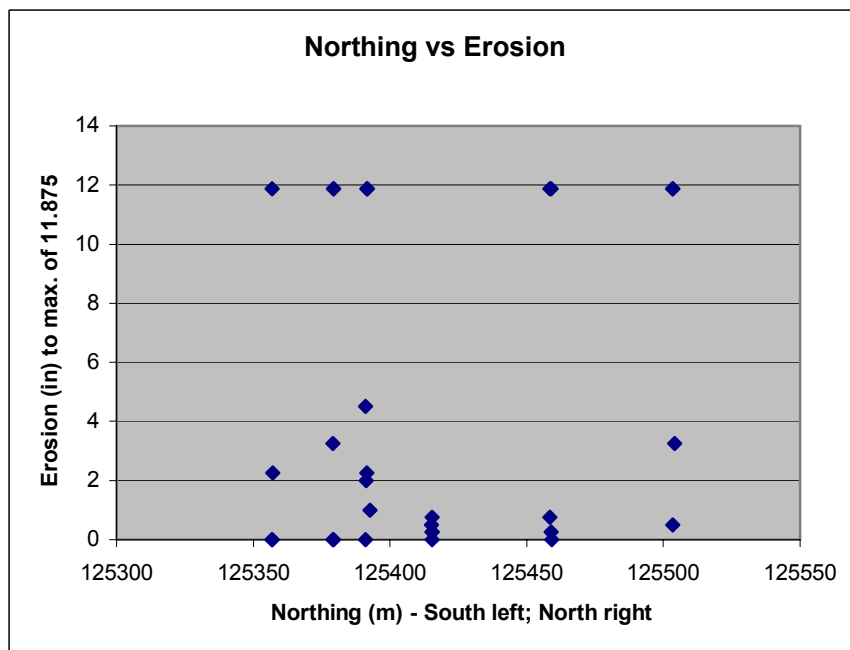
EROSION MEASURED BEHIND MARKER NAILS IN SEA CLIFF

Bluff erosion data for December 9, 2002 to April 10, 2003. Note no obvious correlation of erosion and bluff height or position north-south. The maximum length of pins was 11.875", so no larger amount could be measured; that is why there are a number of points at this value on the graphs. Where pins were gone, this was generally caused by a block of rock falling out of the sea cliff that was similar in size or larger than the pin.

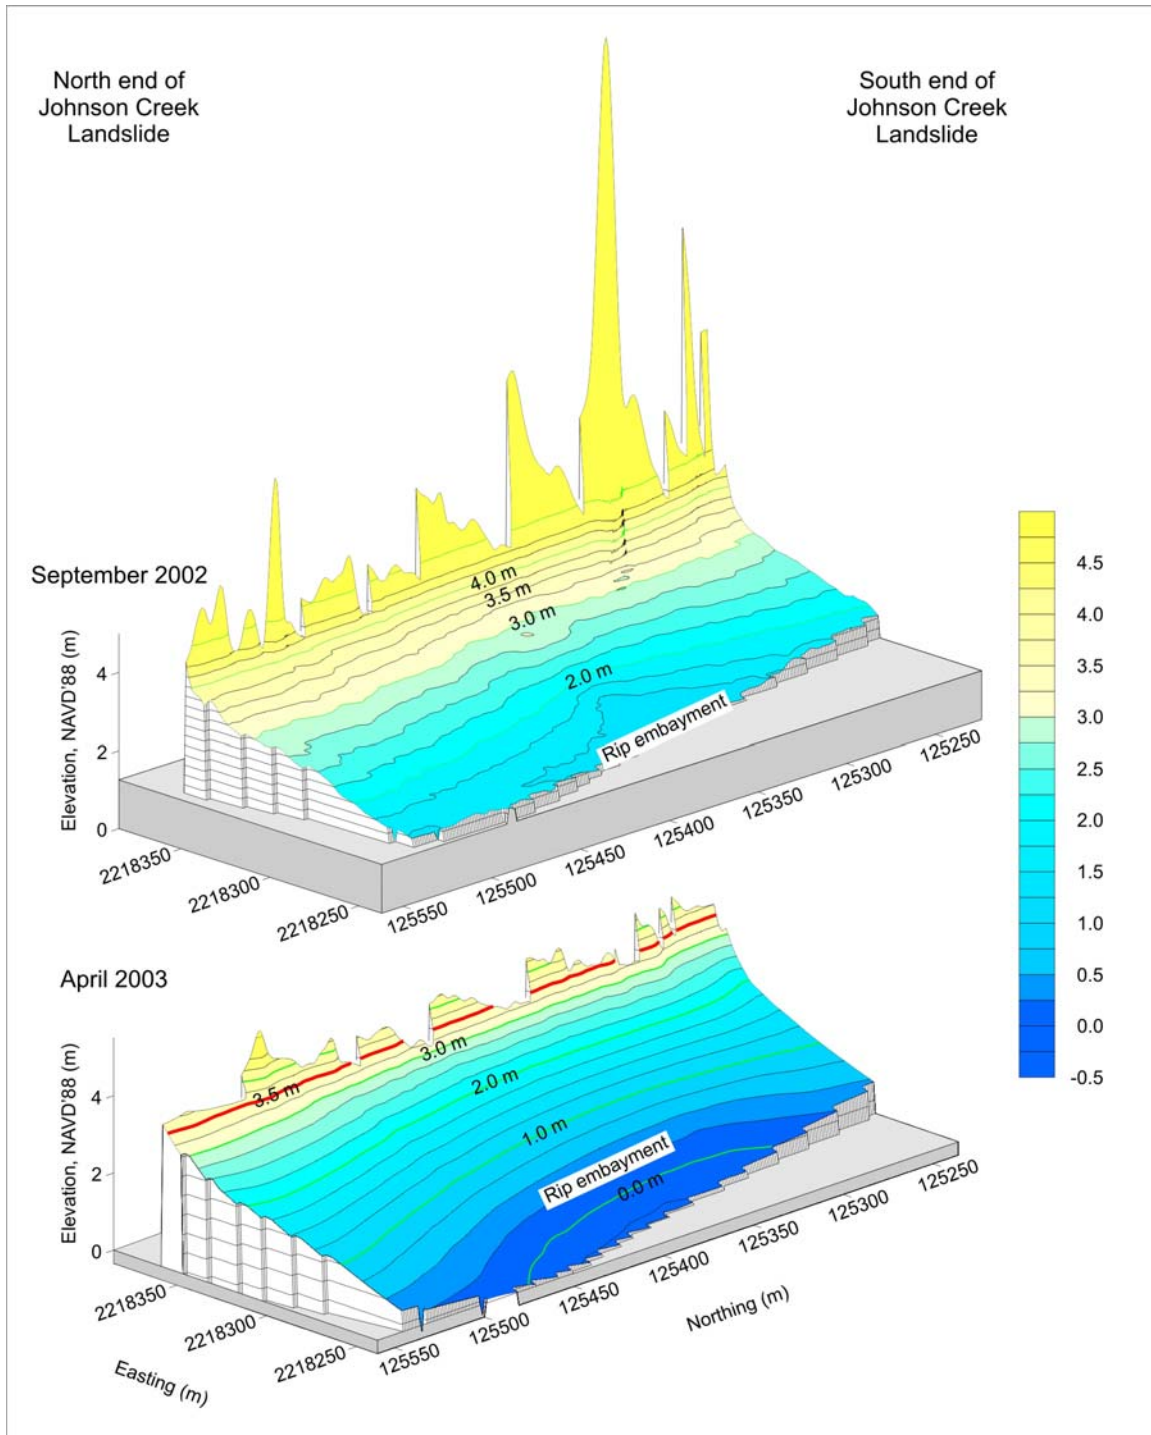
Figure 2: 3-D perspective overlooking the beach in front of the Johnson Creek landslide. View is towards the south-east. Contour elevations are 0.25 m, with 1.0 m contours delineated by the green line. The red line denotes the approximate location of the mudstone/beach contact in April 2003. The beach experienced a vertical drop of 1 – 2 m over the 2002-03 winter storm season.

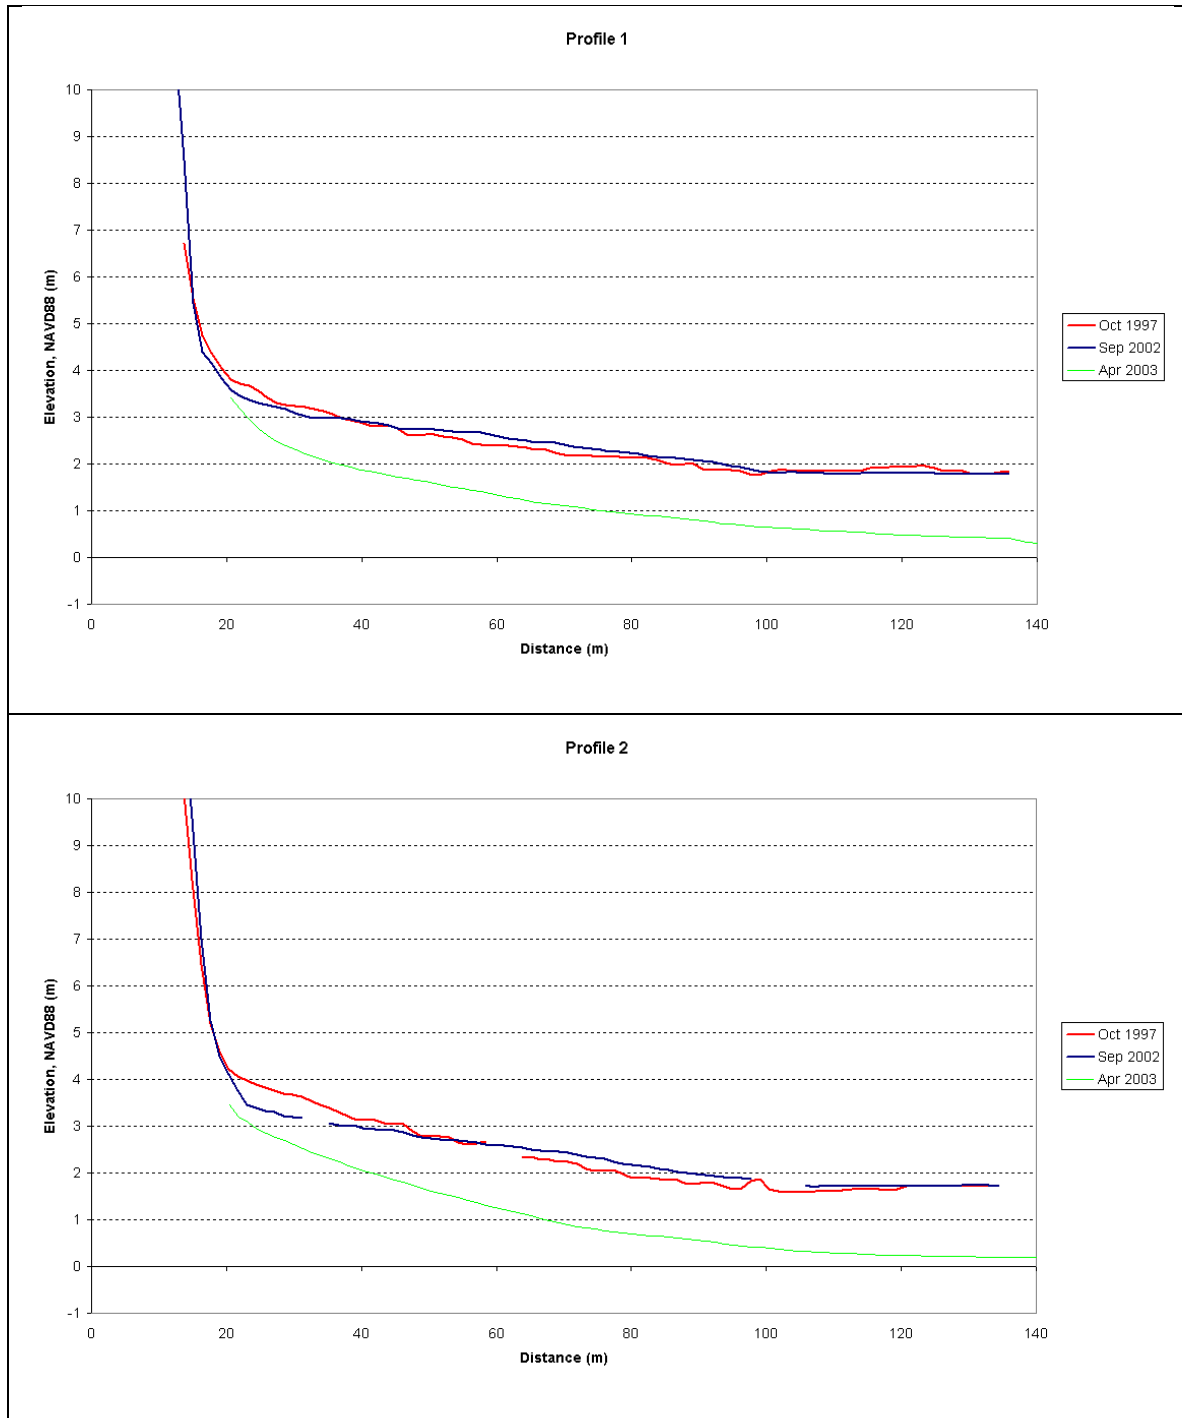
Figure 3: Beach profile surveys derived from LIDAR data and from the April 2003 topographic survey.
