OFR O-04-15

**REVIEW AND ANALYSIS OF THE WINSTON SLIDE
EVENT OF FEBRUARY 2, 2004**

Randy Moore and Vaughn Balzer
Oregon Department of Geology and Mineral Industries
Mineral Land Regulation and Reclamation

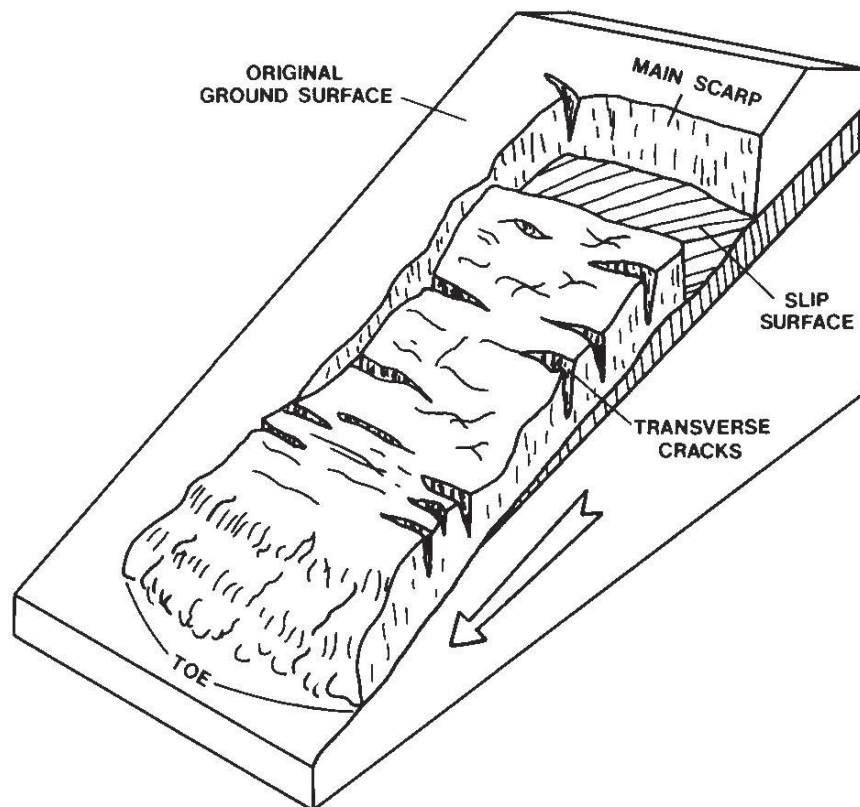
Figure 2. Schematic drawing of a typical translational slide

2. This slide would probably be classified as translational, a debris avalanche. A translational slide is a mass that moves down and outward along a relatively planar surface and has little rotation or backward tilting. It is depicted below in Figure 2.

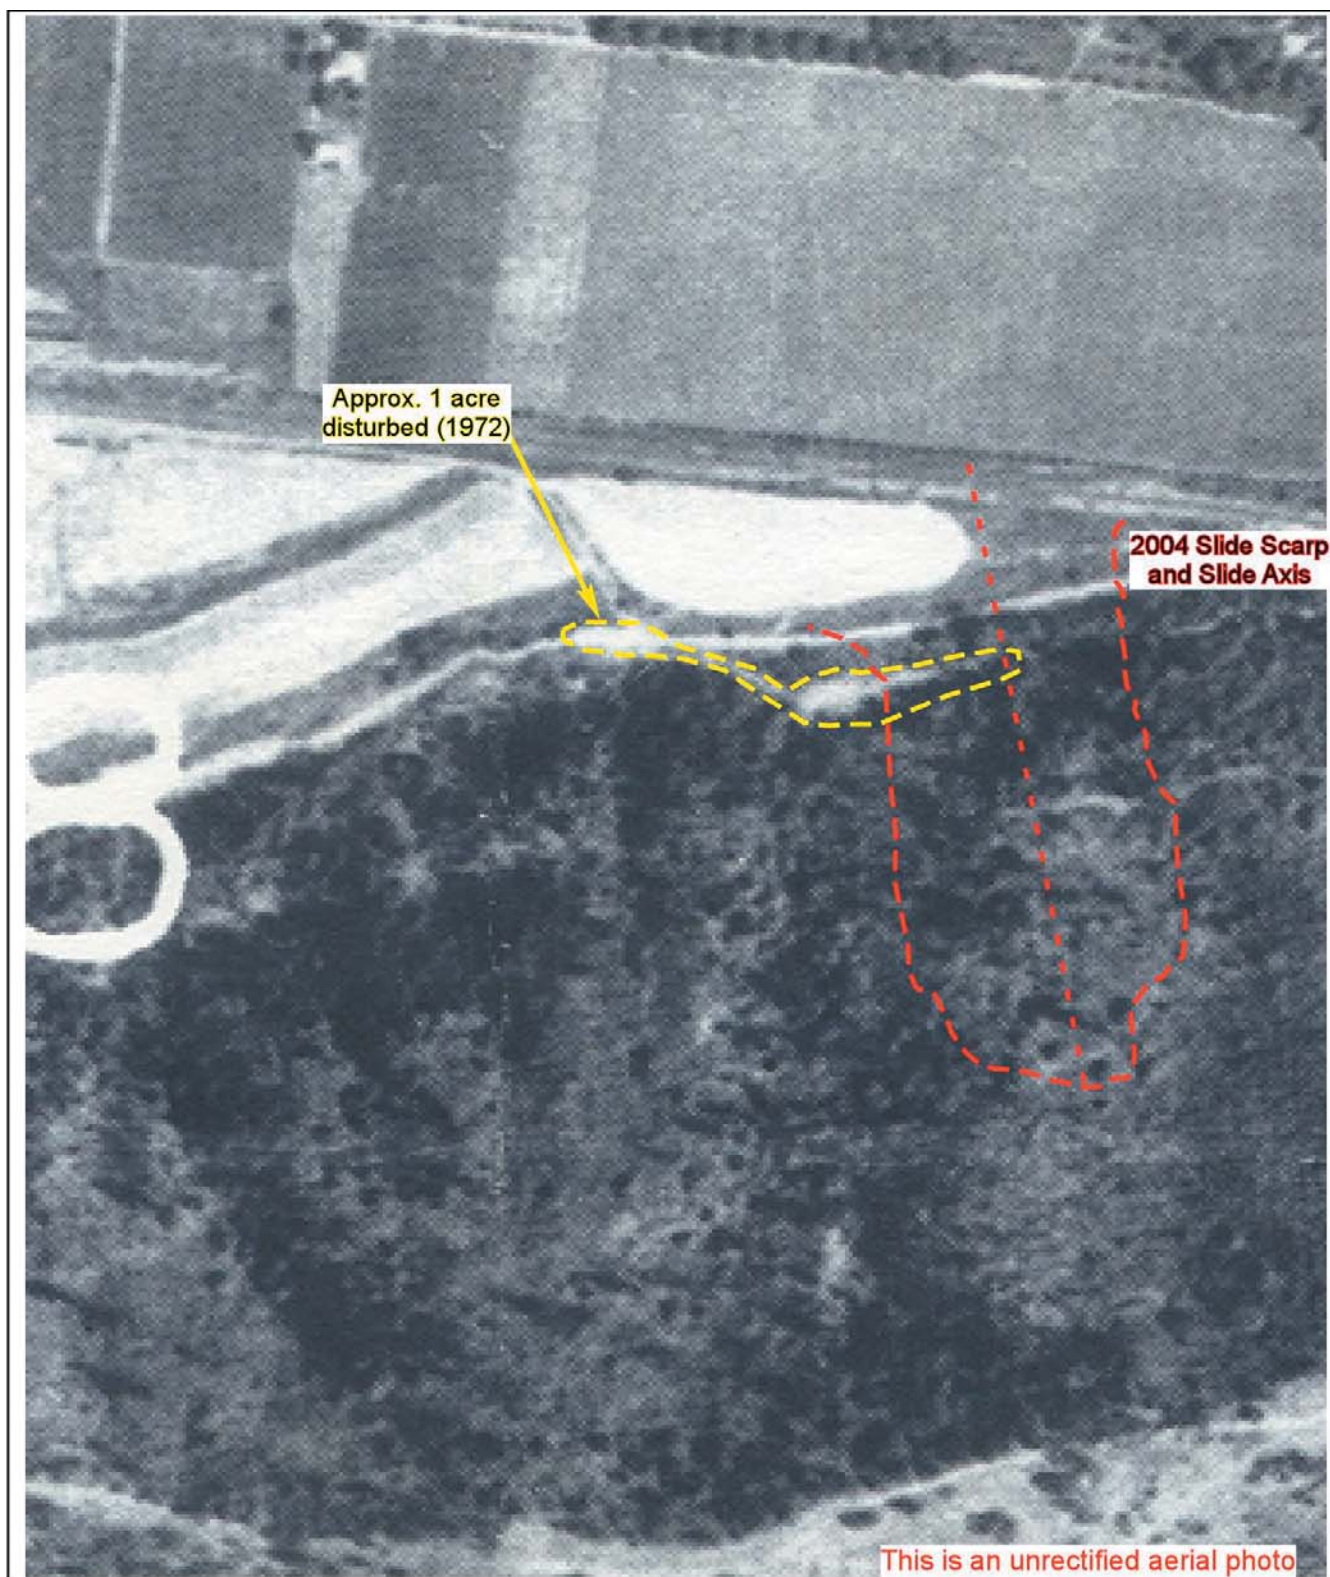
Figure 3.
 DOGAMI ID#: 10-0197
 Permittee: Sundance Rock Inc.
 Site Name: Winston
 Photo Source / Date: ODF? / 5-1972
 Prepared By / Date: V. Balzer / 3-23-2004

The site was originally mined prior to 1972 though no date has been established for the initial excavation at this site. The mining related disturbance visible on the 1972 aerial (Figure 3) consists of the initial development of a minor high wall, quarry floor, haul road and small stockpile area. This disturbance was approximately 1 acre in area and was confined to the base of the hill. Except for the noted disturbance, the site had a significant amount of vegetation at the base of the hill. This vegetation appears to consist of trees, shrubs and grasses and/or ground cover. On the hillslope there appears to be an older partially vegetated road cut above which vegetation, especially trees, are not as abundant indicating that the hill may have been logged several years prior to the date that this aerial was taken. There are also patches of bare soil and an interesting arcuate “gap in vegetation” visible above the road cut on the hillslope. The arcuate “gap in vegetation” appears to be located in approximately the same location as the 2004 slide scar and may be an indication that the slope had experienced or was experiencing some form of mass movement or instability prior to May 1972.

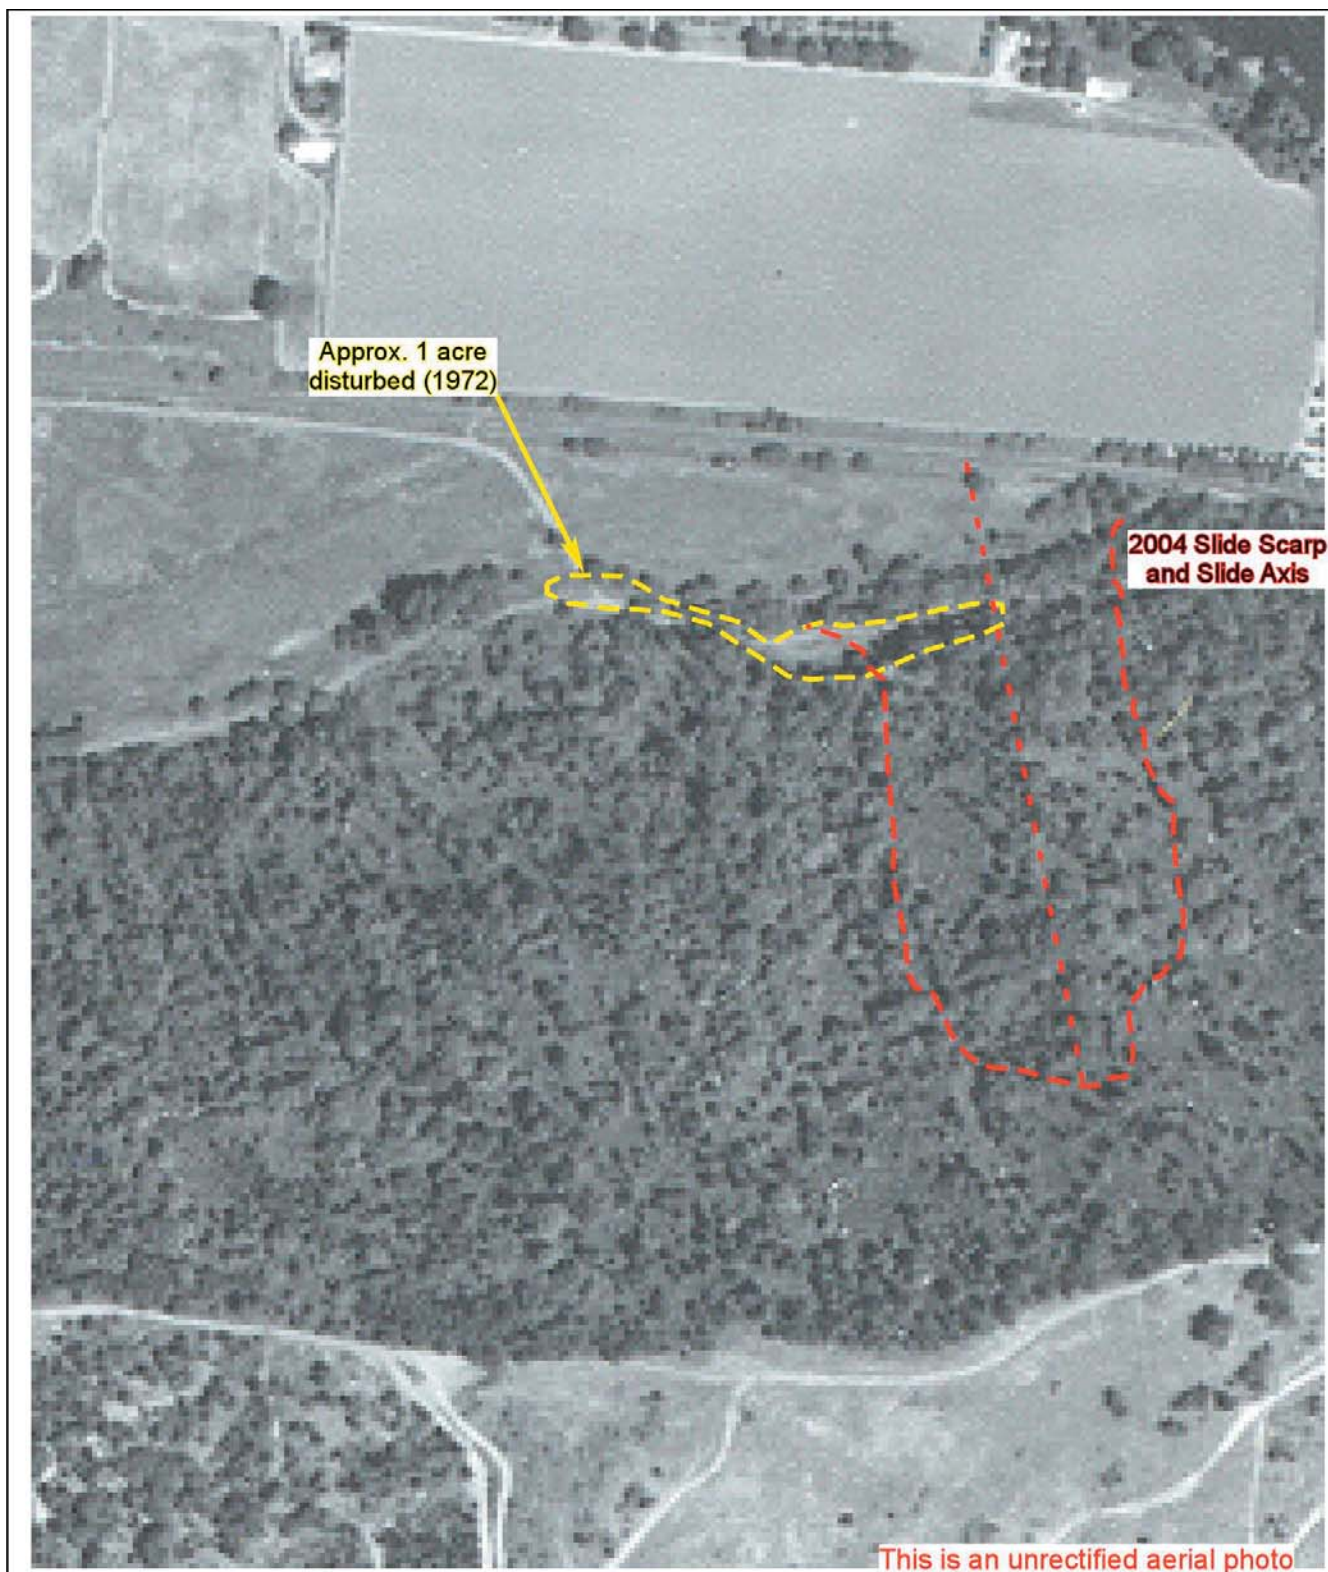
Figure 4.

Based on the 1995 aerial and inspection report, the site remained inactive or had very little activity between 1972 and 1995 (Figure 4). The only significant change was in the extent and type of vegetation cover. During this period ground cover vegetation has encroached on to the quarry floor and is clearly visible in ground photos taken during the initial site inspection of 12/12/1995. The quarry high wall is also clearly visible in the ground photos taken during the initial site inspection and was approximately 20-30 feet high prior to site permitting. The hillside appears to have a greater amount of vegetation especially trees and shrubs at the time of the inspection. The road cut on the hillslope and the “gap in vegetation” noted in the 1972 aerial are no longer visible partly due to the increase in vegetation and the fact that this aerial is of poor resolution as it had to be significantly enlarged to match the scale of the other aerials (see Table 1).

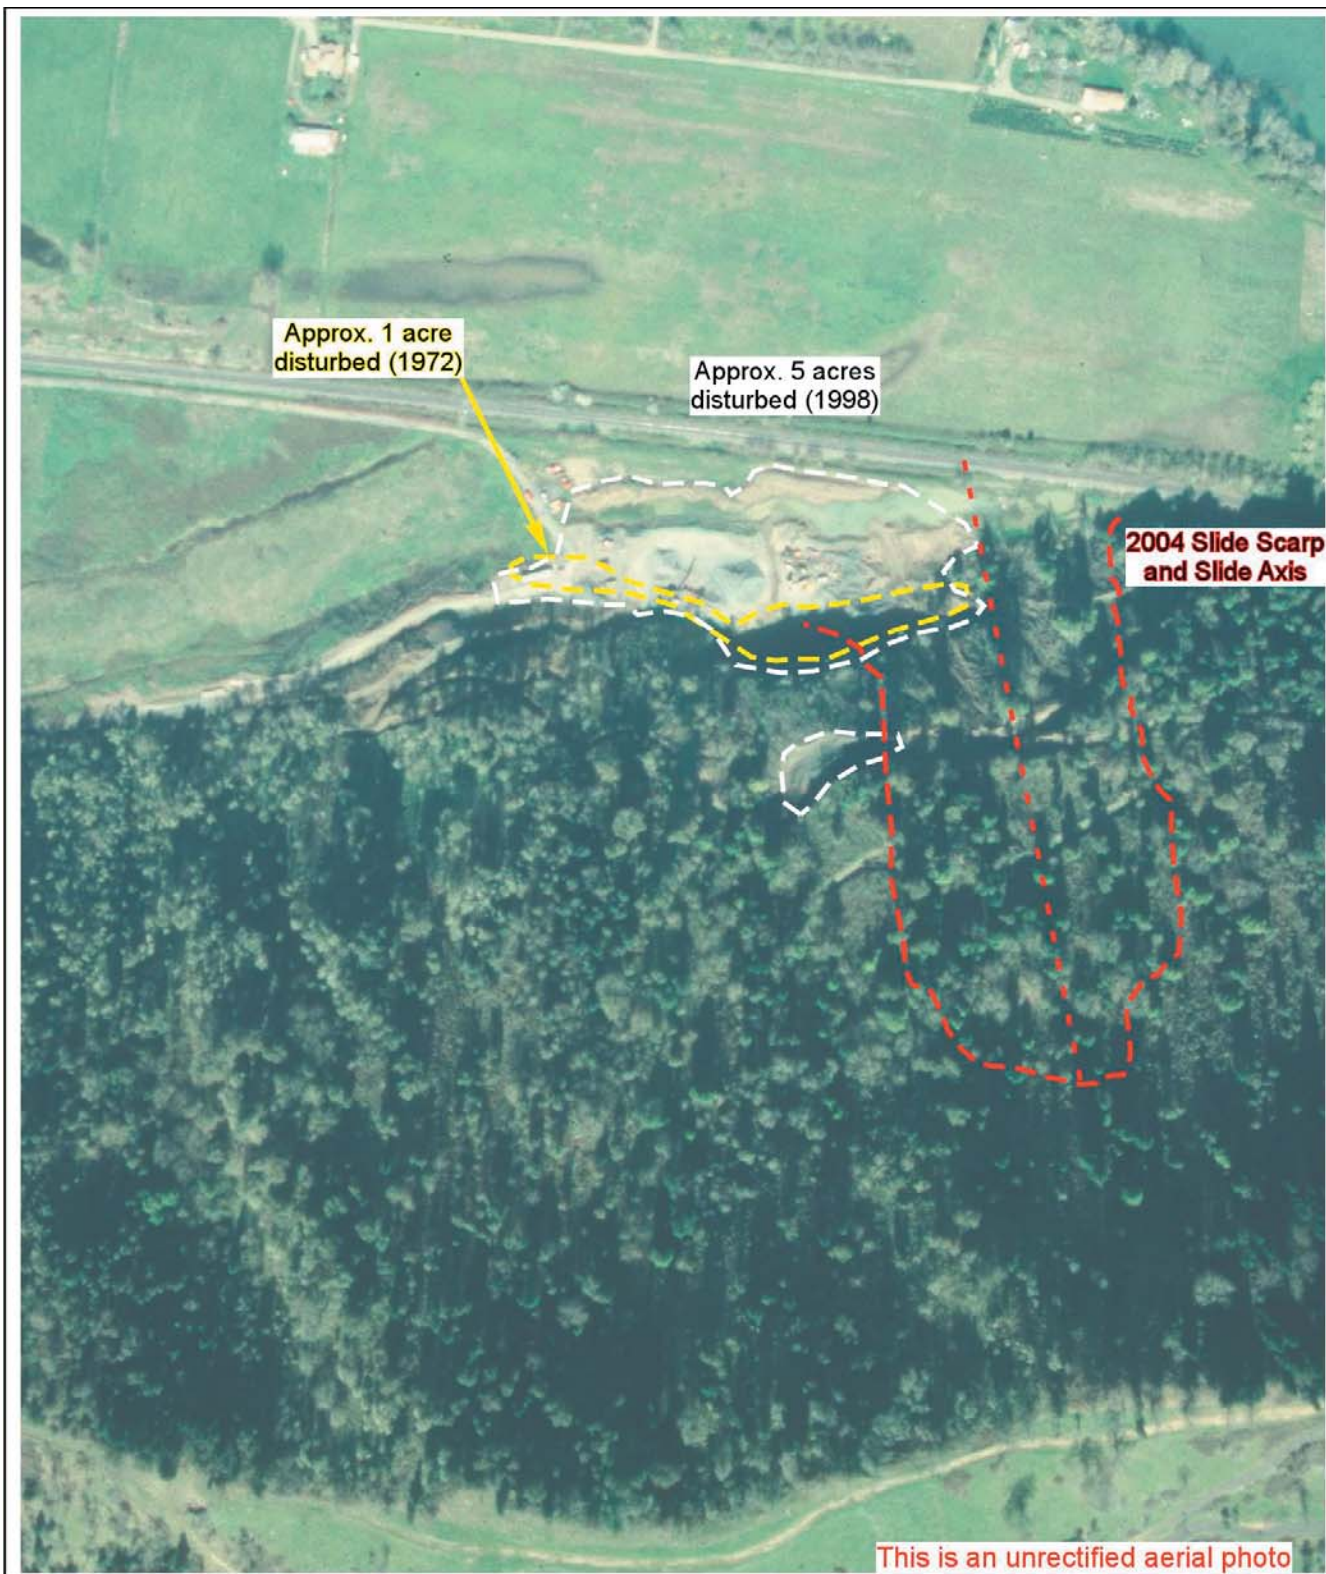
Figure 5.

nal high wall, construction of access roads on the hillslope, the initial development of the secondary high wall or bench approximately 80 feet above and slightly east of the original high wall (the approximate elevation of this bench is noted in the site inspection report of 9/9/1998), and the clearing of trees and shrubs on the hillslope. By the time of the 1998 aerial vegetation cover on the hillslope within the confines of the 2004 slide scar was reduced by approximately 20% as a result of mining activity when compared to the 1995 aerial.

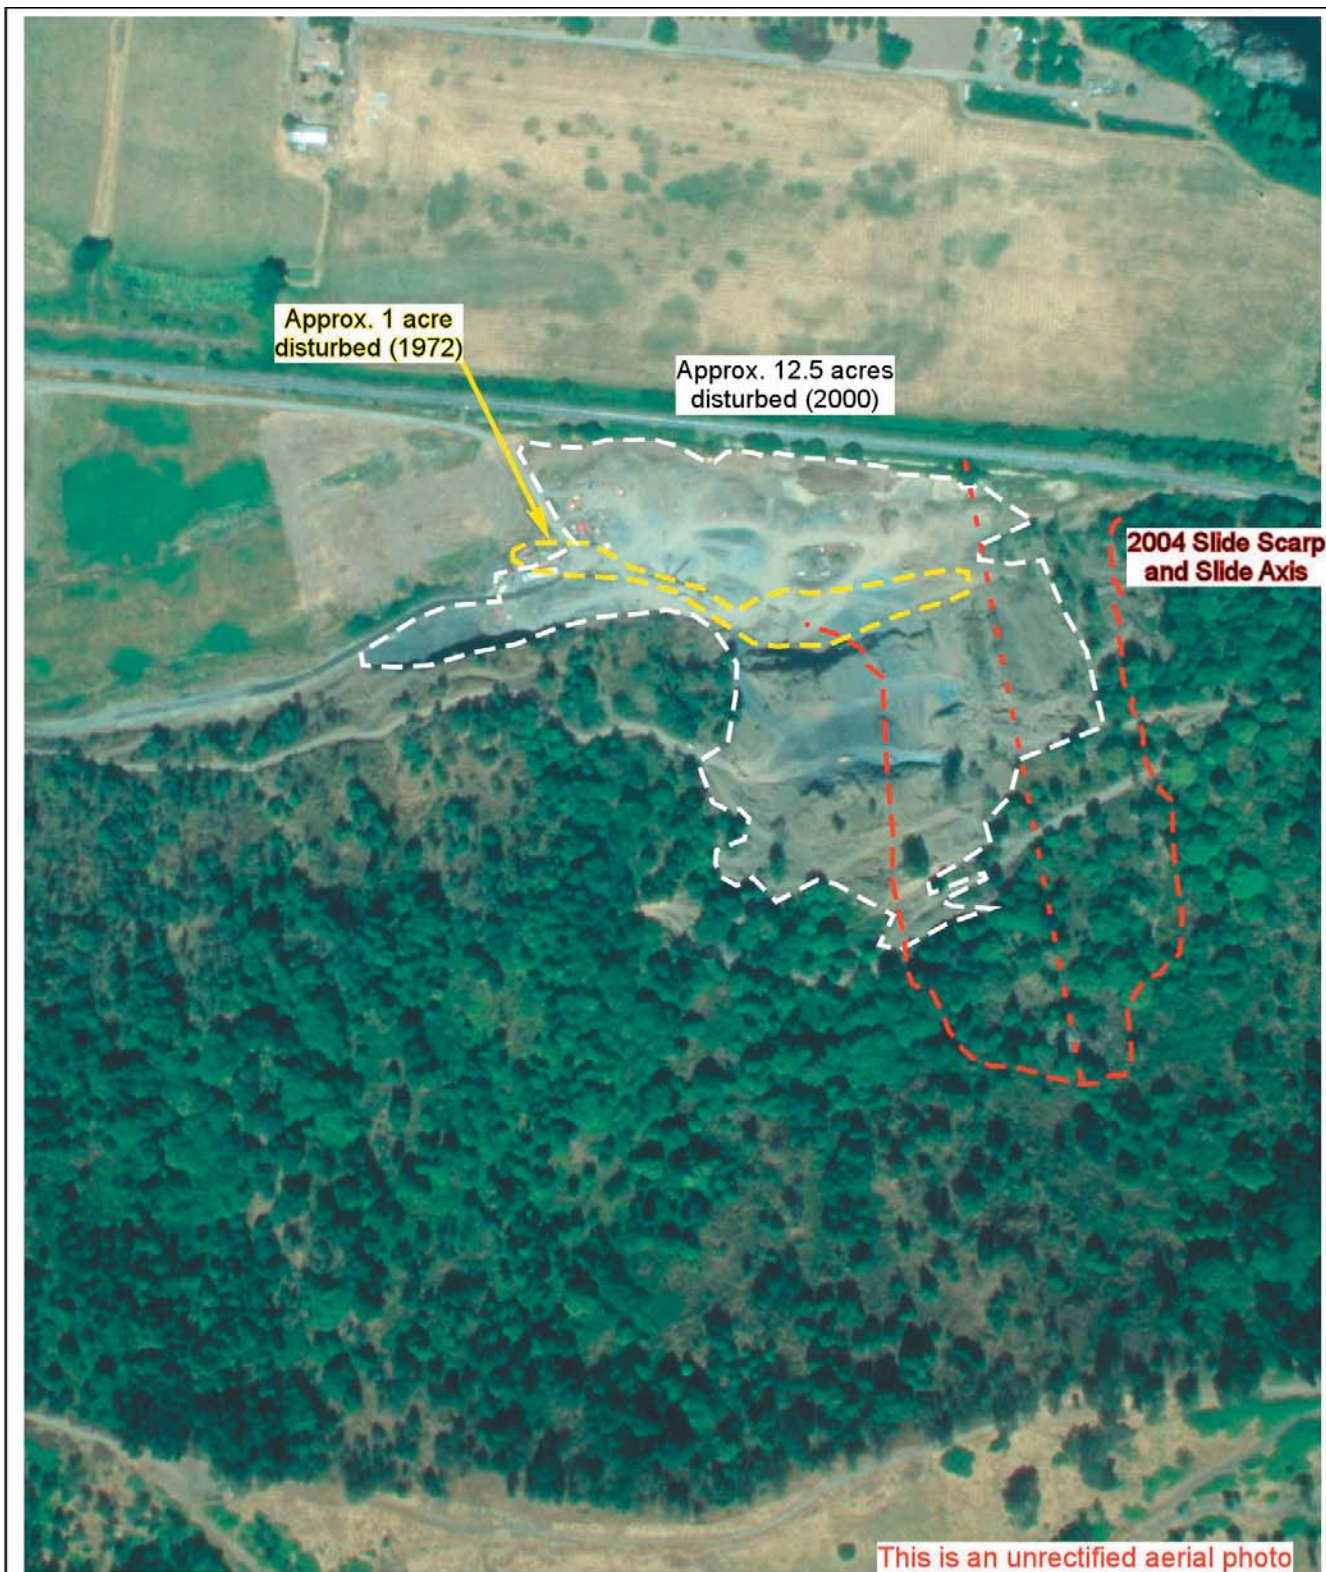
Figure 6.

This was a very significant period for mine site development and expansion with the area disturbed by mining more than doubling to 12.5 acres (Figure 6). During this period, mine site development was accomplished by expanding of the original quarry high wall, development of an additional high wall at the toe of the hillslope to west of the original high wall, expanding of the benched high wall, stripping of overburden, and continued stripping of vegetation. The original high wall continued to be mined into the hillside, however, the bulk of mine site development during this period occurred both up slope and to the east of the original high wall. One exception to this was the development of an additional high wall at the base of the slope to the west of the original high wall and outside of the confines of the 2004 slide area. Mine site development both up slope and to the east of the original high wall was well within the confines of the 2004 slide scar and included expansion of the benched high wall into the hillslope and a substantial amount of vegetation and overburden stripping. Both material mined from the benched high wall and material (overburden) stripped from the hillslope above the benched high wall to the east of the original high wall was side cast down to the of the original quarry floor. Places where material was side cast are clearly visible in the 2000 aerial

as bare slope material at the angle of repose. By the time of the 2000 aerial vegetation cover on the hill within the confines of the 2004 slide scar had been reduced by approximately 50 % as a result of mining activity when compared to the 1995 aerial. Also visible in the 2000 aerial is an arcuate “gap in vegetation” at approximately the same location as both the arcuate “gap” in vegetation” noted in the 1972 aerial and the location of the 2004 slide scar. This observation suggests that the hillslope was unstable by the date of the 2000 aerial photo.

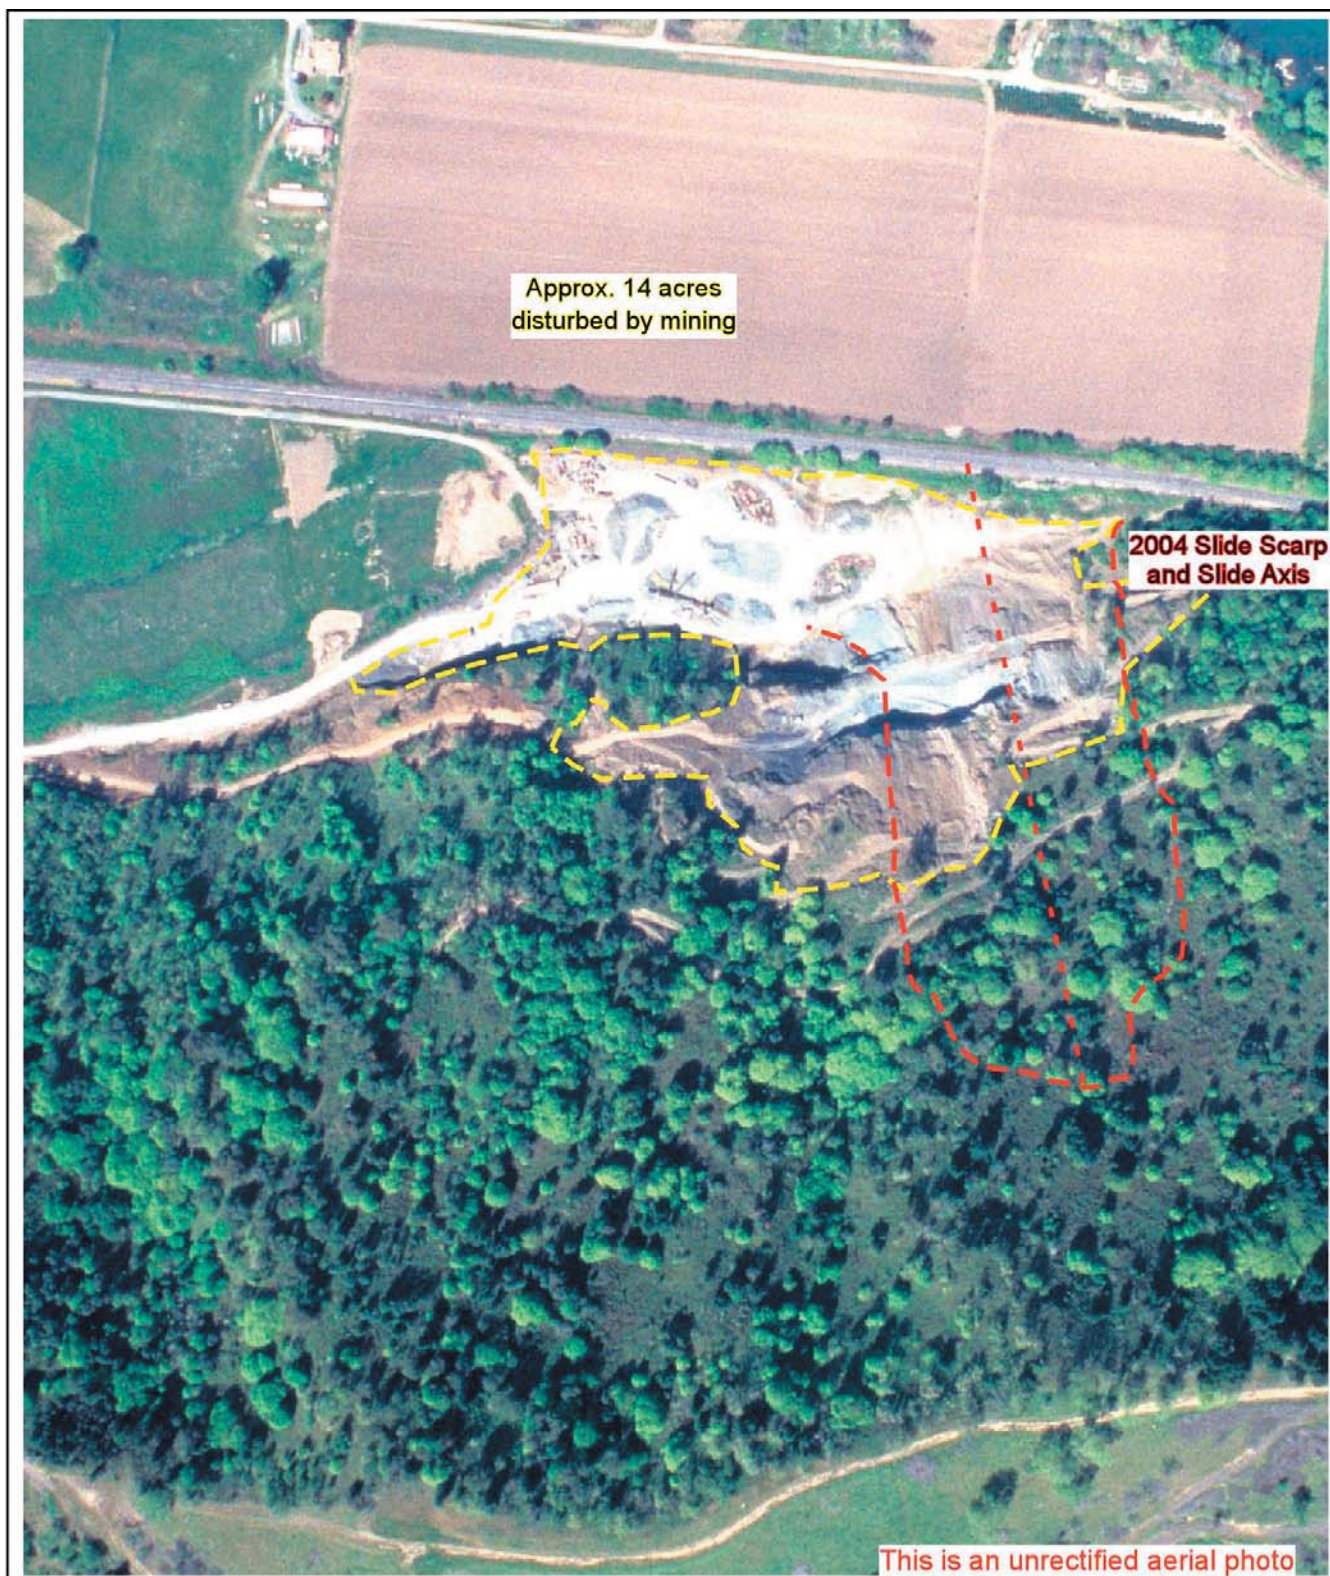
Figure 7.

2. Adjoining landowners reported that along the eastern edge of the failure there was movement over at least one year before the slide. The overburden material traveled down slope where it was collected and sold as fill material. This is supported by both a series of cracks which developed along the eastern margin of the slide between 2000 and the time of the failure (See Appendix A, Figures 6 and 7), and a DOGAMI inspection report dated 9/9/1998 which quoted Lyle Jefferies of Sundance Rock saying that a small slide of overburden had occurred along the eastern margin of the operations. The cracks are observable on the aerial photographs where they cut across both the access roads and the hillside (See Appendix A, Figure 7).

During this period, the aerial extent of land disturbed by mining increased only modestly from 12.5 acres to 14 acres (Figure 7). Despite this fact there was a significant amount of mine site development. Both the original high wall and the benched high wall were worked into the high slope and expanded to the east. By the date of the 2002 aerial the benched high wall had been expanded to the east across axis of the 2004 slide scar (Figures 8 and 9) and overburden directly above this high wall had been stripped down to bedrock almost all the way to the eastern margin of the slide scar. Only minor amounts of vegetation stripping on the hillslope occurred during this period of mine site development. The arcuate gap in vegetation noted on the 2000 aerial is not as visible as it was in the 2000 aerial and ground cover vegetation has grown over portions of this feature.
