Open-File Report O-07-04

**PORTLAND STATE UNIVERSITY MONTGOMERY COURT
SEISMIC REHABILITATION PROJECT, PORTLAND, OREGON**

By
Yumei Wang¹ and Christopher J. Heathman²

2007

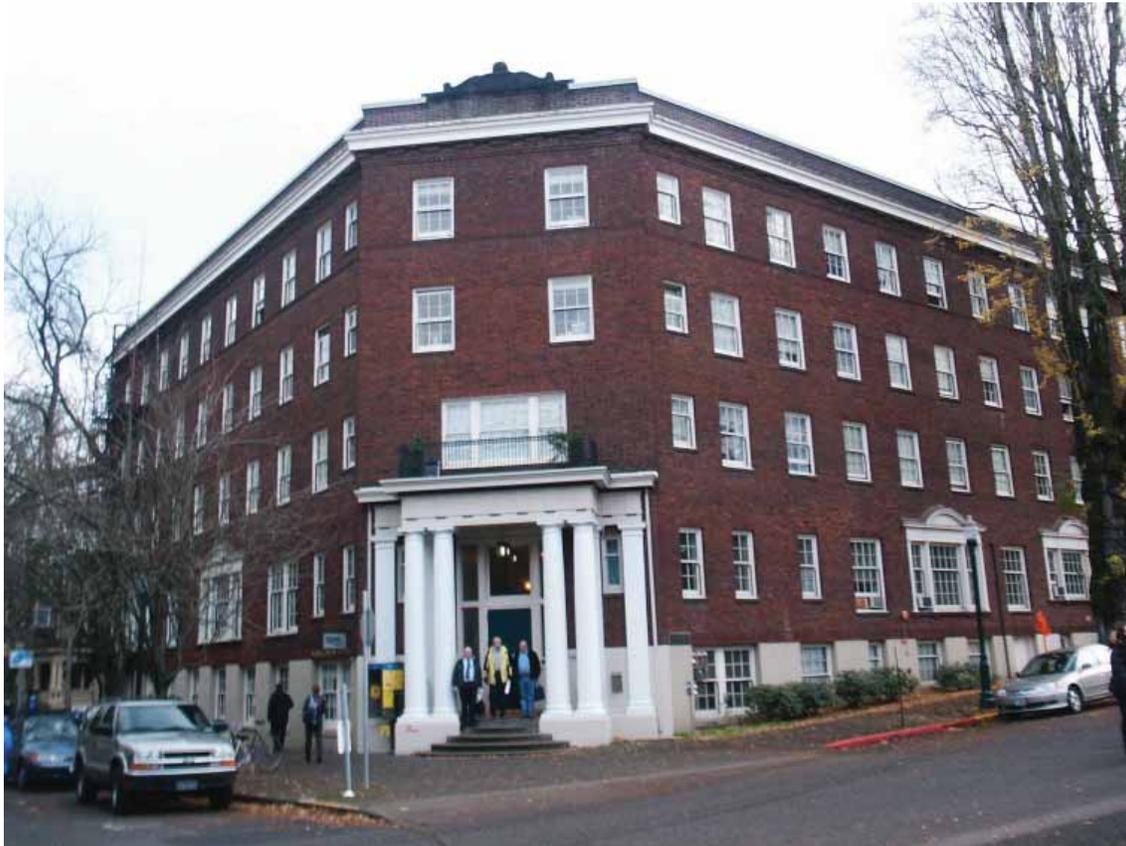
Figure 1. Montgomery Court residence hall on the Portland State University campus.
Photo taken from the northwest.

Montgomery Court was determined to have serious deficiencies and potential for complete collapse during the next major seismic event. It was identified as a high-priority building to rehabilitate on the basis of year-round student occupancy and URM construction type. Furthermore, this building is an integral part of the PSU community: it is a public service building, houses students, and has historical value. If this building were damaged and became dysfunctional following a seismic event, the entire community would be negatively impacted. In addition, the building is adjacent to a major pedestrian walkway, and the unusually tall, unreinforced masonry parapets posed a significant falling hazard.

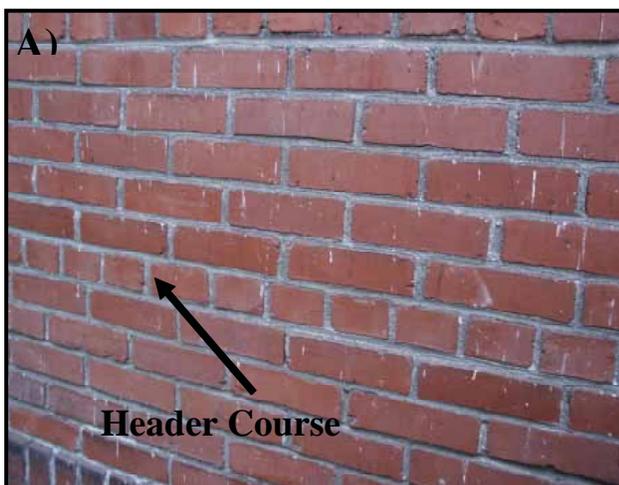
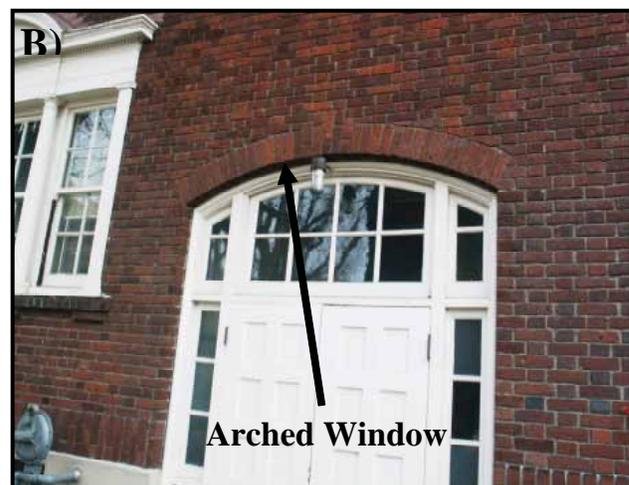
Arched windows in older brick buildings indicate that the building is likely to be a URM because a window is not strong enough to support heavy bricks stacked on top of it. An arched pattern of bricks above the window prevents the wall from collapsing downward into the open window space. Figure 3 shows the typical features of a URM building.

Figure 3. Typical features of unreinforced masonry construction. (A) header course (B) arched windows.

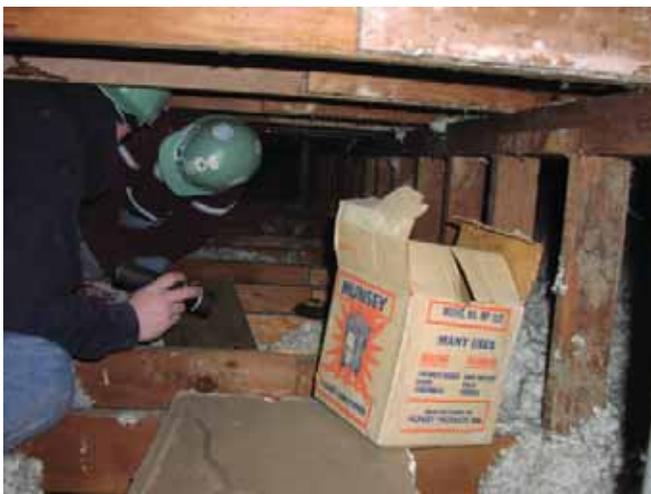
KPFF's findings indicated that the existing roof was completely unanchored and that the fourth floor ceiling was poorly anchored with unbraced, unsheathed pony walls connecting the roof and ceiling framing. Also, using the 1997 Uniform Building Code methods (ICC, 1997), the design level force on the wall anchors was determined to be inadequate. In addition, the roof parapets and other falling hazards such as chimneys and ornaments were poorly attached, and it was estimated that little or no lateral support would be available to prevent them from falling to the ground below. KPFF's findings suggested seismic rehabilitation was needed. However, until the FEMA PDM grant funding became available, no additional work or studies were completed on the building.

Figure 5. Exploration of the top diaphragm connections in attic space below the roof.

WDY Structural and Civil Engineers was hired by PSU to determine appropriate mitigation solutions. The attic space was explored, and it was confirmed that the top diaphragm was not adequately connected to the URM walls (Figure 5). Stairwell walls were examined, and it was determined that there was little or no support available to prevent collapse during a seismic event. This was a major concern because available egress must be available for safe evacuation directly following an earthquake. Because the roof, walls, and high parapets were not structurally tied together, they would likely be damaged if they were not strengthened. Ultimately, it was decided to address significant weaknesses in the parapet bracing, roof anchorage, roof diaphragm improvements, chimneys, and selected architectural features.

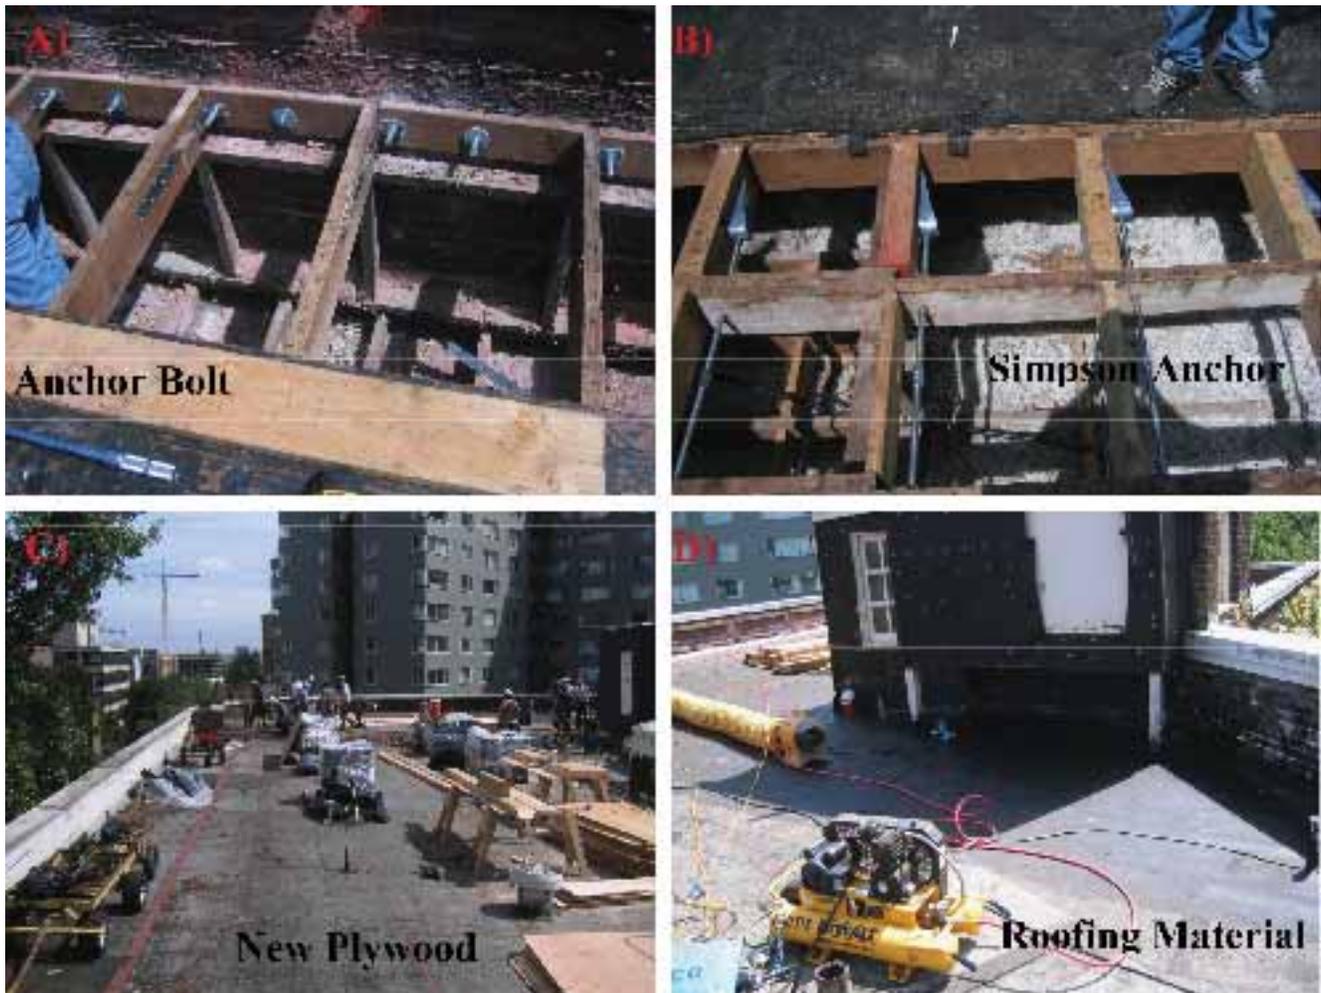
Figure 6. Construction activities on the roof of Montgomery Court. (A) tying the diaphragm into the existing unreinforced masonry wall, (B) installation of long mechanical anchors with anchors and threaded steel rods, (C) placement of structural plywood, and (D) new roof sheathing.

The top diaphragms (horizontal member) were tied in at both the roof and the ceiling of the fourth story. Long mechanical anchors with threaded steel rods were used to secure the new roof joists to the URM walls. Couplers were used as necessary to connect individual threaded rod segments. Epoxy-coated anchor bolts were installed to connect the steel rods to the existing URM walls. A new structural plywood roof was placed on top of the existing roof deck. The new roof was required for adding new anchors to secure the parapets and falling hazards, such as ornaments and the URM chimneys. New sheathing was also installed along the entire surface of the roof, including the access tower.

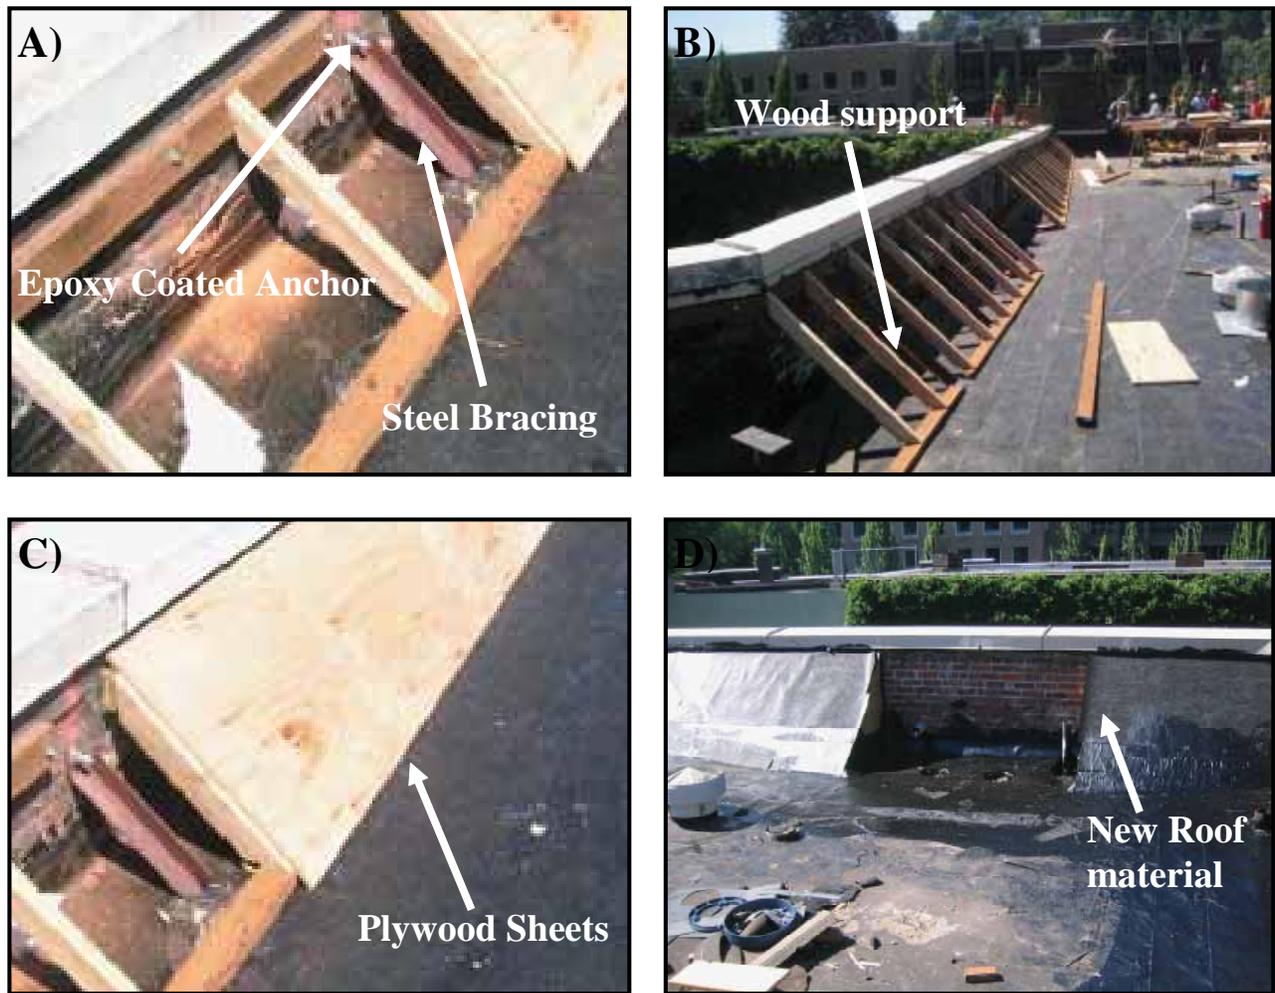
The existing URM parapets, which are about 6 feet tall, were secured at the roof level around the perimeter of the building to mitigate a major falling hazard. Figure 7 shows the construction materials used for securing parapets.

Figure 7. Construction materials used for securing the unreinforced masonry parapets on the roof of Montgomery Court.

were spaced at 48 inches on center. In a few locations due to special circumstances, it was necessary to use a longer spacing of 60 inches.

The steel bracing was covered with 1/2-inch plywood sheets on a diagonal. Then, new roofing material was applied to provide corrosion protection. This covered configuration is easier to maintain and eliminates the possibility of individuals tripping on the new bracing. Small, 2-inch thick, wood support blocks were nailed to the roof and anchored to the parapets in order to connect the plywood sheets to the existing roof and parapets. Two-inch nails were used at regular spacing to connect the plywood sheets to the wood blocks.

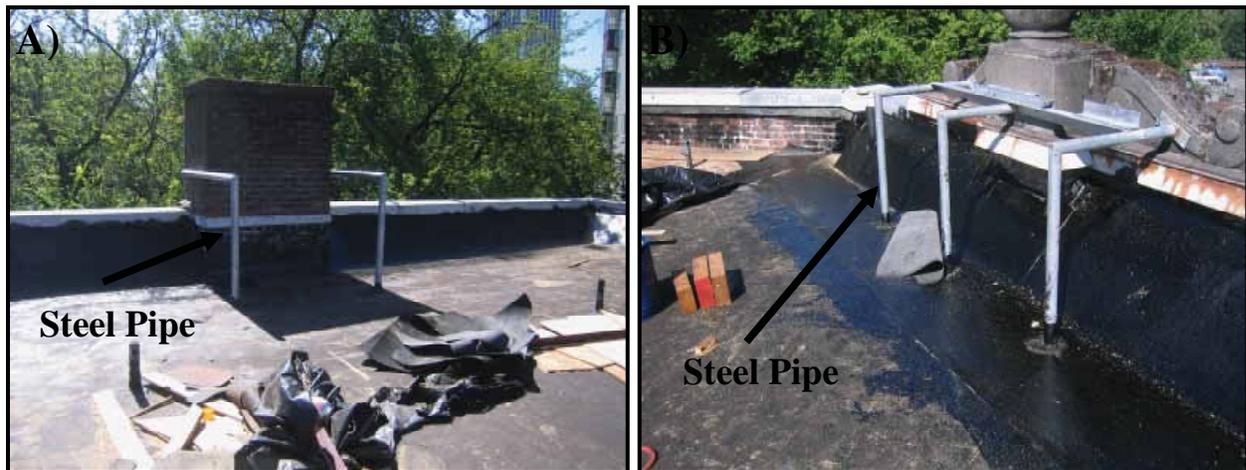
In addition to the tall URM parapets, Montgomery Court includes a variety of other falling hazards. The more notable falling hazards include several concrete ornaments and an URM chimney. Figure 8 shows the bracing used to anchor falling hazards.

Figure 8. Bracing used to anchor falling hazards on the roof of Montgomery Court: (A) chimney and (B) ornament bracing.

The falling hazards were secured at the roof level around the perimeter of the building. Standard 2½-inch diameter galvanized steel pipe was used to brace these features to the existing roof joists. As with the parapet mitigation, a portion of the roof was removed around the entire perimeter in order to expose existing wood joists. Epoxy-coated anchor bolts were then used to connect the galvanized steel pipe to the falling hazards, and 3/8-inch bolts were used to connect to the existing wood joists.

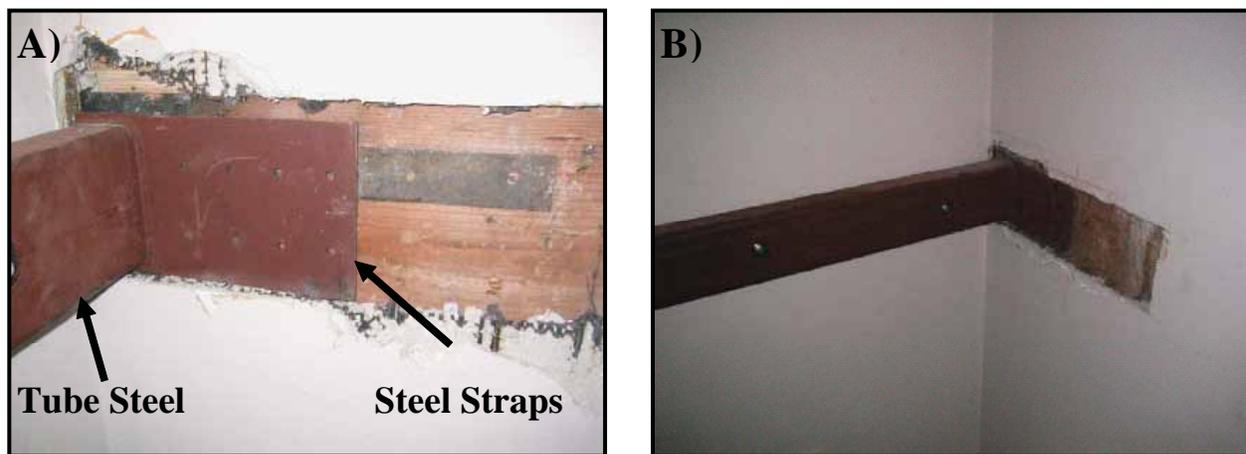
It is critically important to maintain clear, usable egress after an earthquake, especially in URM buildings, which are expected to incur damage. Before mitigation, Montgomery Court had three structurally inadequate stairwells serving as exit paths. For this project, the walls in each stair towers were reinforced by installing structural walls next to the existing walls. Steel bracing was also added for two of the stairwells. In these cases, tube steel was epoxy anchored into the URM wall, and steel straps were bolted to the wood. Figure 9 shows construction of stairwell reinforcement.

Figure 9. Construction of stairwell reinforcement in Montgomery Court. (A) close-up of tube steel and steel straps, and (B) broad view of stairwell reinforcement at corner.

Most of this work was conducted in the stairs or adjacent corridors. However, it was necessary to mitigate some of the walls in the apartment units adjacent to the stairs. In these cases, it was necessary to remove the trim on the affected wall in the unit and construct a new wall adjacent to the existing wall. New walls were finished with new paint and trim.
