APPENDIX F: LINE-OF-SIGHT SURVEYS ON U.S. HIGHWAY 101

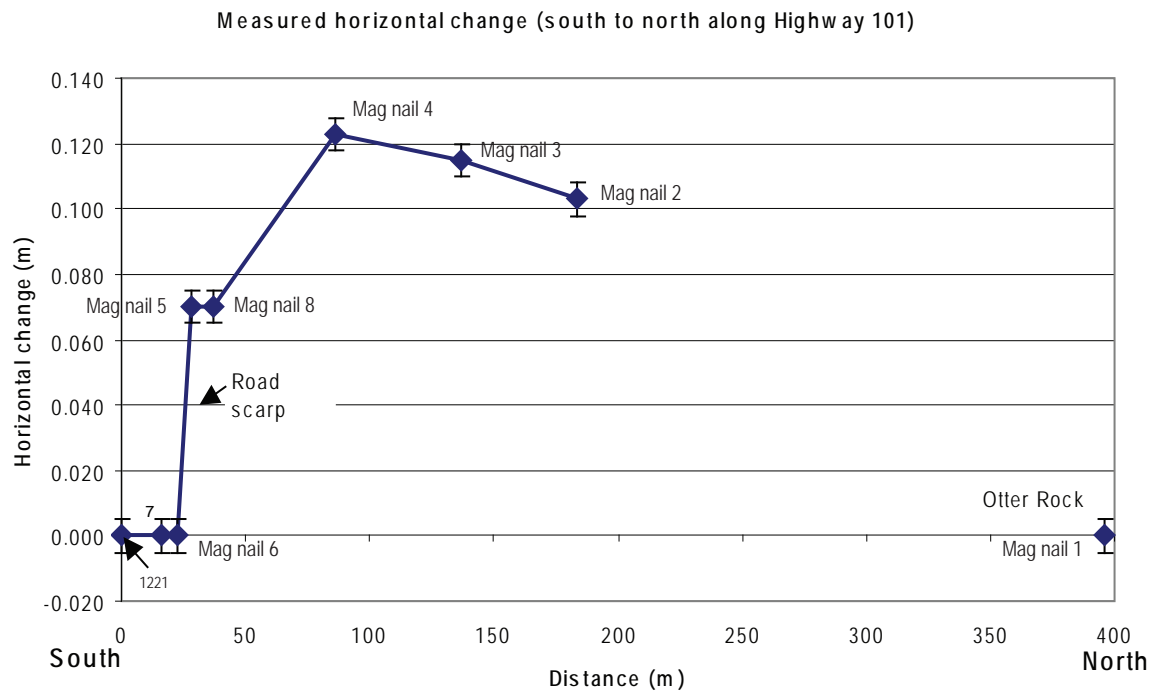
Figure F2. Horizontal change along U.S. Highway 101 January 16, 2003, to February 4, 2003; (+) = westward movement; (-) = eastward movement.

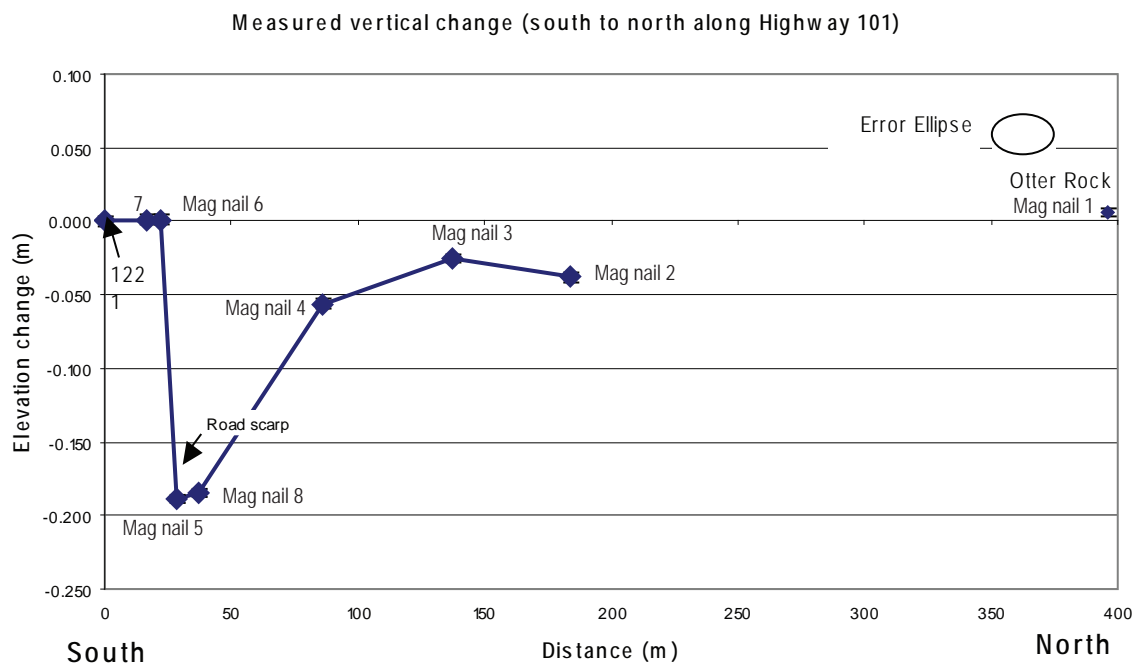
Figure F3. Vertical change along U.S. Highway 101 January 16, 2003, to February 4, 2003; (-) = down; (+) = up.
