OFR O-04-18

**COAST HAZARDS AND MANAGEMENT ISSUES
ON THE OREGON COAST**

**Coastal Workshop, Lincoln City, Oregon
Field Trip to the Oregon Coast
29 April 2004**

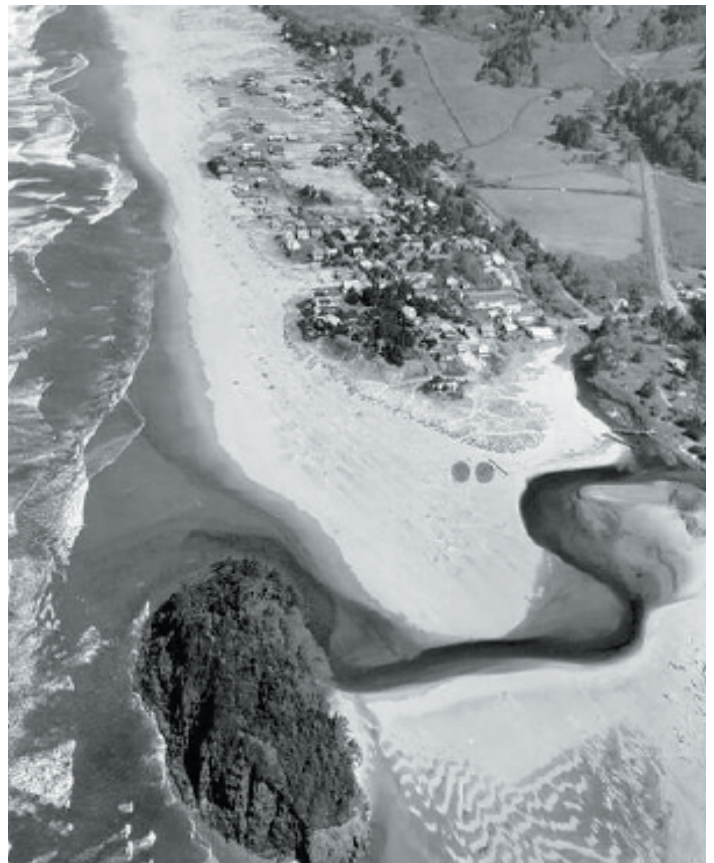
Figure 1. Neskowin in the 1960s (Oregon Department of Transportation photo).

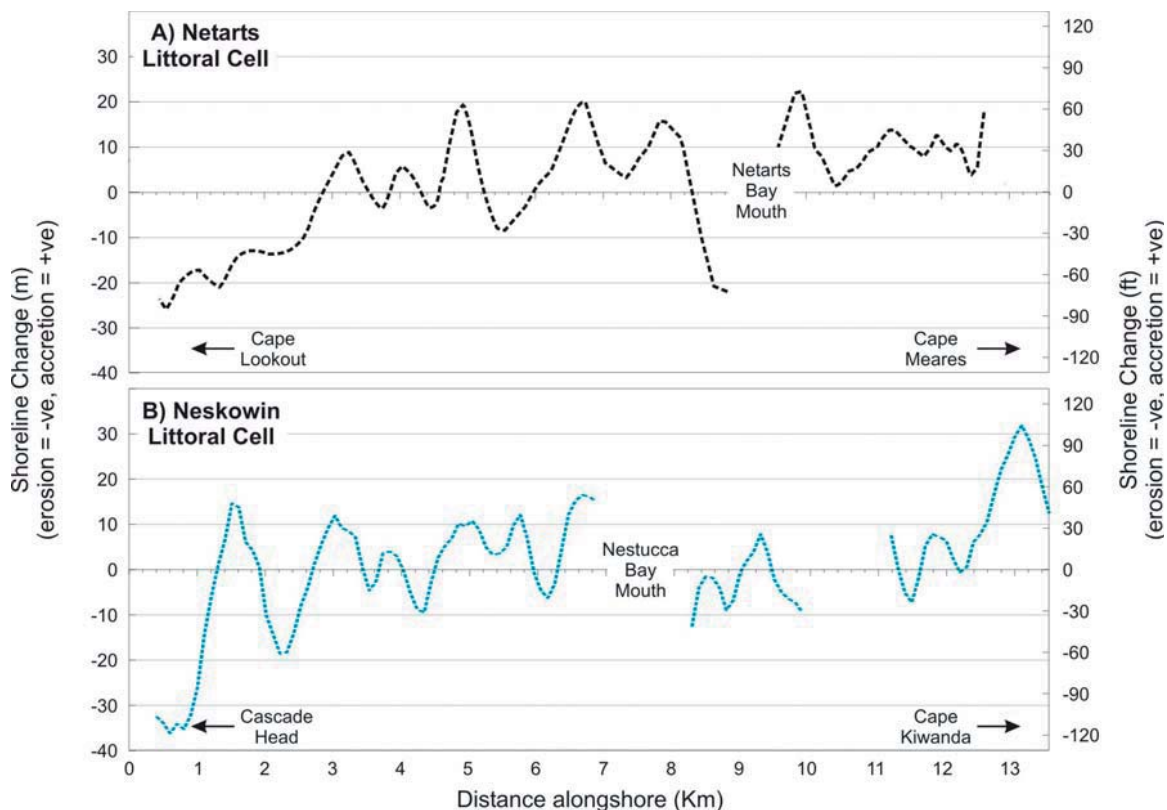
Figure 4. Shoreline variability along the Netarts and Neskowin littoral cells showing the “hot spot” erosion effect caused by the 1997-98 El Niño.

by up to 25 m (82 ft) and progressively decreasing northward along the spit. Similar analyses have been undertaken for the Neskowin Cell (**Figure 4B**). However, the pattern is more complicated, as indicated by the considerable along shore variability in the beach response, ranging from extreme erosion (-37 m (-120 ft)) adjacent to Cascade Head in the south, to accretion at Pacific City (+32 m (+105 ft)). The alongshore variability in the shoreline response shown in **Figure 4** is likely due to the presence of rip current embayments, that result in localized “hot spots” of erosion.

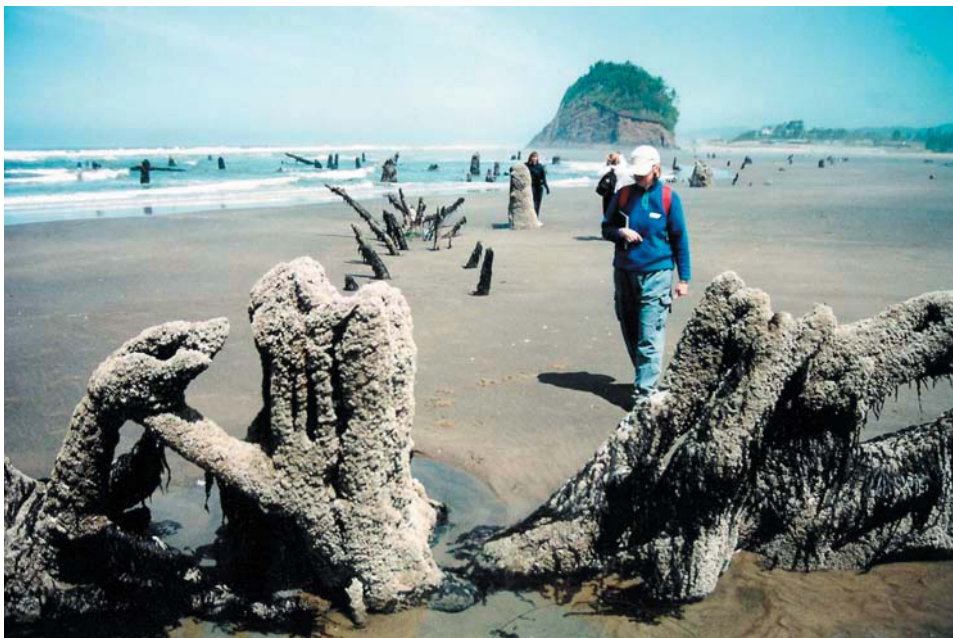
Figure 5. Exposed buried forest at Neskowin as a result of hotspot erosion during the late 1990's (Photo courtesy of Roger Hart, DOGAMI).

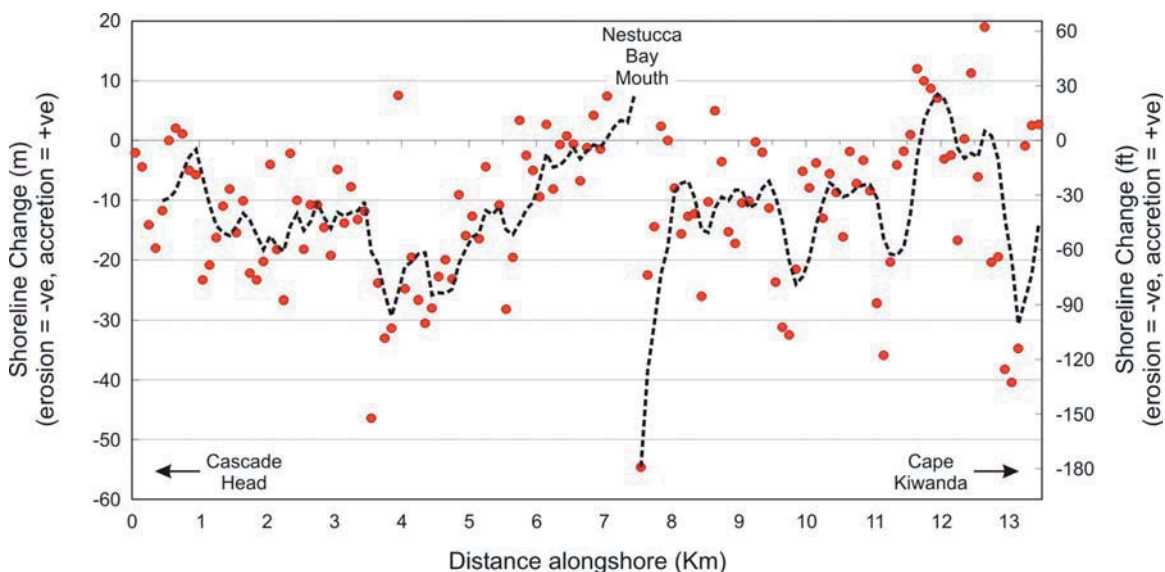
Figure 7. Positional changes in the beach/dune toe along the Neskowin Cell between 1998 and 2002. The dashed line is a 500 m moving average fitted to the data.

necessary information to undertake an up-to-date assessment of the extent of erosion at Neskowin for the period 1998 to 2002. We have examined these data for the Neskowin Cell, by focusing on the change in position of the beach/dune toe (i.e. the base of the erosion scarp shown in **Figure 6** (lower)) between 1998 and 2002 (**Figure 7**), demonstrating the cumulative effect of the winter storms over the past 4 years. As shown in **Figure 7**, the Neskowin Cell has undergone considerable dune erosion since 1998, with the beach/dune toe having been eroded landward by on average 11.5 m (38 ft), and as much as 55 m (180 ft) adjacent to the mouth of the Nestucca Bay. Dune erosion has been particularly severe near Winema Beach, (4 – 5 kilometers north of Neskowin (**Figure 7**)), and at the north end of the cell at Pacific City, where the presence of a rip embayment eroded the dune by as much as 40 m (130 ft). Given the severity of the storms in 1998-99 compared with the last 3 years, we can speculate that the bulk of the erosion shown in **Figure 7** was likely the product of the 1998-99 La Niña winter storms.

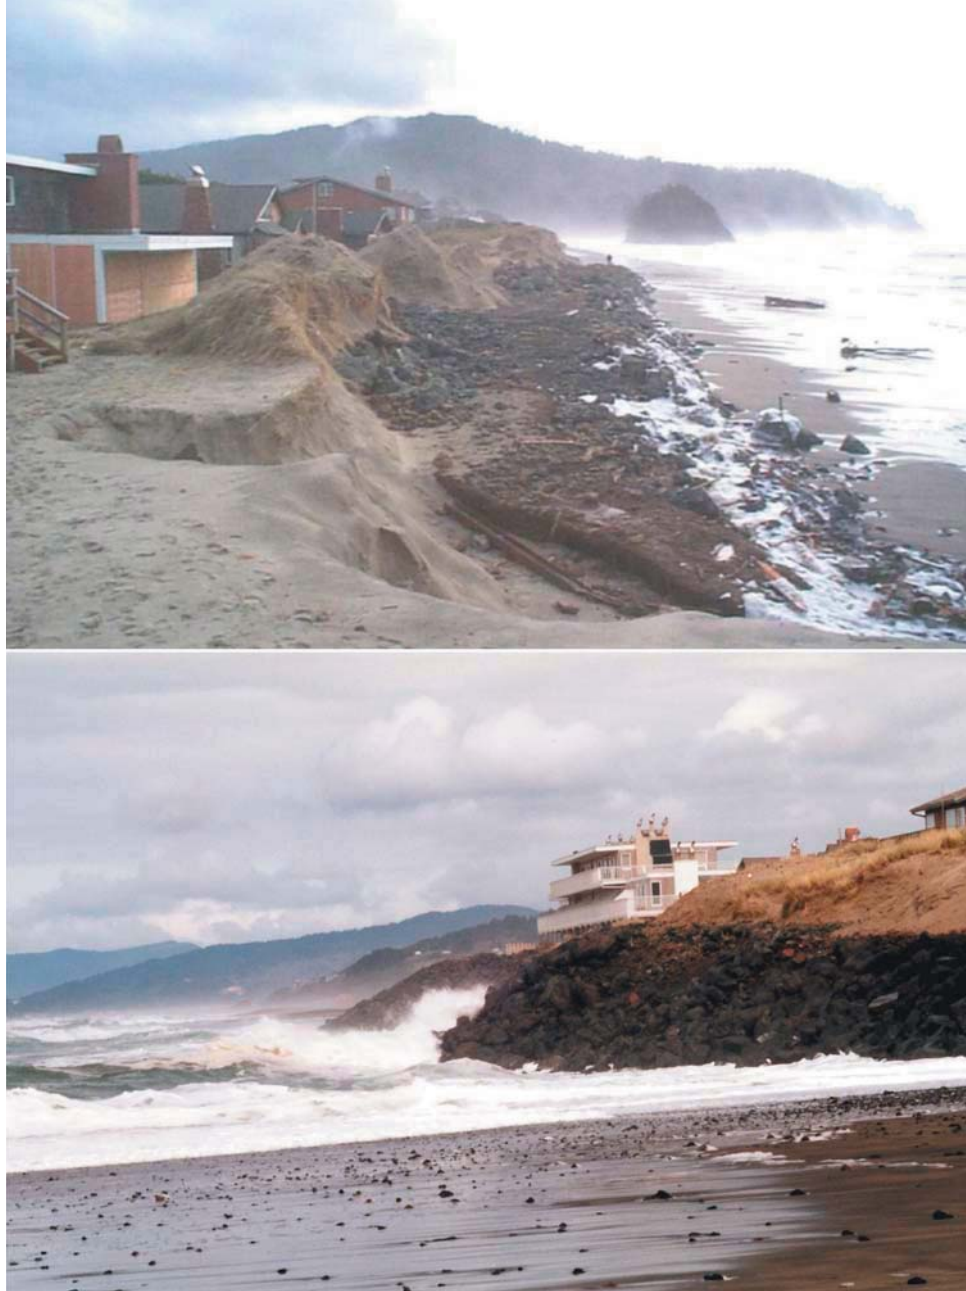
Figure 8. (upper): Emergency riprap in place along Neskowin shoreline, spring 1999 (Oregon Parks and Recreation Department photo). **(lower):** Final riprap structures at Neskowin in winter 2001 following regular permit process. Note that the structure has blocked lateral access along the beach at low tide due to enhanced erosion of the beach in front of the structure caused by the presence of a rip embayment and from wave reflection off the structures (Paul D. Komar photo).

The extreme erosion at Neskowin has necessitated emergency riprap placement, which is authorized under Oregon's 1967 Beach Law (**Figure 8, upper**). Following the emergency, property owners were required to go through the normal shore protection

permit process, whereby regular permits were granted and riprap was placed along much of the developed shoreline (**Figure 8, lower**). By 2003, approximately 14.5% of the Neskowin littoral cell (i.e. from Cascade Head to Cape Kiwanda) has been hardened (**Figure 9**), with most of the structures (8.2%) having been built at Neskowin.

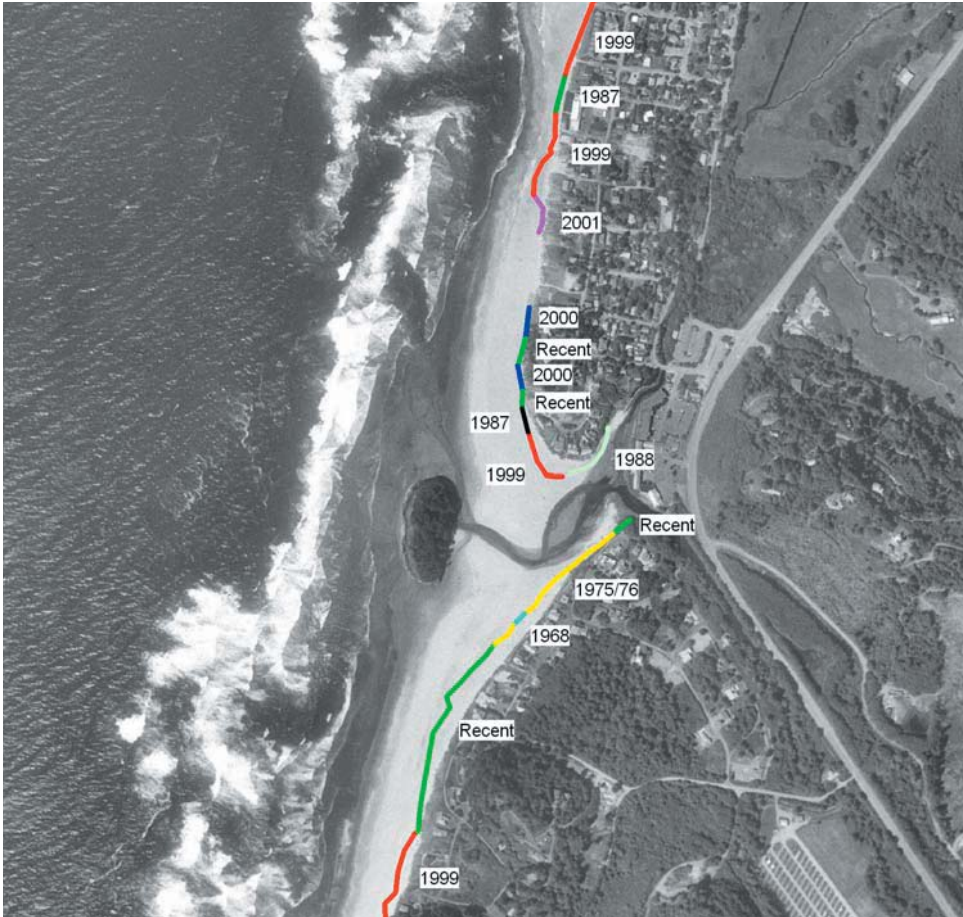
Figure 9. Expansion of riprap along the Neskowin shoreline since 1968. As at 2003, approximately 14.5% of the Neskowin cell had been “hardened”.

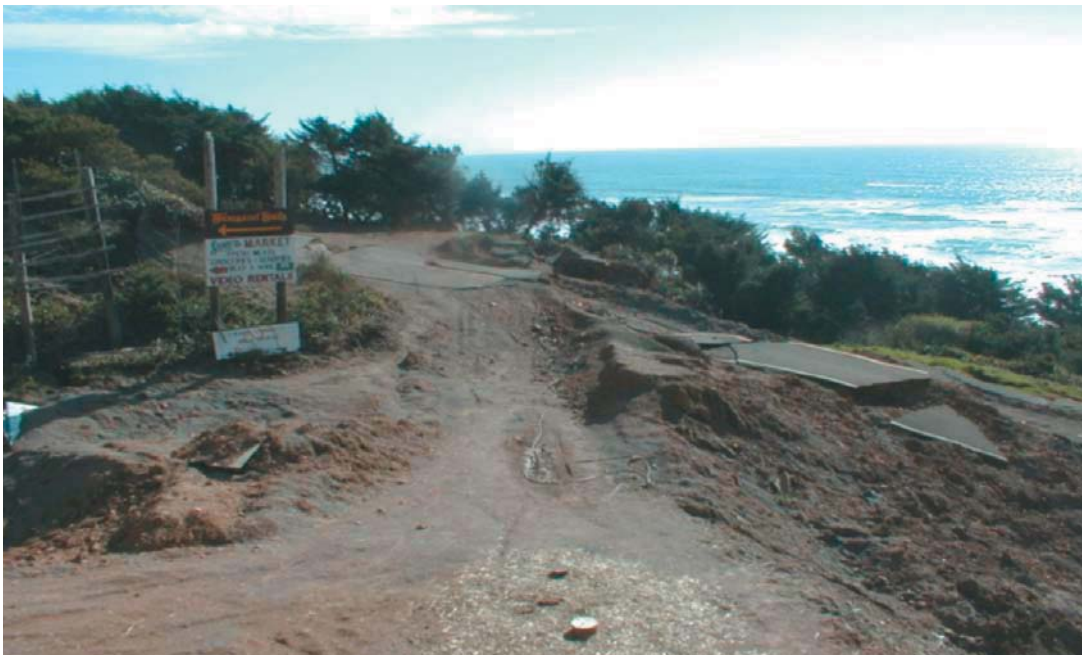
Figure 15 Complex oceanfront landslide on Three Capes Loop Road between Pacific City and Sand Lake.

around a major landslide just north of Pacific City on the Three Capes Loop (**Figure 15**). This complex translational/rotational landslide occurred in June 1999 and consists of Holocene dune sands overlying the Tertiary seaward-dipping sandstone and mudstone deposits of the Astoria formation. The slide was subsequently stabilized by Landslide Technology, Inc. using a shear key buttressing system, with dewatering. We will pass other landslides as we move along the coast, but this is the most recent and visible.

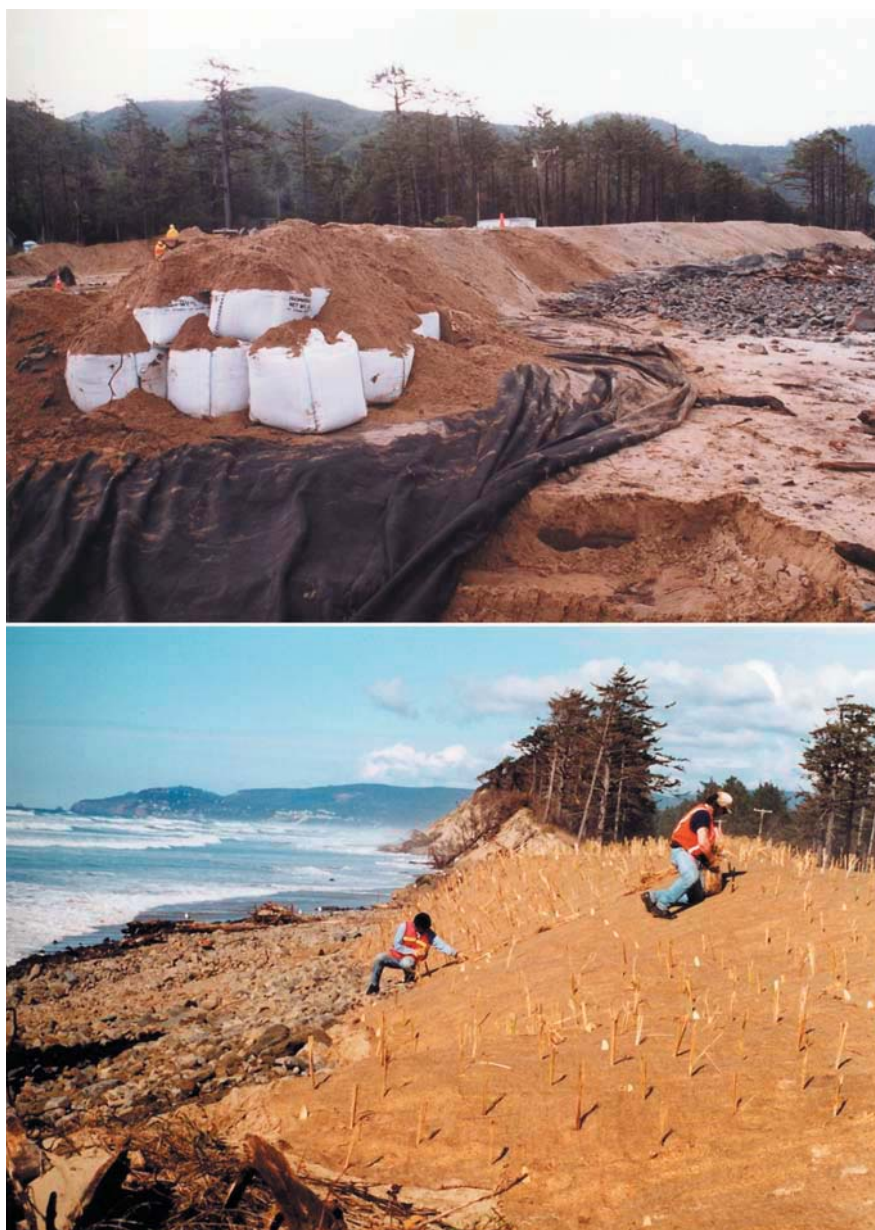
Figure 18. The completed cobble revetment in July 2001, backed by a line of reconstructed artificial dunes containing a core of sand-filled geotextile bags. Recent storms have deposited drift logs atop the dunes, while sand carried by summer winds has also begun to accumulate and cover the cobble berm (Jonathan Allan photo).

storms and to restore the former appearance of the park (Komar and others, 1999b). OPRD decided to have this re-constructed dune become an integral part of their shore protection strategy, thereby constructing the dynamic revetment at a lesser scale than was recommended. The core of the artificial dune consists of 2,750 geotextile bags, each filled with approximately 1 cubic meter of sand, **Figure 18 (upper)**. The mound of bags was then buried under 15 to 30 cm (0.5 – 1 ft) of sand, covered with a biodegradable jute-coconut fiber mat, in turn covered by another layer of loose sand that was eventually planted with dune grass native to the Oregon coast, **Figure 18 (lower)**.

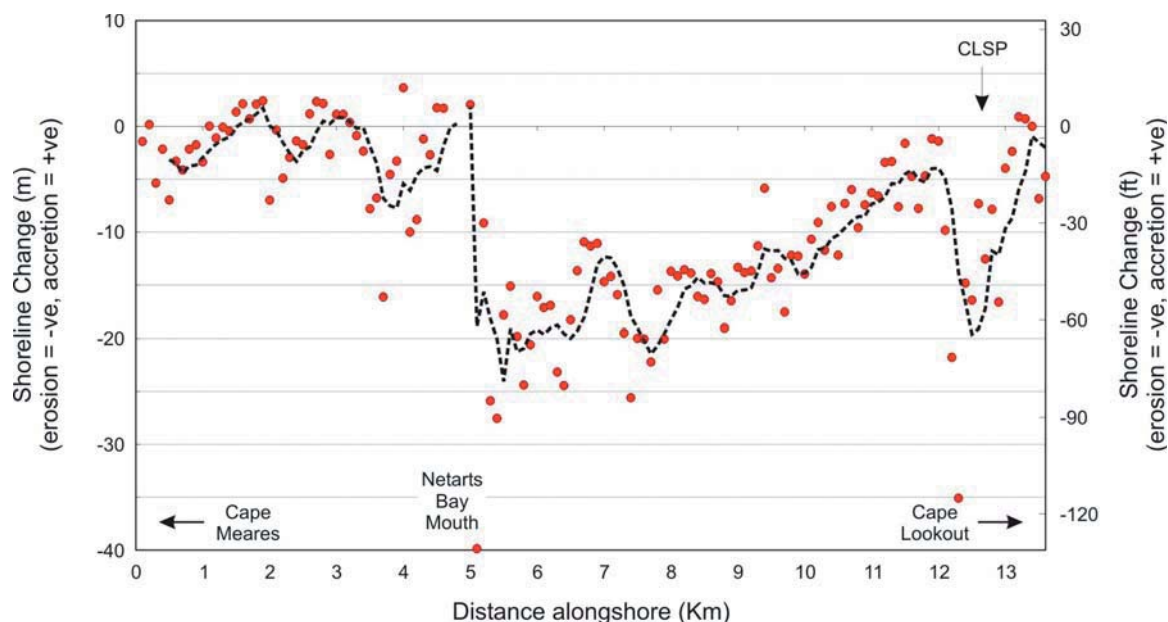
Figure 21. Positional changes in the beach/dune toe along the Netarts Cell between 1998 and 2002. The dashed line is a 500 m moving average fitted to the data.

Aside from the area protected by the dynamic revetment and artificial dune at Cape Lookout State Park, significant erosion has continued to occur along much of Netarts Cell (**Figure 21**). The largest changes are observed along the northern 4.5 km (2.9 miles) of Netarts Spit, with the beach/dune toe having eroded landward by some 15 – 27 m (49 – 88 ft). Given that the dunes have an average height of 15.1 m (49 ft) and the beach/dune toe has eroded landward on average by 15.6 m (51.2 ft), erosion of the spit has released approximately 1.1 million m³ (1.5 million yard³) of sand in four years! Of particular interest is the dune erosion occurring midway along the spit (around 10 kilometers in **Figure 21**). At current rates, it can be expected that ocean waves will breach the foredune sometime in the one to two decades, creating a southern tidal entrance to Netarts Spit. In the south, erosion continues to plague the day-use area operated by State Parks. Our monitoring of this area indicates that the bluff there is eroding landward at a rate of 3.5 m/year (11.5 ft/year). The cause of this erosion is due to the large ocean waves observed in recent years, the ongoing depletion of sand along the spit, and a net loss of protective cobbles from the south due to their along shore movement to the north. Given the success of the
