OFR O-04-20

**EVALUATION OF COASTAL EROSION HAZARD ZONES
FROM SISTERS ROCKS TO NORTH GOLD BEACH, CURRY
COUNTY, OREGON:**

TECHNICAL REPORT TO CURRY COUNTY

George R. Priest¹, Ron Sonnevil², and Jonathan C. Allan¹

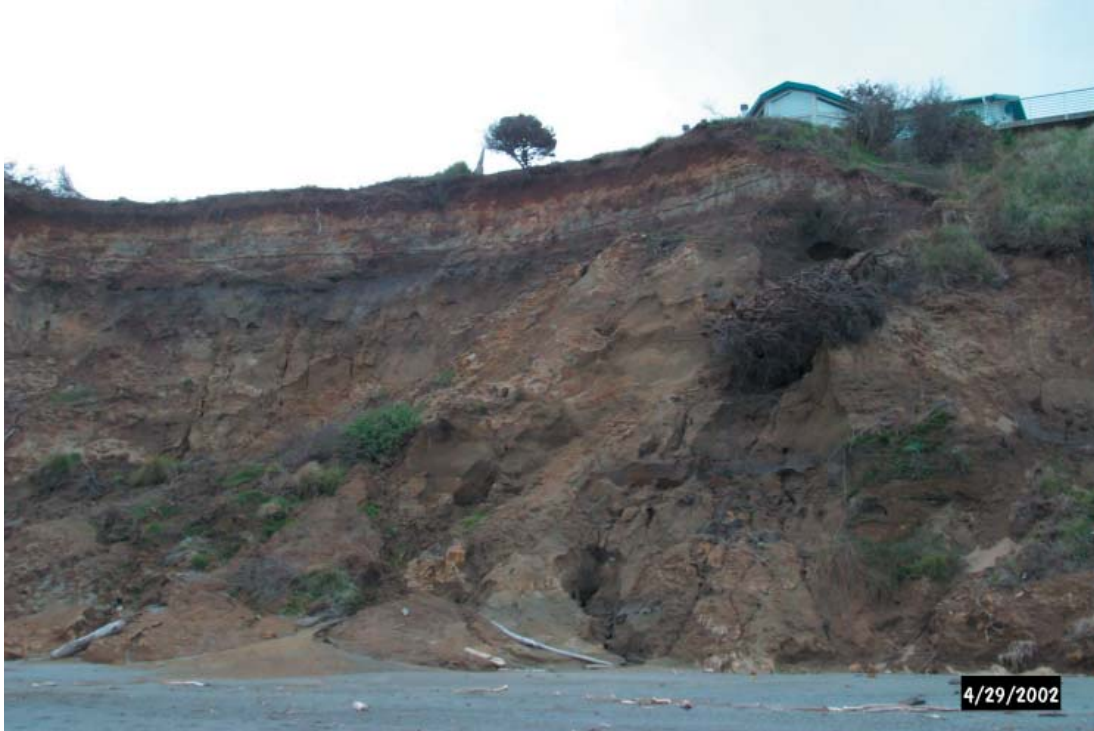
Photo is from Oregon Department of Geology archives and was taken at Nesika Beach April 29, 2002. It illustrates how coastal bluff erosion is threatening many houses in the area.

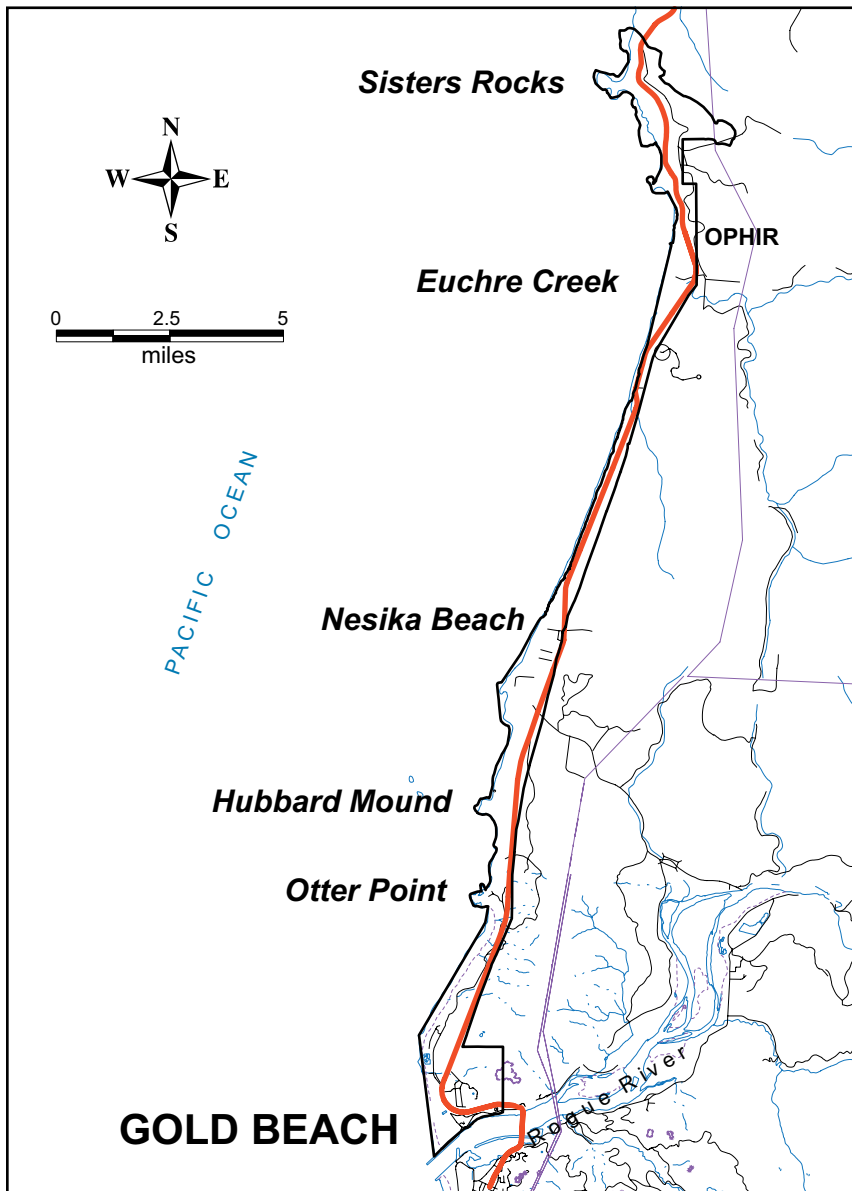
Figure 1. Map showing location of the study area. Heavy line shows extent of project area covered by digital geographic information files containing data on geology, landslides, and erosion hazards. Erosion information covers only open coastal (versus estuarine or river) areas and is mapped only in areas with base map coverage from 2003 color orthophotos.

The Oregon Department of Geology and Mineral Industries (DOGAMI) has been commissioned by Curry County to carry out an assessment of existing and potential coastal erosion and landslide hazards along the shoreline from the North Jetty at Gold Beach 12.6 miles north to the north side

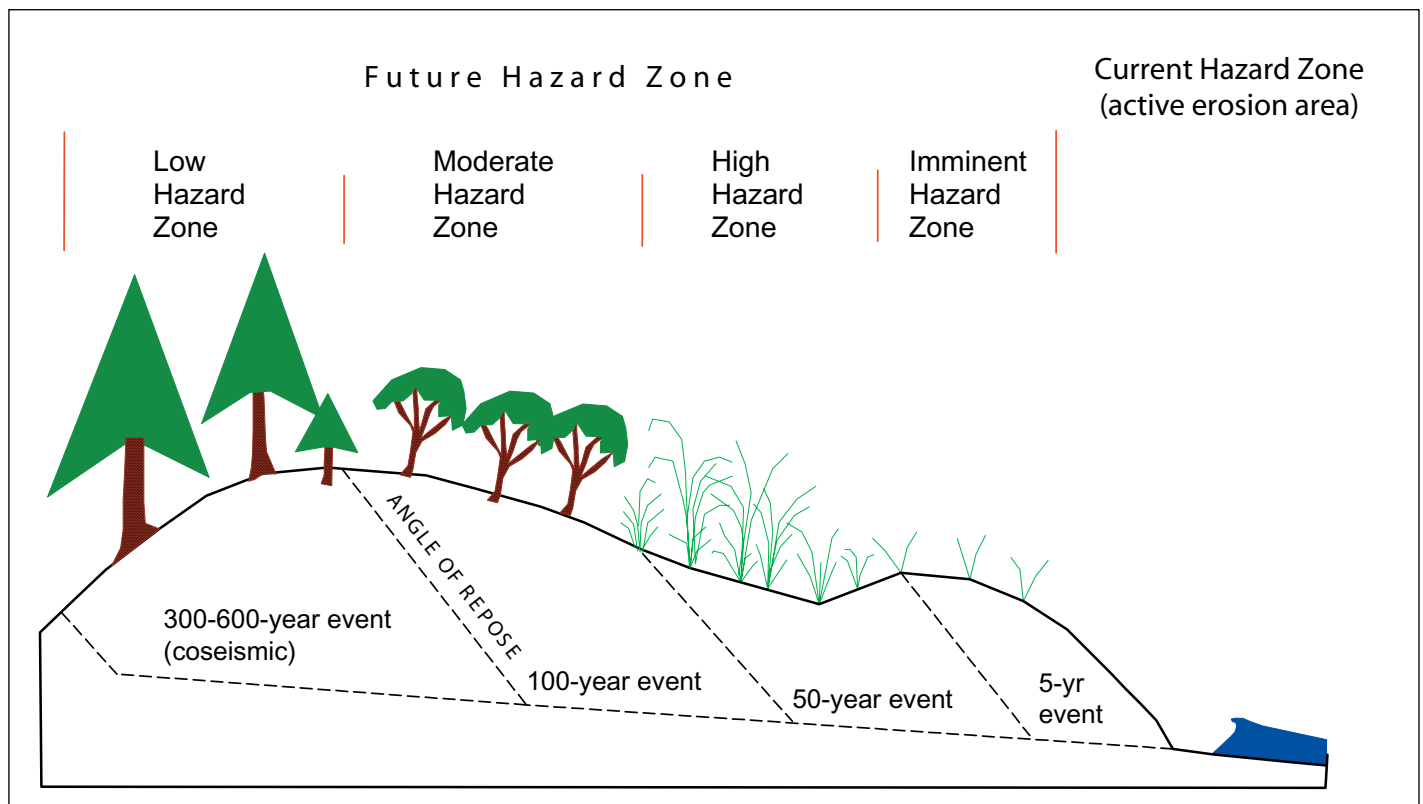
Figure 2. Schematic diagram showing possible dune erosion hazard zones.

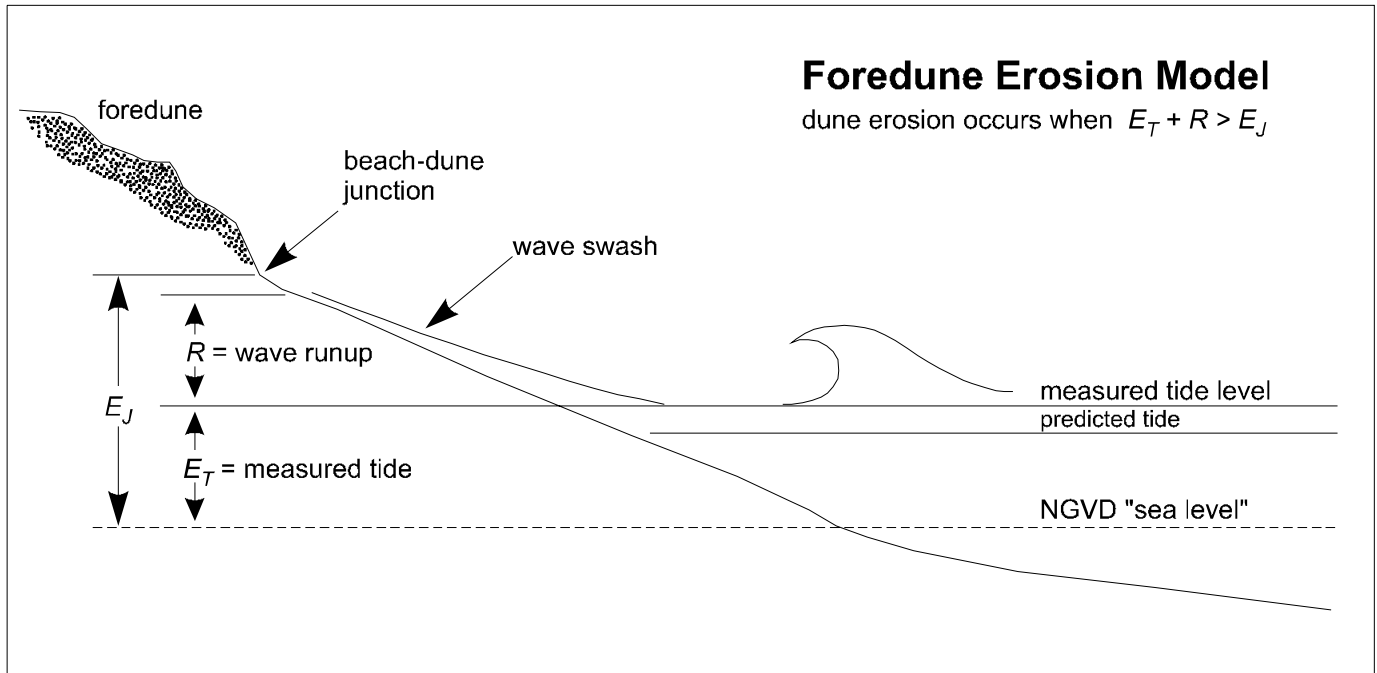
Figure 3. The foredune erosion model (Komar and others, 1999). NGVD '88 = national geodetic vertical datum of 1988.

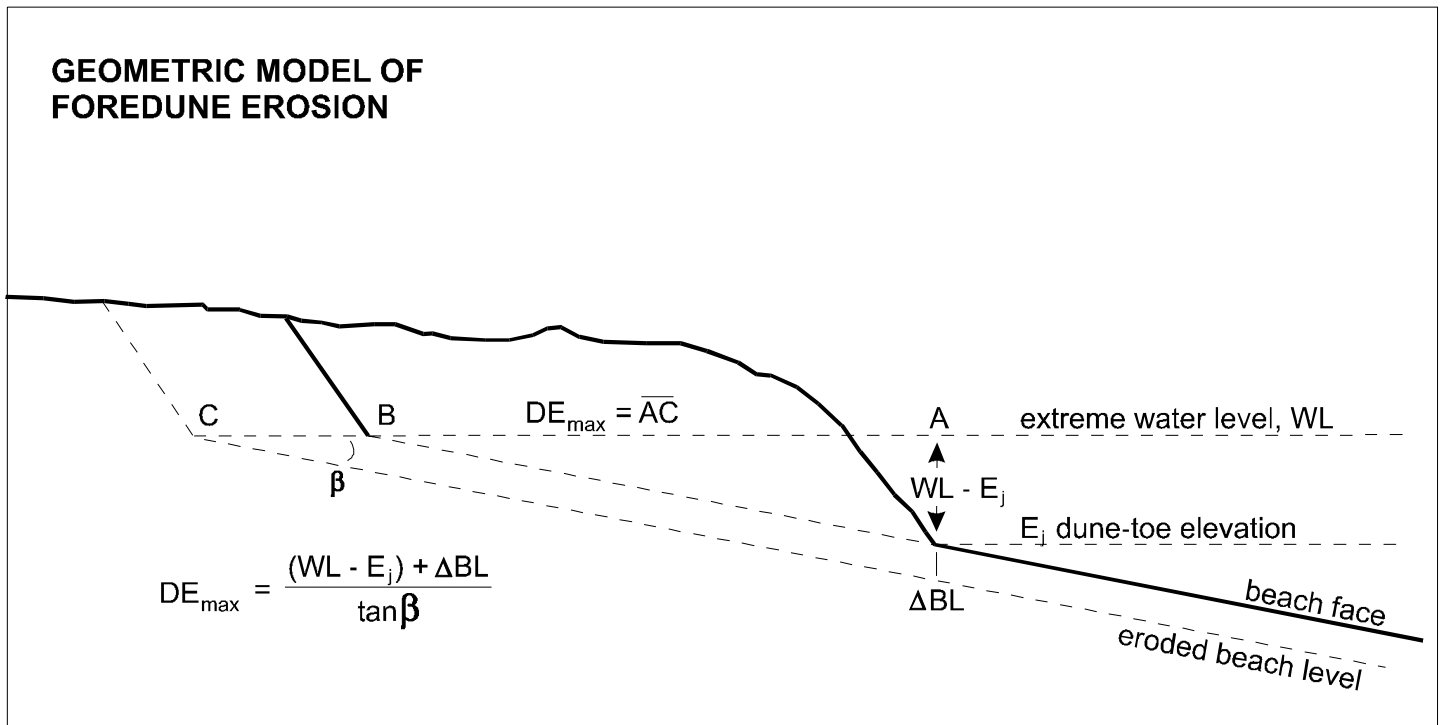
Figure 4. The geometric model used to assess the maximum potential beach erosion in response to an extreme storm (After Komar and others, 1999).

As can be seen from Figure 4, estimating the maximum amount of dune erosion (DE_{MAX}) is dependant on identifying the total water level elevation, T_{WL} , which includes the combined effects of extreme high tides plus storm surge plus wave runup, relative to the elevation of the beach-dune junction (E_j). Therefore, when the $T_{WL} > E_j$ the beach retreats landward by some distance, until a new beach-dune junction is established, whose elevation approximately equals

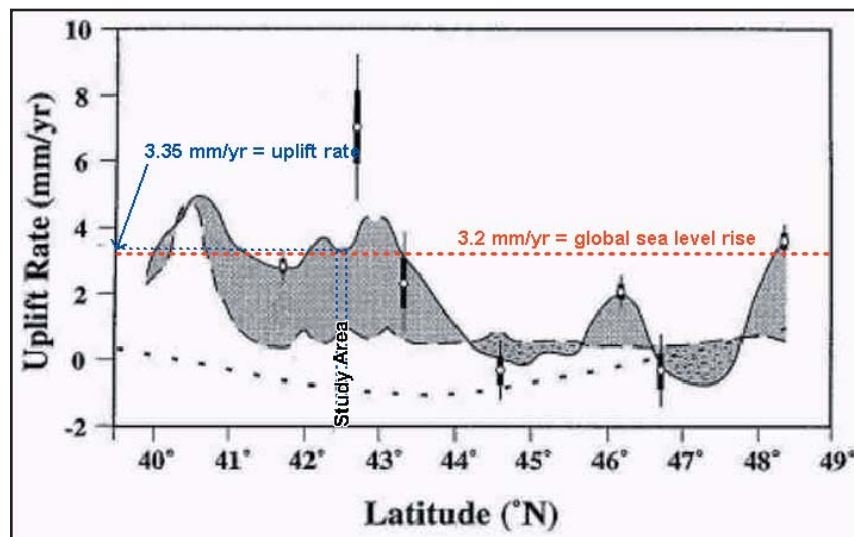
Figure 5. Uplift rate along the Oregon coast, measured by geodetic surveys (solid black line) relative to uplift measured from tide gauges (points with error bars) and long term uplift inferred from elevation of Pleistocene marine terraces (dashed black line). Blue dashed lines show uplift rate of the study area (42.423 and 42.563 N Latitude), which is essentially equal to global sea level rise (red dashed line). Large dotted black line is an approximate cross section from the map of estimated North American post-glacial rebound by Peltier (1986). The elevation changes are relative to the geodetic mean sea level, with positive values representing a rise in the land, while negative values represent the progressive subsidence. Stippled regions are inferred to represent elastic strain accumulation; note that some areas will go up (coarse stippling) and others will go down (fine stippling), when this strain is released during an earthquake. The study area is an area of current tectonic uplift and significant coseismic subsidence. Graph is modified slightly from Mitchell and others (1994).

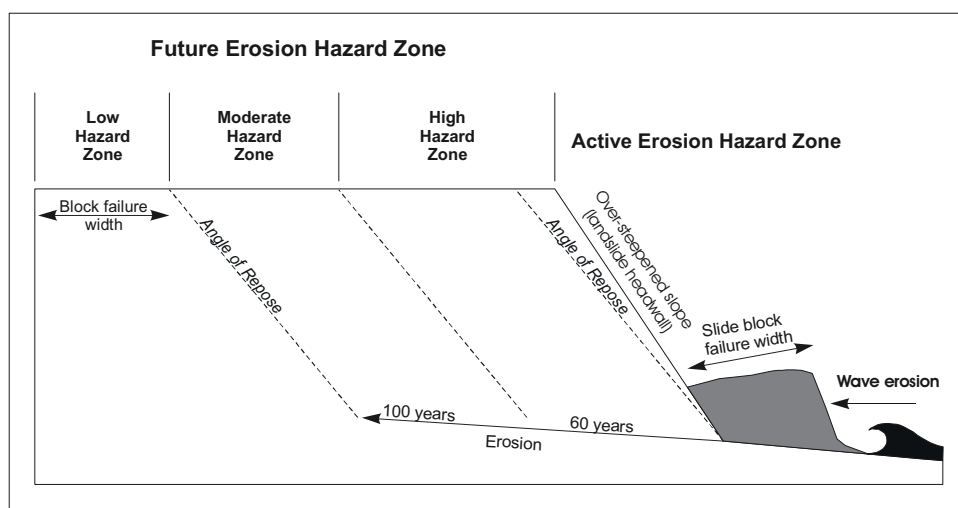
Figure 6. Schematic illustration of block failure on a bluff, angle of repose, and erosion rate in relation to possible hazard zones. These factors can be combined in a variety of different ways to produce hazard zones.

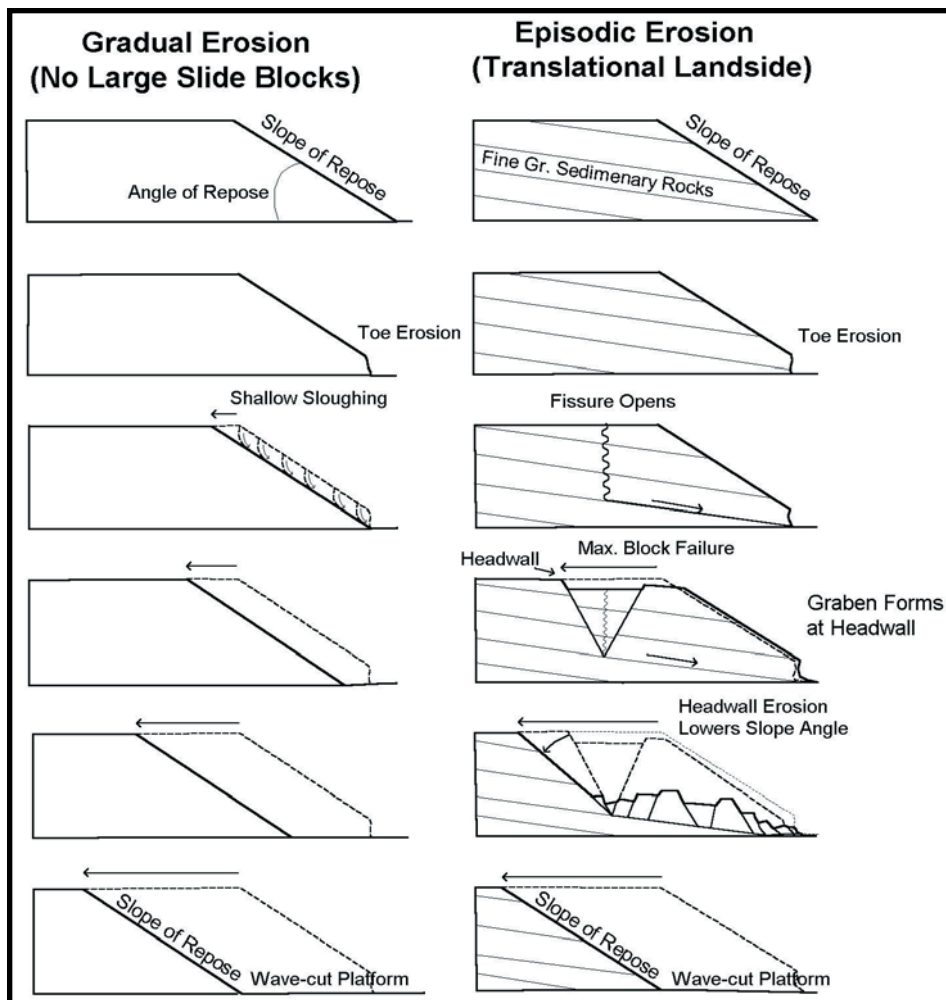
Figure 7. Gradual versus episodic bluff erosion. Note how the landslide toe position remains stable as the headwall retreats; hence erosion rate for bluffs with landslides is better measured at the headwall. Also note that the dangerous part of the bluff is much wider for the landslide-prone bluff, since another maximum block failure could occur at any point in the erosion cycle.

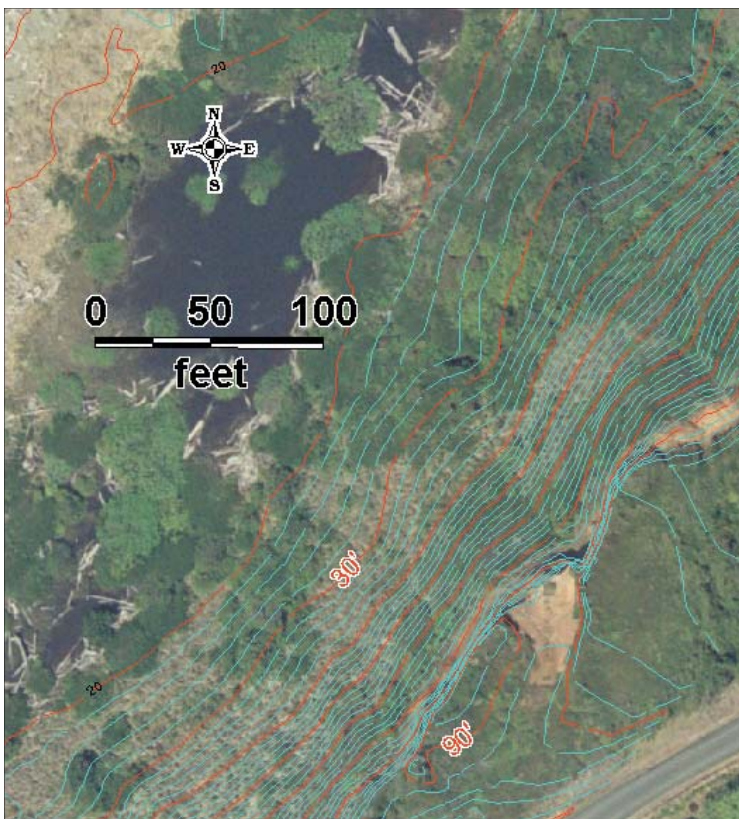
Figure 8. Vegetated bluff 1 mile south of Otter Point is completely protected from wave erosion by vegetated dunes (upper left). Bluff is composed of Pleistocene marine terrace deposits overlying Jurassic sedimentary rocks. Bluff face is mantled by talus lying at a 1.5:1 (horizontal:vertical) slope. Bluff is locally near vertical in upper ten feet where it is not mantled by significant talus. In these areas it probably erodes back by a combination of wind erosion, slope wash, and cantilevered block fall processes. Blue lines are topographic contours at intervals of two feet. Red lines are index contours at intervals of ten feet.

Vegetated, talus-laden slopes of Pleistocene marine terrace deposits overlying Otter Point Formation a mile south of Otter Point (Figure 8) are at a mean angle of 34° (1.5:1), while the same material more fully exposed to wave attack on the south side of Otter Point reaches an overall slope angle of 40 - 42° (Figure 9).

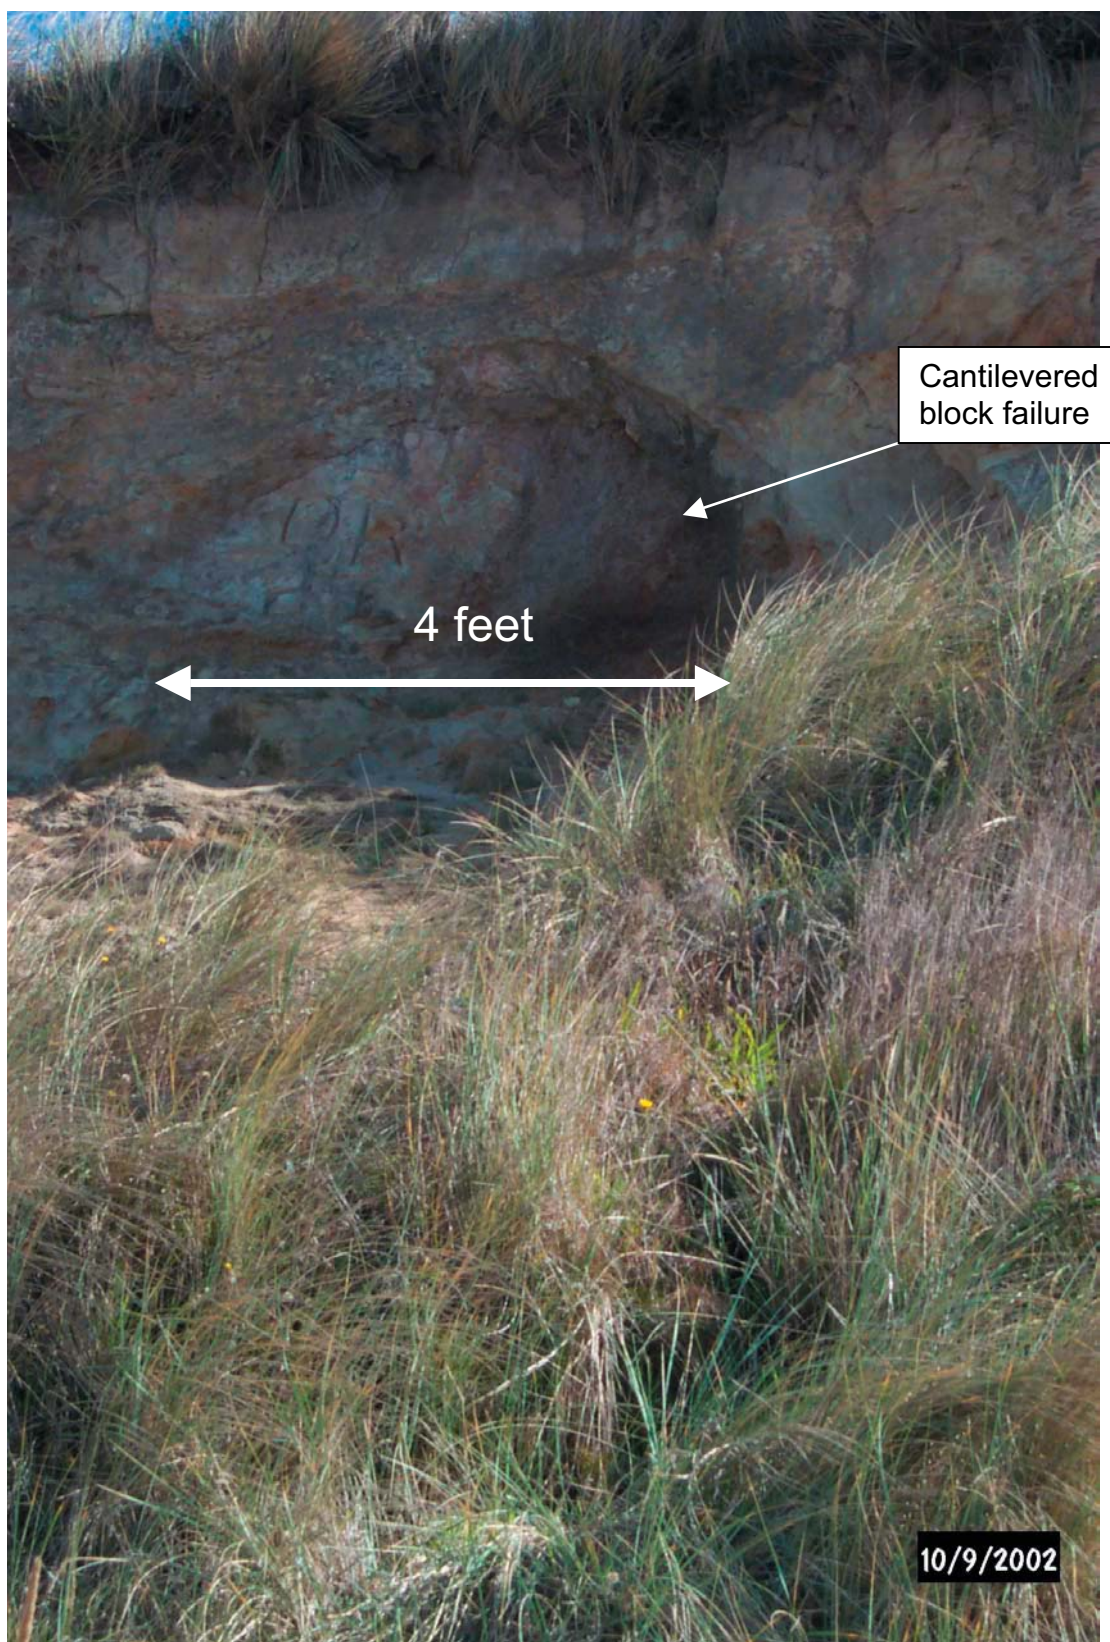
Figure 9. Close-up of scar of a cantilevered block in Pleistocene marine terrace sand at Nye Beach, Lincoln County, Oregon. The lower slope is vegetated talus at the angle of repose. Future retreat of the uppermost escarpment will add to the talus until the entire slope is at the angle of repose and the block falls stop.

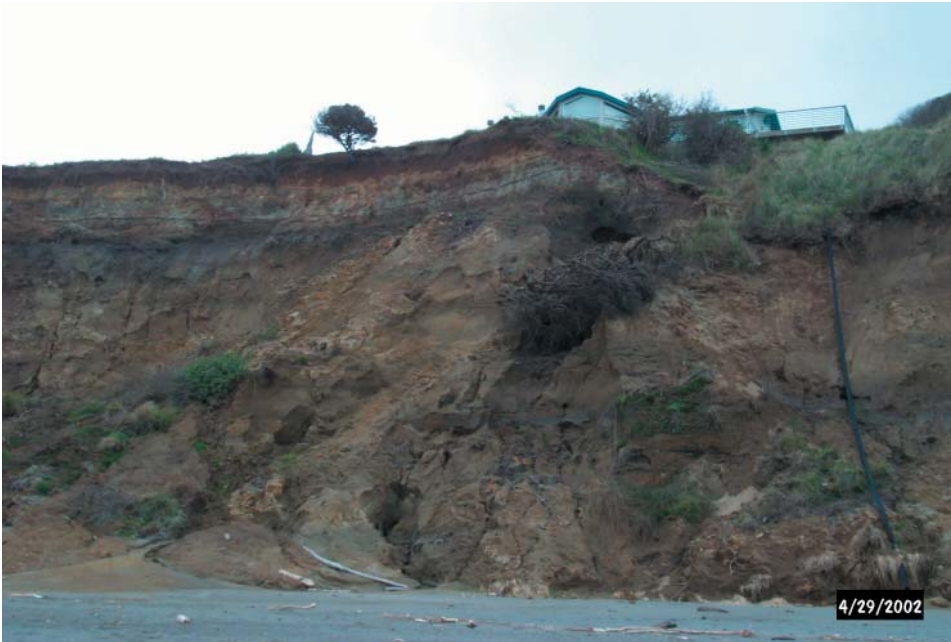
Figure 10. Nesika Beach near vertical sea cliff of Pleistocene marine terrace deposits (horizontally bedded sand in the uppermost part of bluff) overlying sheared Jurassic sedimentary rocks (Figure 11). Cliff erosion is chiefly from undercutting by waves, groundwater-induced sloughing or slumping of the terrace deposits, and cantilevered block falls in terrace deposits. Wave attack is vigorous enough to remove talus except for very recent sloughing events (e.g., left foreground).

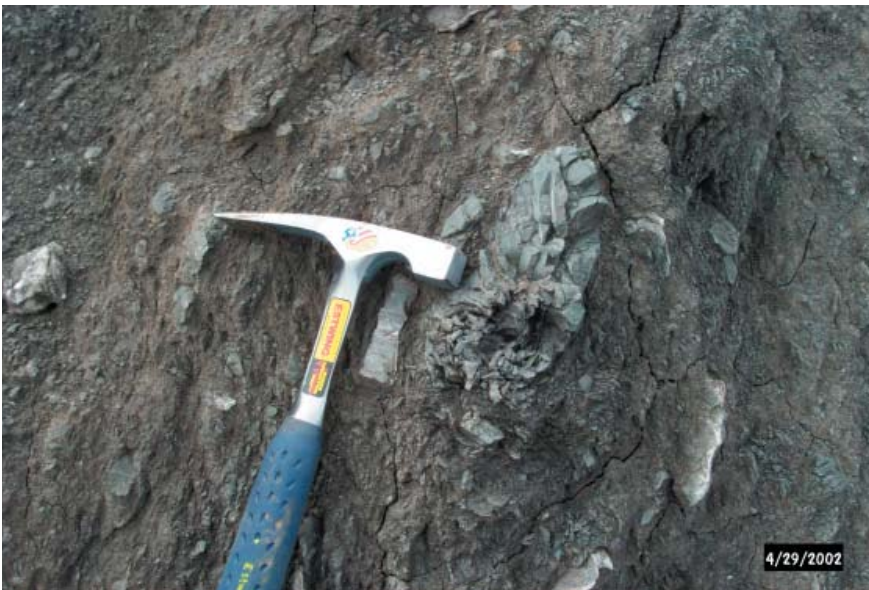
Figure 11. Sheared Jurassic mudstone and sandstone typical of the lower part of many bluffs in the study area. This material has little resistance to wave erosion or slope failure when it is as highly sheared as in this example. Shears are in so many different directions that bluffs are highly vulnerable to slope failure from rotational and translational landslides or block falls.

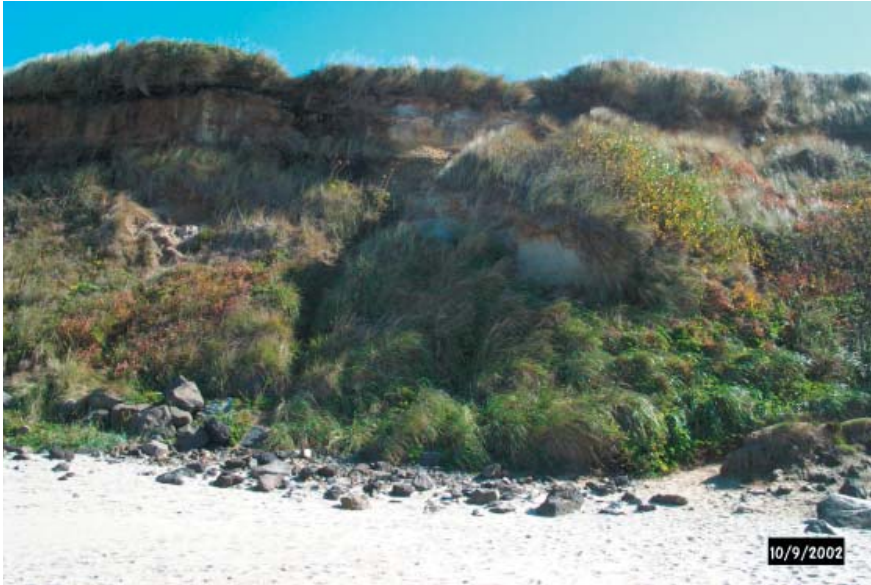
Figure 12. Slump block about 30 feet wide in Pleistocene paleosol, laminated carbonaceous clayey silt and sand deposits at Nye Beach. Note that cantilevered block falls are keeping the upper part of the bluff near vertical. Note also that this slump and the cantilevered block falls occurred on a well-vegetated slope. While the vegetation does not prove that wave undercutting did not trigger this slump, the vegetation is suggestive that waves were probably not the main factor for either type of failure. Groundwater saturation probably played a more significant role in this particular case.

The stress-release block fall process does not mean that larger block failures, either rotational slumps or translational slides, do not occur in these Pleistocene deposits. In fact slumps can be common in the same areas where gradual erosion by cantilevered block fall is occurring (Figure 12). That is why hazard zones

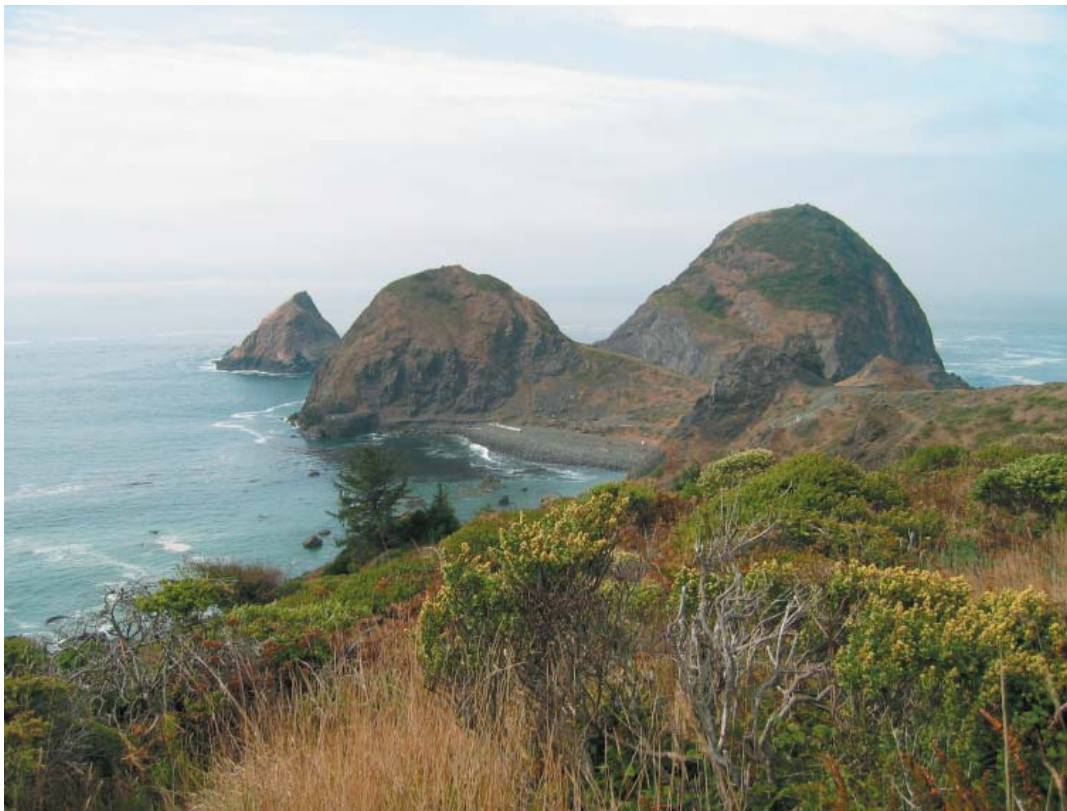
Figure 13. Sisters Rocks area illustrating steep lower sea cliffs where waves have access at all times.

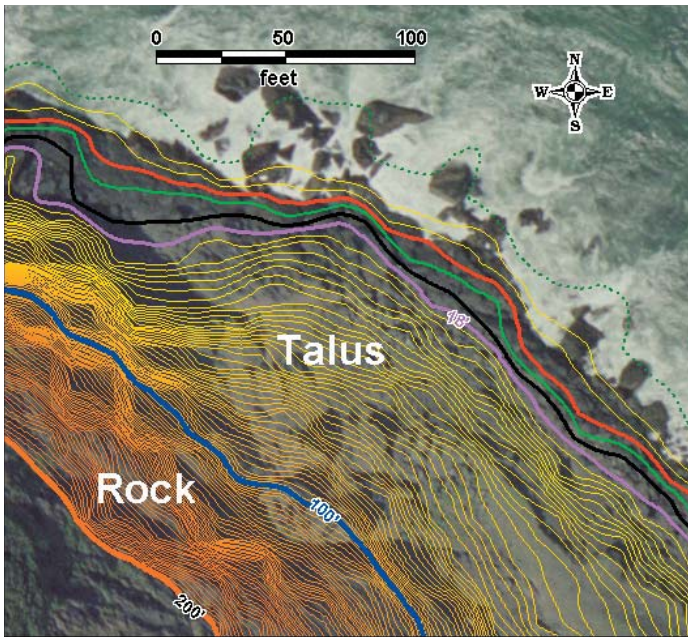
Figure 14. Partially sheltered north side of Sisters Rocks has talus slopes of broken hard metamorphic rock that average about 1:1, horizontal to vertical. Individual blocks up to 20 feet wide have toppled onto this talus slope from the steeper rock slope above. Orange and yellow lines are topographic contours at intervals of 2 feet derived from a 2002 LIDAR survey of this area by USGS.

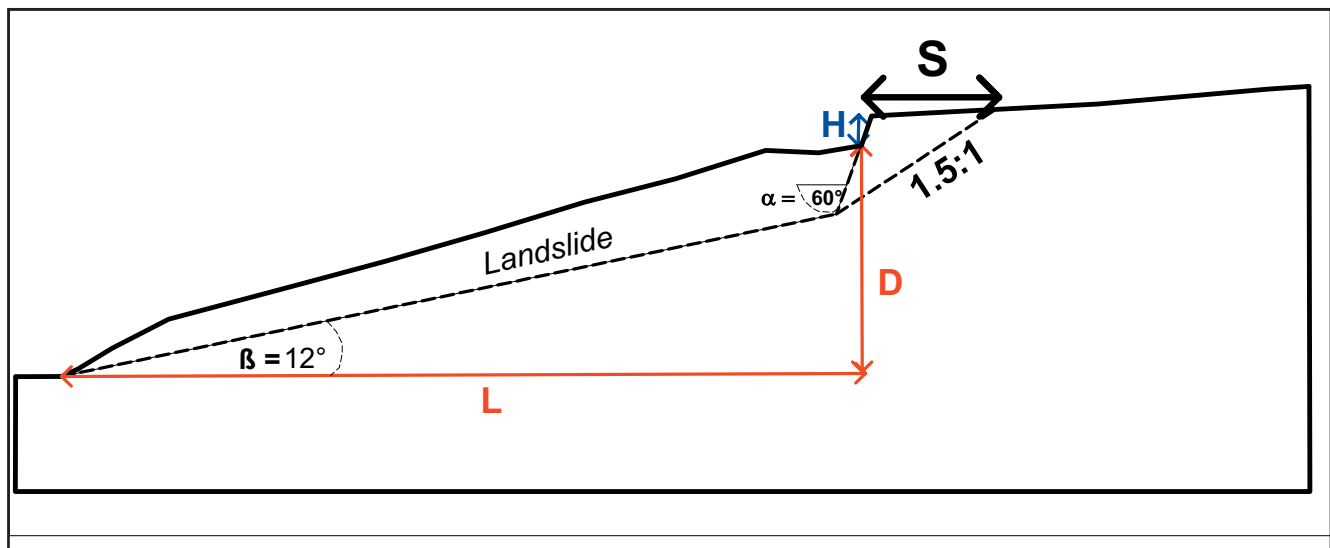
Figure 15. Projection of angle of repose for landslides.

Allan and Priest (2001, their Appendix D). The following formula or a graphical projection (Figure 15) was used for slides in the area:

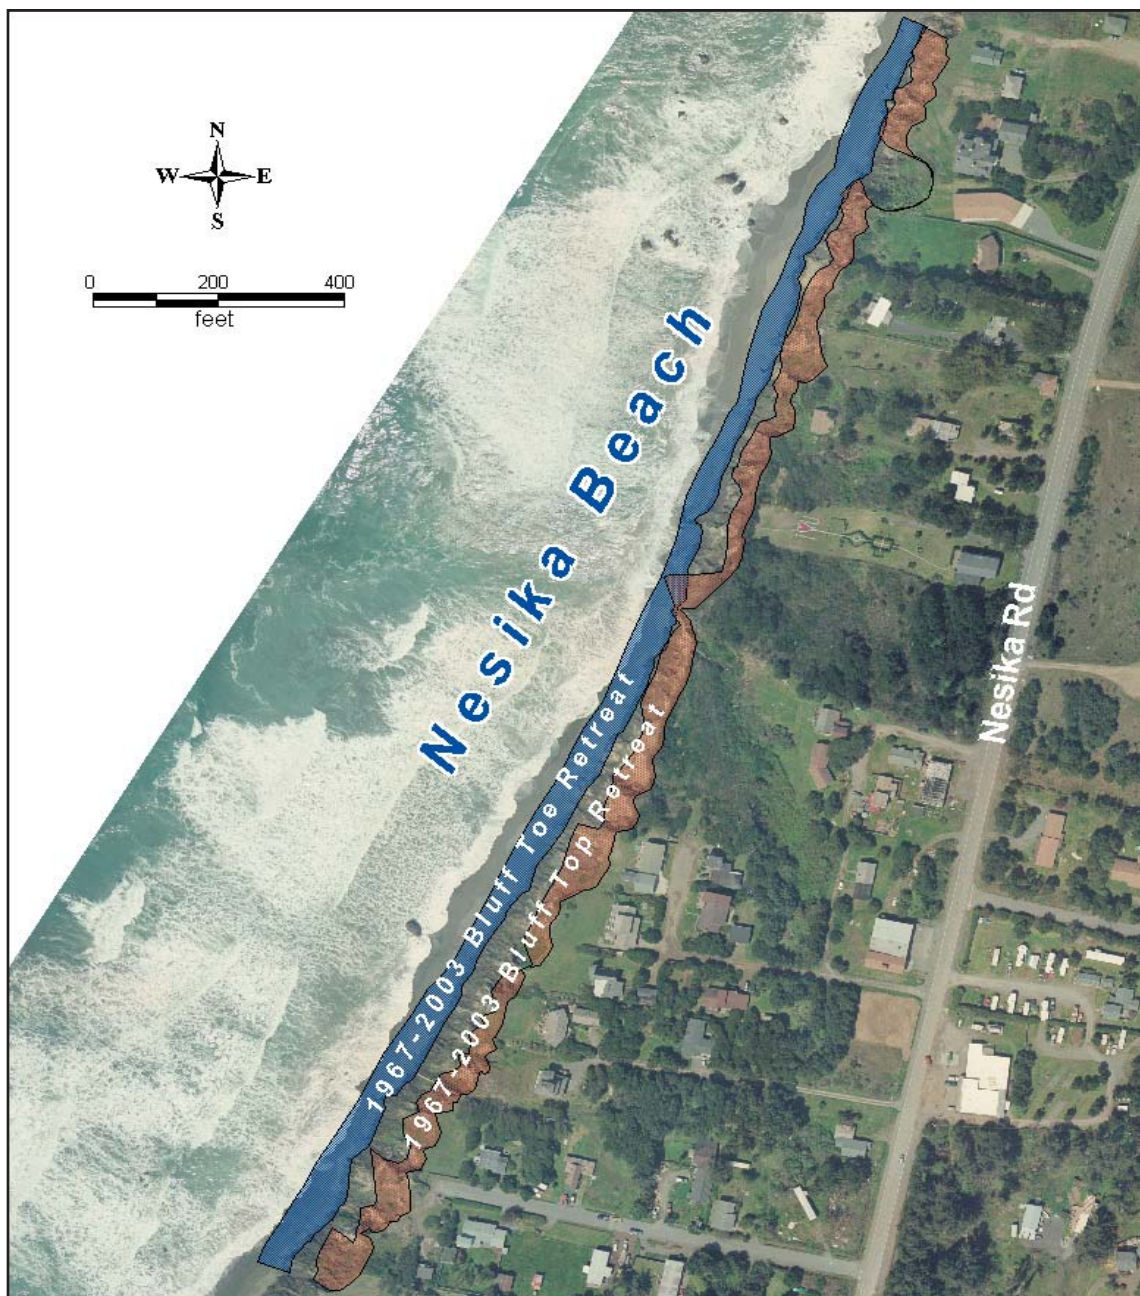
Figure 16. Bluff toe versus bluff top retreat at Nesika Beach between 1967 and 2003; determined from rubbersheeting³ 1967 air photo to 2003 orthophoto of the area. Note how irregular bluff top retreat is relative to bluff toe retreat over this time interval. The bluff toe retreat occurs by fairly constant wearing away by waves, whereas bluff top retreat is more episodic, proceeding more by gravitational failures from slope undercutting and groundwater processes. It is apparent from the illustration that bluff top retreat is approximately equal to toe retreat, but only over a long time interval. The 36-year interval in this example was inadequate to see mean bluff top retreat but adequate for gradual bluff toe erosion. The large changes in bluff top position in several places are probably from local landslide failures. These can happen at anytime and must be taken into account when estimating risk.

Methods: As illustrated in Figure 16, bluff toe retreat is a better estimate of gradual wave erosion not influenced by large block failures. In this study we treat block failure events as a separate variable, so it is important to obtain some estimate of gradual erosion of bluff toes not influenced by large ($\geq \sim 40$ feet-wide) blocks. We tried to establish some conservative estimates of these rates by rubbersheeting historical photography to modern orthophotos in areas that are fully exposed to wave action for large portions of the year, but we only found enough geographic points to do this accurately for the 1967 air photo of Nesika Beach (Figure 17). In this case a mean erosion rate for the entire shoreline segment was then calculated by weighting the east-west change in bluff toe position with the length of affected shoreline north-south (Table 6). We also estimated toe erosion at individual points along the shoreline by estimating air photo scale on 1939 and 1967 photos from local geographic data visible on 2003 orthophotos, and then measuring distances to the bluff toe from distinctive features like sea stacks. These point data were then compiled and mean values calculated. Both sets of erosion data are summarized in Table 6. Point data is also given in digital file **Cliff_Retreat_Meas_Sites.xls** (see Appendix C for summary of all digital data included with this report). For mapping erosion risk zones we will define a low and high erosion rate for geologically and geomorphically coherent bluff segments (Figure 17). No erosion data are available for bluff segments with shoreline protection or altered by emplacement of highway fill.

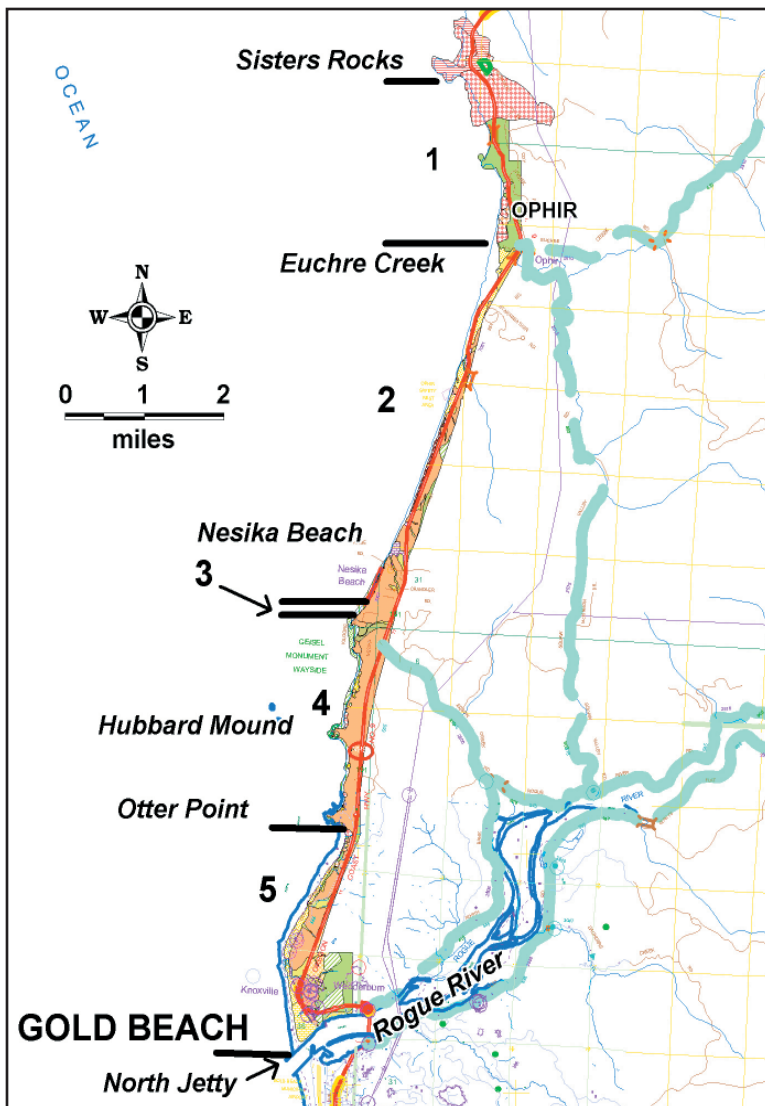
Figure 17. Location map of segments of shoreline with coherent erosion characteristics (black numbers with boundary lines). Headlands like Otter Point, Hubbard Mound and Sisters Rocks are considered a sixth type of bluff segment. Orange areas are outcrops of Quaternary marine terrace deposits; green in upper part of figure are high bluffs of Mesozoic metamorphic and sedimentary rocks; reddish diamond and line patterns in upper part of figure are large landslides in the high bluffs.

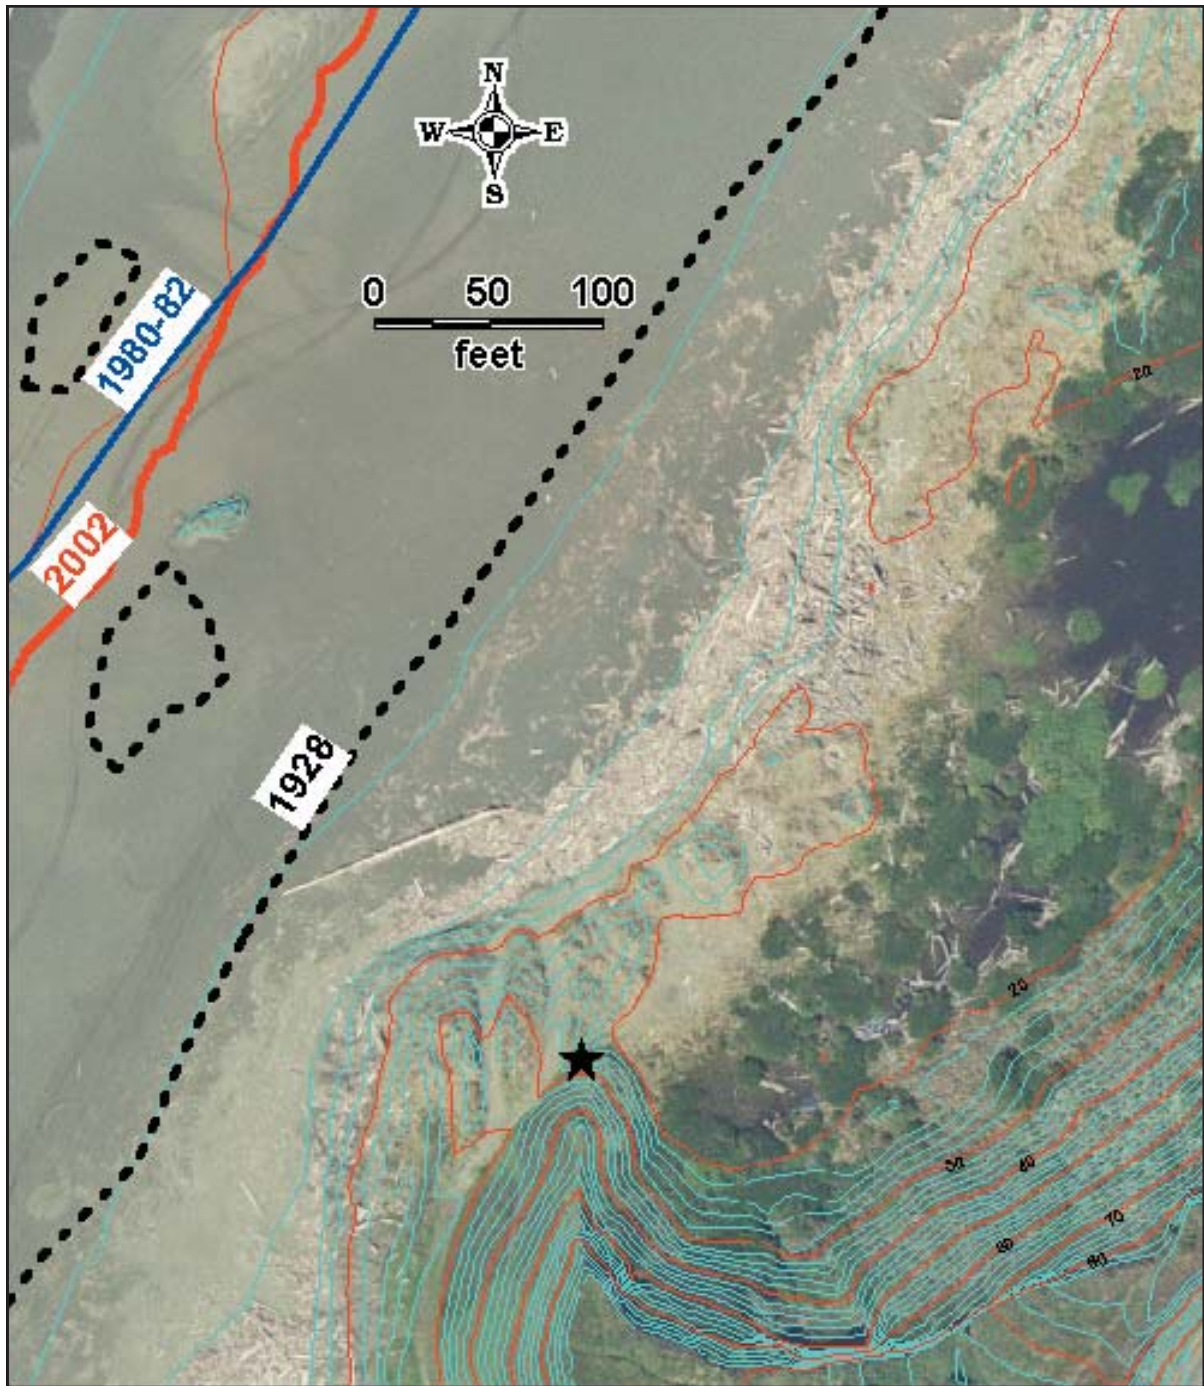
Figure 18. Vegetation on Quaternary marine terrace sand bluff south of Otter Point shows that waves rarely erode the bluff. Mean high water lines from 1928 to 2002 illustrate that the shoreline has fluctuated up to 180 feet in this area. Seaward location of the later shorelines is suggestive that beach sand accretion has occurred during the last 74 years. The star is the location of the erosion measurement listed in Table 6 for this area. Blue lines are topographic contours at intervals of 2 feet.

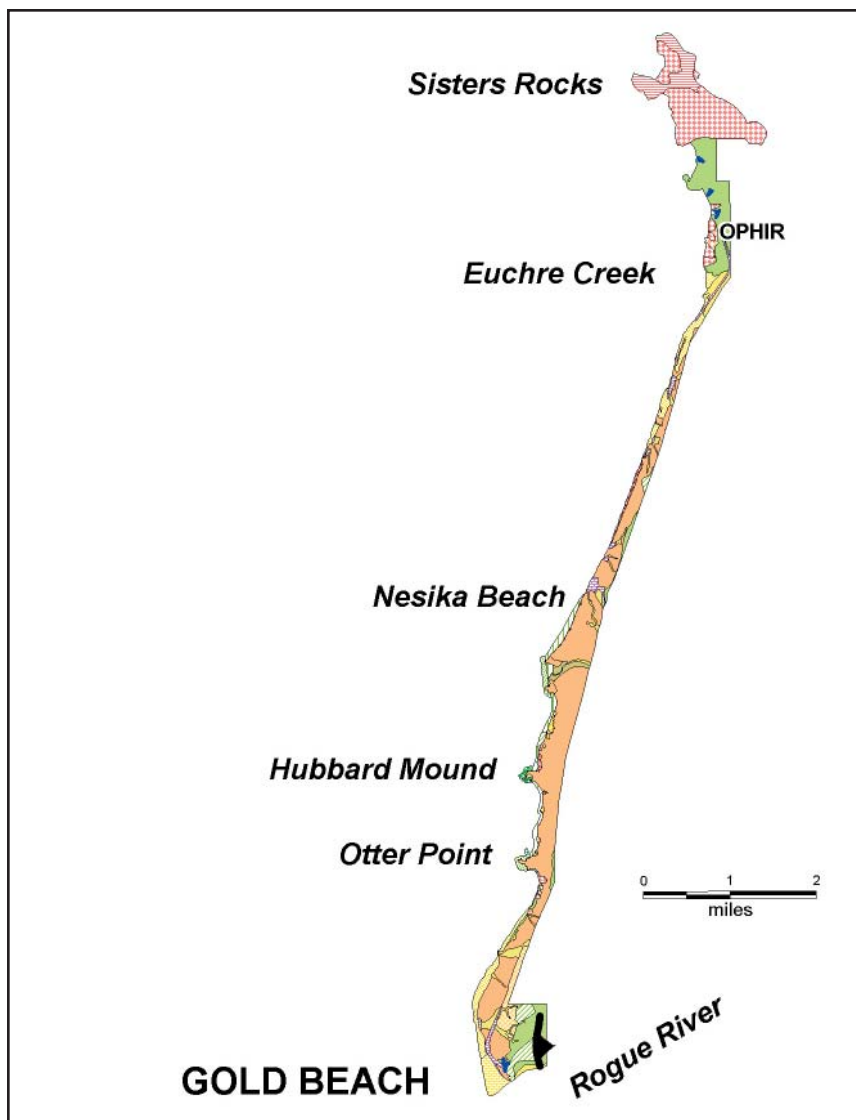
Figure 19. Geologic mapping for the study area covers the full extent of 2003 orthophoto coverage plus a small additional area on the north end of the area. Coverage is generally within about 2000 feet of the coastline, except at the north end where it was expanded to cover the large landslides there. Reddish colored dotted and lined areas at the north end of the study are examples of mapped areas of active landside. Similar but smaller landslides occur to the south. Green area north of Euchre Creek is a high bluff of Mesozoic metamorphic and sedimentary rocks. Orange area areas to the south are much lower bluffs capped by Quaternary marine terrace deposits. See Appendix B for detailed views of the mapping plus a complete map legend explaining geologic map units.

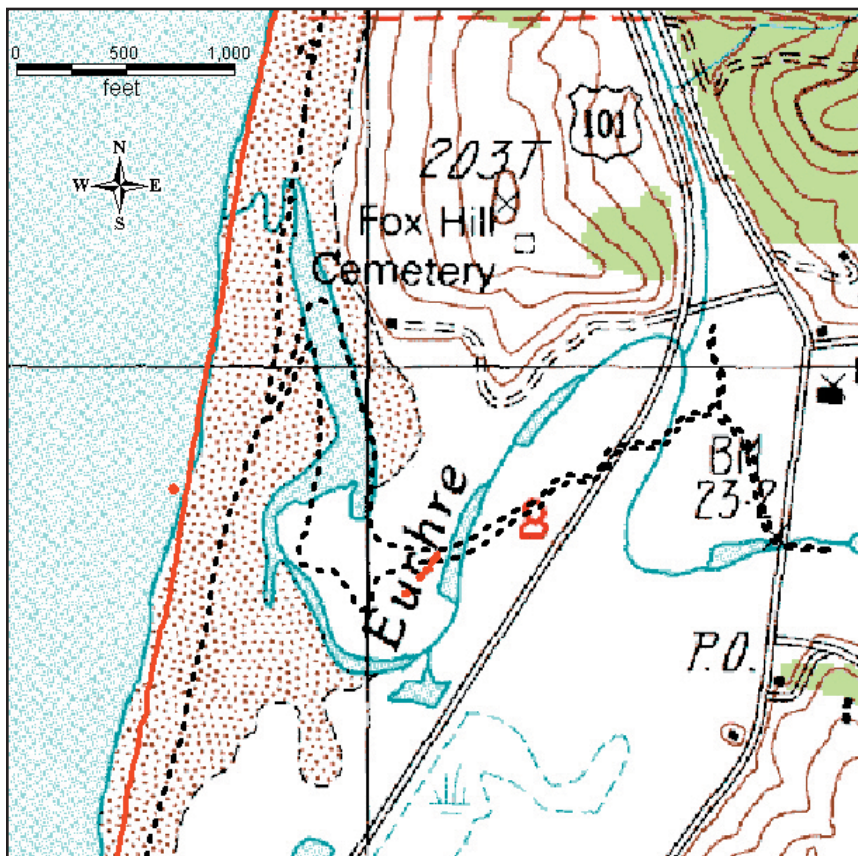
Figure 20. Historic shorelines in the Euchre Creek area. Red line is the 2002 mean higher high water shoreline defined from LIDAR data; dashed line is the same shoreline taken from a 1928 topographic map; blue shoreline is from the 1980-1982 USGS topographic base map. Note that there is overall accretion of the beach from 1928 but little change between 1982 and 2003. Also note the complex changes in position of the Euchre Creek channel.

Table 10 presents values of the MPED identified for the dune-backed shorelines around the mouth of Euchre Creek. Figure 20 illustrates historic shoreline change. As can be seen for the high-risk hazard zone, estimated erosion distances range from 341 to 415 feet, with

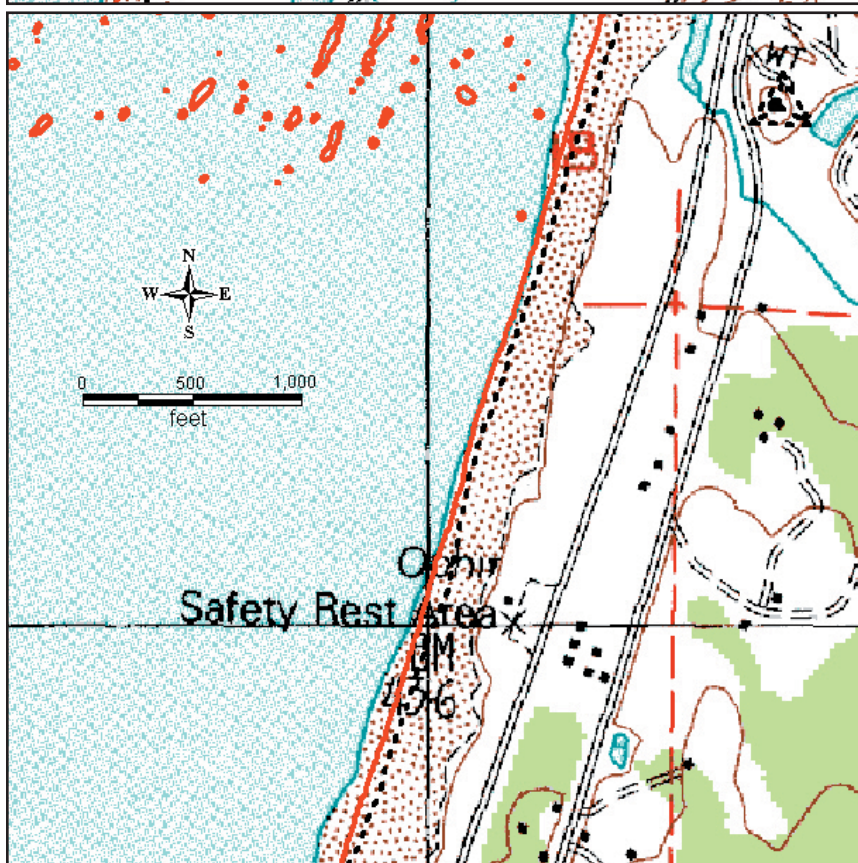
Figure 21. Historic shoreline change at northern Nesika Beach (Ophir Wayside). See Figure 20 for explanation of symbols.
