OFR O-04-20

**EVALUATION OF COASTAL EROSION HAZARD ZONES
FROM SISTERS ROCKS TO NORTH GOLD BEACH, CURRY
COUNTY, OREGON:**

TECHNICAL REPORT TO CURRY COUNTY

George R. Priest¹, Ron Sonnevil², and Jonathan C. Allan¹

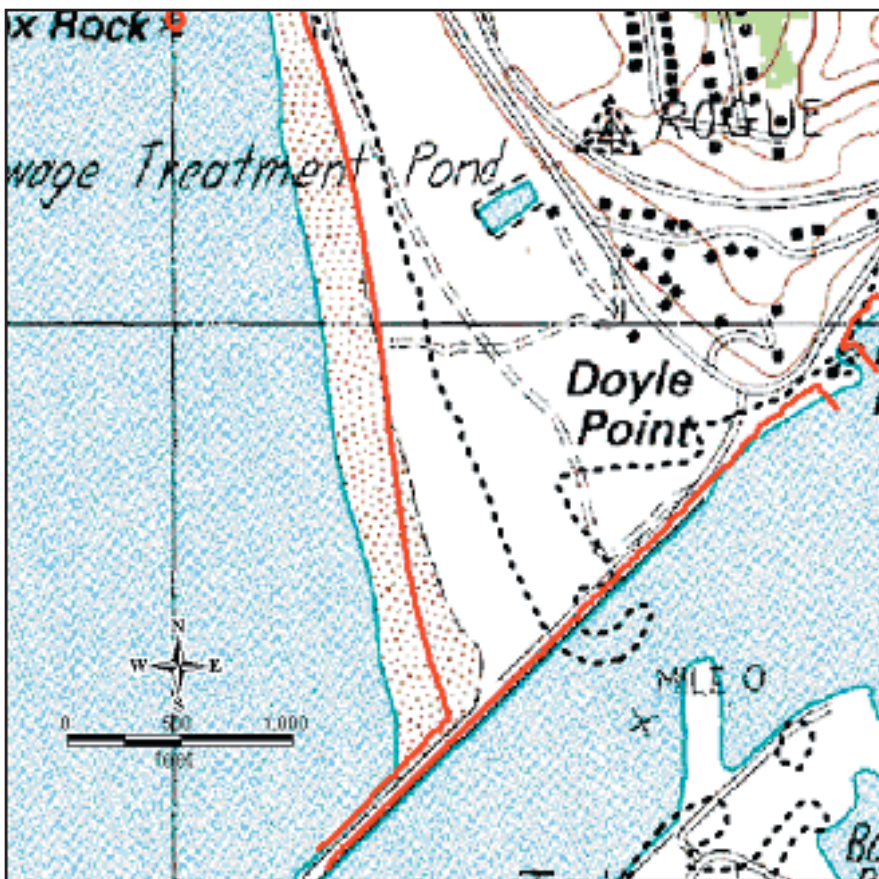
Figure 22. Beach accretion caused by construction of jetties at Gold Beach. The effect is most pronounced on the north side of the North Jetty where the pre-jetty shoreline of 1928 (dashed line) is hundreds of feet east of the 2002 shoreline (red) defined by LIDAR. The effect decreases north. The base map is a 1980/1982 USGS DRG (digital raster graphic quadrangle). Note the eastward translation of the shoreline from 1980-1982 to 2002 probably resulting from the extreme storms that occurred during the 1997-98 El Niño and 1998-99 La Niña winters.
