# Montgomery Court Residence Hall

## Seismic Rehabilitation Project at Portland State University

Yumei Wang, Oregon Department of Geology and Mineral Industries, and Chris Heathman, formerly at Oregon Department of Geology and Mineral Industries

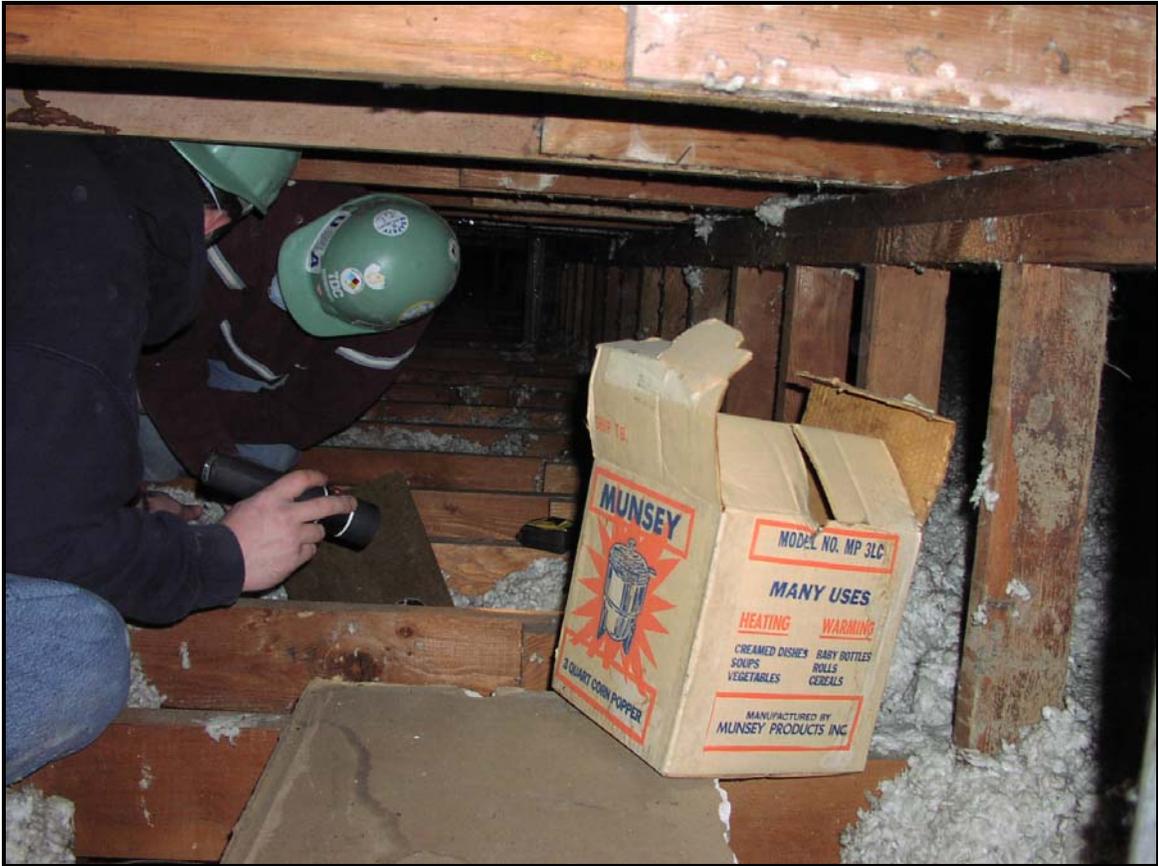
As with most URMS, Montgomery Court lacks shear strength to withstand earthquake shaking, structural connections to remain intact, and ductility to rebound back to an upright standing position. Upon inspection, it was verified that the roof and the top floor were not well connection (Figure 2).

**Figure 2. Exploration of the attic space to examine the top diaphragm connection**

The seismic rehabilitation design, which cost \$685,000, includes four mitigation measures:

- Connecting the top diaphragm/floor to a new roof
- Adding reinforcement to the stairwells for safe exiting
- Anchoring the falling hazards, such as ornaments and chimneys
- Securing the parapets (Figure 3)

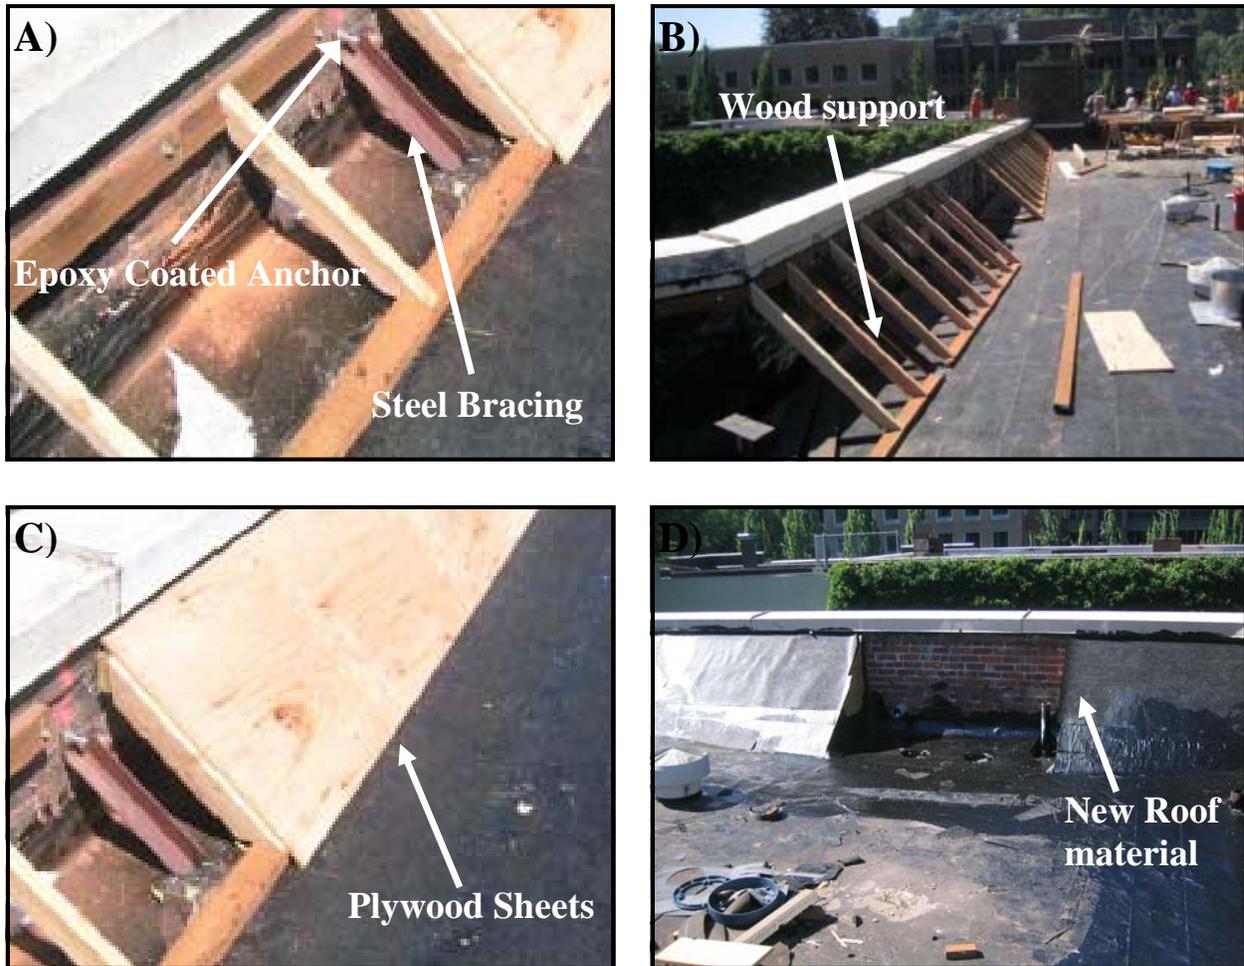
**Figure 3. Construction process used for securing the unusually tall parapets, which posed a significant falling hazard because they are situated over high traffic walkways**
