State of Oregon
Department of Geology and Mineral Industries
Vicki S. McConnell, State Geologist

Open-File Report O-09-01

BEACH AND SHORELINE RESPONSE TO AN ARTIFICIAL LANDSLIDE AT ROCKY POINT, PORT ORFORD, ON THE SOUTHERN OREGON COAST

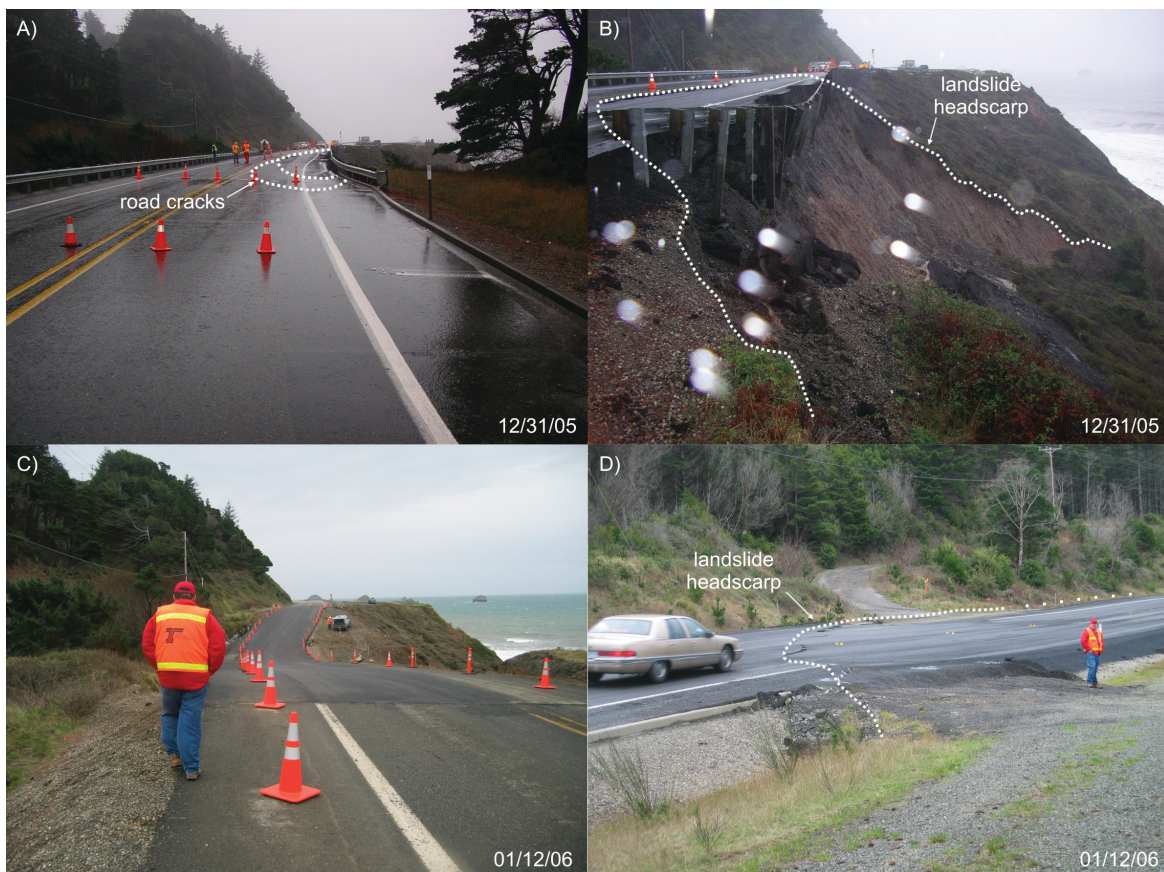
Figure 2. **A)** The Rocky Creek landslide on December 31, 2005, with surface cracks extending across the western lane of U.S. Highway 101; **B)** the western lane of the highway is undermined due to a slump/block failure (note the head scarp running seaward near the top-right center of the photo); **C)** the main slump on January 12, 2006, which caused Highway 101 to drop by approximately 6 m (20 ft); **D)** surface cracking on January 12, 2006, some 230 m (760 ft) north of the main slump/block failure across Rocky Creek, indicating other movements in the area.

On December 31, 2005, a large crack developed across a portion of U.S. Highway 101, at Rocky Creek, approximately 3.5 km (2.2 mi) south of the town of Port Orford on the southern Oregon coast (Figure 1, Figures 2A and 2B). Initial construction of this section of Highway 101 was carried out in the early 1940s. A culvert was constructed over Rocky Creek in 1949, and the creek valley was eventually filled with material that was locally derived from the excavation of Highway 101. The site has been subject to previous phases of slumping and, according to ODOT staff, was scheduled for repairs in ~2008. By January 4, 2006, the crack had developed into a major landslide (hereafter referred to as the Rocky Creek Landslide) and was classified by Oregon Department of Transportation (ODOT) geologists as a “fill/block failure.” The landslide caused a portion of Highway 101 to slump seaward, and its western lane dropped vertically some 6 m (20 ft) (Figure 2C). Road traffic between Port Orford and Gold Beach was reduced to one lane, causing significant disruption along this portion of the highway. At the same time, additional cracking associated with another landslide

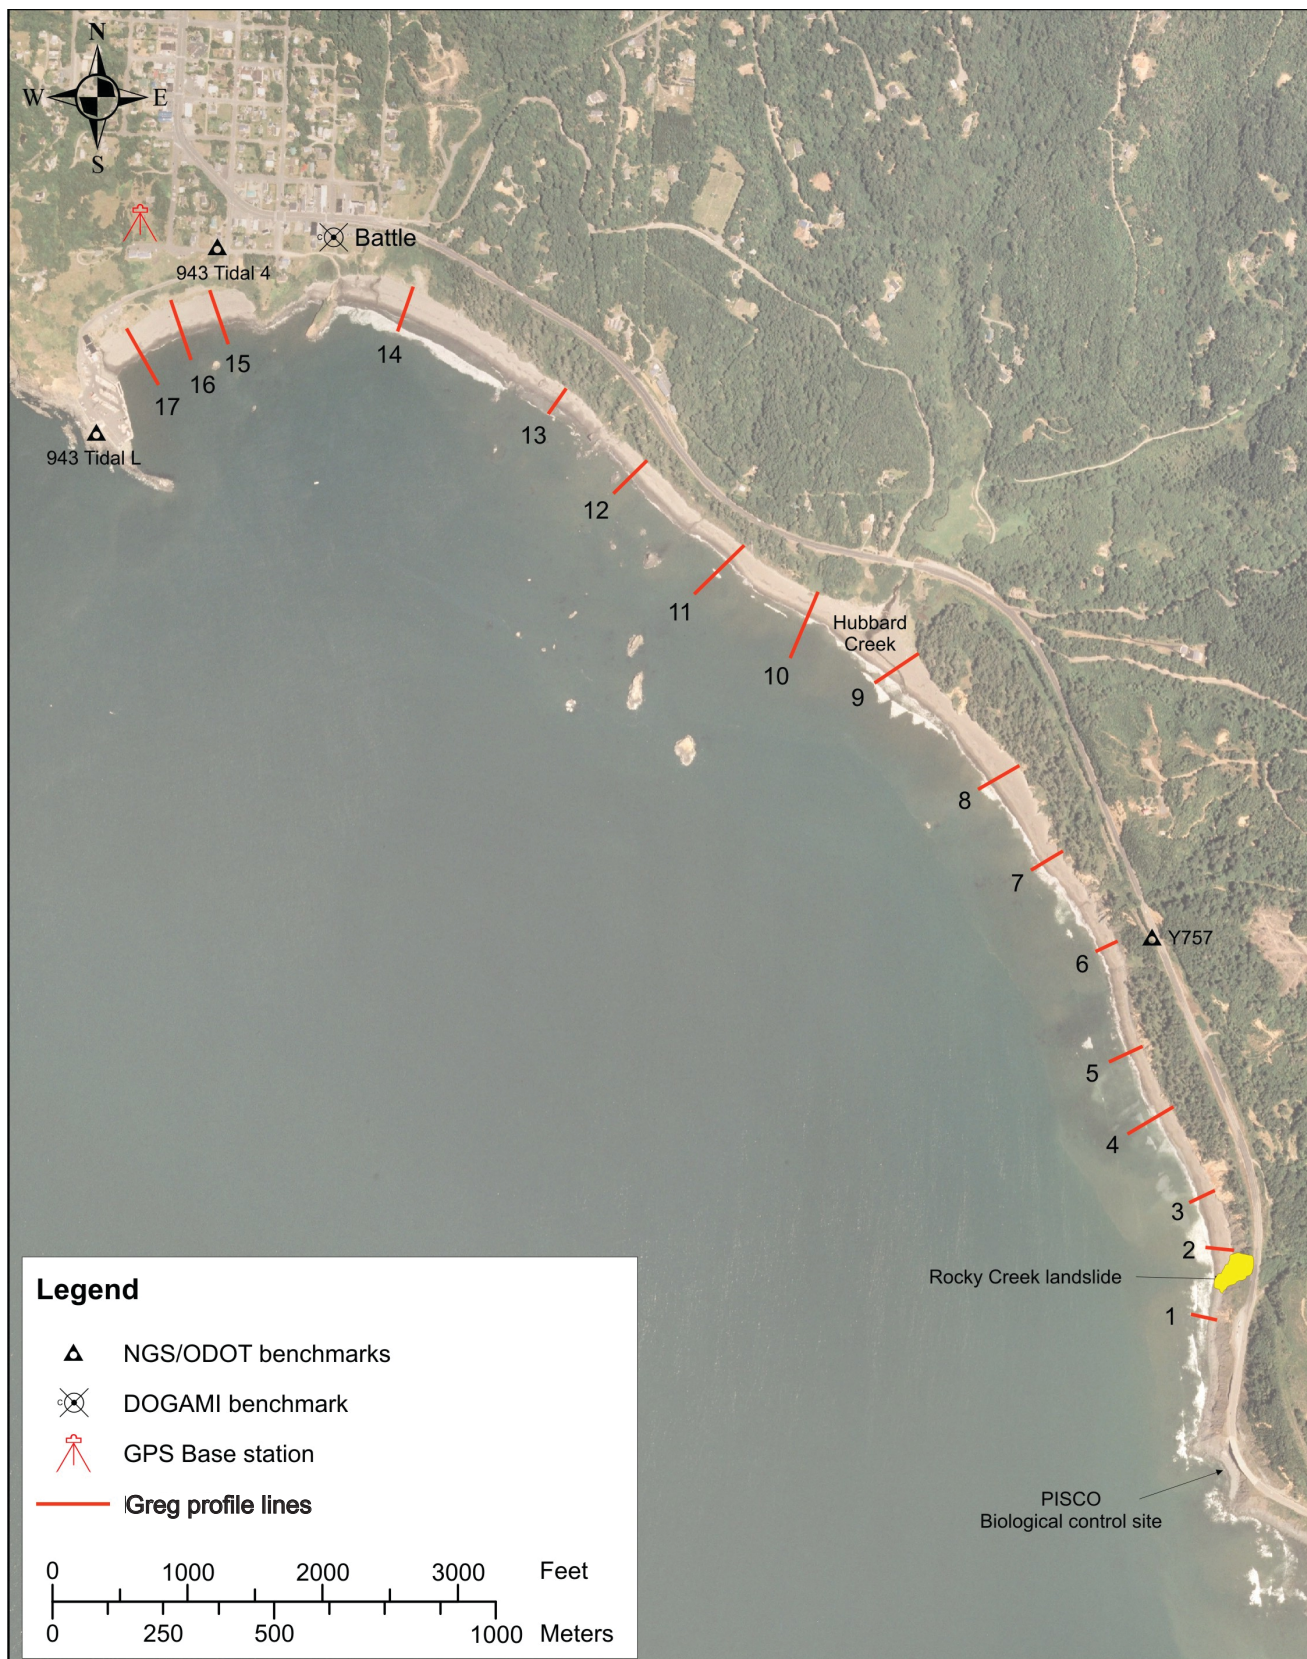
Figure 3. Location map showing the distribution of beach profile stations established in the Hubbard Creek littoral cell, Global Positioning System (GPS) survey control sites, National Geodetic Survey (NGS) and Oregon Department of Transportation (ODOT) benchmarks, and the Rocky Creek landslide.

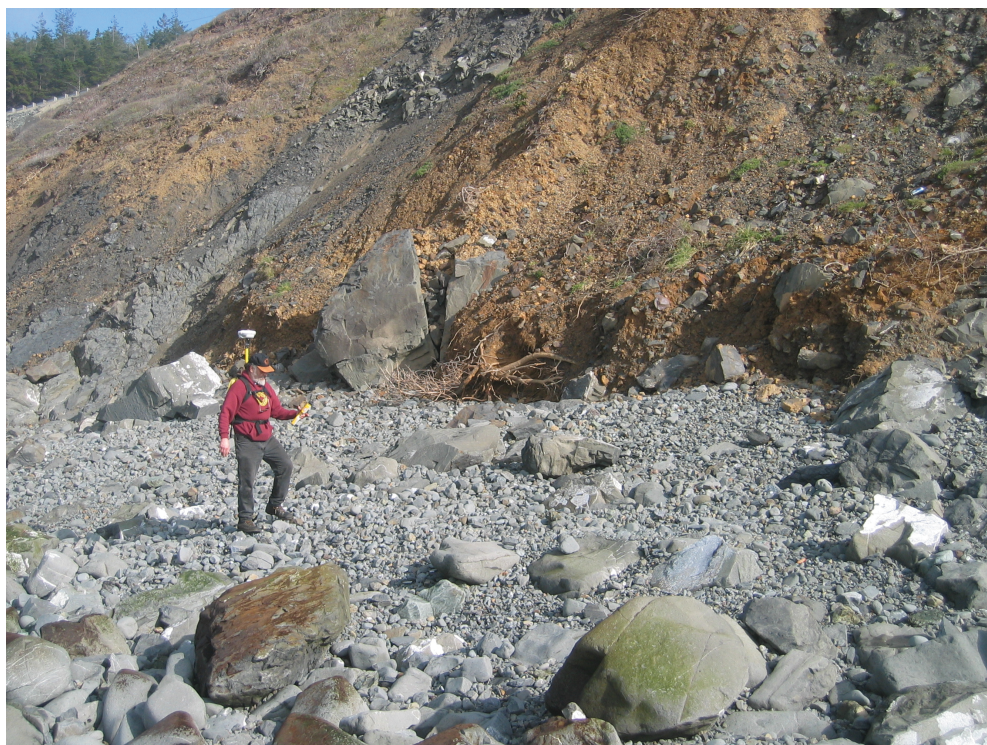
Figure 4. Mass wasting of the bluff face immediately south of the Rocky Creek landslide is occurring in response to winter rainfall and from toe erosion by ocean waves. The photo, taken in January 2007, shows the result of recent storm wave erosion — a 1 m (3 ft) high erosion scarp at the toe of the bluff. The mean elevation of the scarp toe is ~5.6 m (18 ft) and indicates that the wave swash is reaching and exceeding this elevation. Erosion of the bluff is naturally contributing a wide range of sediments to the Hubbard Creek littoral system.

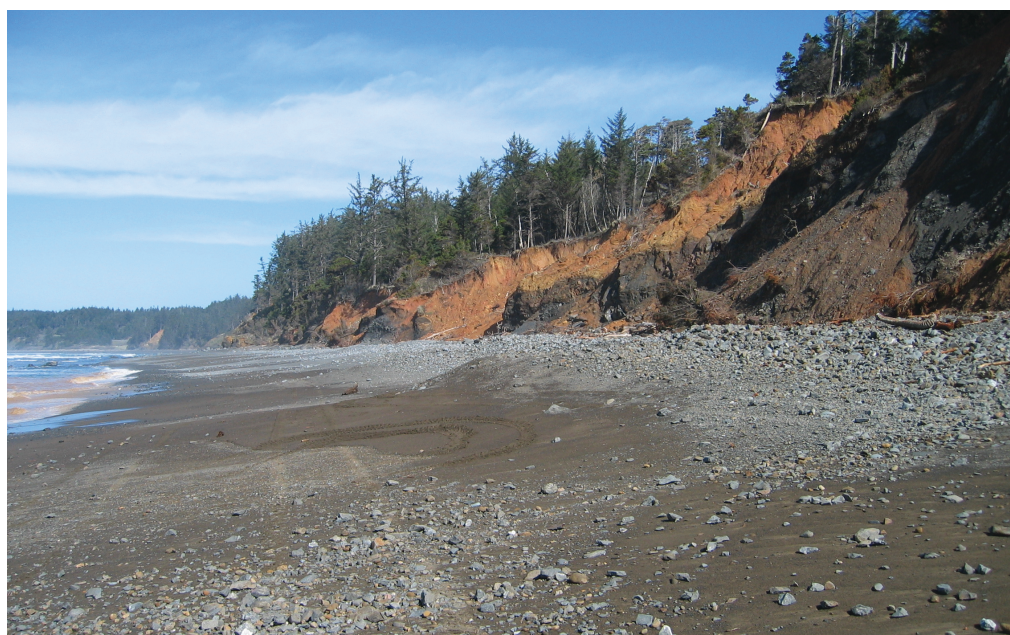
Figure 5. Mixed sand and gravel beach backed by a cobble berm. Looking north from Greg2 (Figure 3) on April 4, 2006.

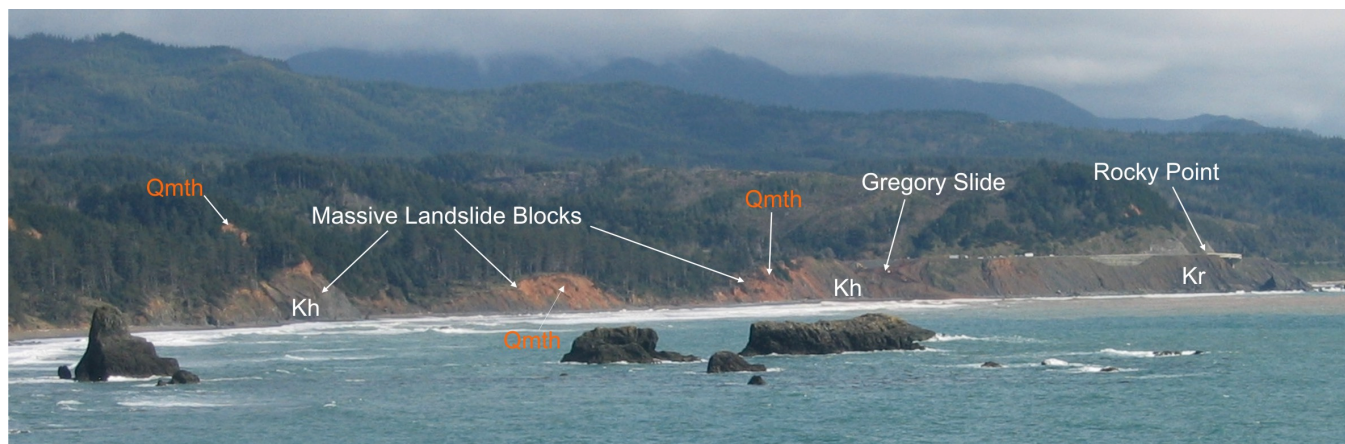
Figure 7. View of the southern end of the Hubbard Creek littoral cell looking south toward Rocky Point. Locations of massive landslide blocks that dissect the bedrock geology are shown.

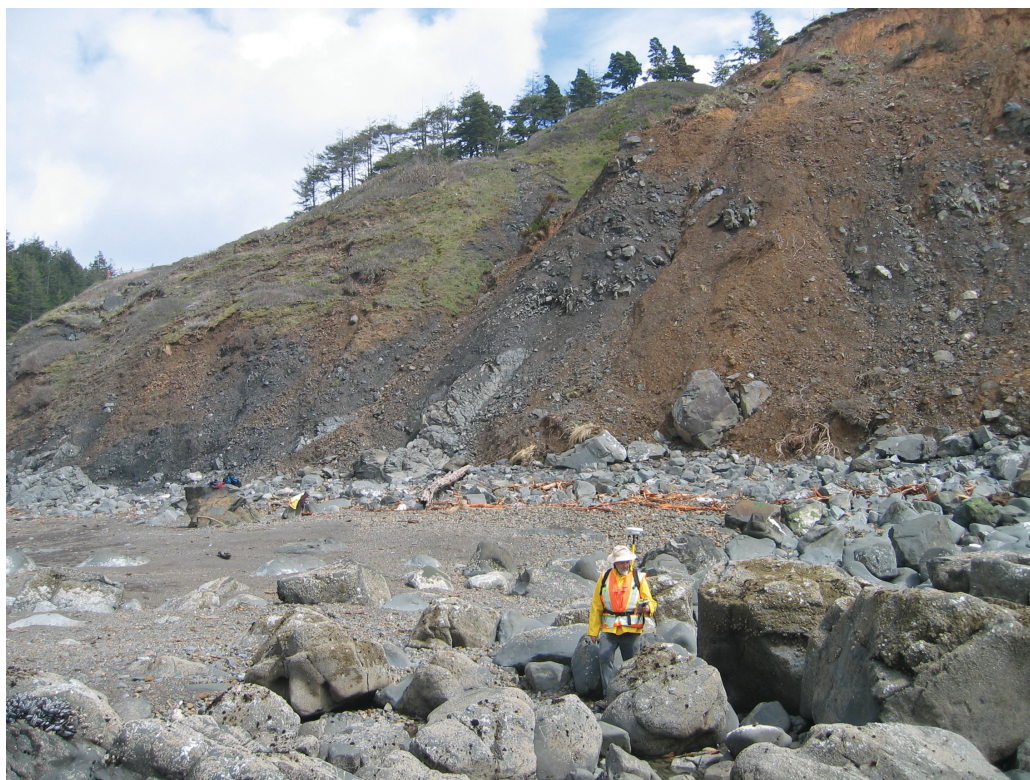
Figure 16. Beach surveys were undertaken by walking lines perpendicular to the water's edge, navigating along a predetermined line identified on a hand-held TSCe Trimble computer connected to the Trimble 5800 GPS rover. The example here is of R. Hart undertaking a topographic survey of the landslide toe adjacent to the Rocky Creek culvert on January 26, 2007. Note the accumulation of gravel associated with the southward transport of some of the fill.

After local site calibration had been completed, cross-shore beach profiles were surveyed with the 5800 GPS rover unit mounted on a backpack, worn by a surveyor (Figure 16). This was typically undertaken during periods of low tide. The general approach was to walk from the landward edge of the primary dune or bluff

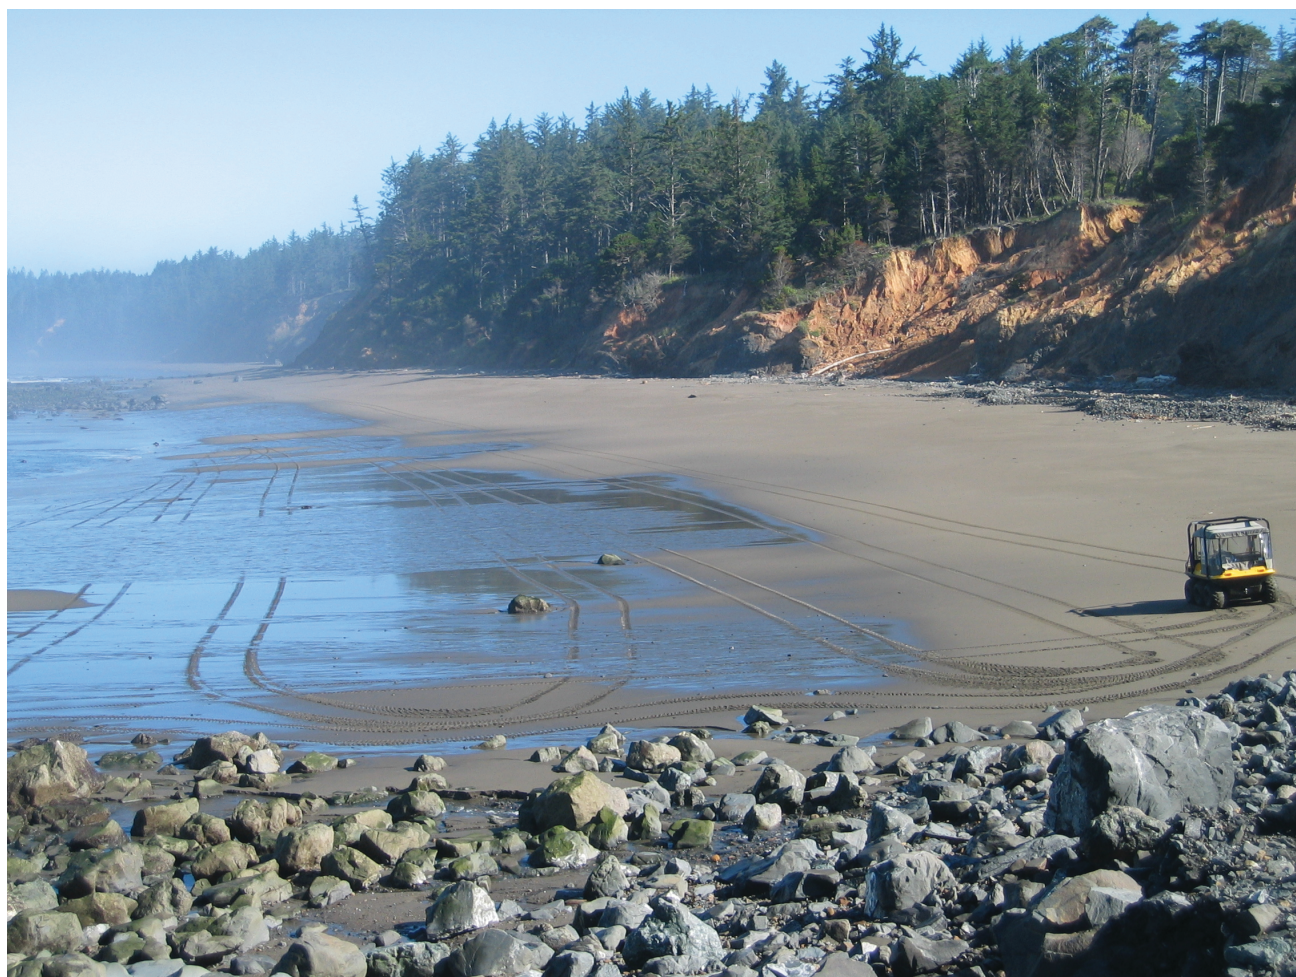
Figure 17. Topographic mapping of the beach was undertaken using a Trimble 5800 GPS unit mounted on top of a six-wheel ARGO ATV. Photo shows the presence of survey tracklines undertaken on the lower beach face, which are spaced roughly 5 to 10 m apart.

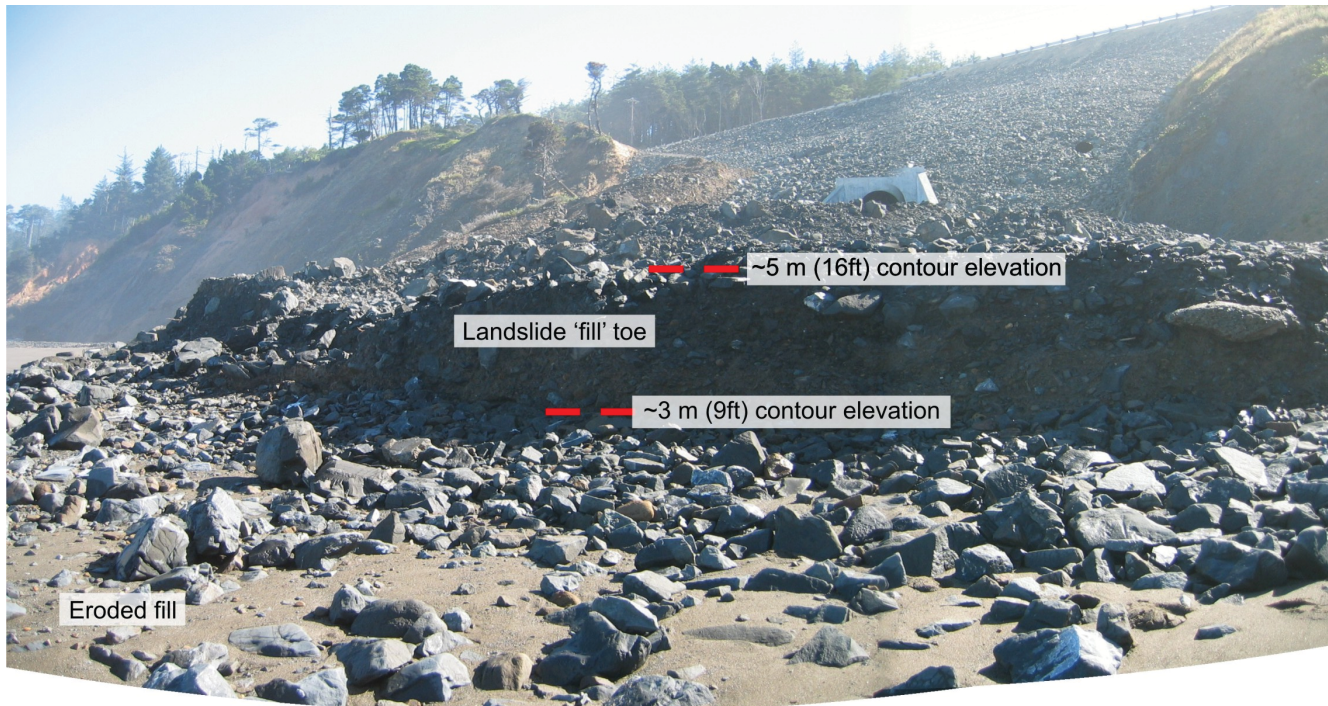
Figure 18. The toe of the artificial landslide on July 14, 2006, showing the presence of an erosion scarp that formed over the latter part of the 2005-2006 winter. To capture the change in position of the landslide toe, various elevation contours (e.g., the 3-m [9 ft] and 5-m [16 ft] contours) are tracked over time. (See Figure 21.)

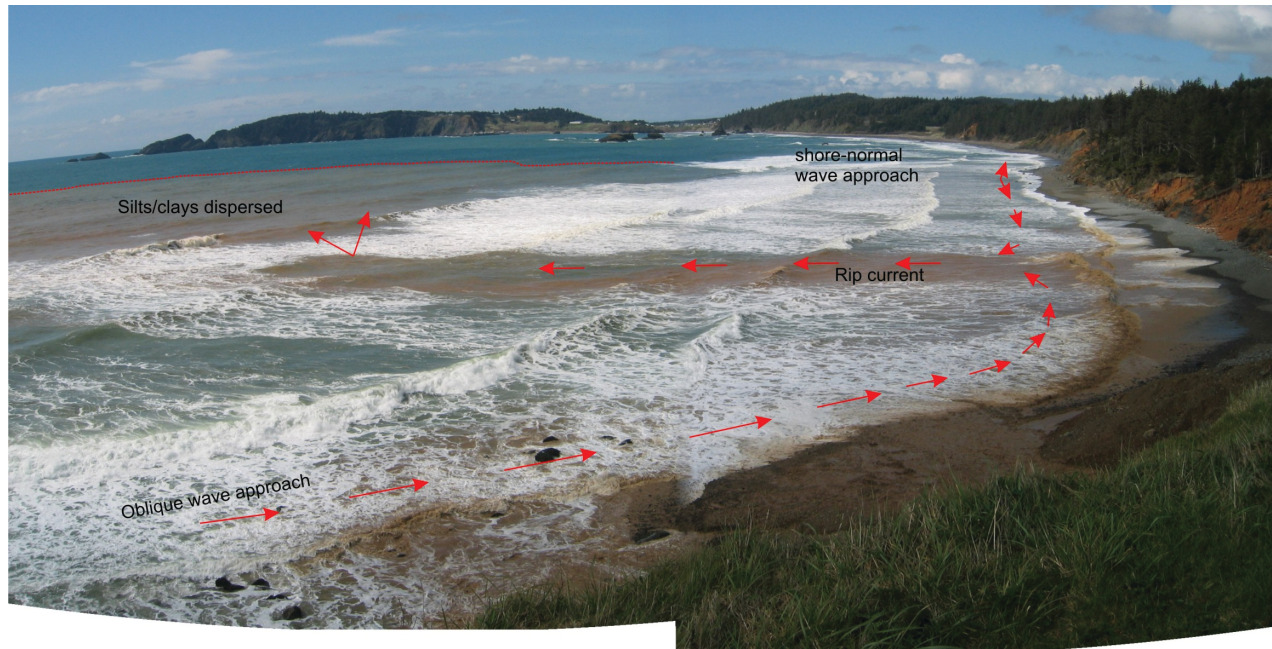
Figure 22. A rip current on April 3, 2006, carries fine-grained sediments (silts and clays) offshore, where the rip current is broadly dispersed by surface wind driven currents.

The removal of the fines and its rapid dispersal offshore from Rocky Creek was aided by the presence of a strong rip current that develops just north of Rocky Creek (Figure 22). The formation of this rip current is probably due to the interaction of oblique wave approach near Rocky Point, which generates a northward flowing longshore current within the breaker zone and landward of it. North of the Greg3 beach profile site (Figure 3), wave approach tends to be predominantly normal (parallel) to the shore, which results in the development of longshore currents flowing north (i.e., toward Greg4 and farther north) and south toward the creek. Convergence of the currents (Figure 22, middle) results in the formation of a strong seaward flowing rip current capable of transporting large amounts of fine sediments offshore, where the rip current is subsequently dispersed by surface wind driven

currents. Over time, the finer particles settle out of the water column and accumulate on the ocean bottom. Since visiting the Rocky Creek site in January 2006, we have repeatedly observed the presence of a rip current at this same location.

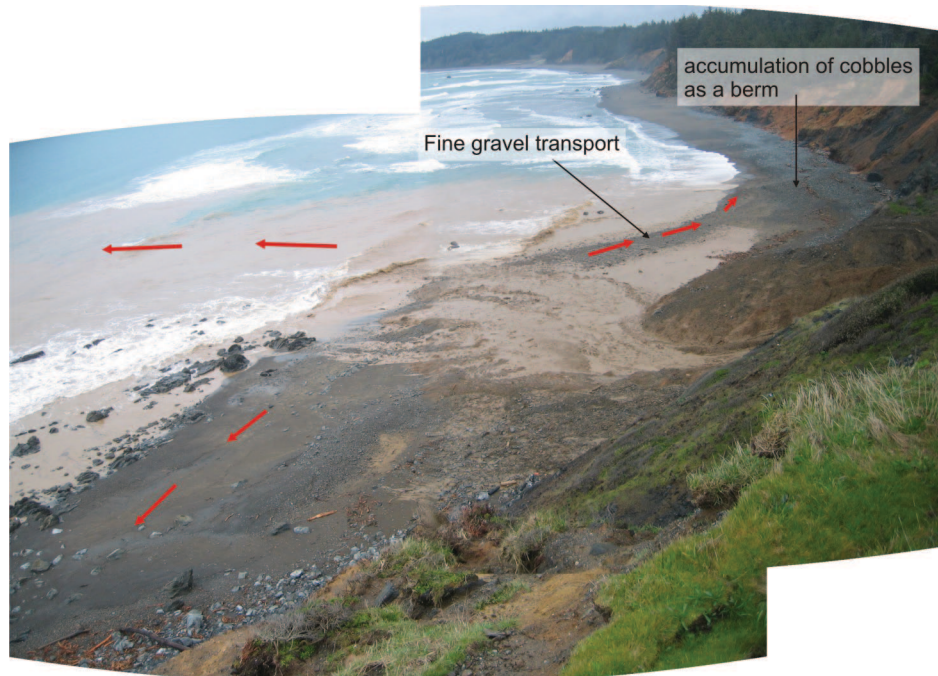
Figure 23. Beach conditions on April 5, 2006, showing the dispersal of the coarser sediments (medium sand to gravel fractions) to the north and south of the creek outlet, while the finer particles continue to be removed offshore.

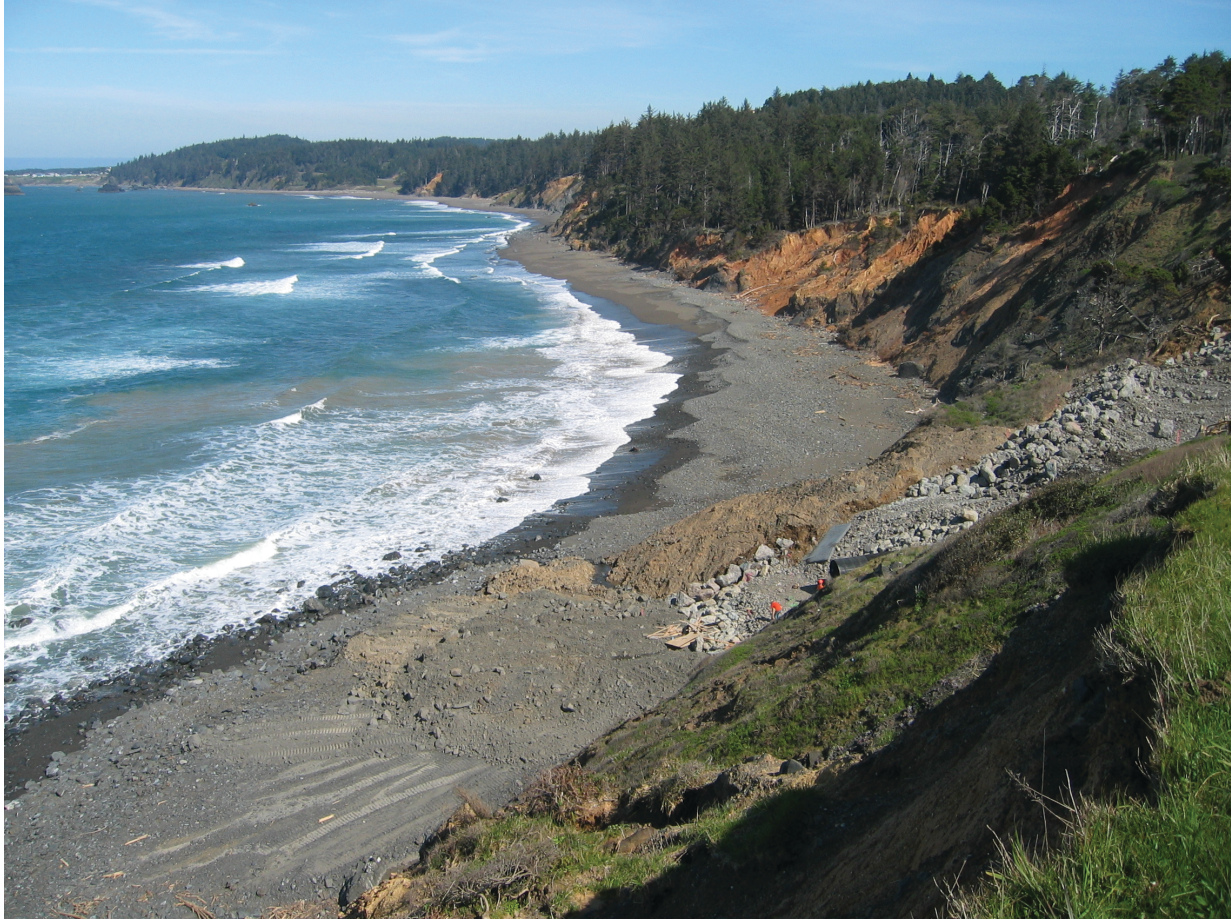
Figure 25. Photograph of Rocky Creek beach on April 27, 2006, four weeks after excavation of the landslide had begun. Red dots, center right, are jackets worn by ODOT contractors.
