State of Oregon
Department of Geology and Mineral Industries
Vicki S. McConnell, State Geologist

**OPEN-FILE REPORT
O-09-06**

**COASTAL EROSION HAZARD ZONES IN SOUTHERN CLATSOP COUNTY,
OREGON: SEASIDE TO CAPE FALCON**

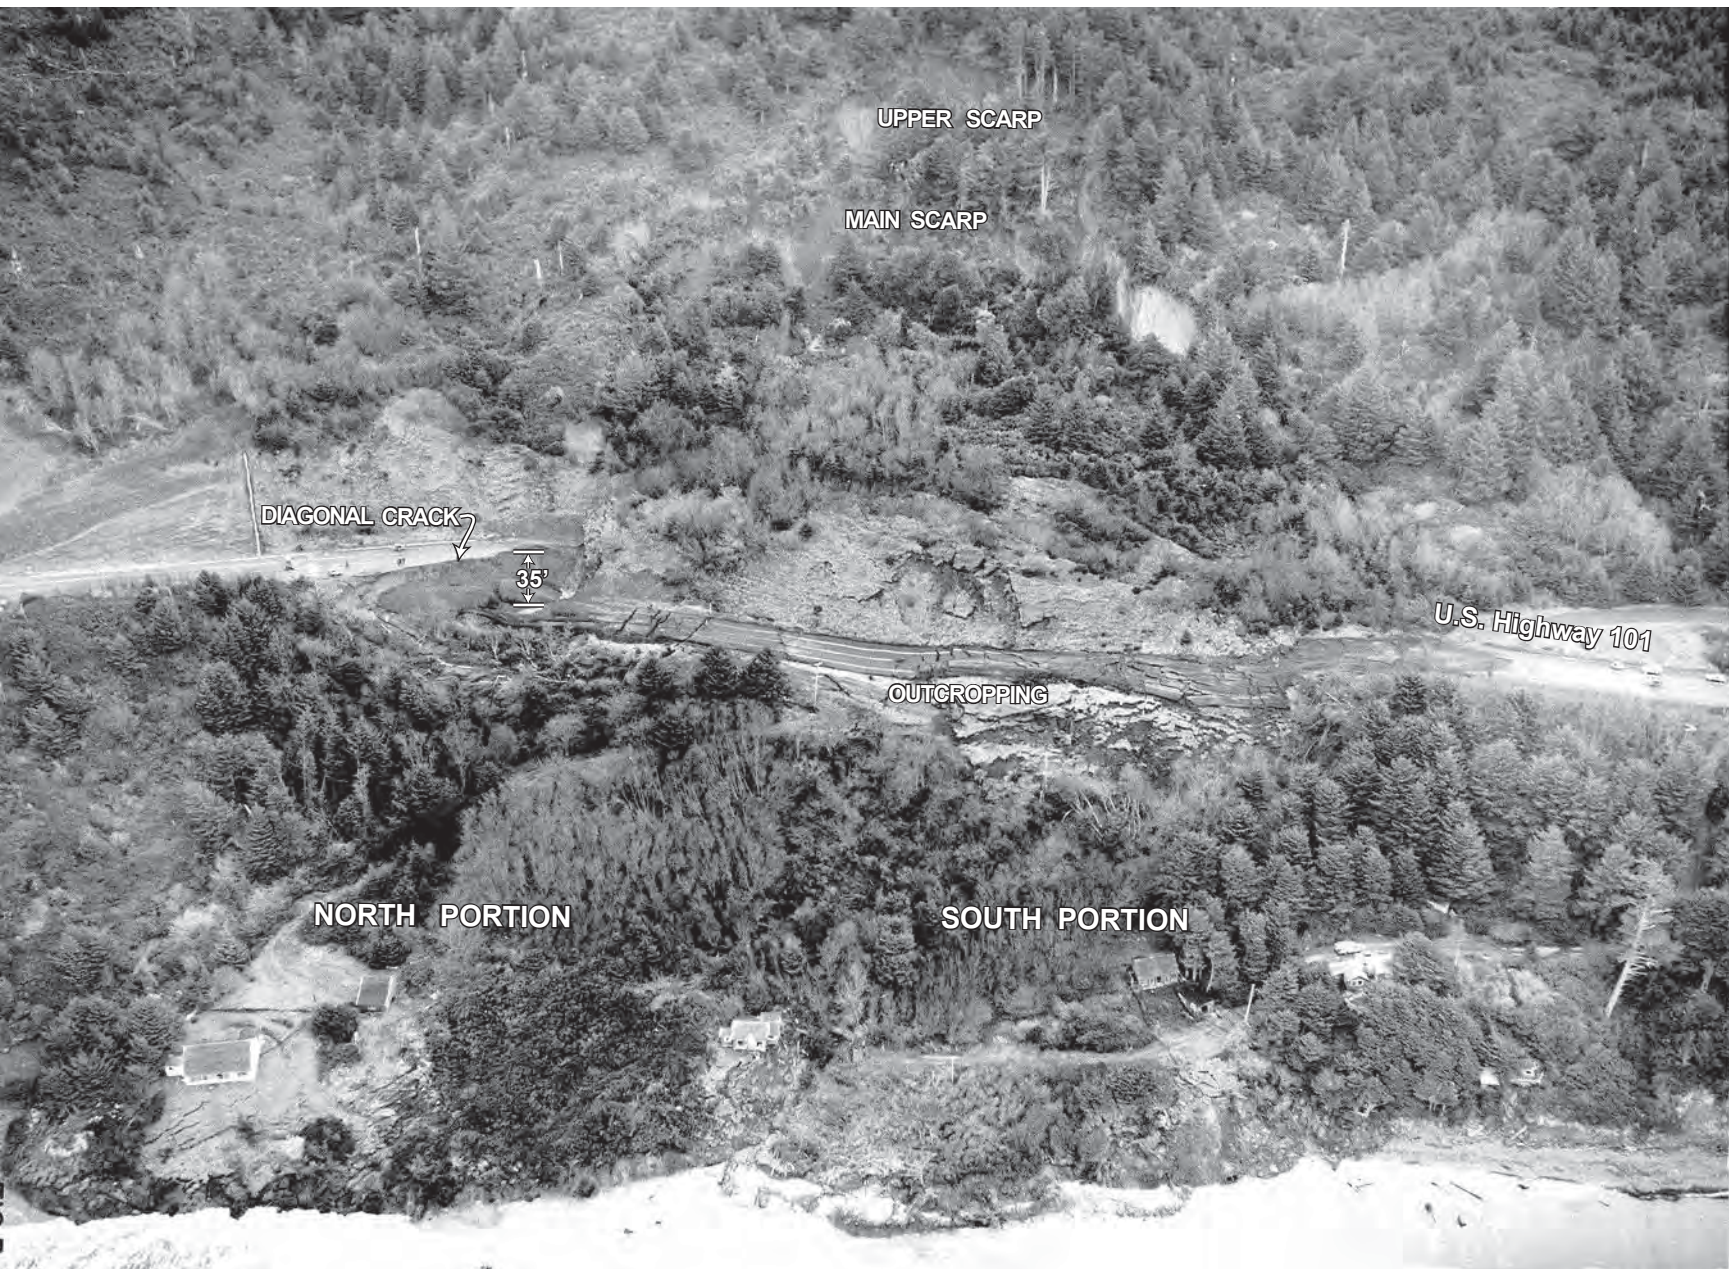
Figure 2. Ecola State Park geologic map (Schlicker, 1961).

In February 1961 heavy precipitation caused movement of a large (more than 61 acres) landslide that closed Ecola State Park (Figure 2) (Schlicker and others, 1961). Recurrent movement over several years following 1961 (Carson and Hankel, 1975) has tilted trees, cracked pavement, and formed intermittently drained sag ponds. Movement in 1961 involved an area approximately 3000 ft long and 1000 ft wide that started at an elevation of 240 ft and tapered seaward, resulting in a maximum horizontal displacement of about 100 ft. Schlicker and others (1961) mapped other large, active landslides nearby at Bald Point and along bluffs backing Crescent Beach.

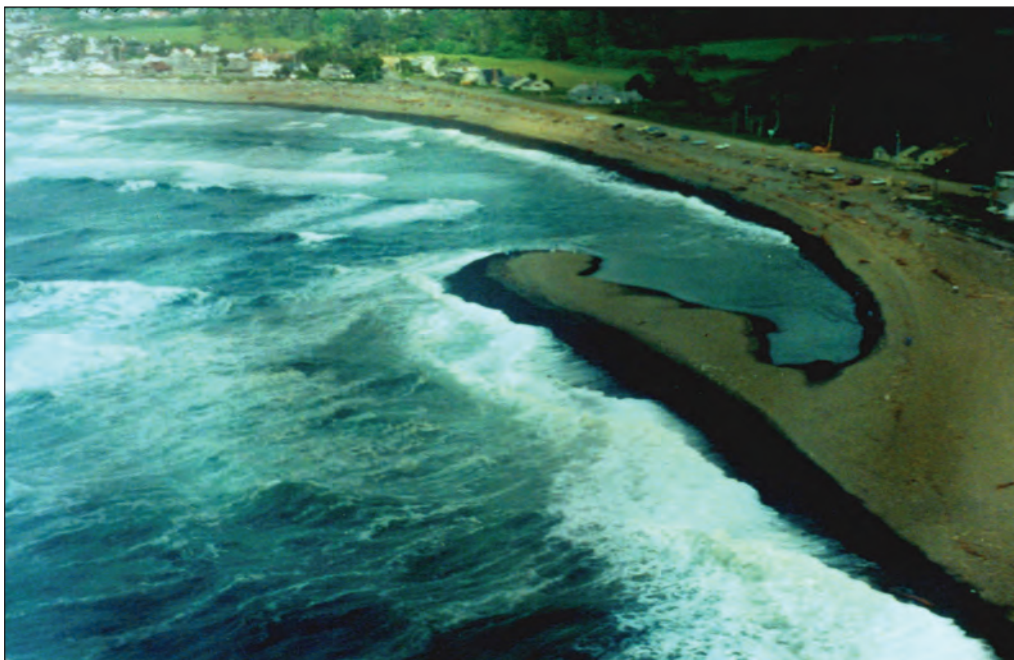
Figure 7. Oblique aerial photo (view to southeast) of a migrating cobble-boulder berm that developed at the cove, at Seaside's southern shoreline, from the 1987 landslide on Tillamook Head. Within one month the berm connected to the north-south beach at the upper left corner of the photo. Larger winter surf pushed the rubble onto the original east-west shoreline (foreground in lower right of photo), killing all intertidal sea life. Waves then moved the cobbles and boulders westward with negligible progradation of the east-west shoreline and onto the north-south beach where the material formed a series of coalescing berms that shifted the shoreline 300 ft westward. The rocky material continues to advance slowly northward along the beach, driven by winter surf. Photo courtesy of Paul D. See.

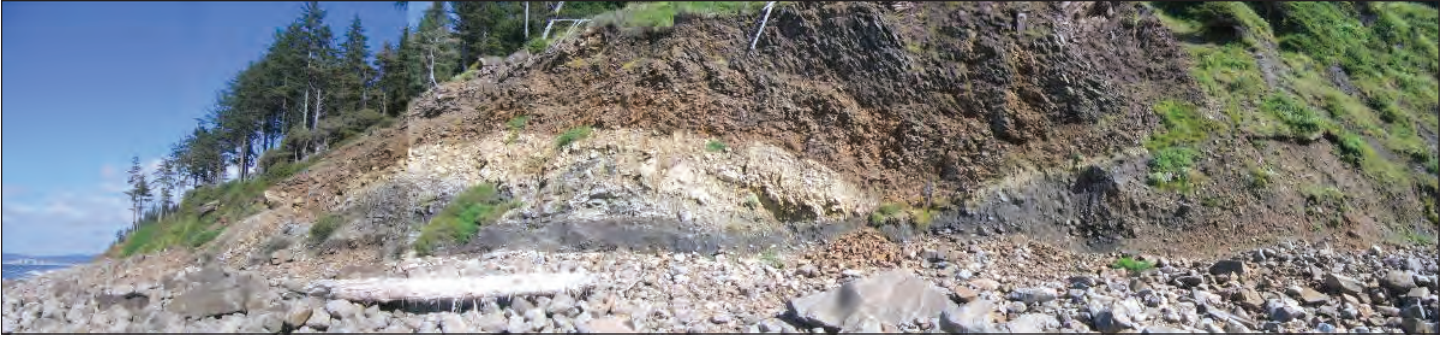
Figure 8. Panorama of the toe of an active landslide on the northwestern side of Tillamook Head. Reddish-brown basalt (Tgri) overlies white and gray mudstone (Tsc), which sharply overlies dark gray breccia. The landslide failure plane is inferred to correspond to the contact between mudstone and breccia.

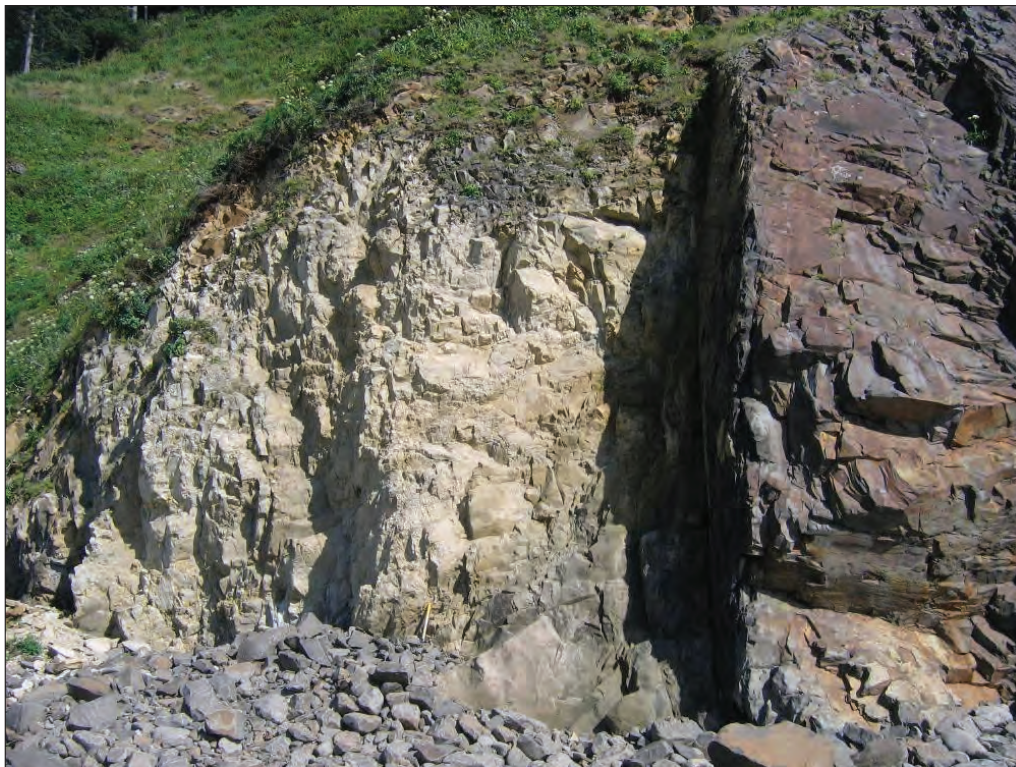
Figure 9. Geologic contact between white, tuffaceous mudstone of the Smuggler Cove formation (Tsc) (left) and strongly jointed, west-dipping Grande Ronde Basalt (Niem and Niem, 1985), northwest flank of Tillamook Head.

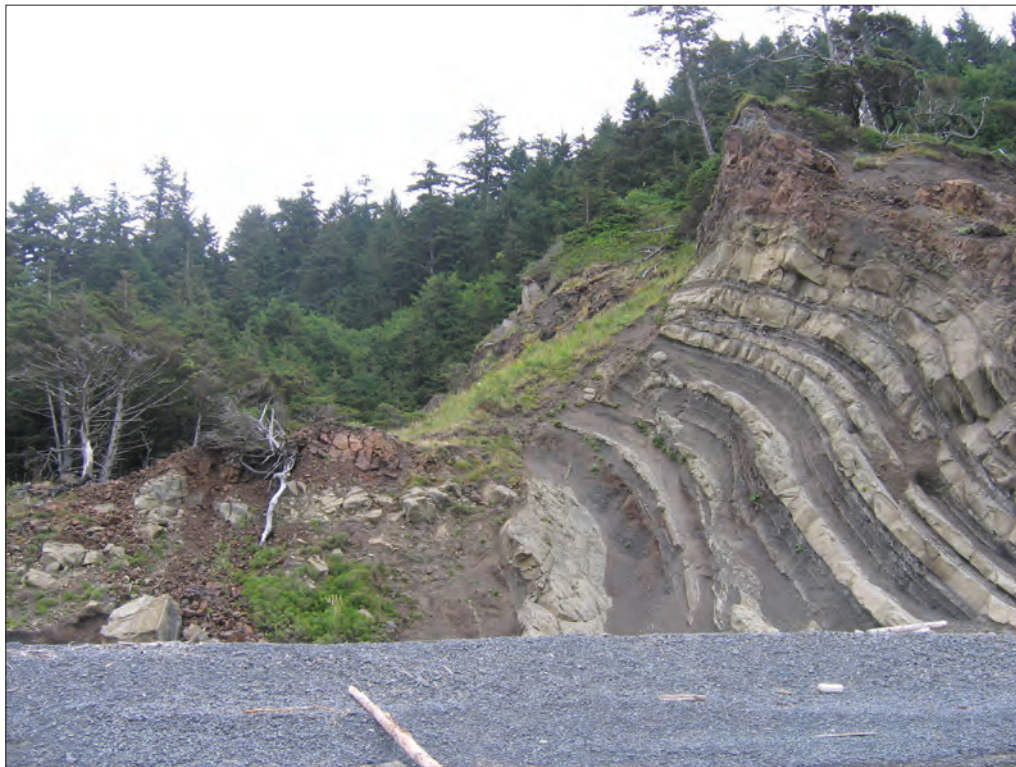
Figure 11. Folded strata in Astoria Formation sedimentary rock along the southern margin of landslide near Bald Point, south of Indian Beach, Ecola State Park.

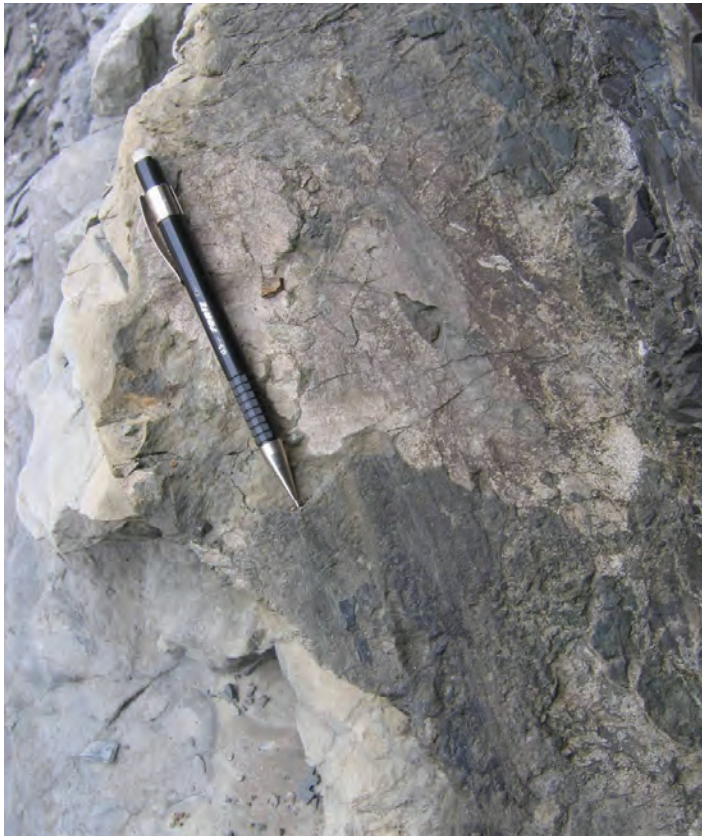
Figure 12. Slip indicators (linear striations parallel to pencil) on a possible landslide failure plane exposed along the beach directly north of the Bald Point, Ecola State Park, indicate a southwest slip direction.

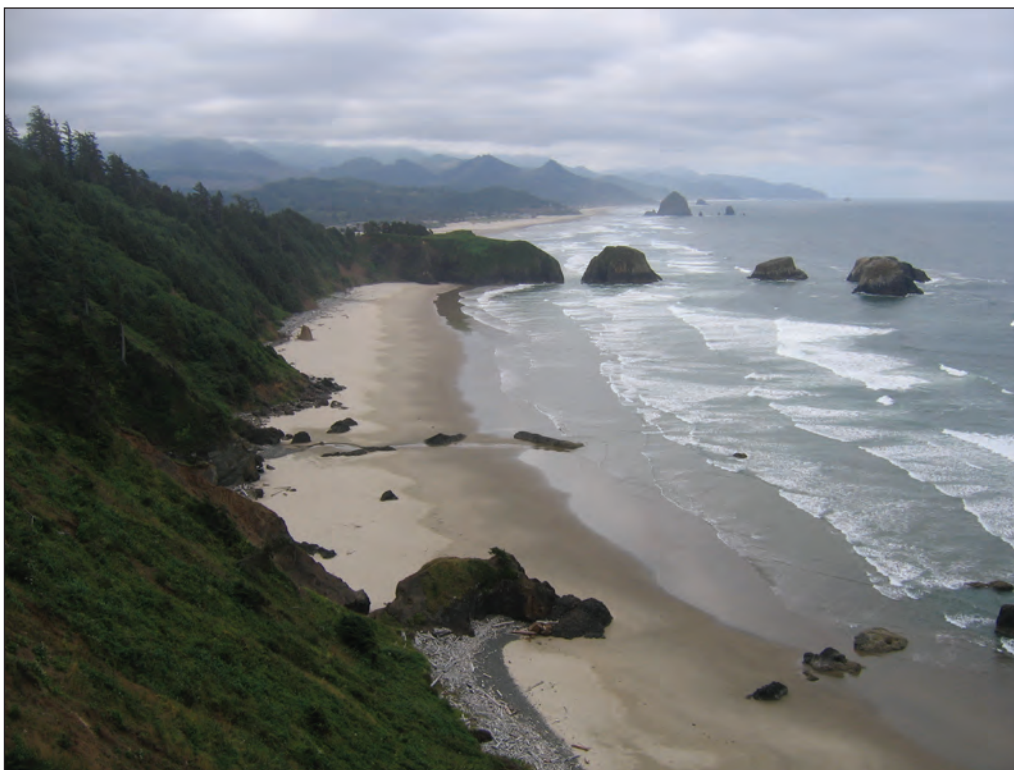
Figure 13. View looking south toward Chapman Point. Cannon Beach and Haystack Rock are visible in the distance. Coastal Bluffs in Ecola State Park (foreground), north of Chapman Point, are susceptible to mass movement and in many places are underlain by active landslides.

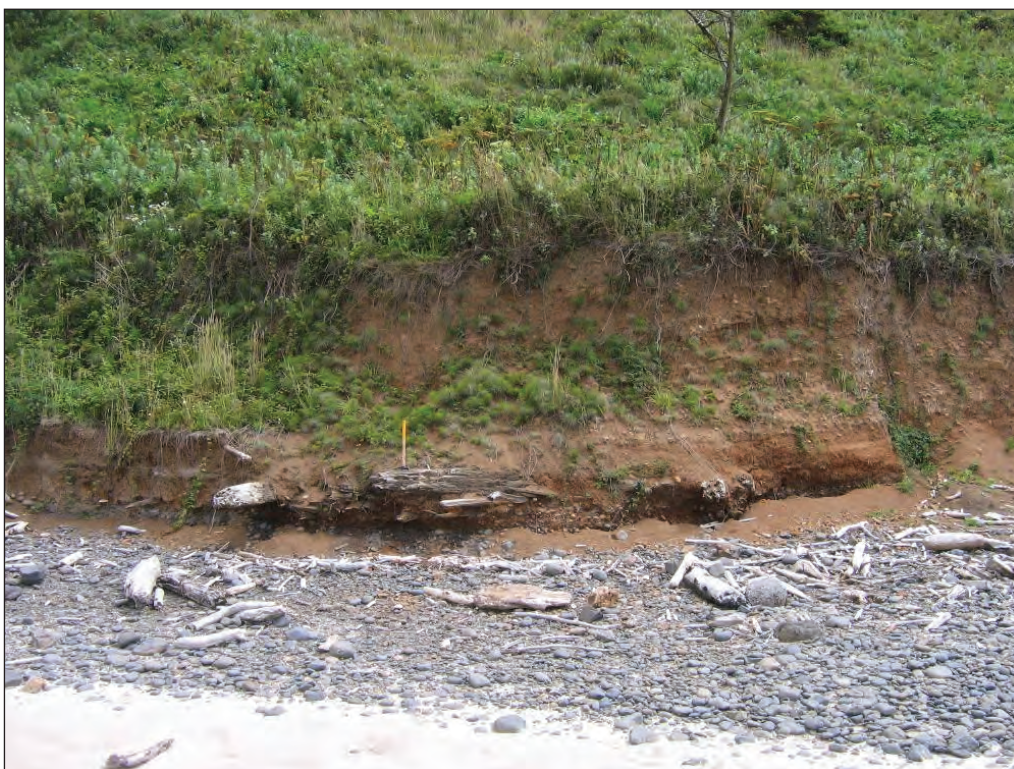
Figure 14. Wave erosion scarp exposes landslide debris that overrides beach cobbles and drift logs along Crescent Beach in Ecola State Park.

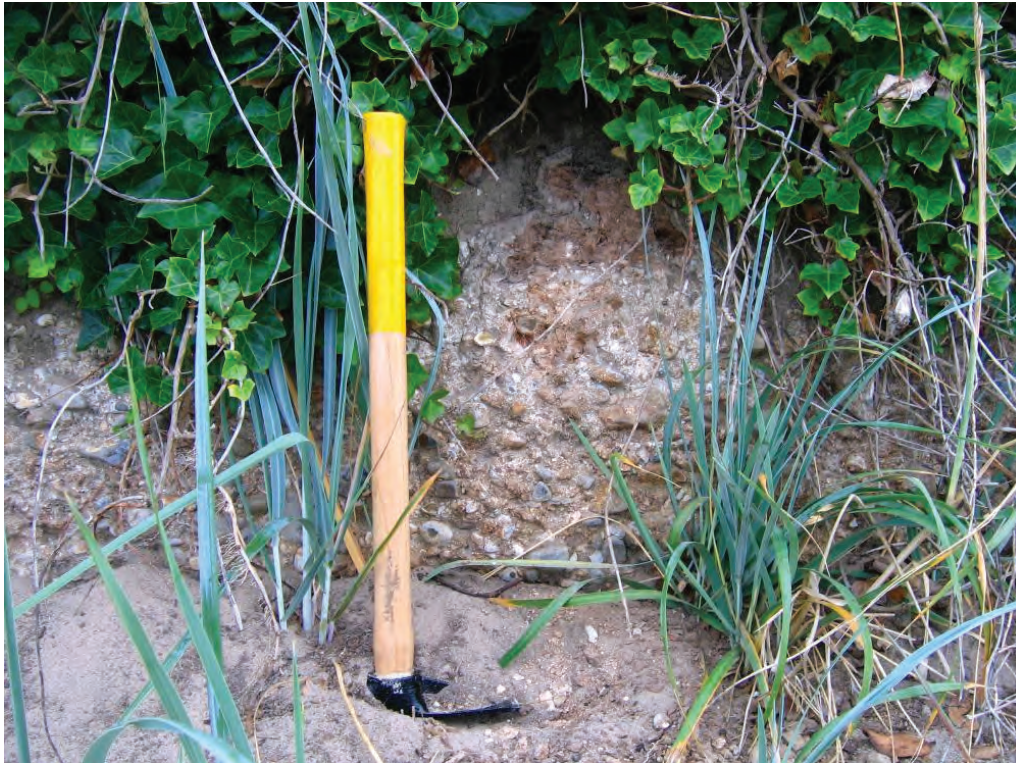
Figure 15. Cemented gravel deposit exposed at base of low bluff near Haystack Rock in Cannon Beach. Well-rounded beach or fluvial gravel includes mudstone and basalt clasts and forms late Pleistocene coastal terraces (Qpt).

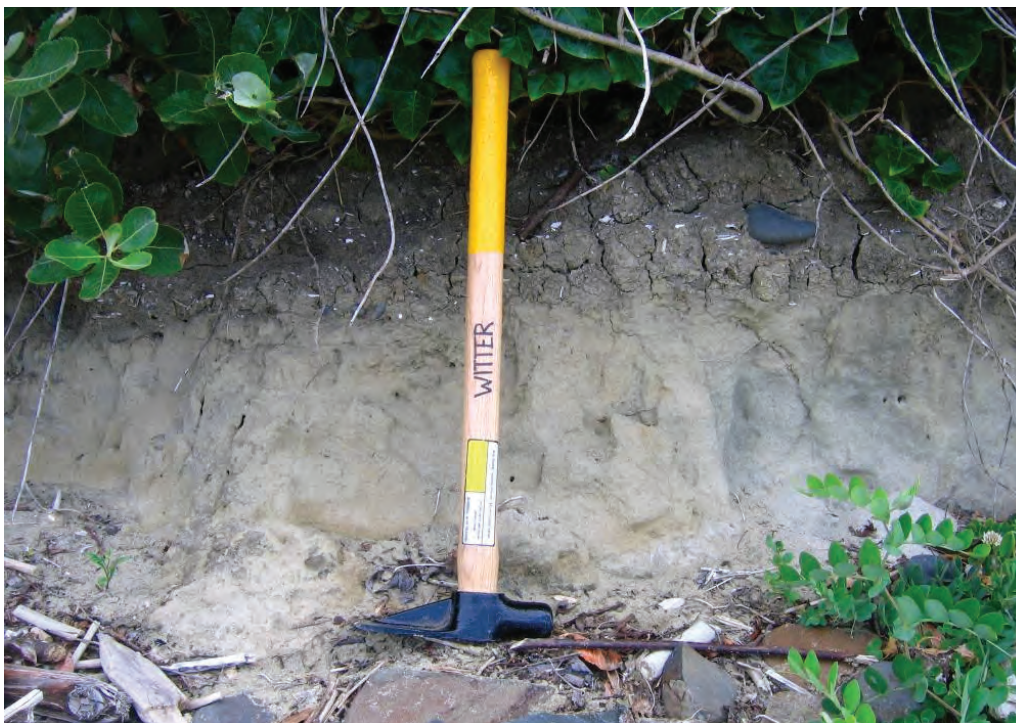
Figure 16. Low bluffs in the southern part of the Tolovana Park community consist of hard, medium- to fine-grained grey sand, overlain by brown sandy mud with shell fragments. From the presence of shells and the texture and massive structure of the sand in these late Pleistocene coastal terrace deposits (Qpt) suggest transgression from a beach to an estuarine depositional environment.

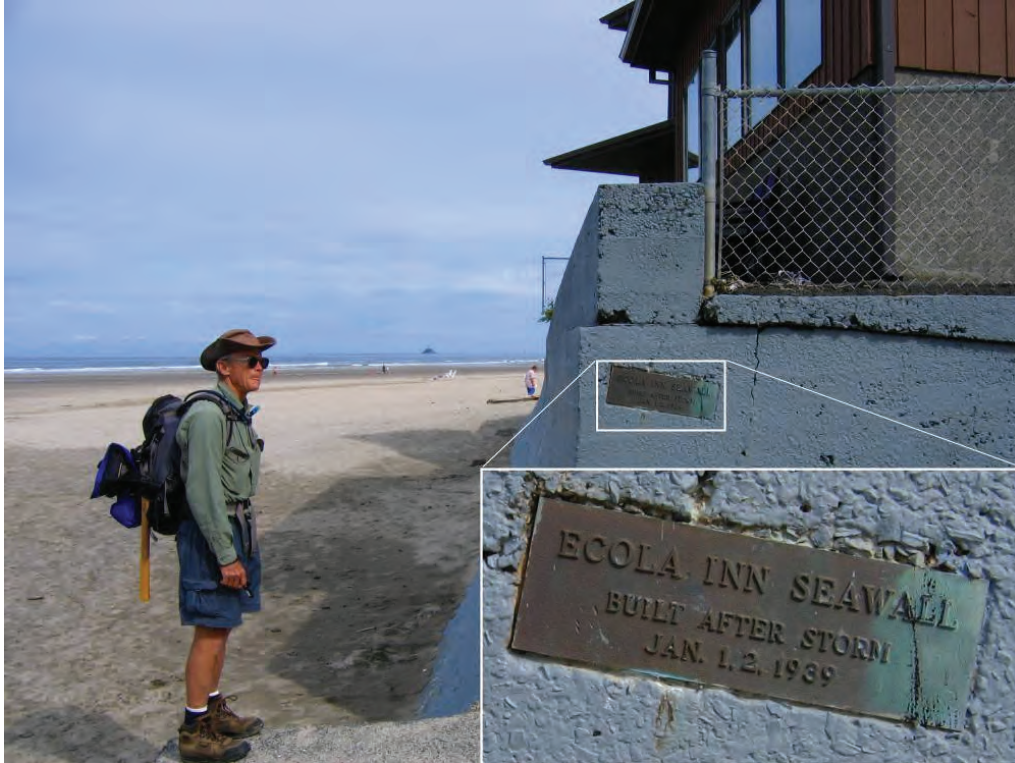
Figure 17. Forty-eight-percent of the shoreline of Cannon Beach is armored with sea walls or riprap to mitigate coastal erosion. This seawall was built after a severe winter storm in January 1939.

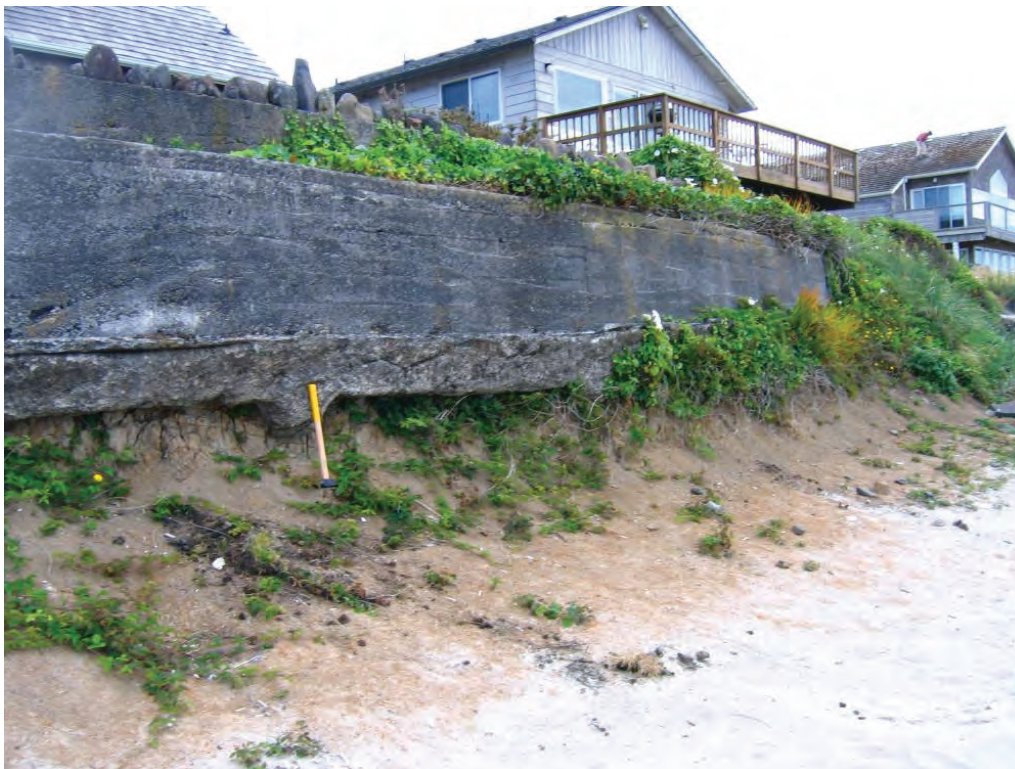
Figure 18. Example of a seawall in Cannon Beach that has been undermined by wave erosion.

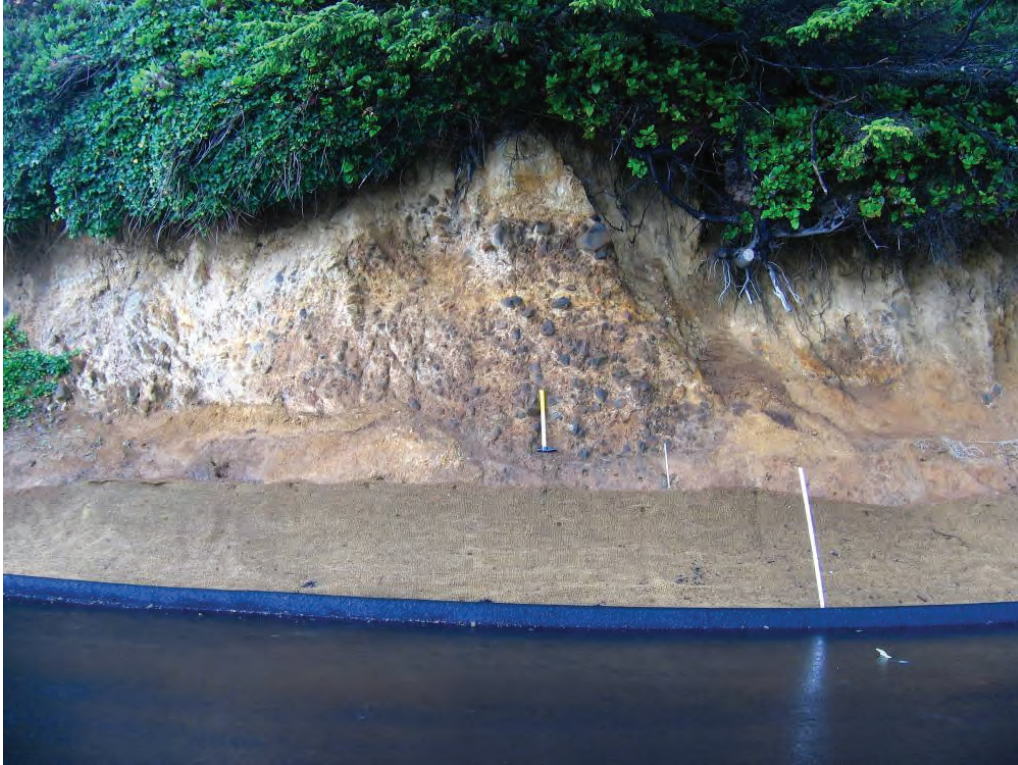
Figure 20. Road cut along Hemlock Street at the top of the S-Curves landslide. The deposit consists of angular basaltic rubble in a matrix of orange-brown sandy silt.

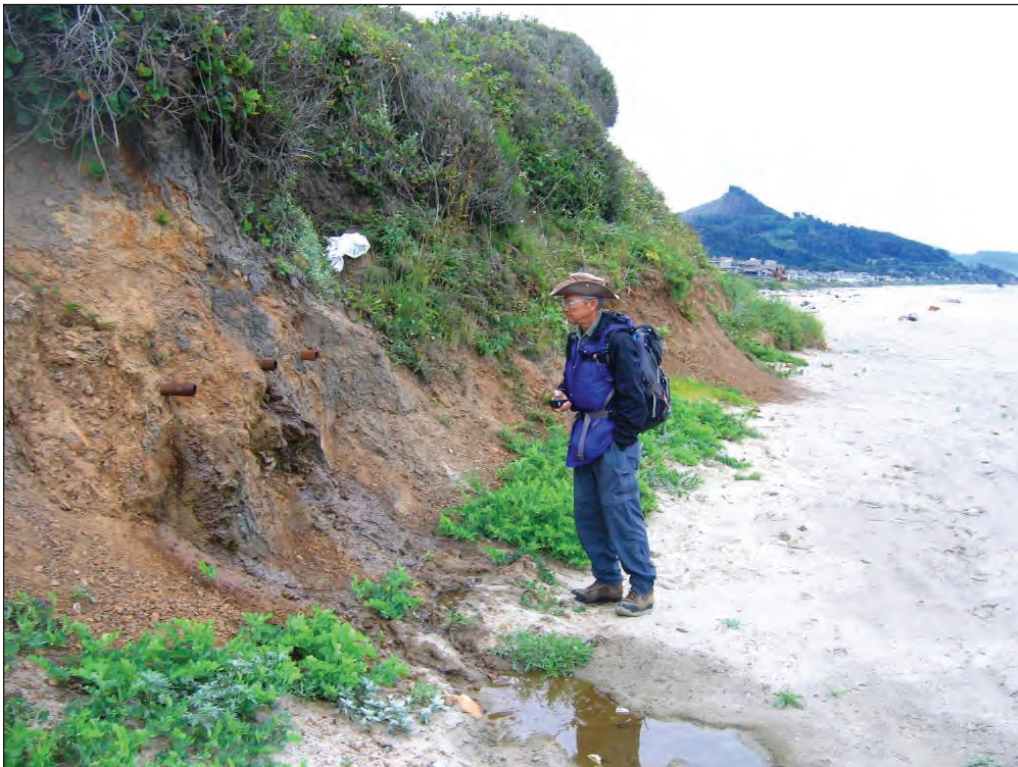
Figure 21. Horizontal drains exposed at the toe of the S-Curves landslide consist of 150- to 300-ft-long, 1.5-in slotted PVC pipe. The drains carry away ground water for the purpose of lowering the water table and potentially stabilizing the S-Curves landslide in Cannon Beach (Horning, 2004).

Hummocky topography, landslide headscarps, vertical displacements of Hemlock Street, and cracking and settlement observed at multiple properties illustrate the impacts of landsliding on the west side of Tolovana Hill (Figure 19). The S-Curves landslide is a smaller (2.3 acres) complex of slumps and block rotational landslides on the southwestern flank of the hill. The slide involves Cannon Beach member mudstone, although chaotic debris flow deposits that overlie the sedimentary bedrock (Figure 20) suggest a long history of landsliding in the area. Motivated by chronic slope movement that has caused damage to Hemlock Street and adjacent properties and houses for decades (Ross [1977] noted up to 3 ft of vertical displacement in the road in 1977), the City of Cannon Beach hired engineering consultants to study the area and propose a solution to stabilize the landslide (White and Rondema, 2003). From our inspection of the repaired road surface, which showed no evidence of displacement, a system of subsurface drains designed to lower groundwater level and dewater the slide mass appears to have temporarily stabilized the landslide, at least by the date of this report. (Figure 21).

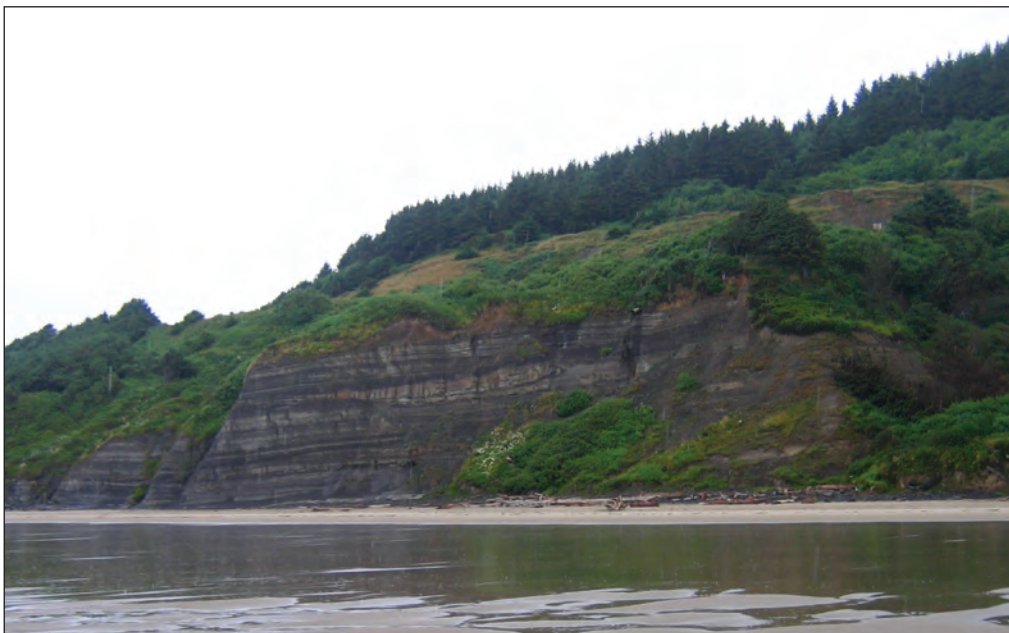
Figure 22. West dipping, interbedded mudstone and sandstone of the lower Cannon Beach member (Tac1), Astoria Formation at Silver Point. Note the lenticular sandstone bed in the middle section.

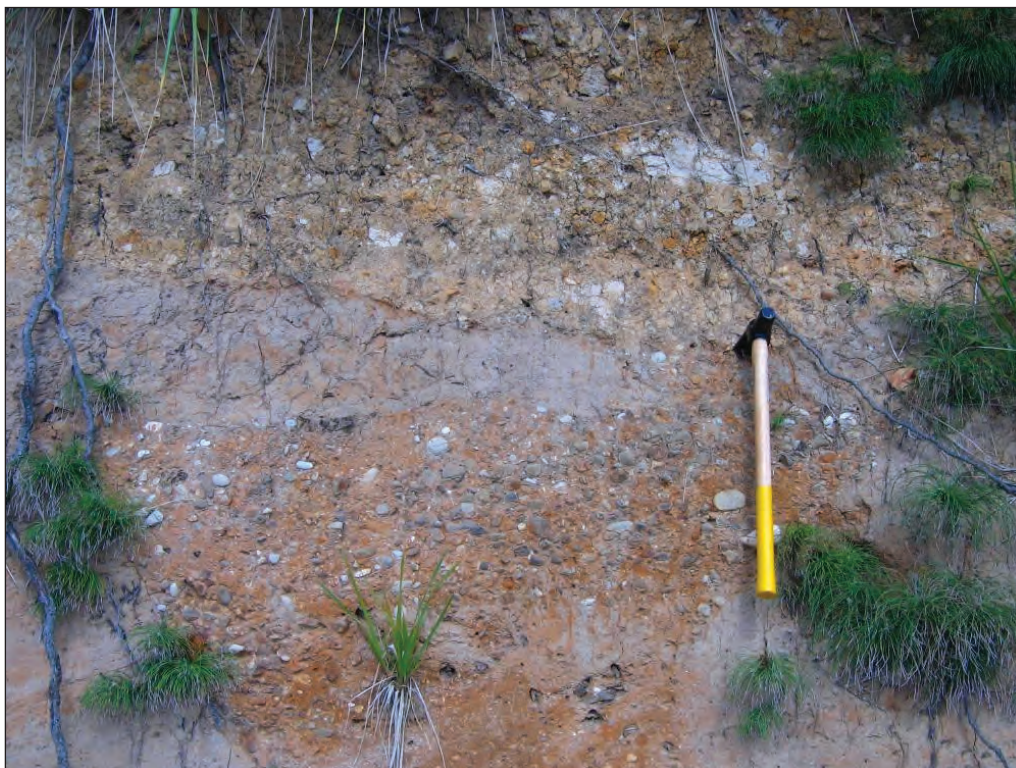
Figure 24. Bluff exposures south of Humbug Point at Redrock Creek reveal an eroded contact between late Pleistocene coastal terrace deposits and the overlying gravel-rich landslide deposit with chaotic clast orientations. The sharp lower contact, marked by the rock hammer, may be an ancient landslide failure plane.

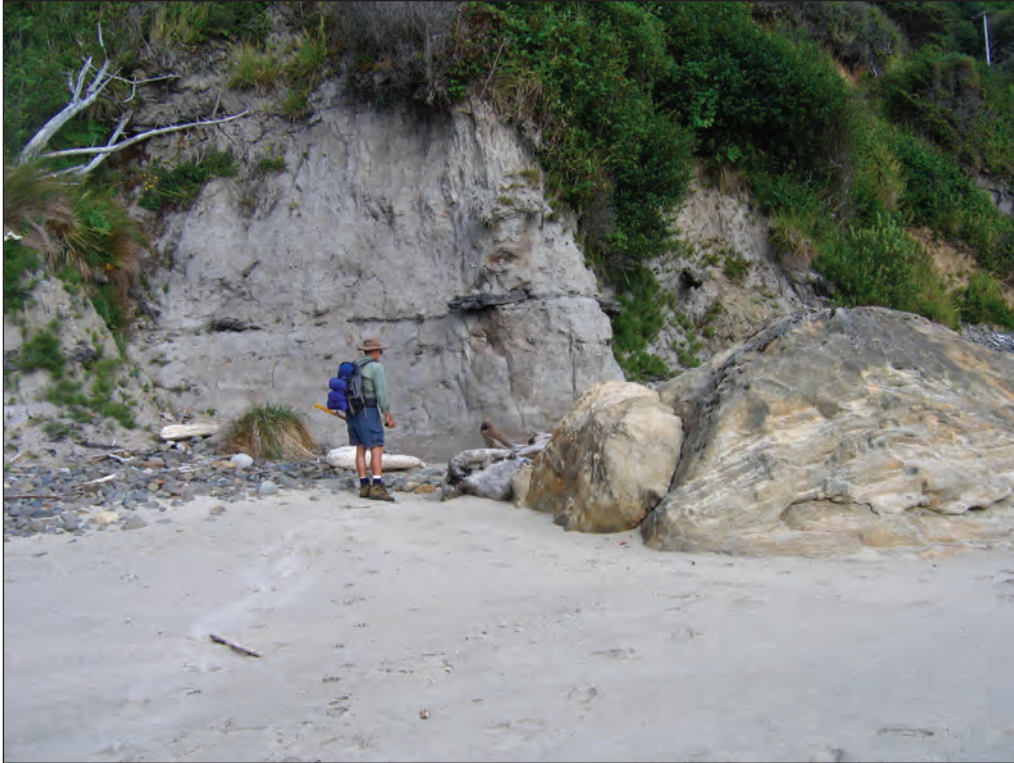
Figure 26. Large, deep-seated landslides north of Hug Point involve gray, weakly-bedded silts mapped elsewhere as late Pleistocene coastal terrace deposits. Vertically bedded slabs of sandstone blocks (middle right) and anomalous blocks of basalt, located on the beach, may be the resistant remains of prehistoric landslide deposits eroded by ocean waves.

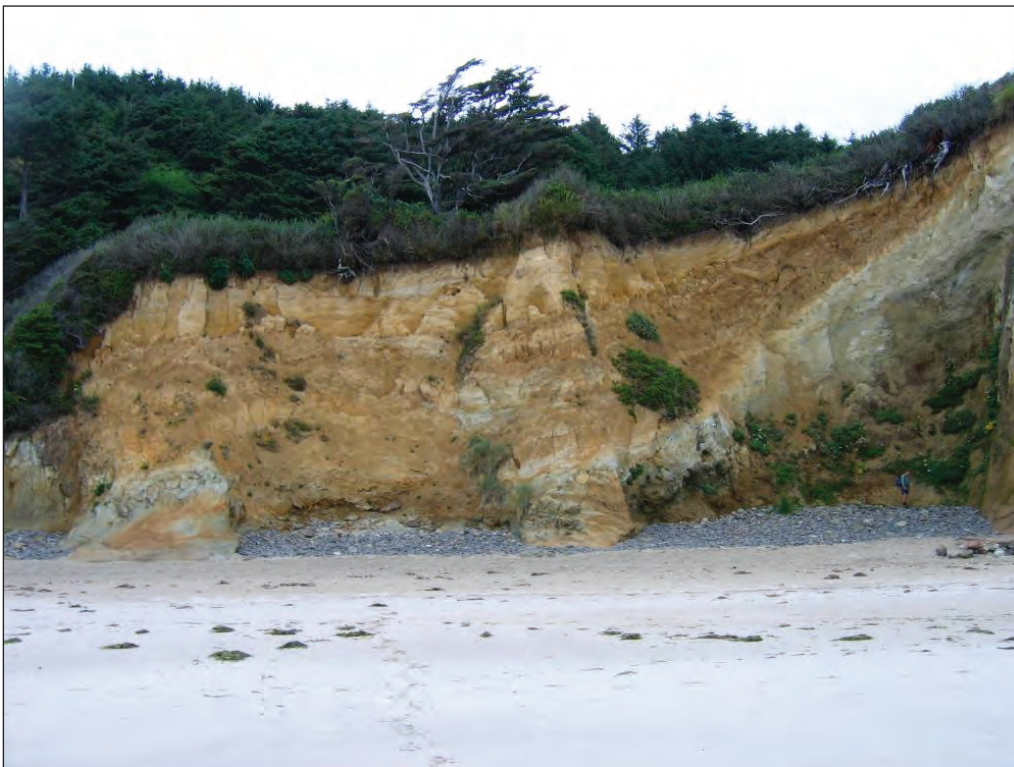
Figure 27. Late Pleistocene debris flow deposits fill a paleovalley incised into Angora Peak sandstone north of Hug Point. Overlying coastal terraces deposits consist of sand with lenses of pebble gravel.

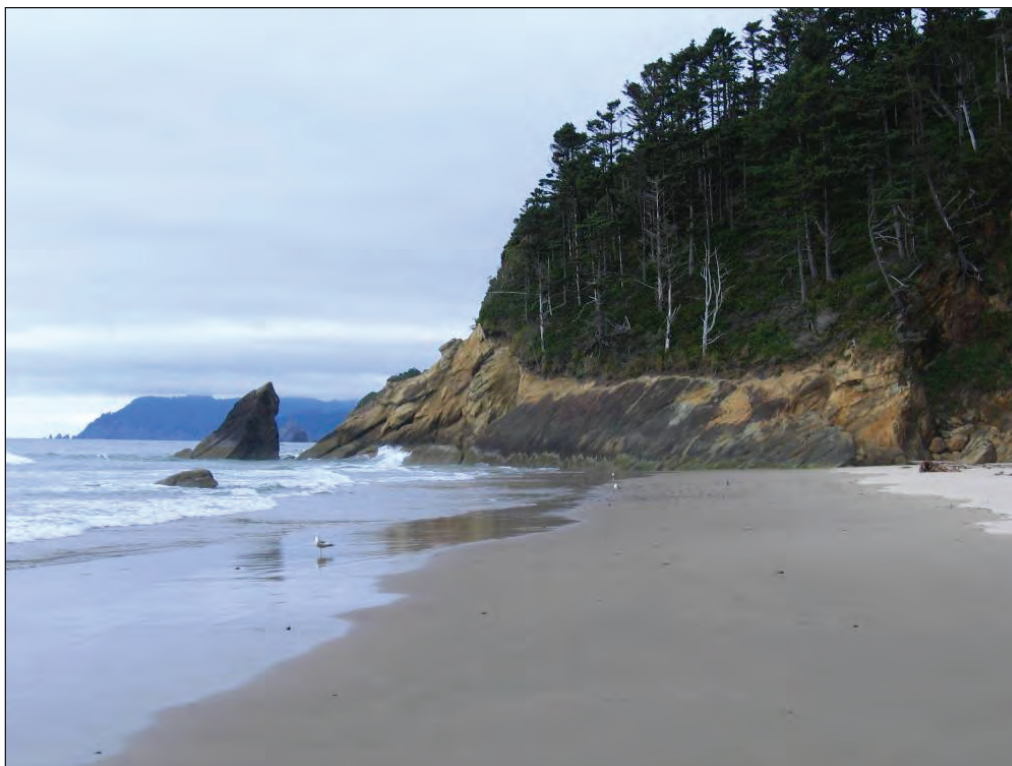
Figure 28. A syncline deforms Angora Peak sandstone forming a small pocket beach south of Austin Point and north of Arch Cape beach. The north limb of the syncline dips 45 degrees to the southwest, making the slopes above prone to dip slope block sliding.

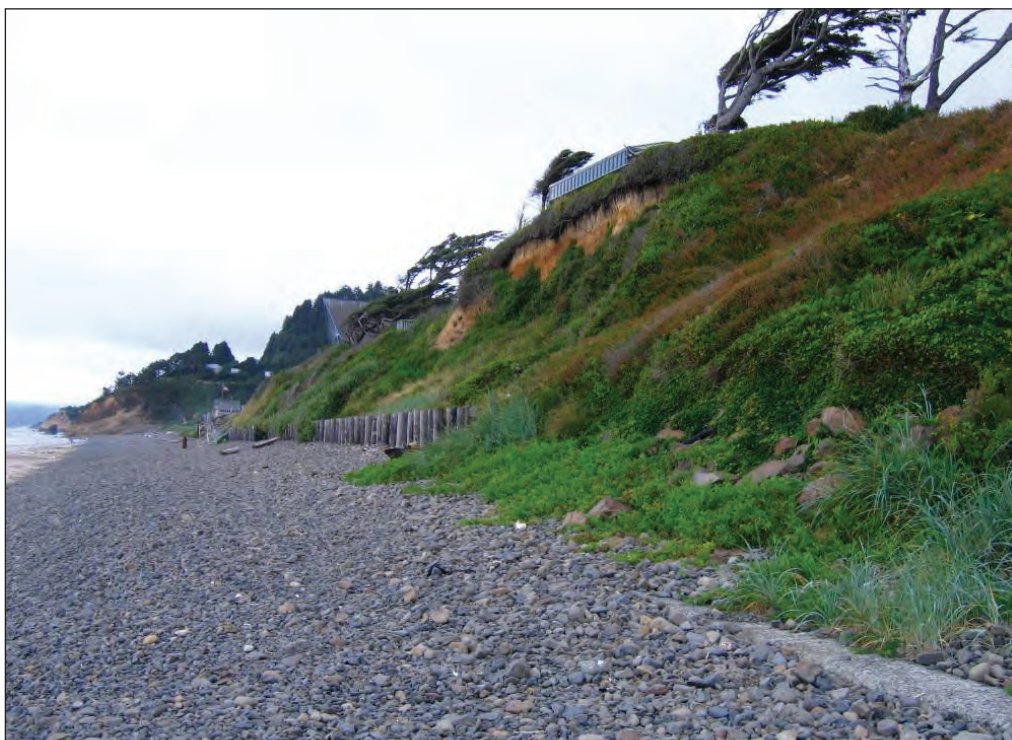
Figure 29. Wood pilings form a rudimentary sea wall (middle distance) along Arch Cape. Bluffs 20 to 30 ft high in late Pleistocene coastal terrace deposits expose dense, cemented gravels (above sea wall).

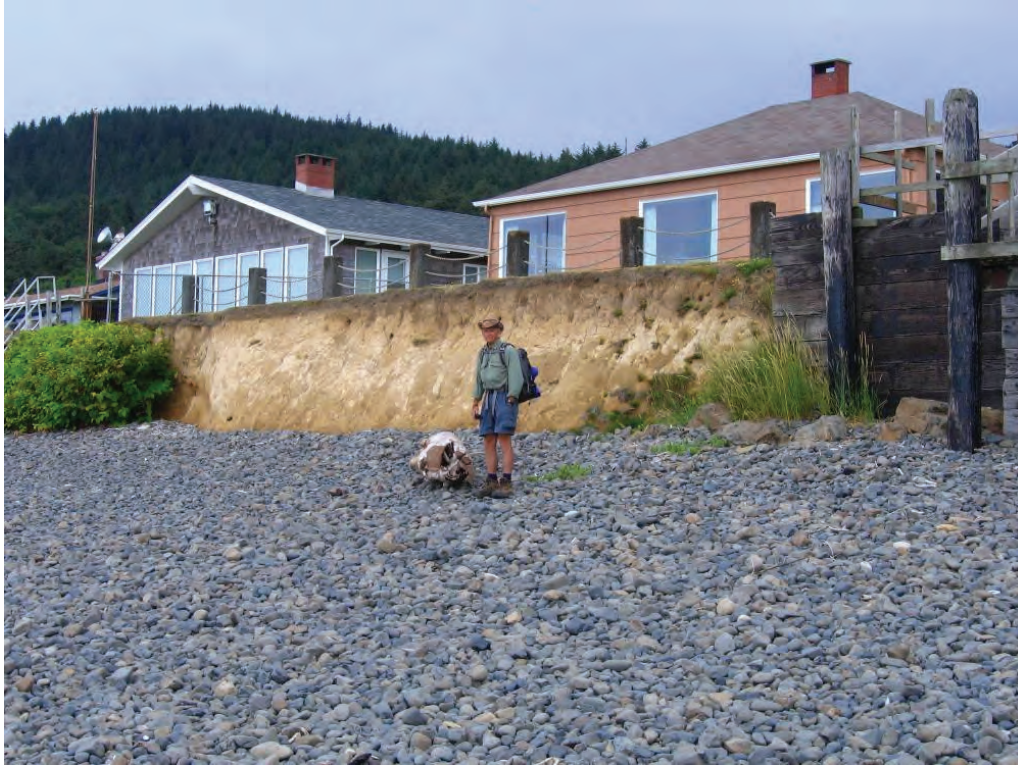
Figure 30. At the north end of Arch Cape, late Holocene stream terrace deposits of Austin Creek consist of largely massive, yellowish brown silt with minor lenses of coarse sand to gravel. The Austin Creek terrace is inset into late Pleistocene coastal terrace that underlies the Arch Cape area.

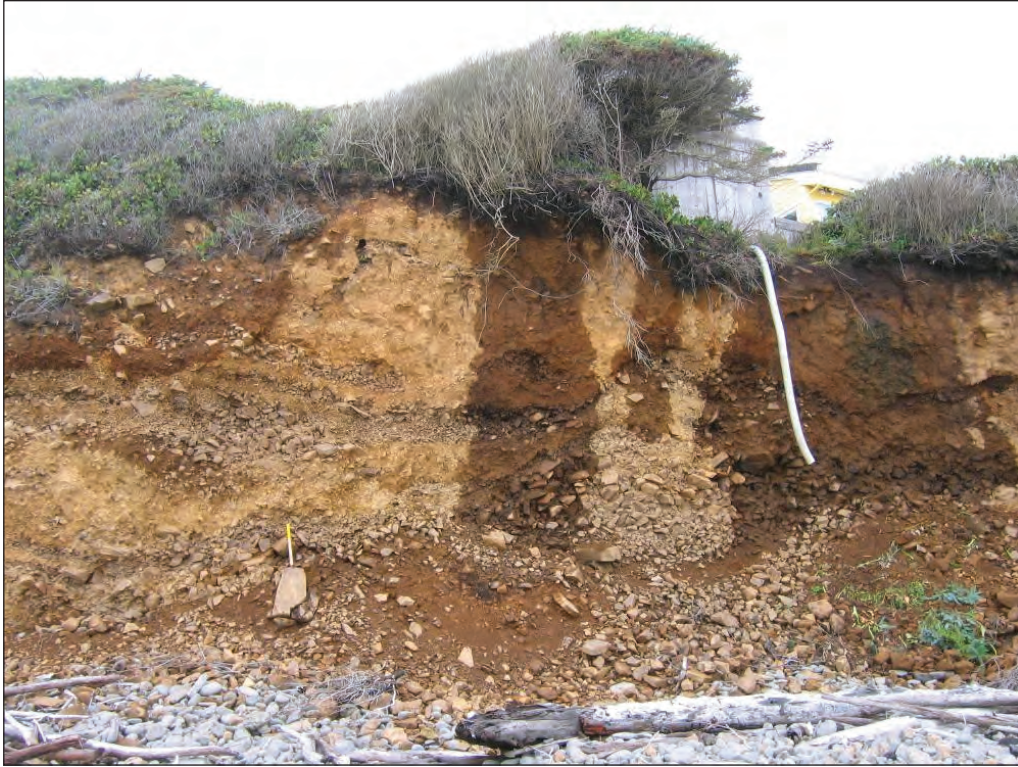
Figure 31. At the north end of Cove Beach, 20- to 30-ft-high bluffs cut into debris fan deposits expose debris flow channels rich in coarse, angular basalt clasts.

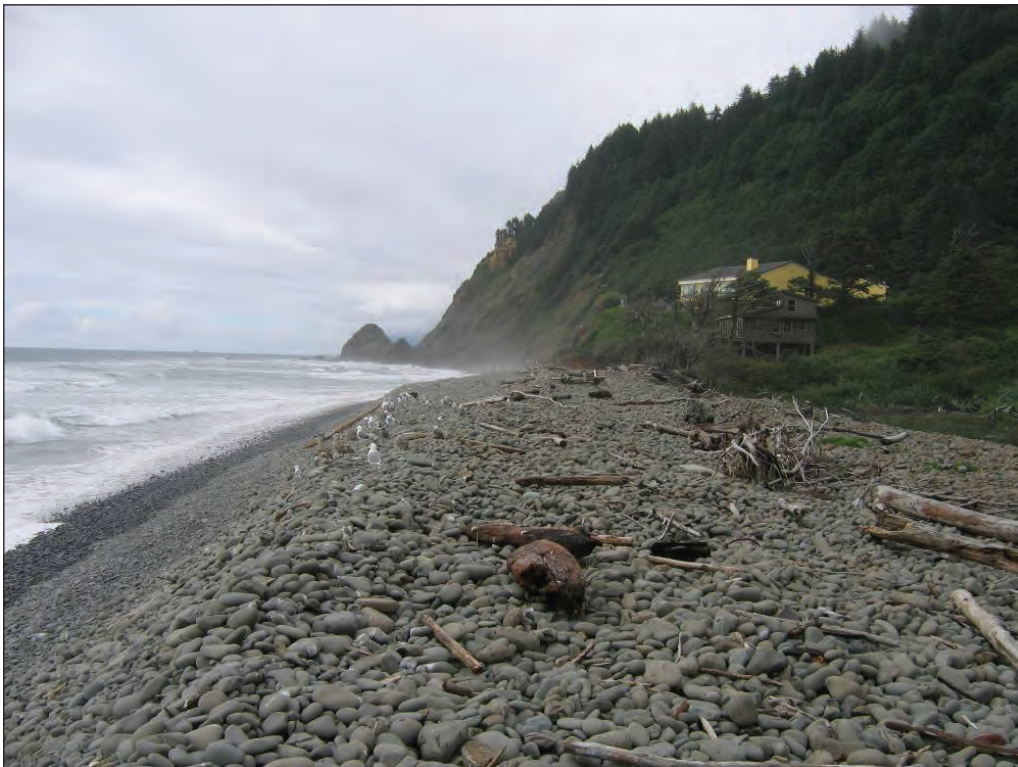
Figure 32. A broad cobble berm impounds a small lagoon near the north end of Cove Beach. Arch Cape can be seen in the distance.

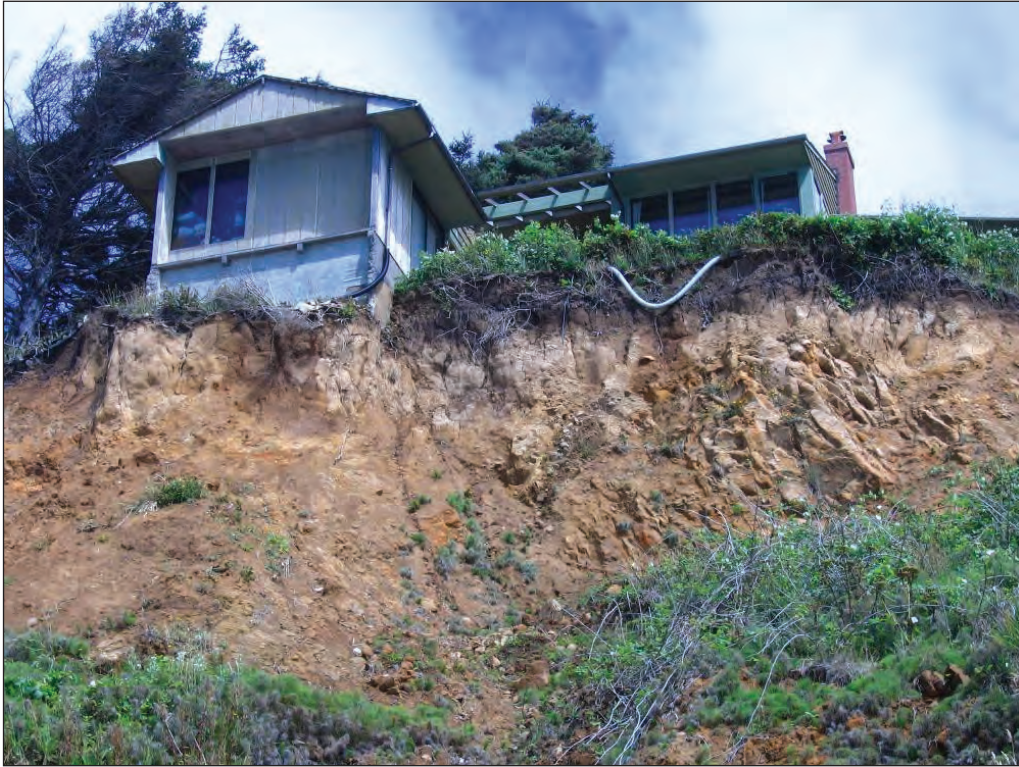
Figure 33. Chronic erosion and land sliding along Cove Beach has required many homeowners to modify or move houses away from retreating sea cliffs. Large, jointed sandstone blocks surrounded by sand and silt are inferred to reflect late Pleistocene rock avalanche deposits.

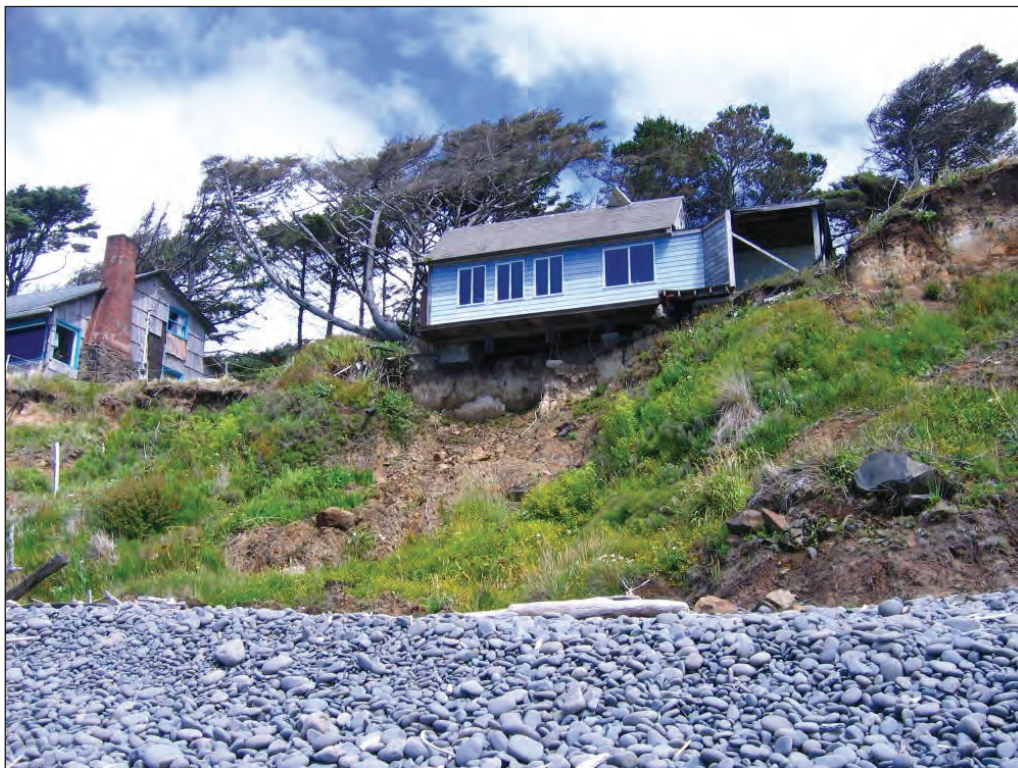
Figure 34. House undermined by bluff collapse due to wave erosion, southern part of Cove Beach.

shallow slumps and soil sloughs impact the entire length of the bluff (Figure 34). However, at the southern end of Cove Beach, wave erosion has exposed bluffs composed entirely of prehistoric landslide deposits (Figure 35). Exposure of a landslide failure plane in the toe of this ancient landslide (Figure 36) and active debris flow aprons shedding off the bluff (Figure 37) suggest recent renewed movement or impending reactivation of prehistoric landslides destabilized by wave erosion at the base of the bluff.
