State of Oregon
Department of Geology and Mineral Industries
Vicki S. McConnell, State Geologist

**OPEN-FILE REPORT
O-09-06**

**COASTAL EROSION HAZARD ZONES IN SOUTHERN CLATSOP COUNTY,
OREGON: SEASIDE TO CAPE FALCON**

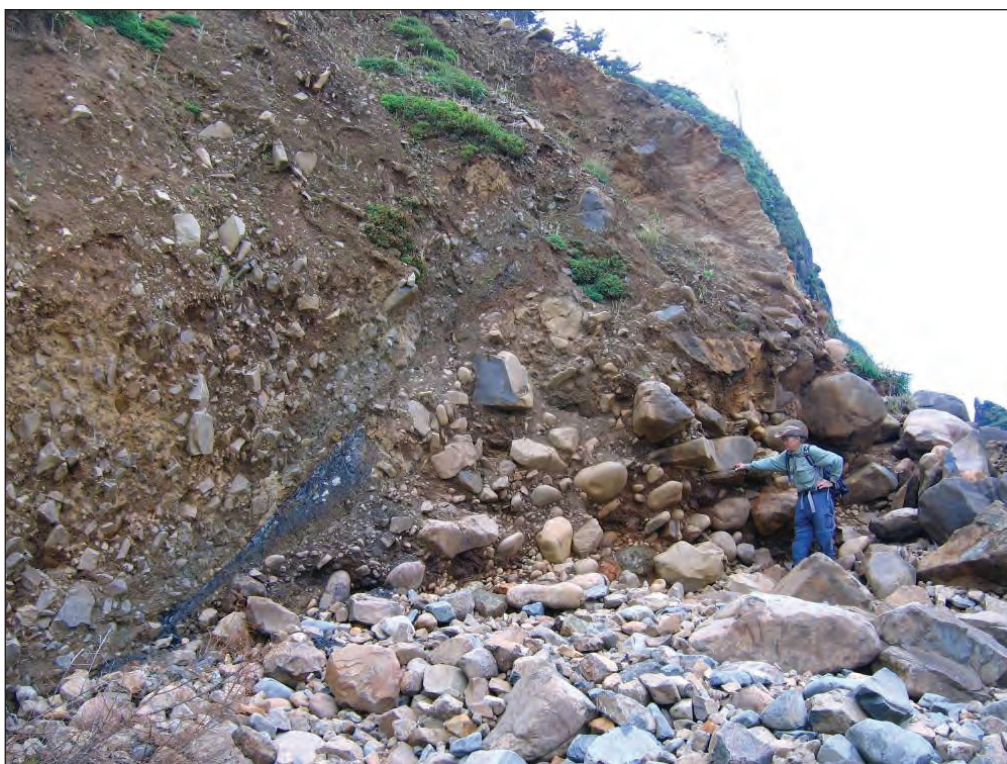
Figure 35. Angular basalt clasts in sandy silt matrix form a chaotic landslide deposit (left) at the south end of Cove Beach. The deposit overlies late Pleistocene beach cobbles and sand (right). Along the failure plane at the base of landslide deposits is a 10- to 15-cm-thick, dark gray, fat clay gouge layer. Back-tilted bedding in the beach deposits indicates the entire bluff has moved in the past.

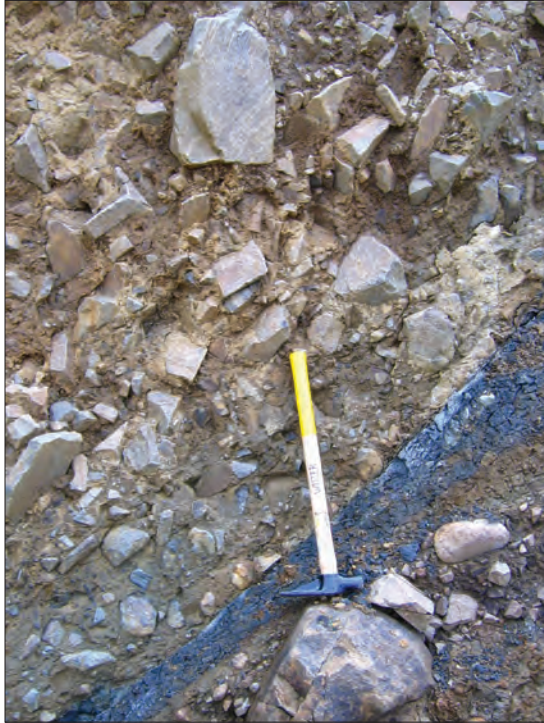
Figure 36. A 10- to 15-cm-thick, dark gray, fat clay gouge layer has developed along the landslide failure plane at the south end of Cove Beach.

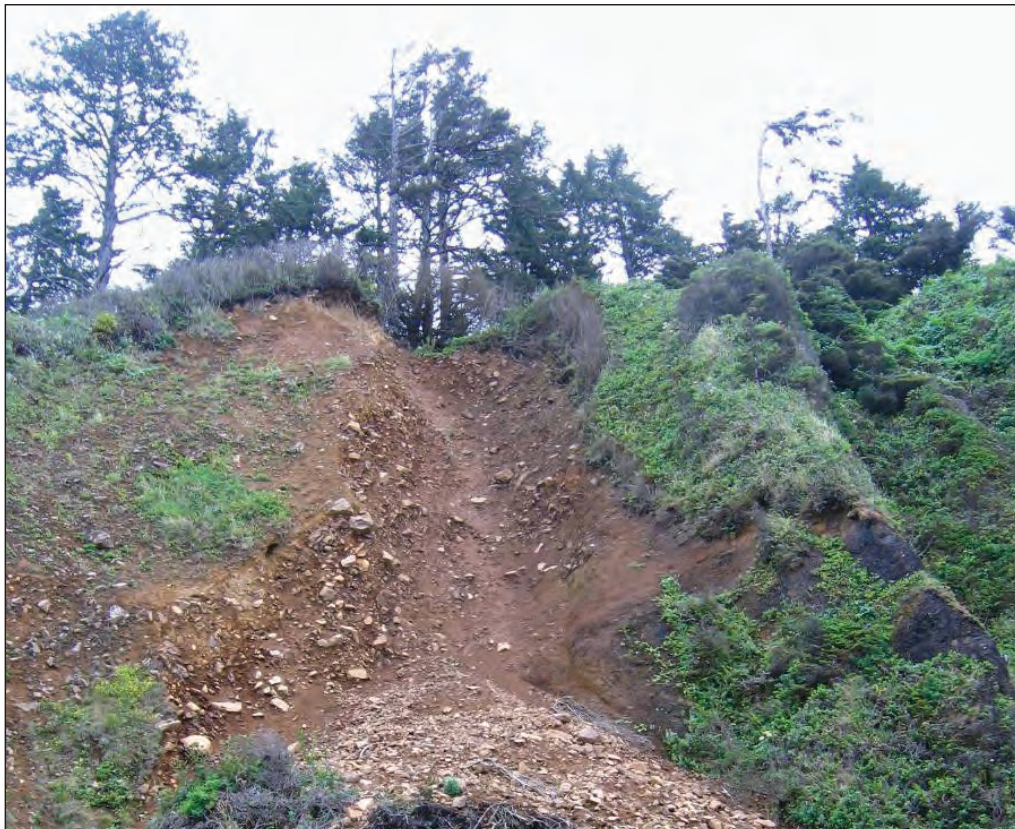
Figure 37. Debris flow deposit and debris chute at the south end of Cove Beach. This rock avalanche occurs along the northern margin of resistant Cape Falcon conglomerate (dark gray rock on right) that forms near vertical, 130 to 180-foot-high sea cliffs.
