**OPEN-FILE REPORT O-24-09**

## **CHANNEL MIGRATION ZONE MAPS FOR THE ZIGZAG RIVER, CLACKAMAS COUNTY, OREGON**

This report describes the methods and results of channel migration zone mapping for the Zigzag River in Clackamas County, Oregon. This information can help communities plan and prepare for natural disasters.

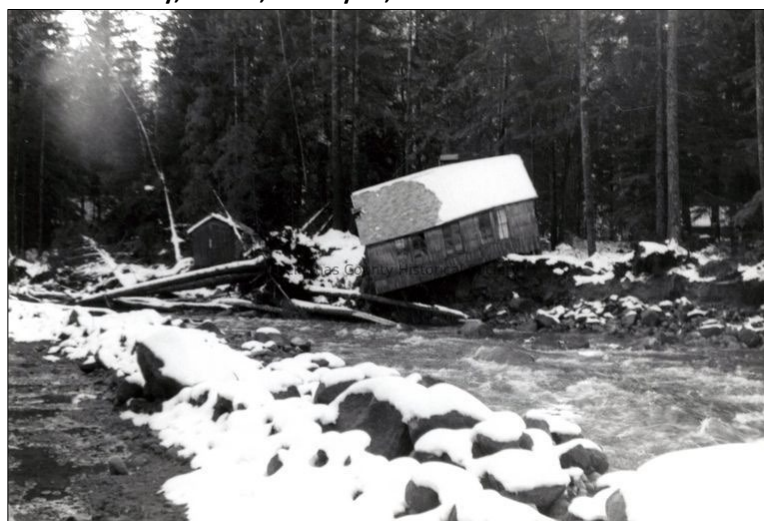
**Figure 1-3.** Photograph of houses on the Zigzag River after the December 1964 and January 1965 floods. Credit: Clackamas County Historical Society, P-2100, January 12, 1965.

The 1964, 1995, and 2011 floods caused extensive damage to the roads, bridges, homes, and other structures along the floodplain due to the combination of riverine flooding, channel migration, and landslides. Across Oregon, more than 7,000 homes were damaged or destroyed during the 1964 flood (United States Army Corps of Engineers (USACE), 2024) and 20 people lost their lives (Department of Land Conservation and Development (DLCD), 2020). The estimated cost of damages in Oregon ranges from DLCD's (2020) estimate of more than \$157 million in 1965 dollars (~\$1.6 billion in 2024 dollars) to the USACE (2024) estimate for home damage of \$245 million in 1965 (~\$2.4 billion in 2024 dollars). According to the Clackamas County Board of Commissioners (Bernard, 2018), 155 dwellings were destroyed in the Upper Sandy River Basin, primarily due to channel migration. The USGS (Waananen and Williams, 1971) reported that there were also two bridges upstream of Rhododendron that suffered damage, and the road and bridge closures isolated approximately 80 people locally. **Figure 1-3** shows an example of one of these homes undermined by channel migration. In response to the flood, the USACE channelized the mainstem of the Zigzag River by deepening and straightening the channel and cutting off meanders, oxbows, and side channels (USFS, 1995). The USACE and USFS also removed large logs and boulders from Still Creek, Camp Creek, and the mainstem of the Zigzag River (USFS, 1995). Unfortunately, the location and extent of these modifications is not well documented. Additionally, the Oregonian newspaper (Tomlison, 2011) reported that the recent 2011 flood destroyed three homes (two along the Sandy River and one along the Zigzag River) by undercutting the banks and foundations; East Lolo Pass Road was heavily eroded and the bridge over the Zigzag River had to be closed due to structural concerns.
