OPEN-FILE REPORT O-25-02

**ECOLA STATE PARK LANDSLIDE RISK ANALYSIS,
CLATSOP COUNTY, OREGON**

This paper evaluates landslide hazard and risk at Ecola State Park, Clatsop County, Oregon. The intended audiences for this paper include those in government, industry, academia, and the public.

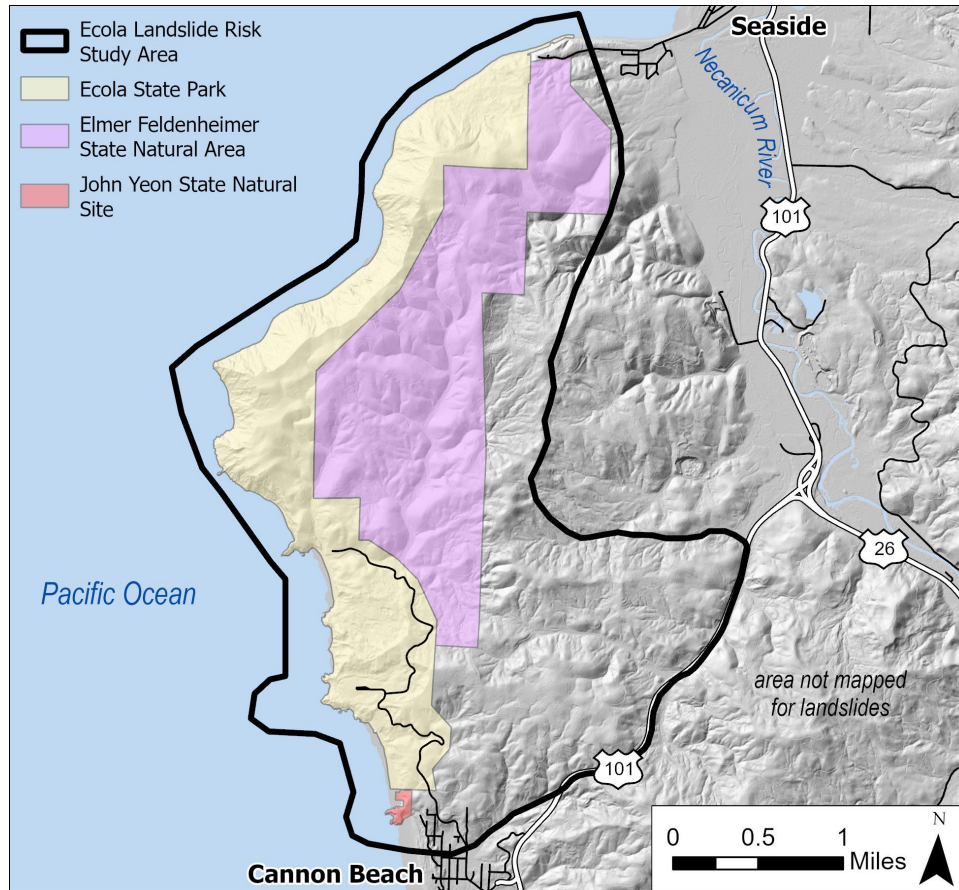
Figure 1-3. Map of Ecola and this study's area. Ecola is adjacent to Elmer Feldenheimer State Natural Area to the east and John Yeon State Natural Site to the south.

Ecola is located very close to the intersection of Oregon State Highways 26 and 101 in Clatsop County (Figure 1-3; Plate 1). Ecola is directly adjacent to Elmer Feldenheimer State Natural Area (east of Ecola), which is currently undeveloped. This project's study area includes both OPRD properties as well as a portion of private land between the state lands and Highway 101 (Figure 1-3; Plate 1).

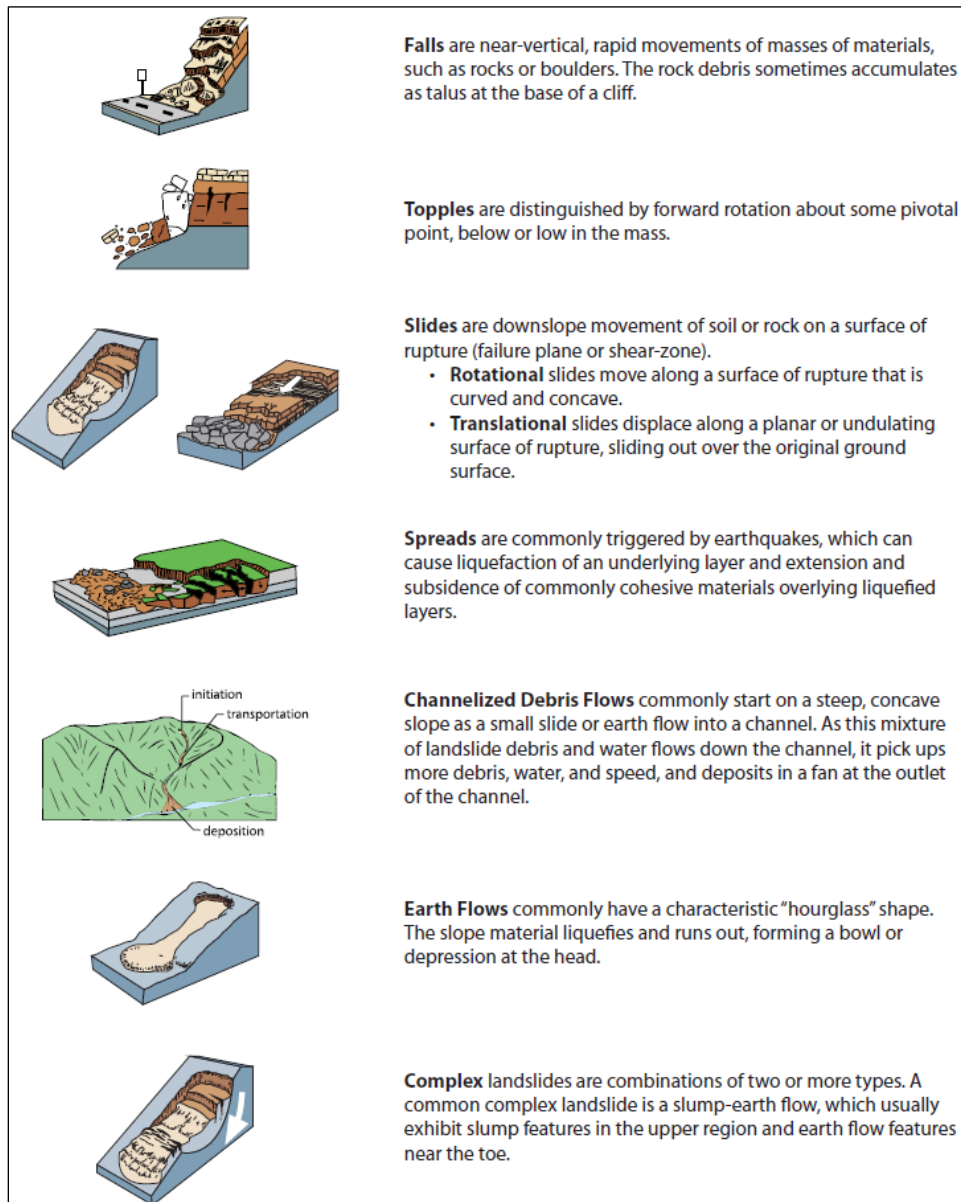
Figure 1-5. Types of mass movements (Burns and Madin, 2009; Highland, 2004).

Generally, falls and topples occur in areas in Oregon with semicompetent rock like basalt, which is most commonly exposed at the surface as near-vertical cliffs and lacks soil and vegetation cover. Rock falls/topples generally occur in isolated locations because of the unique landscape conditions. The events are usually small to medium sized, but are a continuous process.

Slides, referred to as landslides for the remainder of this report, occur in Oregon in areas with relatively weak geology (meaning the bedrock is not very hard or consolidated), along contacts between weak and strong units, and/or in locations where the structural geology promotes instability (e.g., small crustal faults). Landslides are commonly divided into two types: shallow and deep. Shallow landslides have a failure surface <15 ft below the ground surface and deep landslides have a failure surface >15 ft (Burns and Madin, 2009). It is important to distinguish this difference because the level of effort required to mitigate these two types is significantly different. For example, shallow slides can commonly be mitigated using standard excavation procedures, but deep landslides commonly require much more complicated and expensive mitigation techniques.

Spreads are the least common, but when found, are almost always along a riverbank as they are usually triggered during earthquakes and caused by liquefaction of underlying materials.

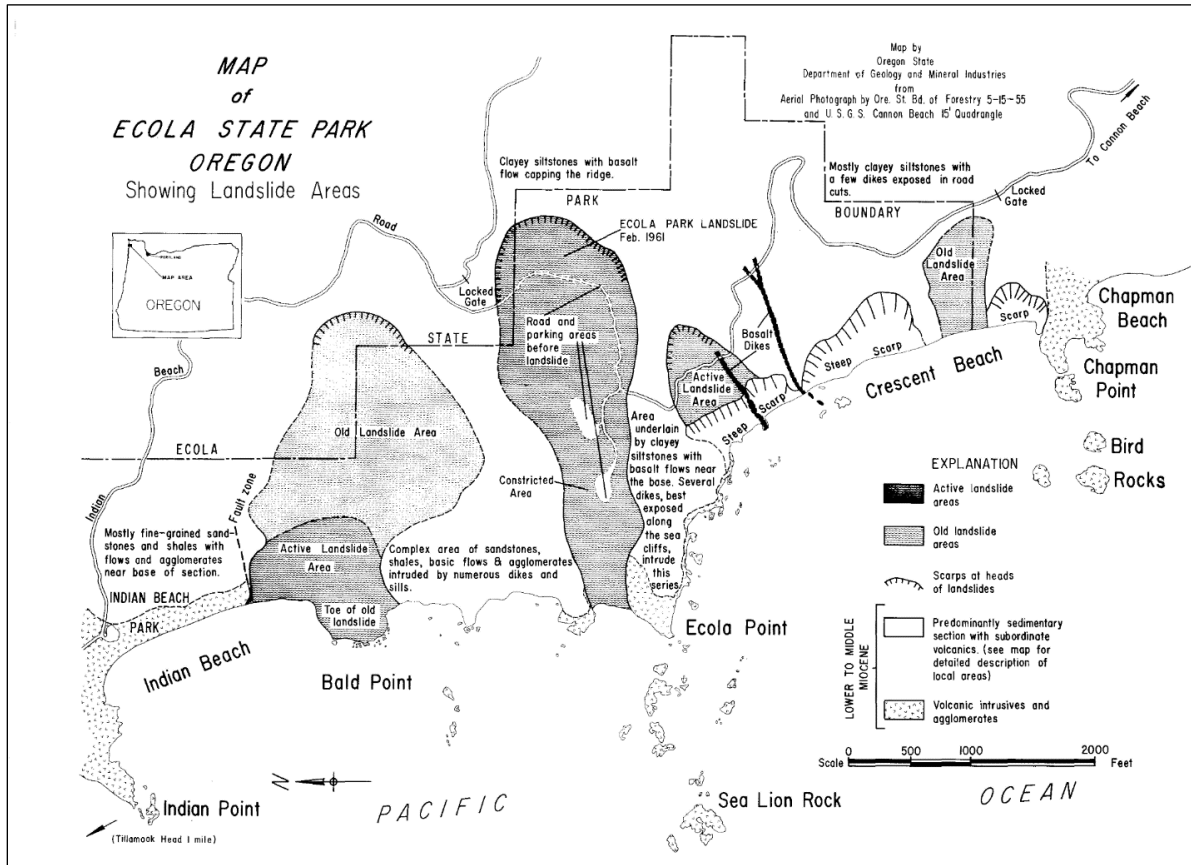
Figure 1-6. Landslide map of the southwest portion of Ecola from Schlicker and others (1961).

Point Landslide just south of Indian Beach (**Figure 1-6**). North and Byrne (1965) observed that erosion by wave action had removed material from the toe of the Bald Point Landslide, leaving only basalt boulders and cobbles to outline its extent. They suggested that the basalt base may protect Bald Point from complete erosion by waves.

The Ecola Point Landslide is mapped as a historic, deep, rockslide/rotational landslide and earth flow (**Figure 1-6; Figure 3-4; Plate 3**). This landslide is relatively flat ($\sim 10^\circ$ slope) and the failure surface appears to be perched approximately 50 ft above sea level. This landslide's movement is most likely influenced by two main factors that increase pore-water pressure: 1) intense, prolonged precipitation and 2) rapid loading onto the landslide body. Earth flows generally mobilize during periods of prolonged intense rainfall. If the infiltration from the rain is faster than the soils can drain, increased pore-water pressure along the failure surface will result in movement (Keefer and Johnson, 1983). The other trigger is rapid loading onto the landslide body. The rapid loading in this case are shallow landslides along the flanks or the head scarp (yellow and teal arrows **Figure 3-4**). The shallow landslide loads the Ecola Point Landslide rapidly, creating undrained conditions that result in increased pore-water pressures that allow earth flow to move on very shallow slopes (Keefer and Johnson, 1983). The overall process was captured in the serial orthophoto and serial lidar change analysis (**Plate 4 and Plate 5**). Both two main factors are present, making this landslide susceptible to future movements. Our research shows this landslide was active in 1961, which resulted in significant damage to park infrastructure, including roads, picnic areas, and parking lots (Schlicker and others, 1961). This landslide is mapped as *High* on the landslide susceptibility/risk map (**Plate 6**). Unfortunately, critical infrastructure (the only public road in and out of the park and utilities) cross the central portion of this landslide and have been damaged in the past; they will likely be damaged again in the future as the process reoccurs, unless this process is mitigated or avoided.

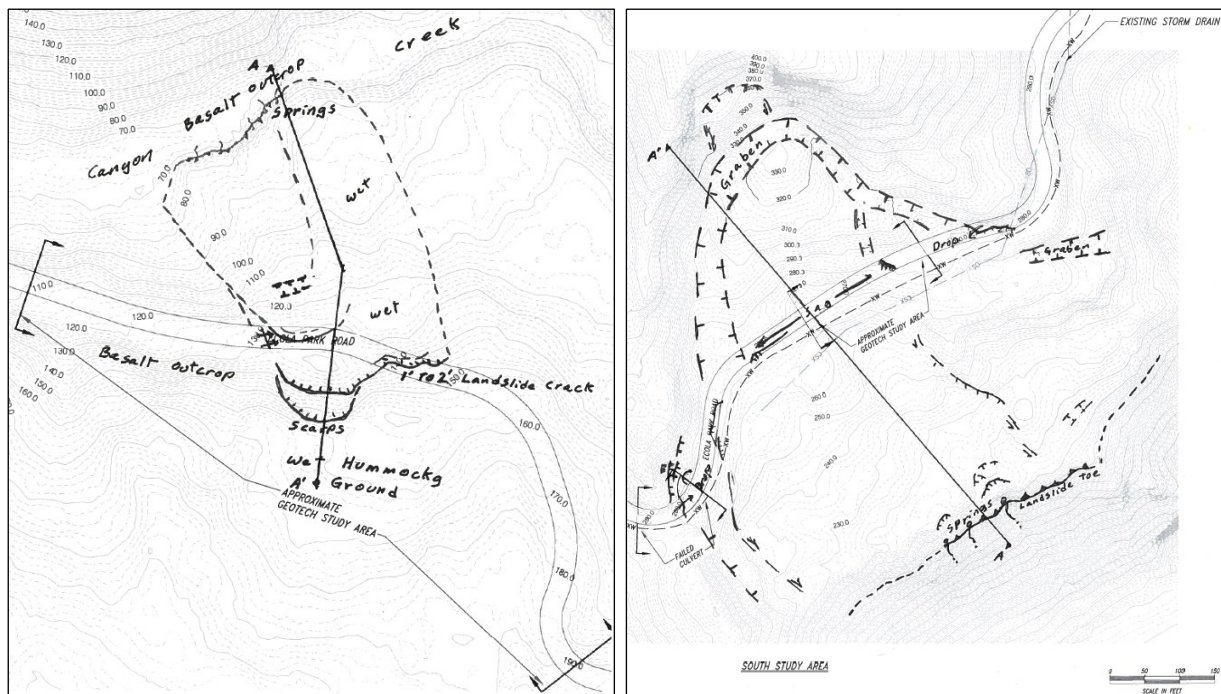
Figure 1-7. Maps of the Canyon Creek Landslide (left) and Ecola Park Road Landslide (right) from Pfeiffer (2016).

Pfeiffer (2016) estimated the Ecola Park Road Landslide to be 700 ft wide, with the northern extent of sliding occurring just 400 ft south of the entrance booth to the park. The slide surface was observed near the top of the very steep cliff down to Crescent Beach, approximately 350 ft downslope from the road (**Figure 1-7**).
