**OPEN-FILE REPORT O-25-10**

**CHANNEL MIGRATION ZONE MAPS  
FOR UMATILLA RIVER AND LOWER MCKAY CREEK, UMATILLA  
COUNTY, OREGON**

by Christina A. Appleby<sup>1</sup>, Lowell H. Anthony<sup>1</sup>, and Jesse K. Noone<sup>2</sup>

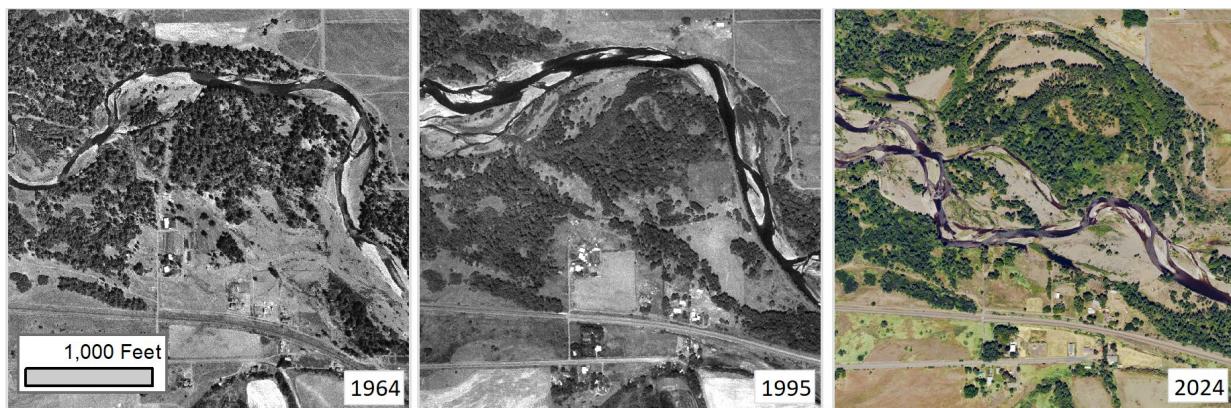
**Figure E-1.** An example of channel migration from 1964 (U.S. Geological Survey, 1964), 1995 (U.S. Department of Agriculture, 1995), and 2024 (Oregon Geospatial Enterprise Office, 2025) along the Umatilla River near Mission, upstream of Pendleton, in Umatilla County, Oregon.

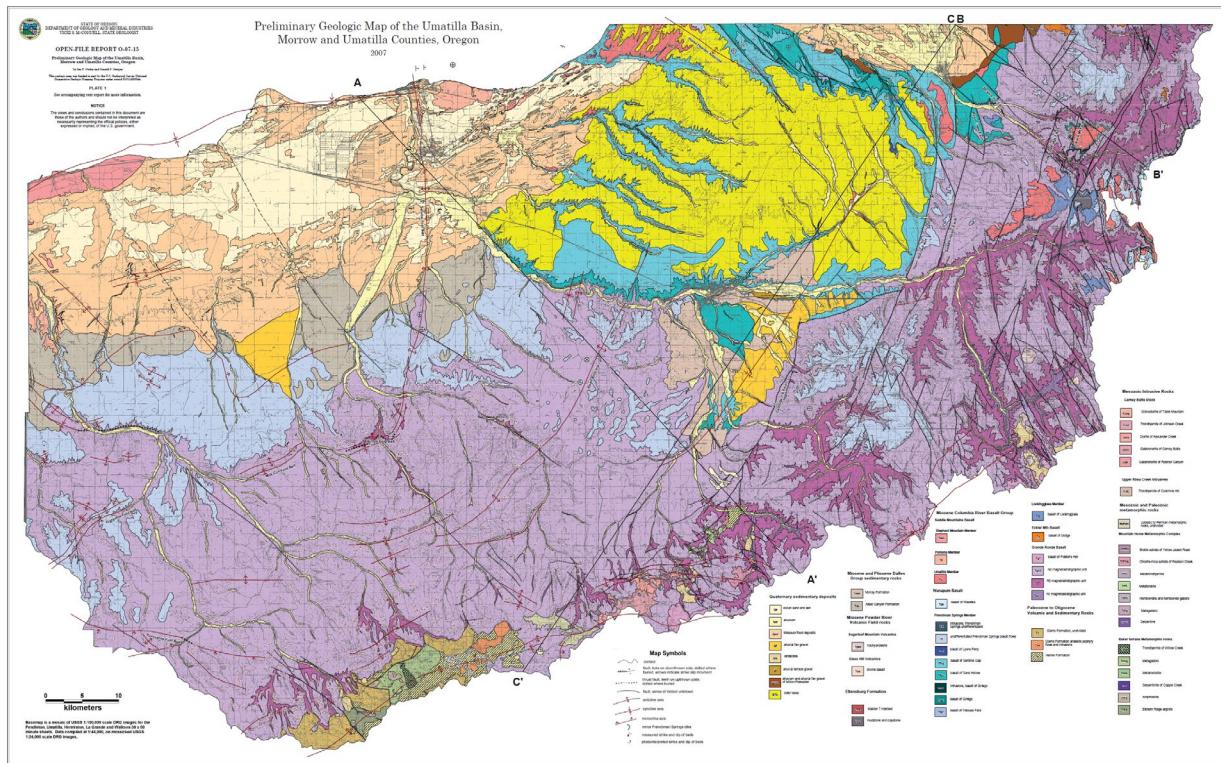
**Figure 1-2. Reproduction of the Preliminary Geologic Map of the Umatilla Basin, Morrow and Umatilla Counties** map plate from Madin and Geitgey (2007). The Frenchman Springs member basalts are shown in shades of blue and teal, the Grande Ronde basalts are shown in shades of purple, Quaternary loess is shown in bright yellow, Missoula Flood deposits are shown in light orange, and recent eolian sand and ash, which postdates the Missoula Flood is shown in light yellow-tan.

Bedrock between Echo and the town of Umatilla is also composed of CRBG, but it is overlain by thick packages of younger, Quaternary sedimentary deposits. In the northern center of the watershed, wind-deposited silt (loess) that pre-dates the Missoula Floods (commonly 33–49 ft (10–15 m) thick, shown in bright yellow) is found directly above the CRBG and McKay Formation (Madin and Geitgey, 2007). The area to the northwest, between the town of Umatilla and Echo, was repeatedly impacted by the large glacial outburst floods, including the Missoula Floods. As a result, there is a thick package of Missoula Flood deposits (commonly 16–49 ft (5–15 m) thick, shown in light orange) and recent eolian sand and ash, which postdates the Missoula Flood (no thickness described; shown in light yellow-tan) in this area (Madin and Geitgey, 2007).

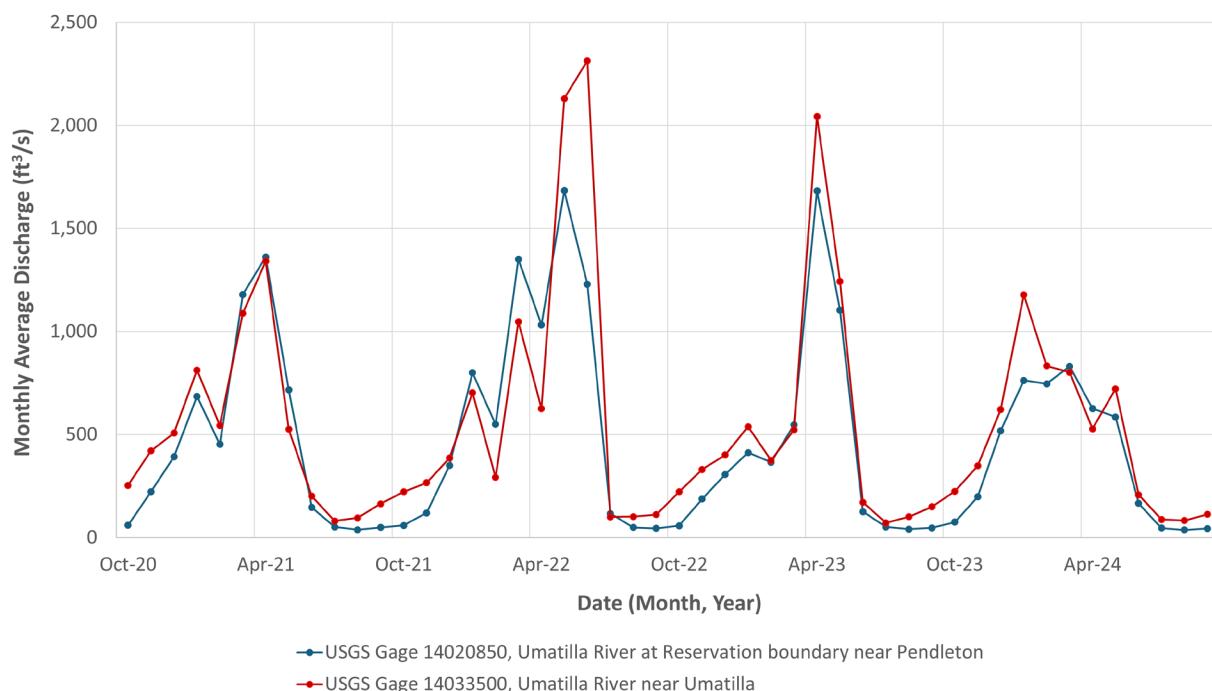
**Figure 1-3.** Graph of monthly average discharge for 2020–2024 water years along the Umatilla River near Pendleton and near the town of Umatilla (USGS, 2025a). These gages are in RS 28 and RS 2, respectively.

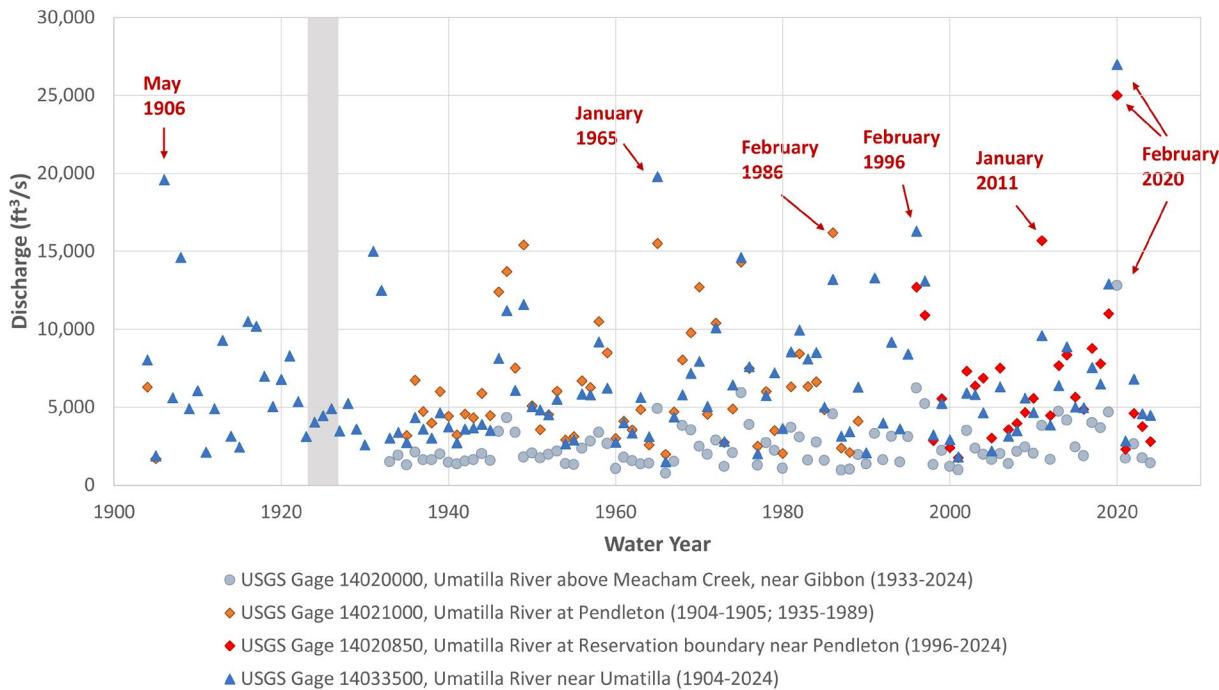
**Figure 1-4.** Peak streamflow at four USGS streamgages located near Gibbon in RS 38 in gray circles (USGS, 2025b), Pendleton in RS 26 in orange diamonds (USGS, 2025c), Pendleton near the Umatilla Indian Reservation boundary in RS 28 in red diamonds (USGS, 2025a), and Umatilla in RS 2 in blue triangles (USGS, 2025d). A gray bar indicates the years during which the McKay Reservoir was constructed (1923–1927).

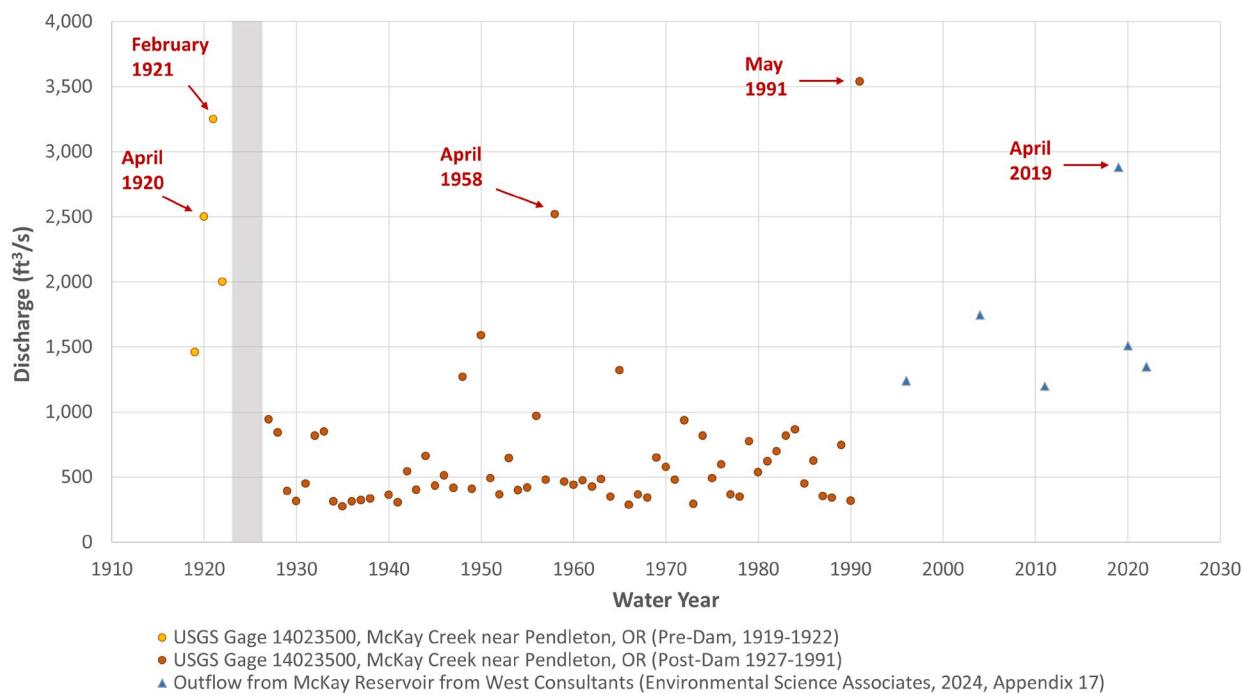
**Figure 1-5. Peak streamflow along lower McKay Creek below the reservoir in RS 5 (USGS, 2025e; Environmental Science Associates, 2024). Gray highlight indicates the years during which the McKay Reservoir was constructed.**

Since the construction of the McKay Reservoir in 1923–1927, the USBR has controlled the quantity and timing of flow in lower McKay Creek. Prior to the dam's construction, McKay Creek's average daily discharge between 1918–1922 was  $\sim 160 \text{ ft}^3/\text{s}$  ( $\sim 4.5 \text{ m}^3/\text{s}$ ), including no flow recorded for many summer months (July–September), and as shown in [Figure 1-5](#), the annual winter or spring peak flow ranged from 1,460  $\text{ft}^3/\text{s}$  (41  $\text{m}^3/\text{s}$ ) to 3,250  $\text{ft}^3/\text{s}$  (92  $\text{m}^3/\text{s}$ ) each year (USGS, 2025e). After the dam's construction, the controlled flows of the McKay Creek no longer follow this pattern; there are less frequent large floods and much lower average daily flows. Flows above 1,500  $\text{ft}^3/\text{s}$  (42  $\text{m}^3/\text{s}$ ) were recorded only three times between 1927 and 1991, after which time the USGS station records have not been published (2025e). Between 1986–1990, the USGS gage recorded an average daily discharge of 85  $\text{ft}^3/\text{s}$  (2.4  $\text{m}^3/\text{s}$ ). Furthermore, during the winter and spring, flows were frequently less than 10  $\text{ft}^3/\text{s}$  (0.3  $\text{m}^3/\text{s}$ ), but unlike in the past, water flowed through McKay Creek consistently in July and August (USGS, 2025e).

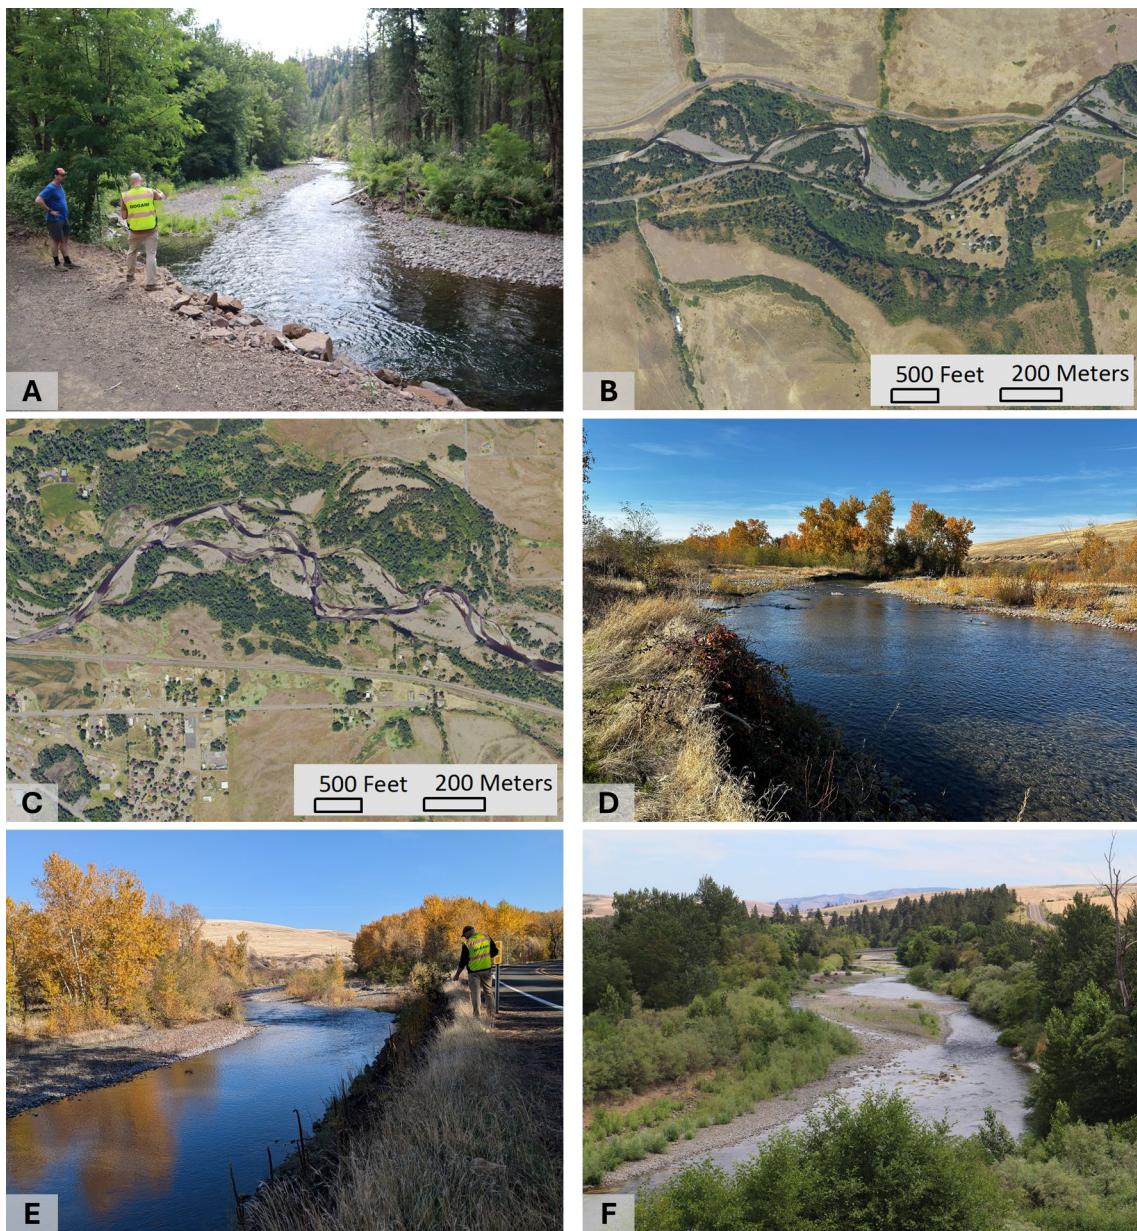
**Figure 1-6. Photographs taken by the authors in 2024 and 2025, and OSIP 2024 aerial imagery along the upper Umatilla River. WGS geographic coordinates. A (45.7309, -118.2695); B (45.6839, -118.4983); C (45.6713, -118.6504); D (45.6781, -118.5780); E (45.6845, -118.5069); F (45.6751, -118.5647)**

The valley walls are composed of CRBG volcanics, and the valley bottom is composed of Holocene fluvial deposits, small alluvial fans, and artificial fill (i.e., levees, berms, roads, and railroad embankments). Although the valley bottom was not directly impacted by the Missoula Floods, the upper hillslopes along the north side of the valley are covered in loess deposits. The channel bed is primarily composed of gravels and cobbles with intermittent bedrock outcrops; Hughes (2008) reported the 50<sup>th</sup> percentile (i.e., median) grain size is ~2.4 inches (~6 cm) and the 84<sup>th</sup> percentile grain size is ~6 inches (~15 cm). The larger tributaries, including Meacham and Isqúulktpé creeks are significant sources of new sediment to the mainstem and aggrade with large packages of sediment each winter in the tributary channels.

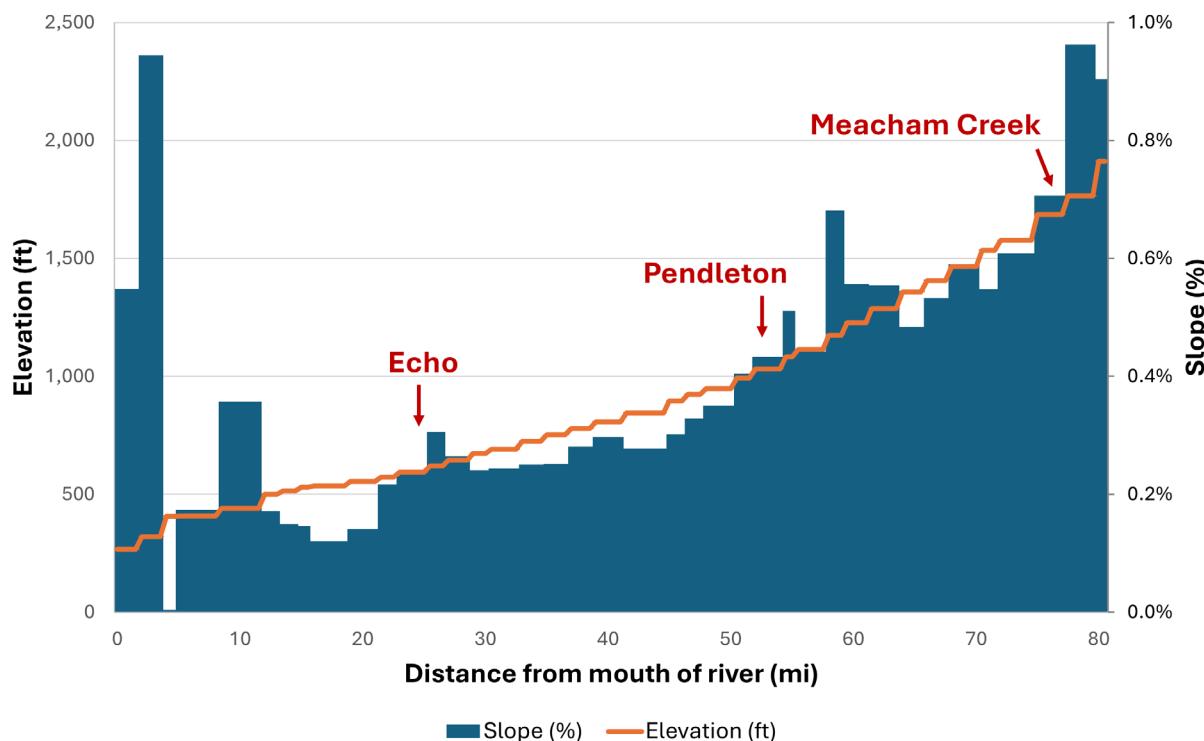
**Figure 1-7.** Umatilla River study area's early fall water surface elevation and slope for each RS. To provide perspective, a 0.2 percent slope is the same as a ~11 ft (~3.2 m) change in elevation across 1.0 mi (1.6 km) and a 1.0 percent slope is the same as a ~53 ft (~16 m) change in elevation across 1.0 mi (1.6 km).

As shown in **Figure 1-7**, the upstream reaches are slightly steeper than the reaches approaching Pendleton. In the farthest upstream reaches, above the confluence with Meacham Creek (RS 38–39), the valley is very narrow, typically between ~350–500 ft (~107–152 m) wide and the water surface slope is relatively steep (0.90–0.96 percent). As a result, there is very little space for human infrastructure. For example, Binghamton Road was constructed directly adjacent to the channel in many locations. The river is confined by both the bedrock valley walls and the road's shoulder in these reaches.

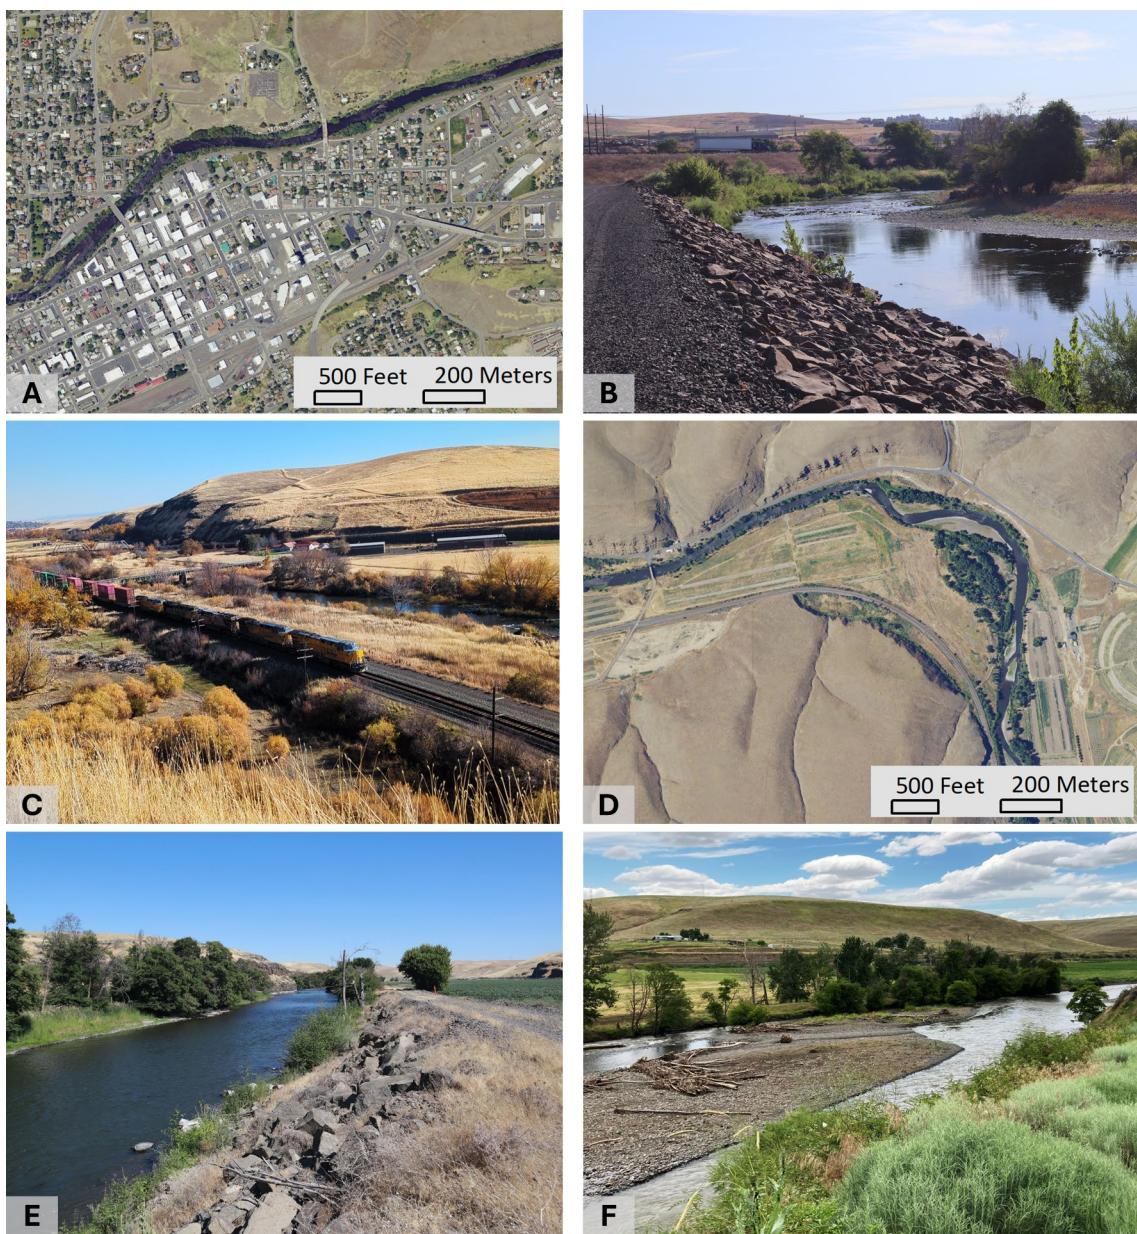
**Figure 1-8. Photographs taken by the authors in 2024 and 2025, and OSIP 2024 aerial imagery along the middle Umatilla River. WGS geographic coordinates. A (45.6766, -118.7774); B (45.6708, -118.8384); C (45.6561, -118.8789); D (45.6786, -119.0244); E (45.6854, -119.0940); F (45.6744, -119.0712).**

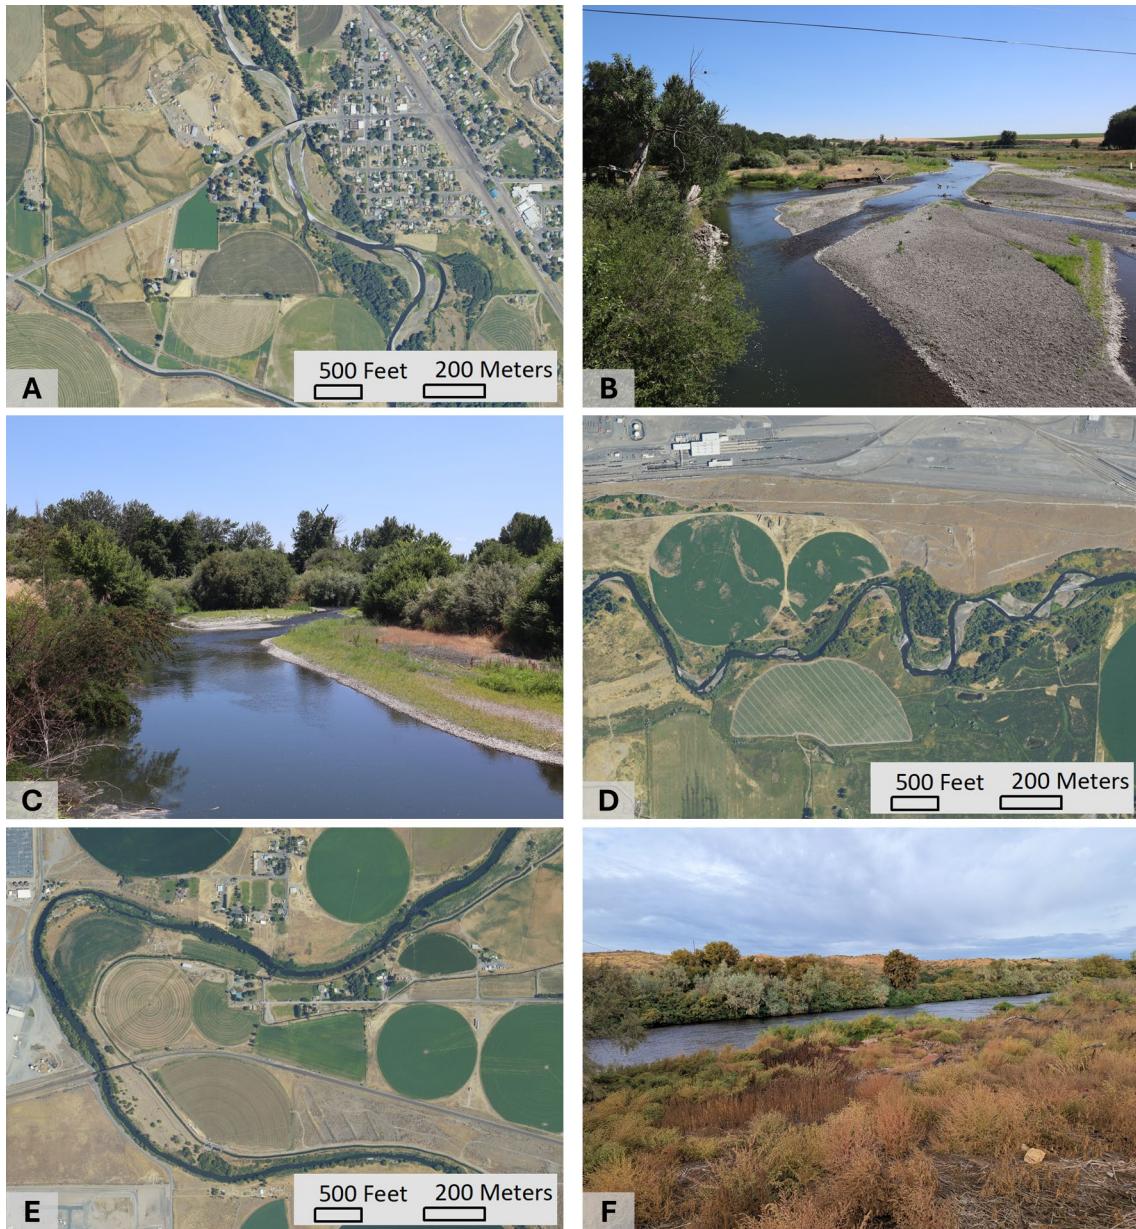
**Figure 1-9.** Photographs taken by the authors in 2024 and 2025, and OSIP 2024 aerial imagery along the lower Umatilla River. WGS geographic coordinates. A (45.7420, -119.1993); B (45.7420, -119.1993); C (45.7851, -119.2410); C (45.7896, -119.2857); E (45.8068, -119.3551); F (45.9140, -119.3468).

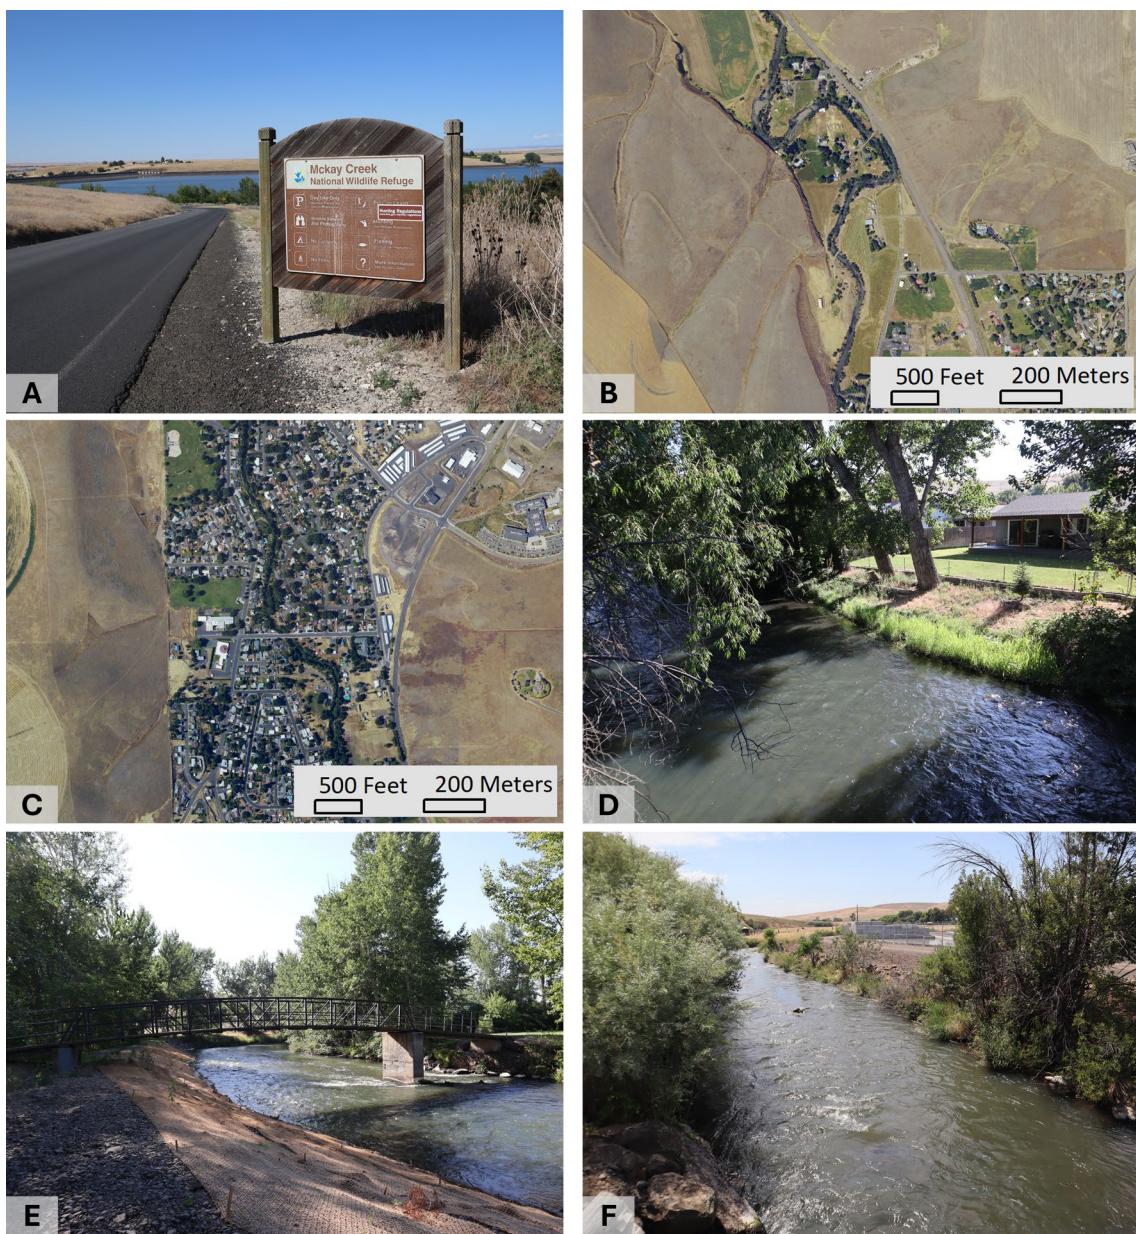
**Figure 1-10. Photographs taken by the authors in 2025, and OSIP 2024 aerial imagery along lower McKay Creek. WGS geographic coordinates. A (45.5972, -118.7983); B (45.6252, -118.8111); C (45.6456, -118.8227); D (45.6478, -118.8234); E (45.6524, -118.8250); F (45.6664, -118.8354).**

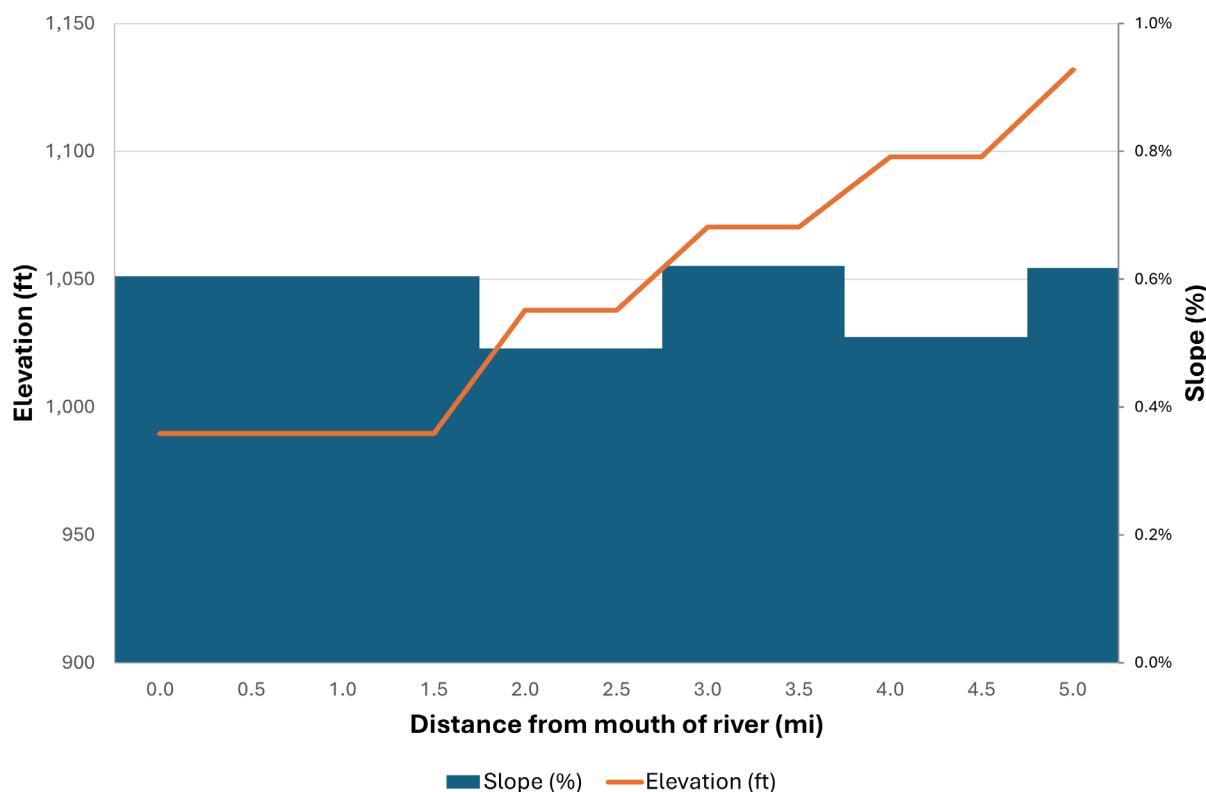
Figure 1-11. Lower McKay Creek's water surface elevation and slope for each RS.

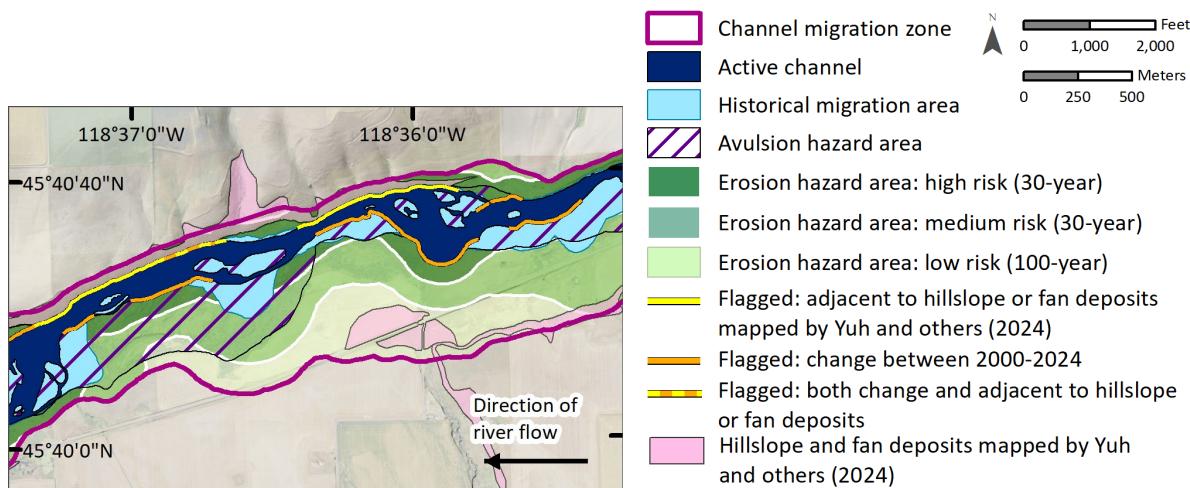
**Figure 2-1. Conceptual diagram of the components of a CMZ map, including the AC, HMA, AHA, EHAs, flagged streambanks, and CMZ. Example from the Umatilla River, Umatilla County.**

The CMZ is composed of the AC, HMA, EHA high hazard (30-year median rate), EHA medium hazard (30-year maximum rate), EHA low hazard (100-year maximum rate), AHA, and Flagged. These units are produced using the approaches described in the following section. [Figure 2-1](#) is an example of an image that can be used to visualize how the channel units are combined. This study mapped the high-, medium-, and low-hazard EHA to show potential movement across the next 30 and 100 years at different levels of confidence. The high-hazard area represents the zone directly adjacent to the AC that is most likely to be impacted by channel migration. The medium- and low-hazard areas represent locations beyond the HMA and have a lower likelihood of being impacted by channel migration within the next 30 and 100 years. A more detailed explanation of each of the components is provided in [Section 2.3](#).

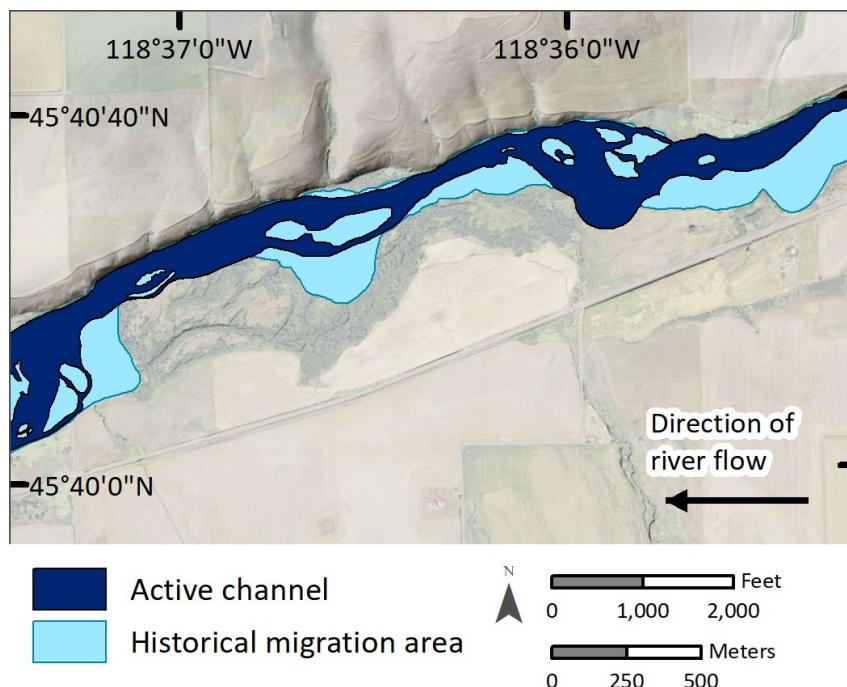
Figure 2-2. Example of the 2024 AC and 1952–2024 HMA mapped along the Umatilla River, Umatilla County.

In this study, the 2024 AC boundary was delineated based on the most recent available aerial photography at the time of mapping (Oregon Geospatial Enterprise Office, 2025). Also, the lidar slope map and REM were used as references to identify banks and boundaries obscured in the imagery by vegetation. In areas where the channel has migrated in the time since the lidar collection, the digitization was aligned to match the most recent aerial imagery.

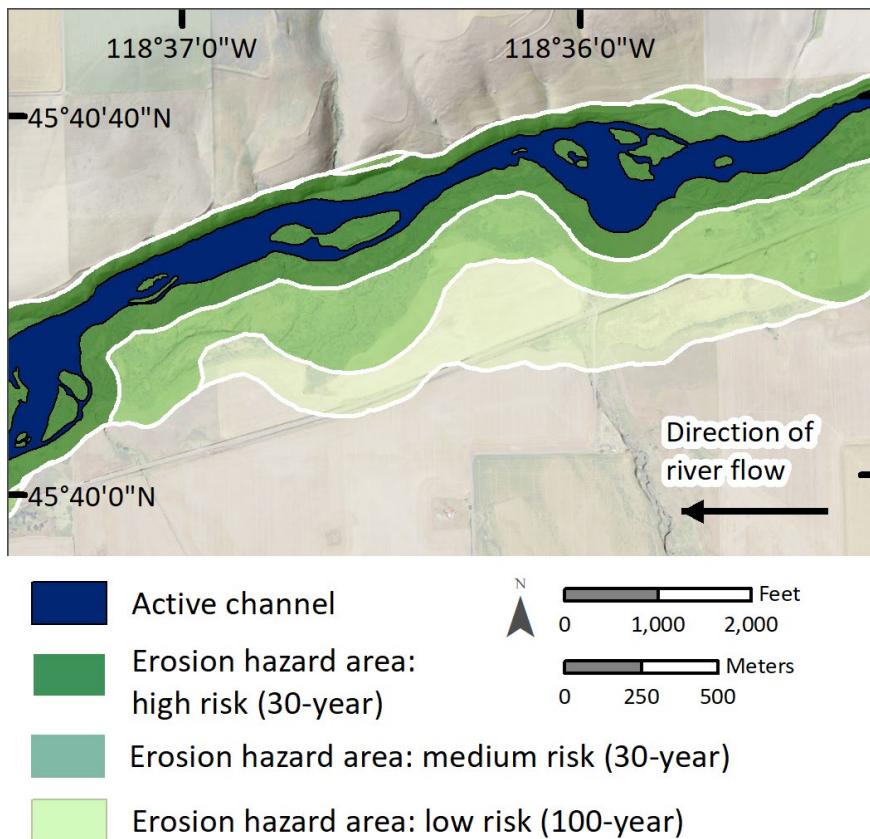
**Figure 2-3. Example of EHAs: high hazard (median erosion rate projected 30 years into the future), medium hazard (maximum erosion rate project 30 years into future), and low hazard (maximum erosion rate project 100 years into future) along the Umatilla River, Umatilla County.**

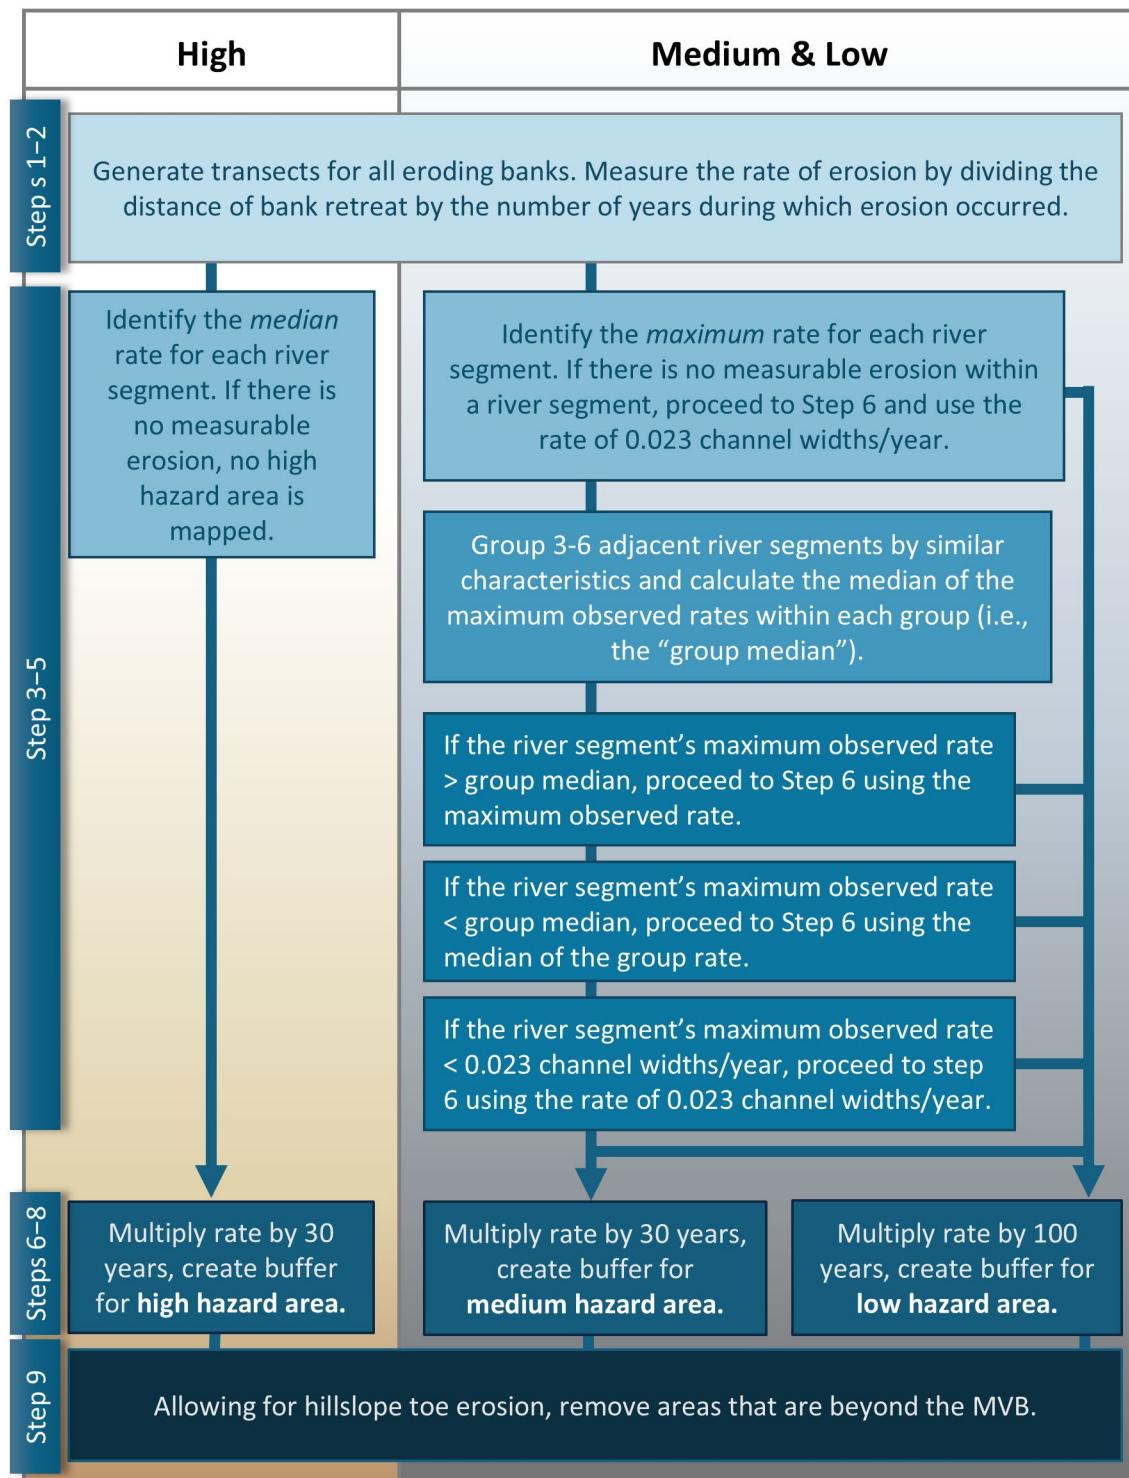
Figure 2-4. Conceptual model for EHA mapping method, divided into high-, medium-, and low-hazard components.

As summarized in **Figure 2-4**, the process this study used to map the EHA included three steps: 1) measuring and selecting historical erosion rates, 2) projecting the erosion rates 30 and 100 years into the future, and 3) removing areas from the EHA that extend beyond the MVB or are constrained by other geologic controls (e.g., basalt). For the segments that did not have measurable migration during the period of observation (1950s–2020s), an erosion rate established by Lagasse and others (2004) was used that conservatively includes the area of erosion for streams that are static for long periods of time (see Step 6, below, for more detail). The EHA methodology was designed to include the median- and maximum-possible extent of lateral erosion for an RS based on the observed historical erosion patterns.

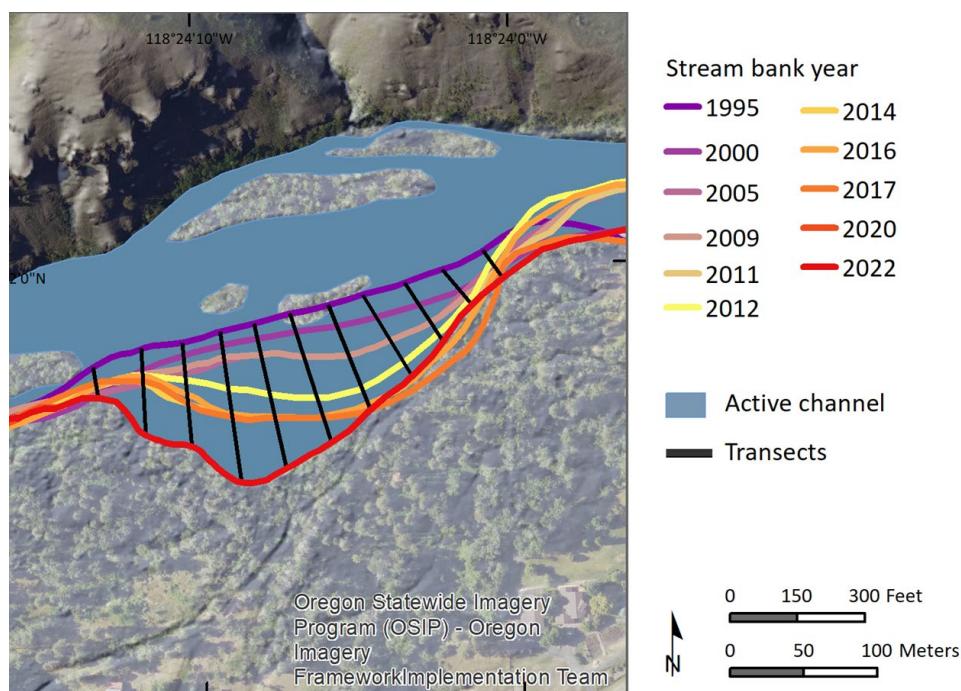
**Figure 2-5. Example of streambank lines from 1980–2022 and transects along the Umatilla River, Umatilla County.**

- b. Bank erosion rates were measured along these transects and identified both the median and maximum erosion rate (ft/yr [m/yr]) within each RS.

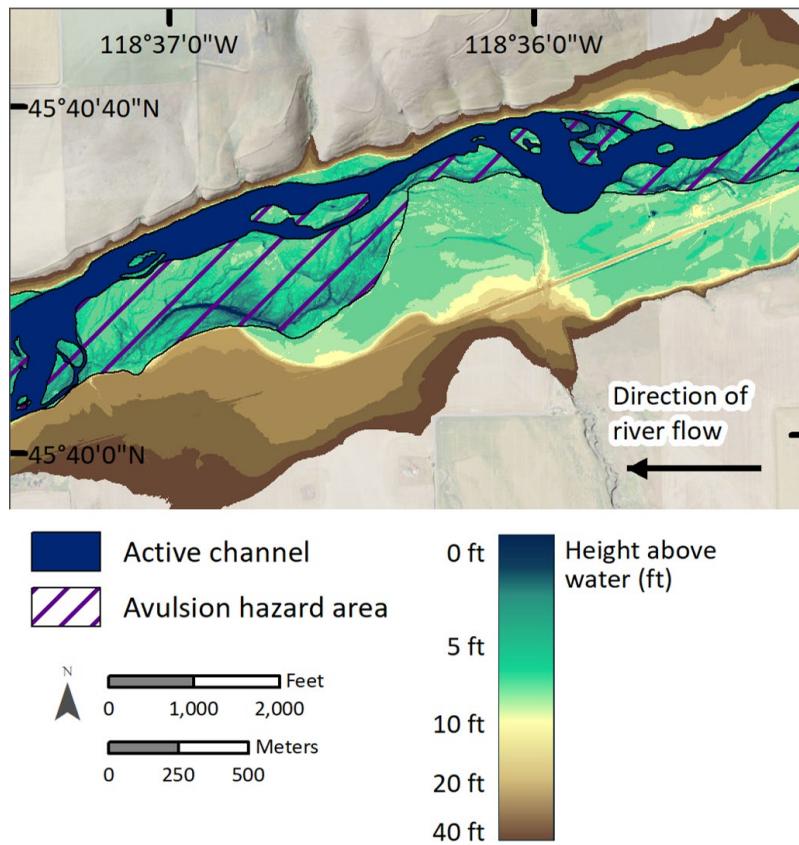
Figure 2-6. Example of the AHA mapped along the Umatilla River, Umatilla County with the REM basemap.

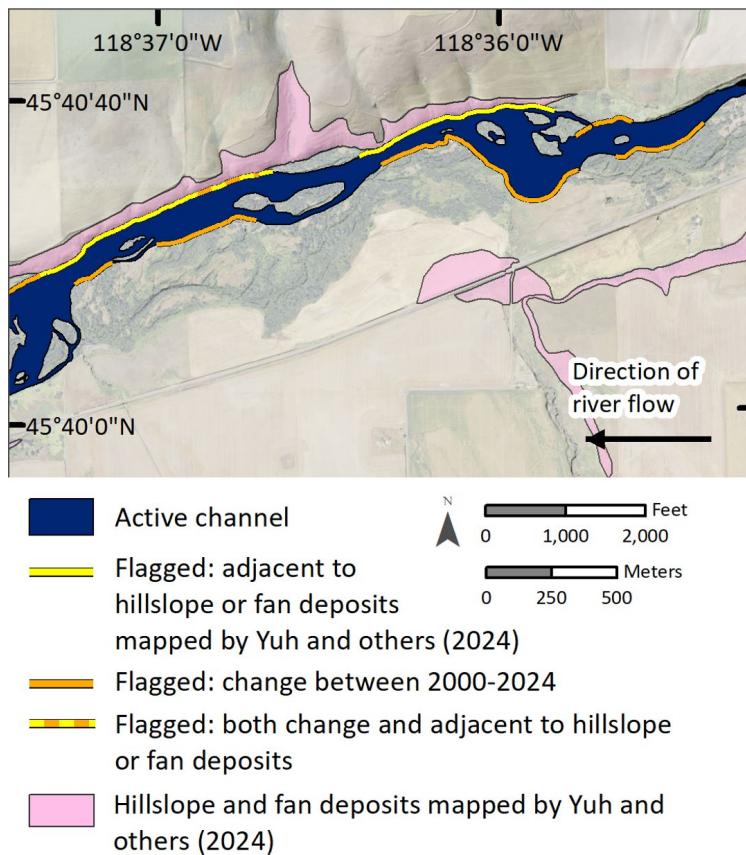
Figure 2-7. Example of flagged banks along the Umatilla River, Umatilla County.

This study flagged stream banks where channel migration and stream bank erosion were observed between 2000 and the most recent aerial image. Aerial images available from the last 24 years were used to define the recent erosion flagged banks because this period of time has relatively similar hydrologic and land-use conditions as the present day and includes the impacts of several large flood events in Oregon.
