**OPEN-FILE REPORT O-25-10**

**CHANNEL MIGRATION ZONE MAPS  
FOR UMATILLA RIVER AND LOWER MCKAY CREEK, UMATILLA  
COUNTY, OREGON**

by Christina A. Appleby<sup>1</sup>, Lowell H. Anthony<sup>1</sup>, and Jesse K. Noone<sup>2</sup>

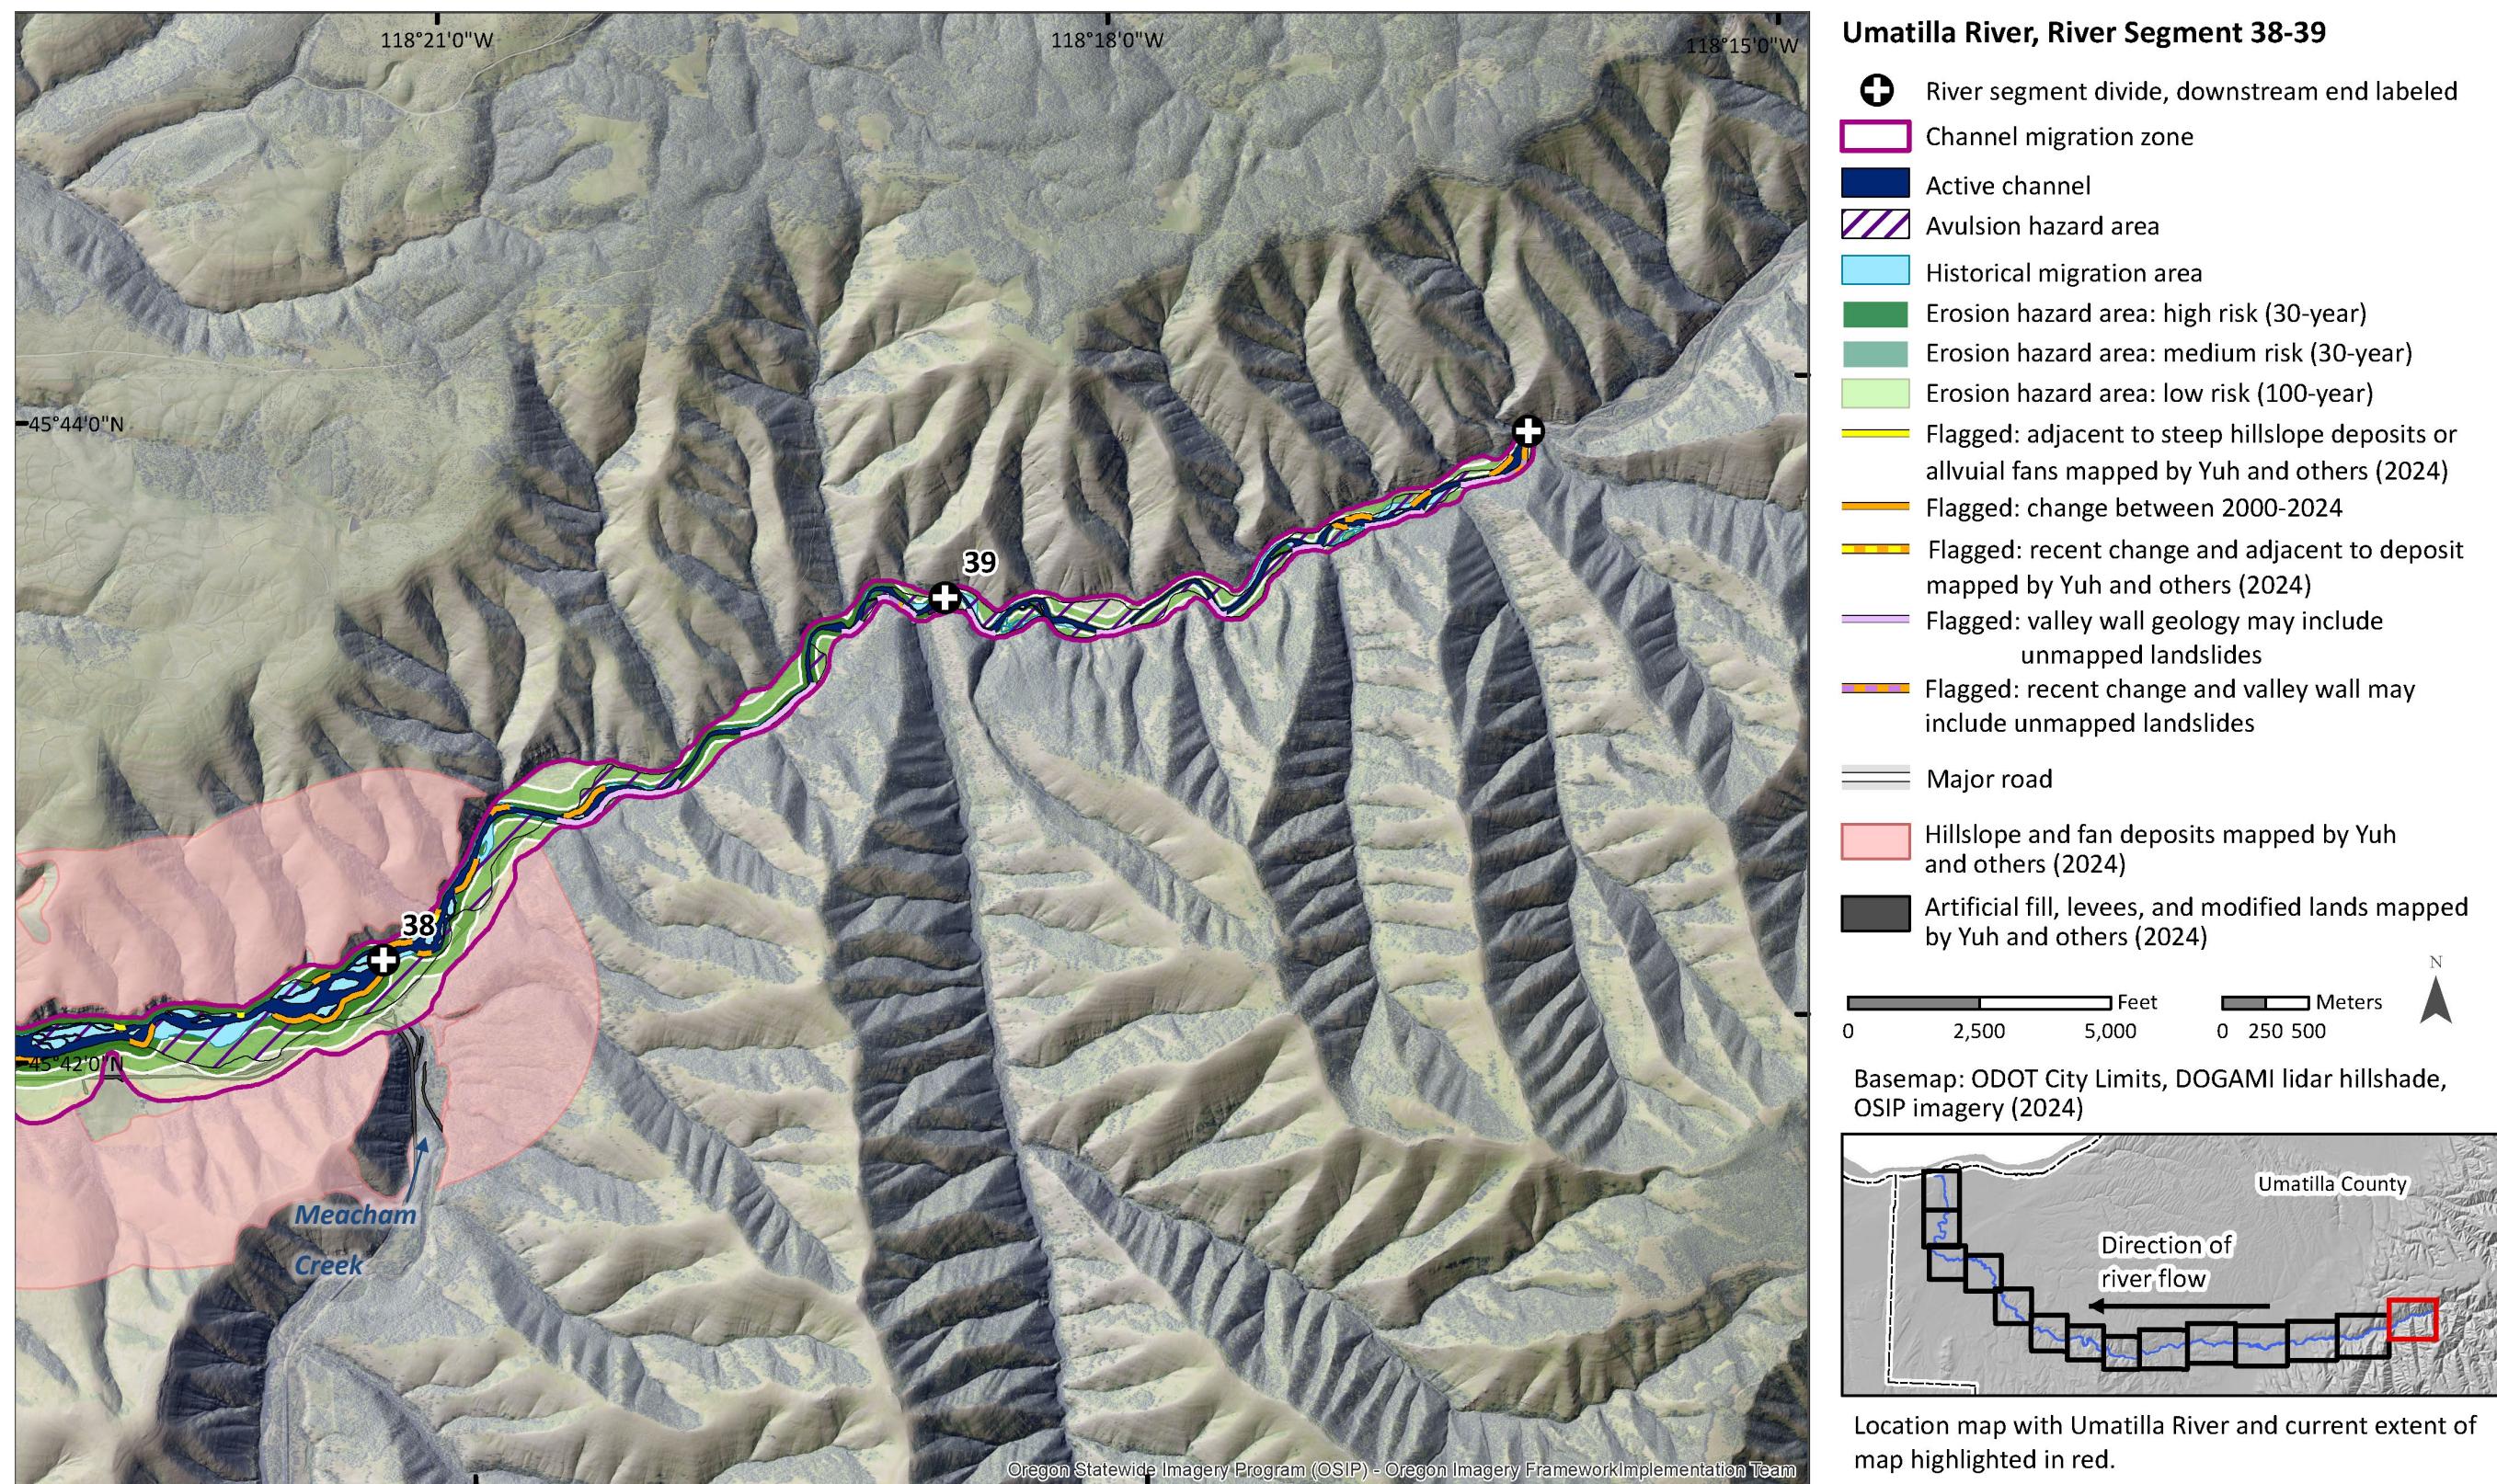
Figure 3-1. Umatilla River CMZ map, RS 38-39, Umatilla County, Oregon.

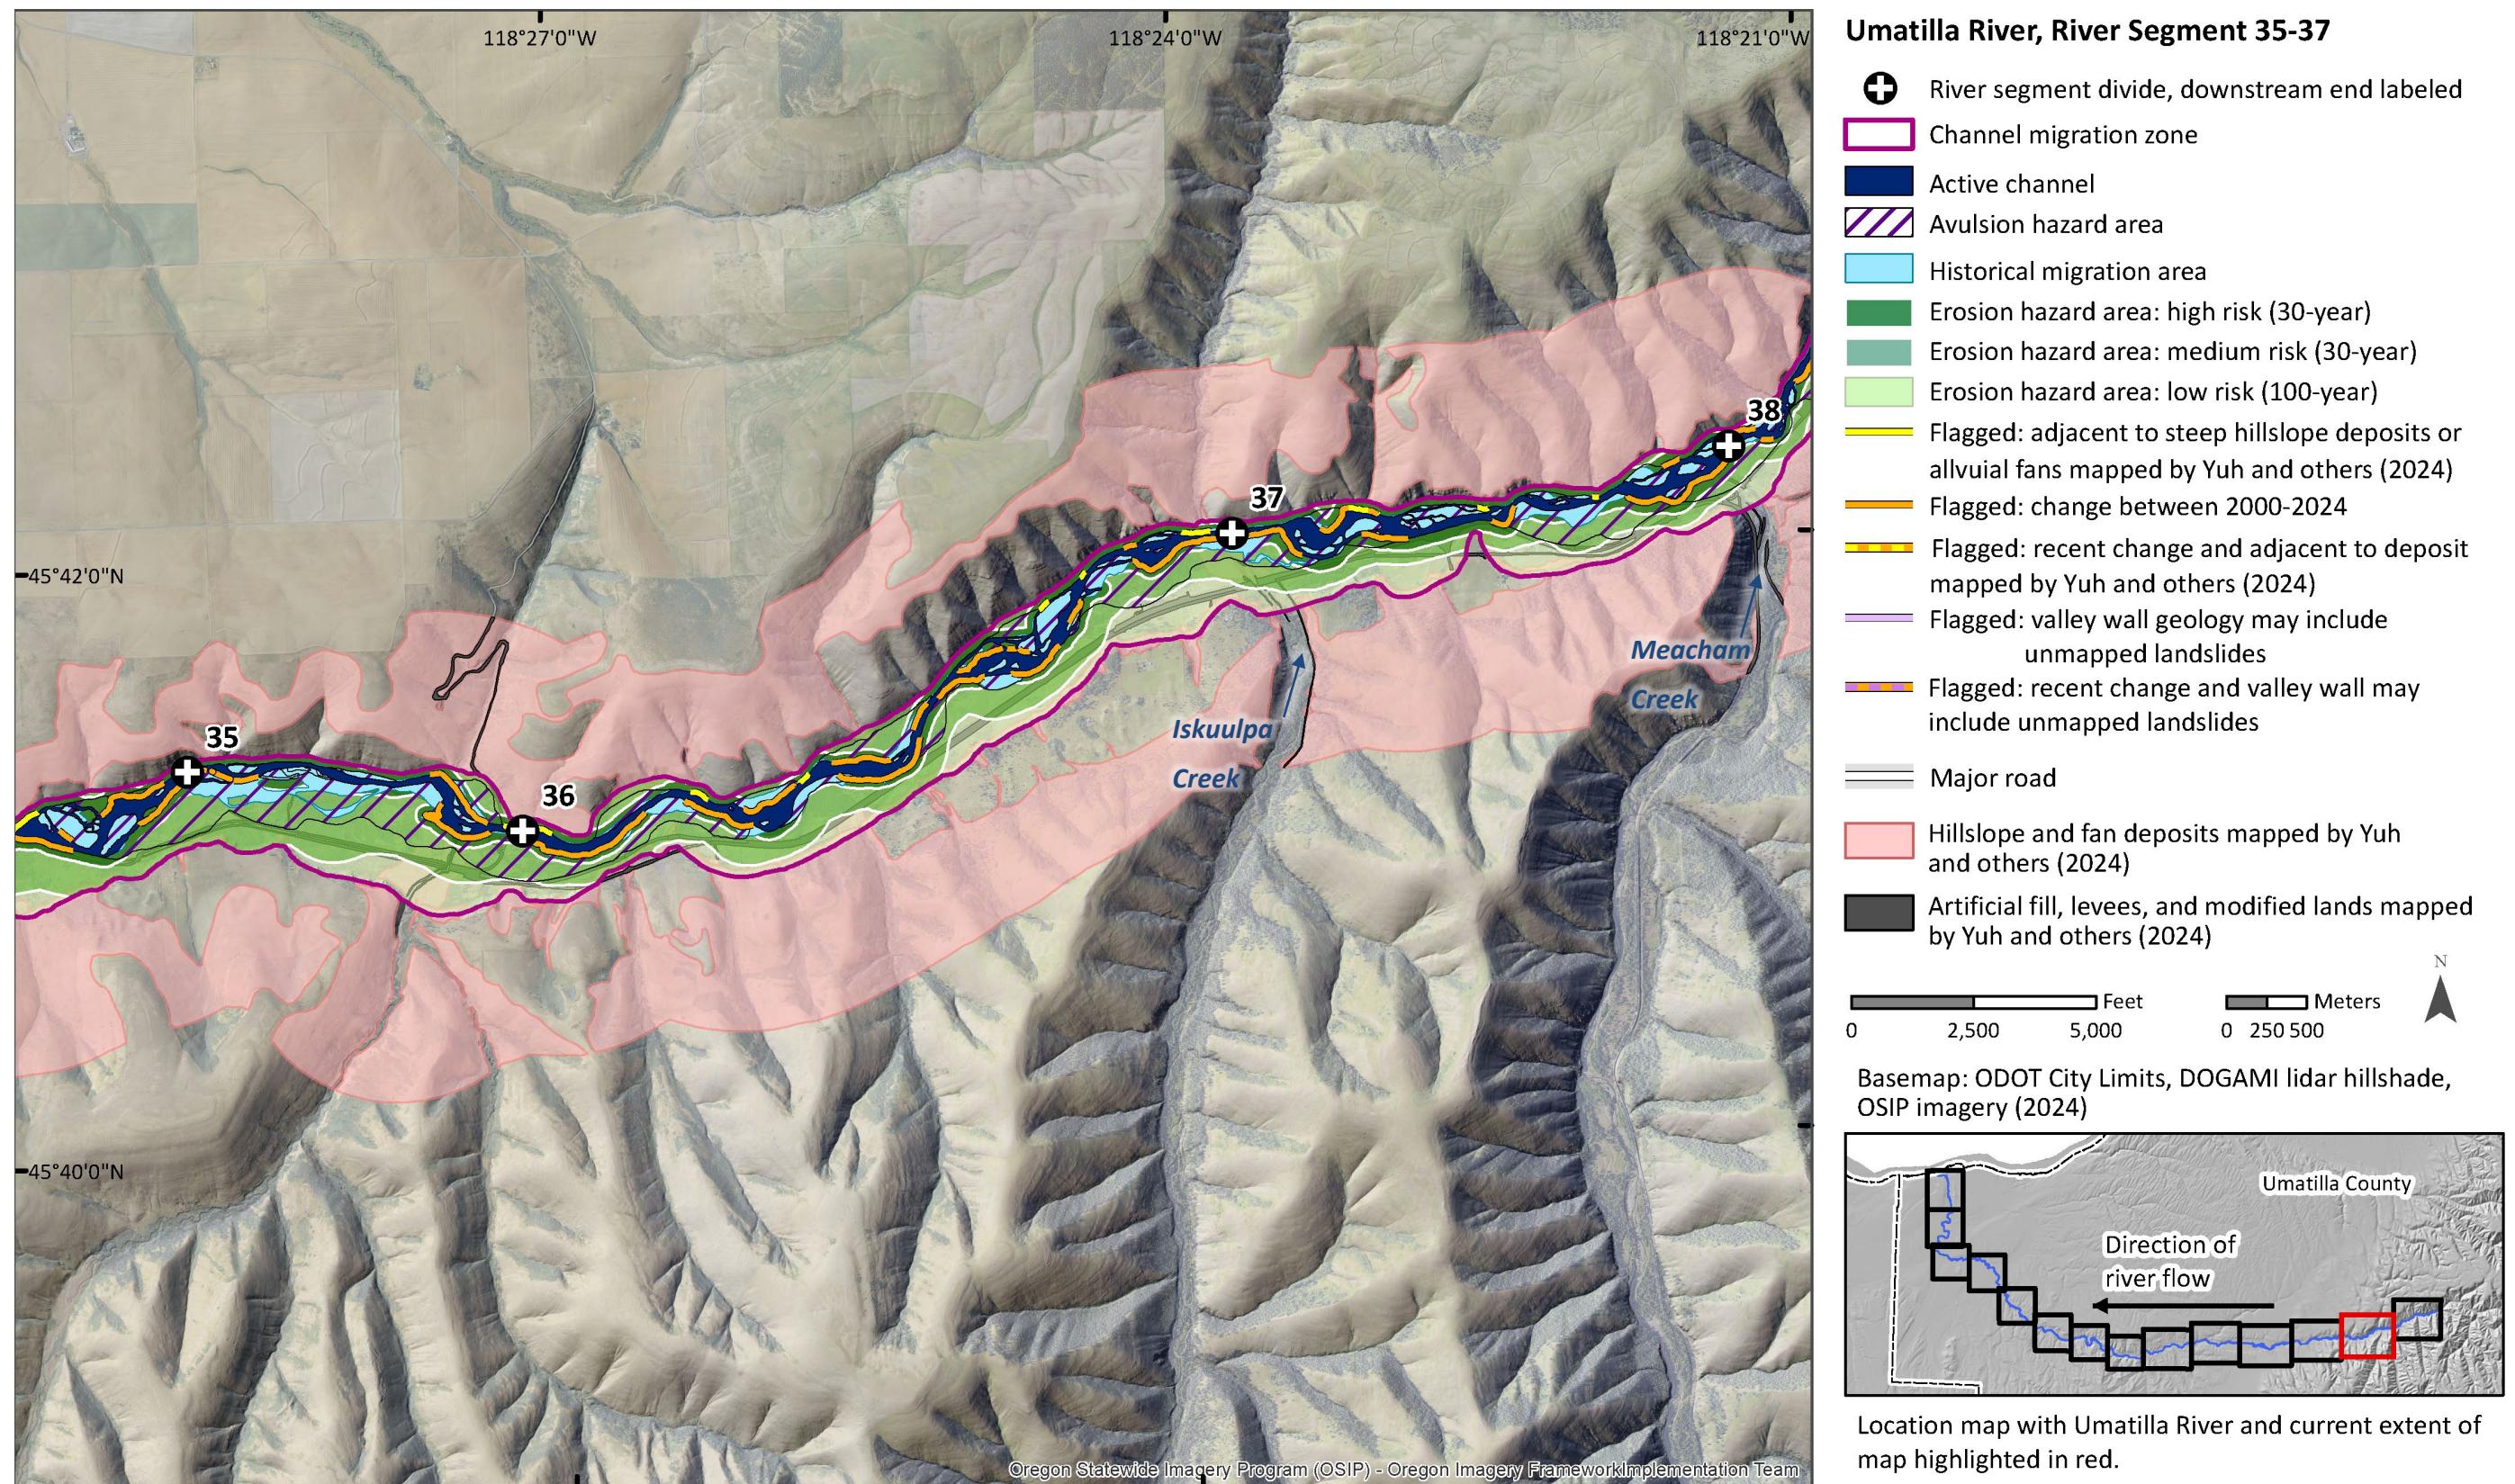
Figure 3-2. Umatilla River CMZ map, RS 35–37, Umatilla County, Oregon.

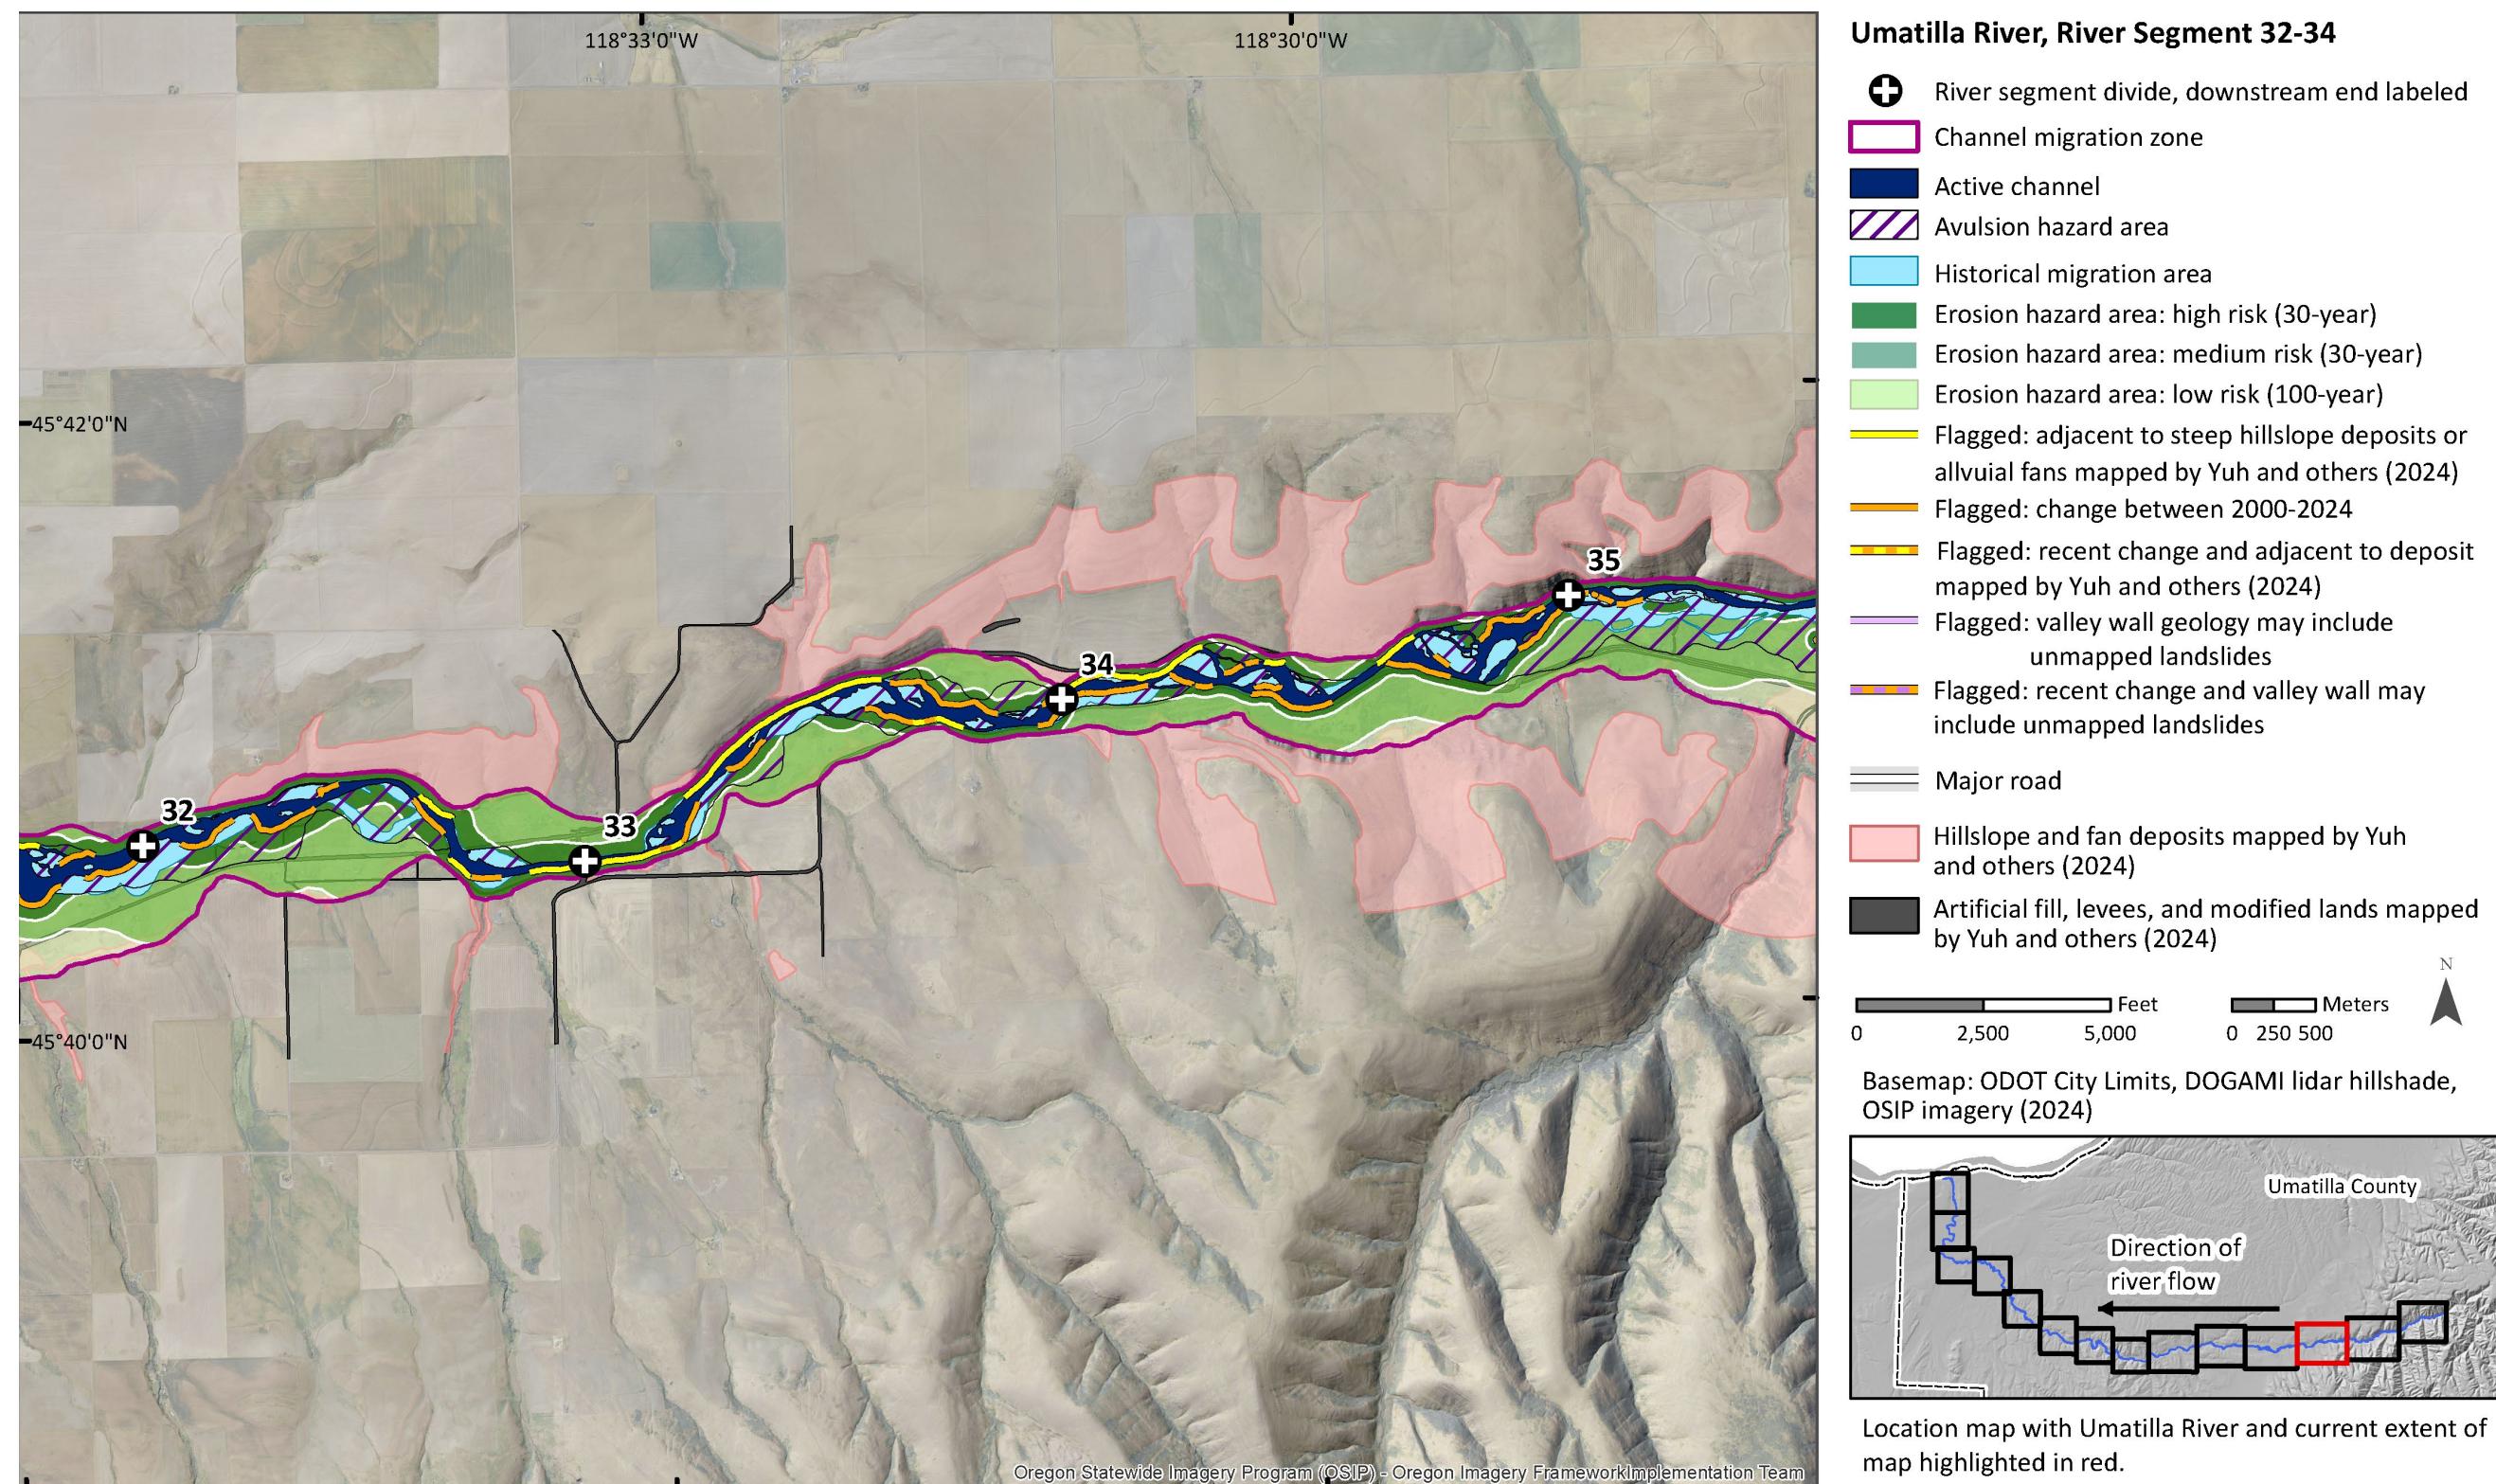
Figure 3-3. Umatilla River CMZ map, RS 32–34, Umatilla County, Oregon.

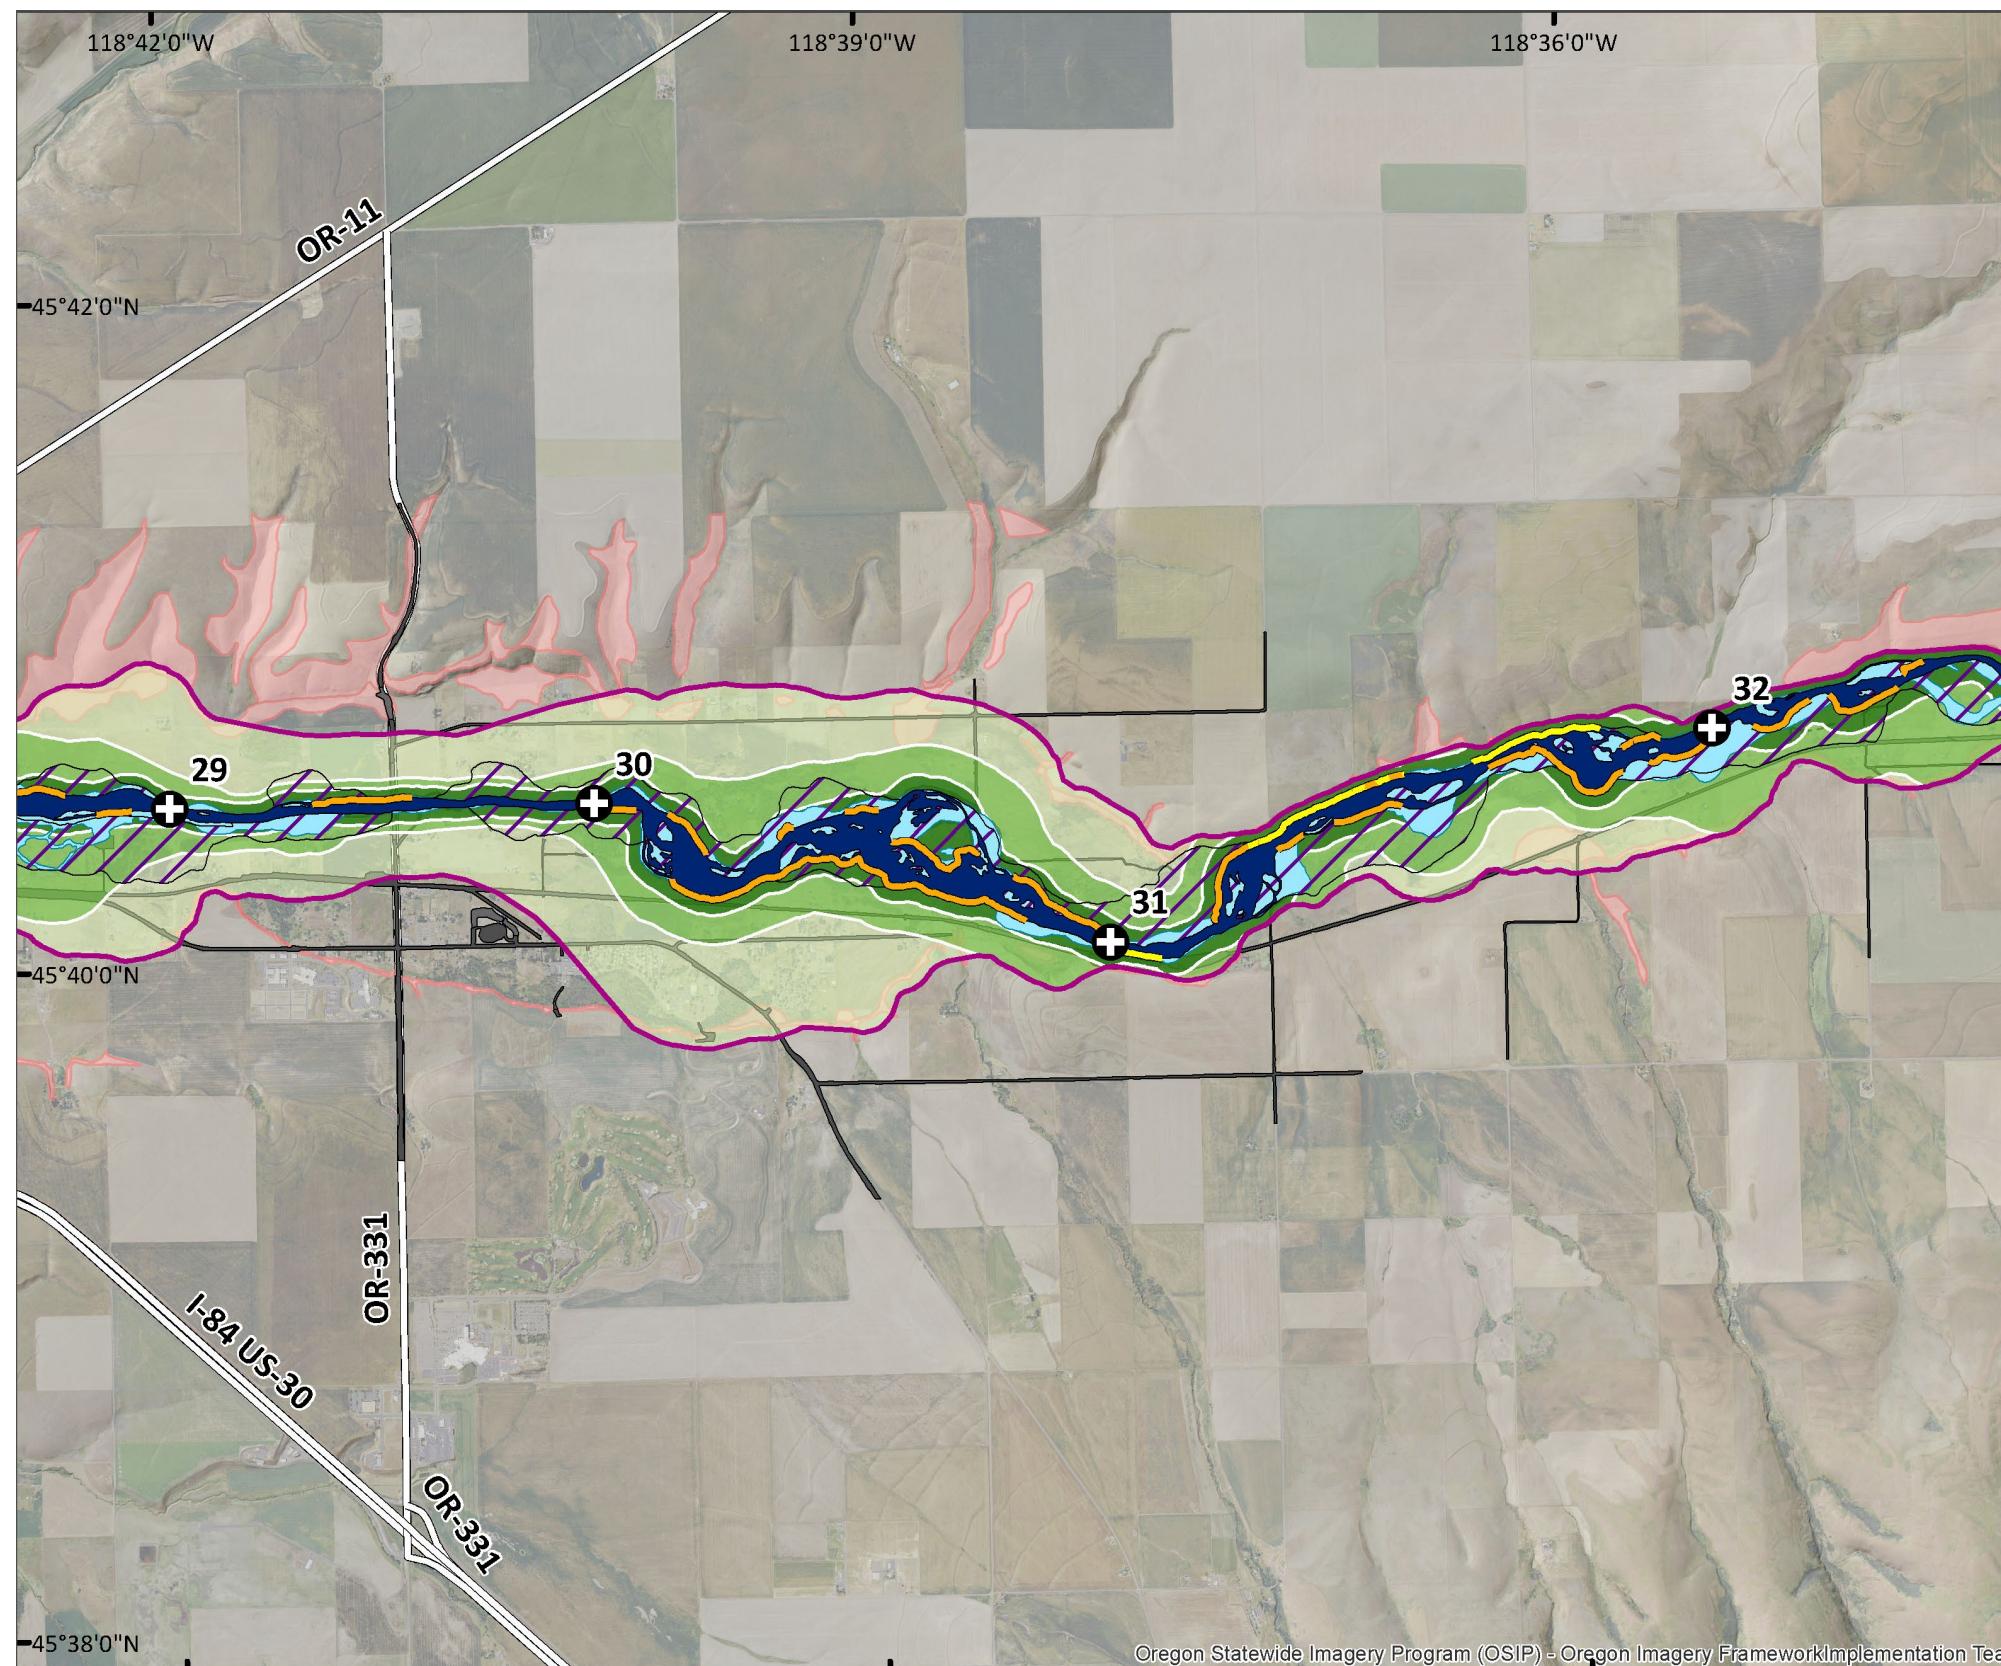
Figure 3-4. Umatilla River CMZ map, RS 29–31, Umatilla County, Oregon.

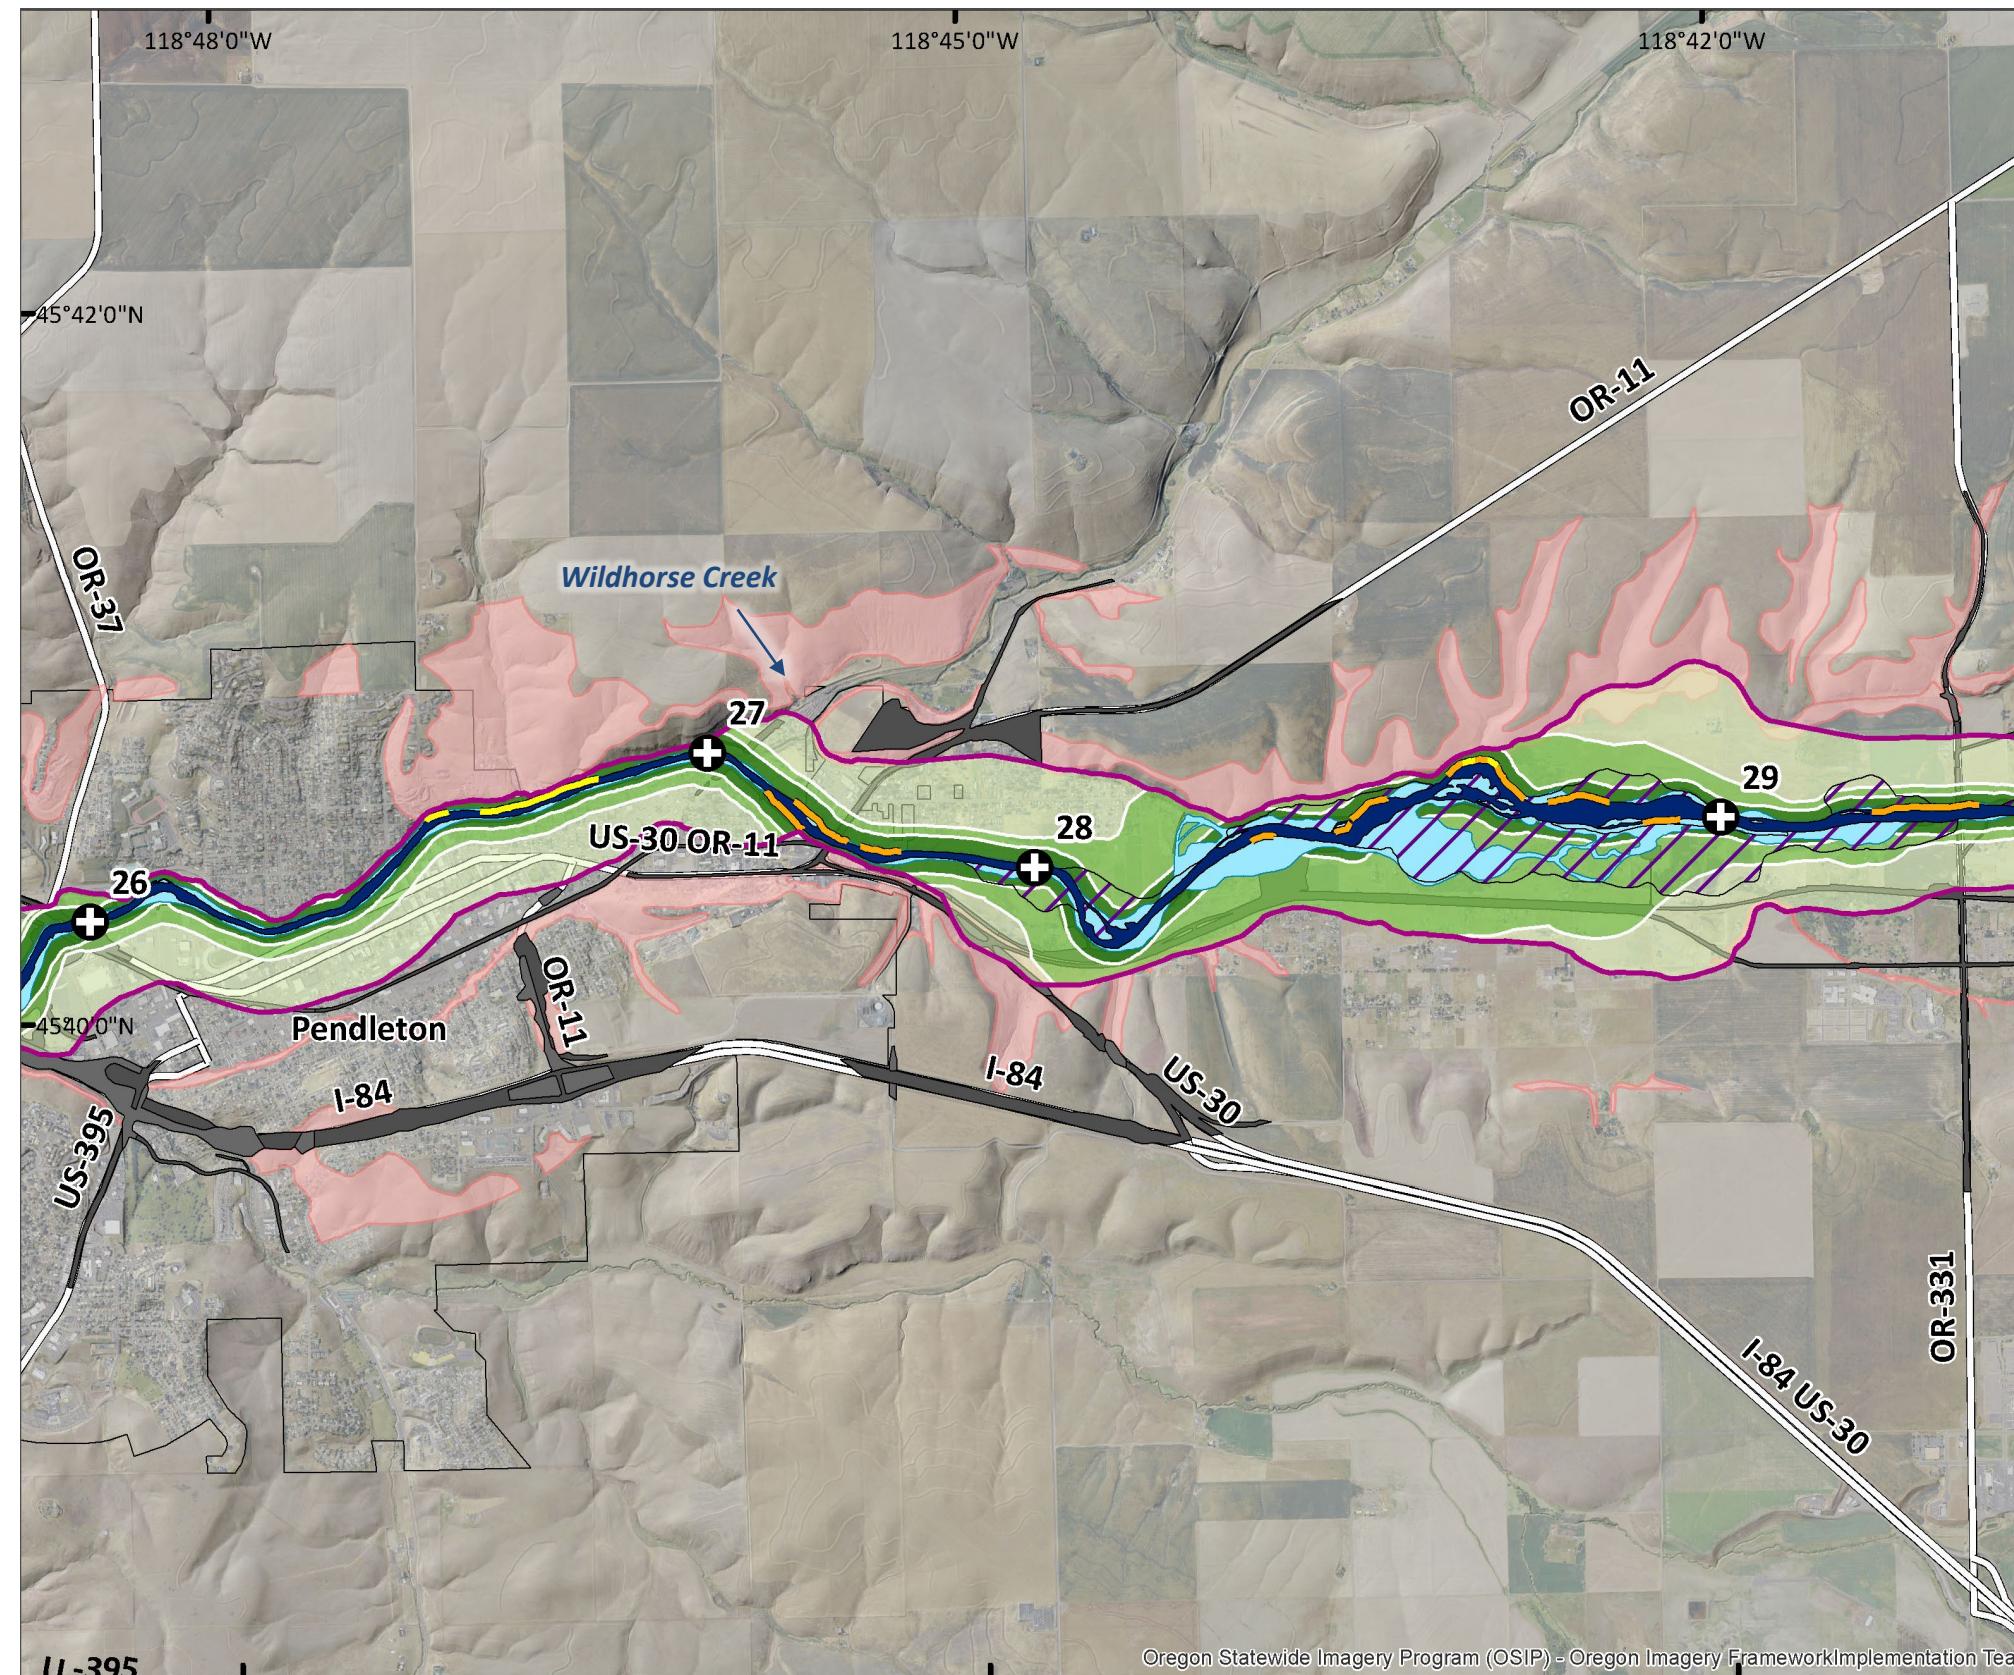
Figure 3-5. Umatilla River CMZ map, RS 26–28, Umatilla County, Oregon.

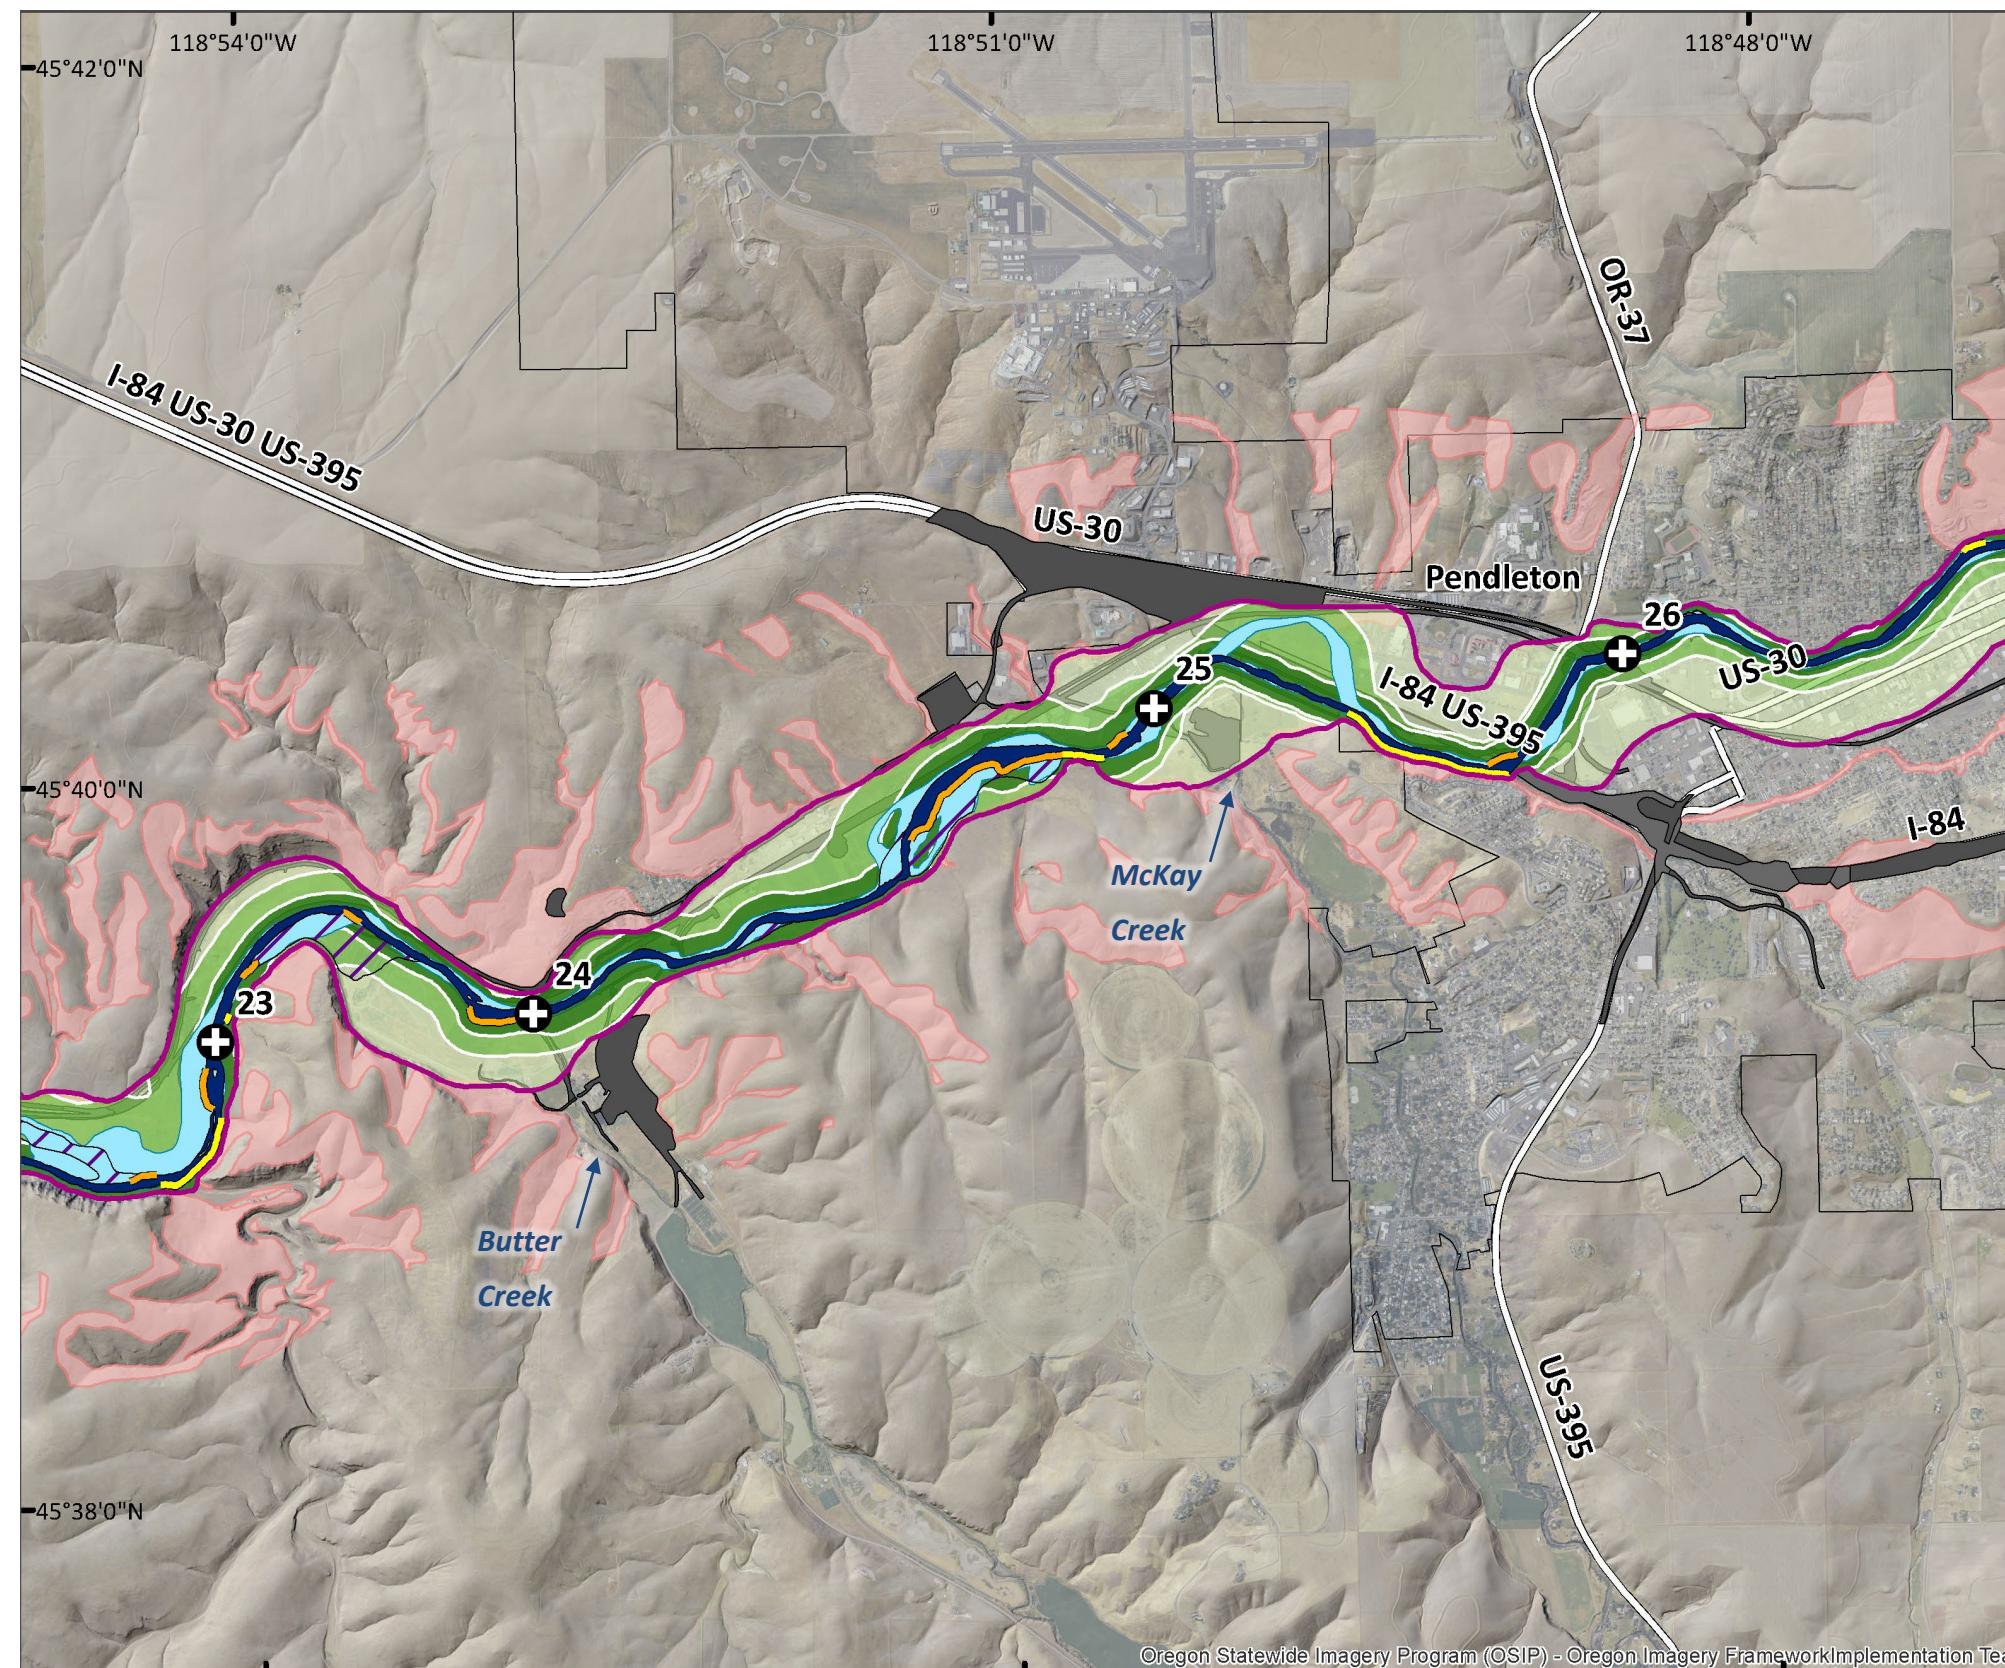
Figure 3-6. Umatilla River CMZ map, RS 23–25, Umatilla County, Oregon.
