**OPEN-FILE REPORT O-25-10**

**CHANNEL MIGRATION ZONE MAPS  
FOR UMATILLA RIVER AND LOWER MCKAY CREEK, UMATILLA  
COUNTY, OREGON**

by Christina A. Appleby<sup>1</sup>, Lowell H. Anthony<sup>1</sup>, and Jesse K. Noone<sup>2</sup>

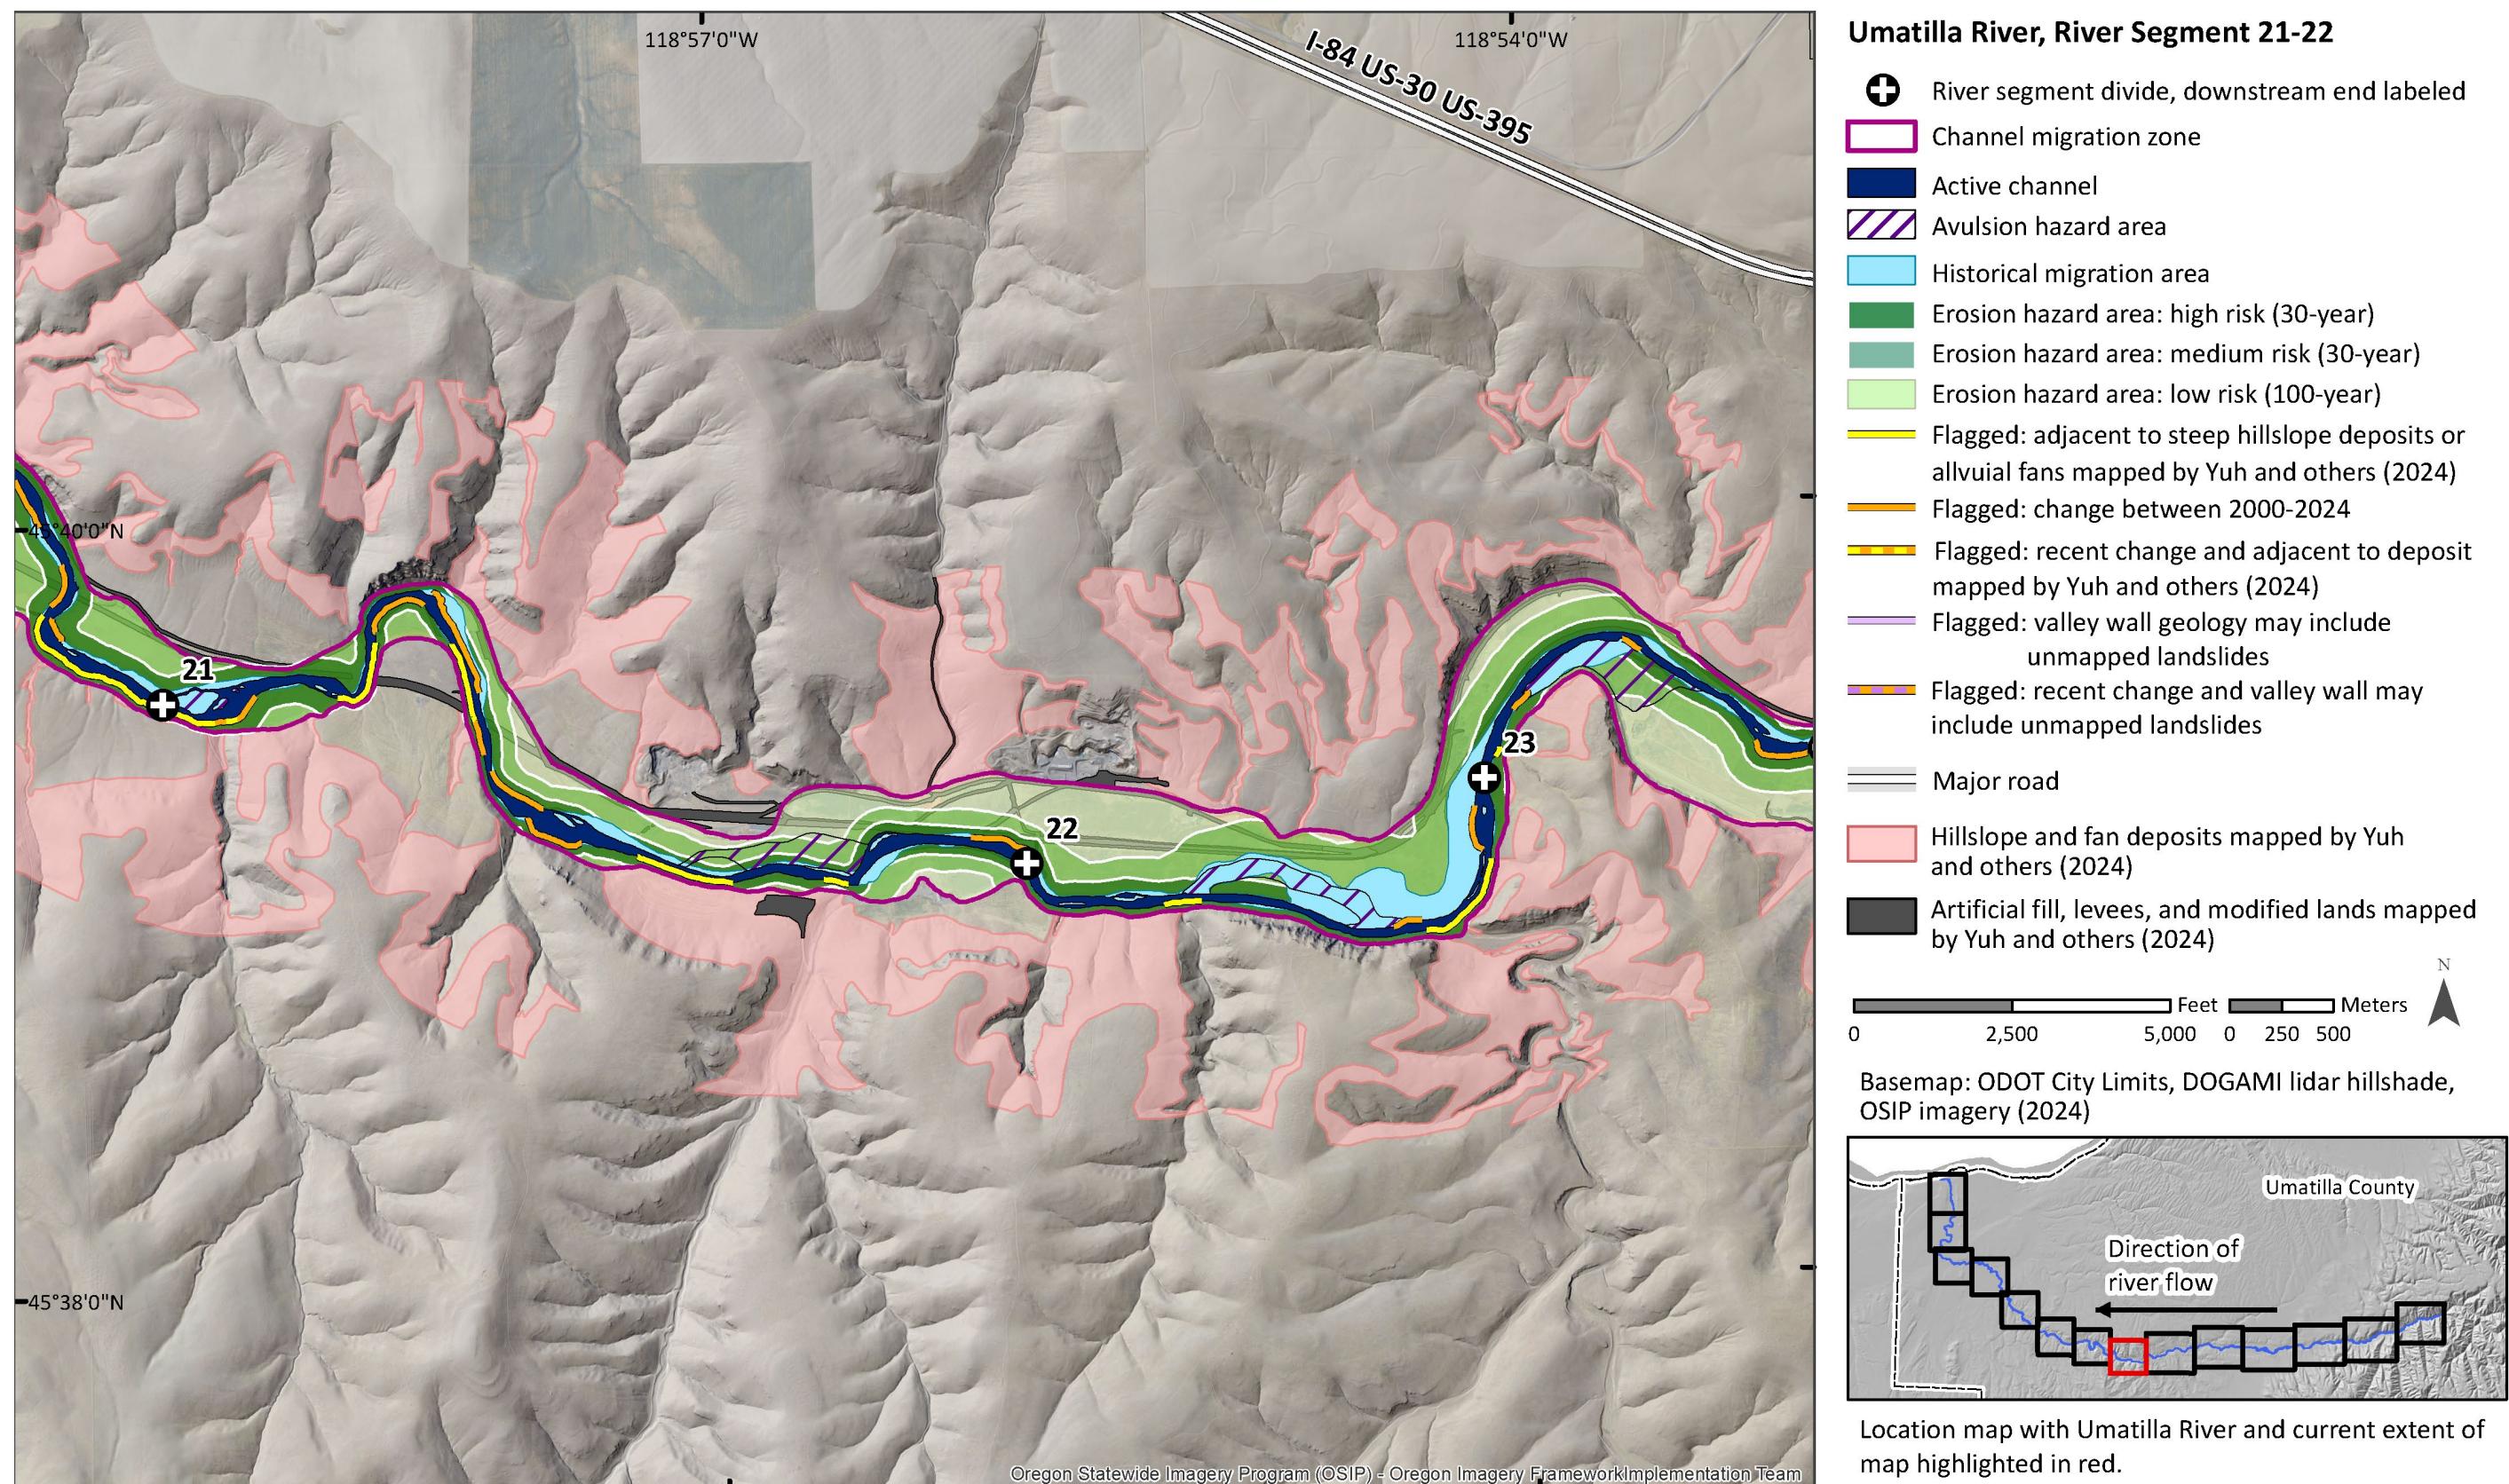
Figure 3-7. Umatilla River CMZ map, RS 21–22, Umatilla County, Oregon.

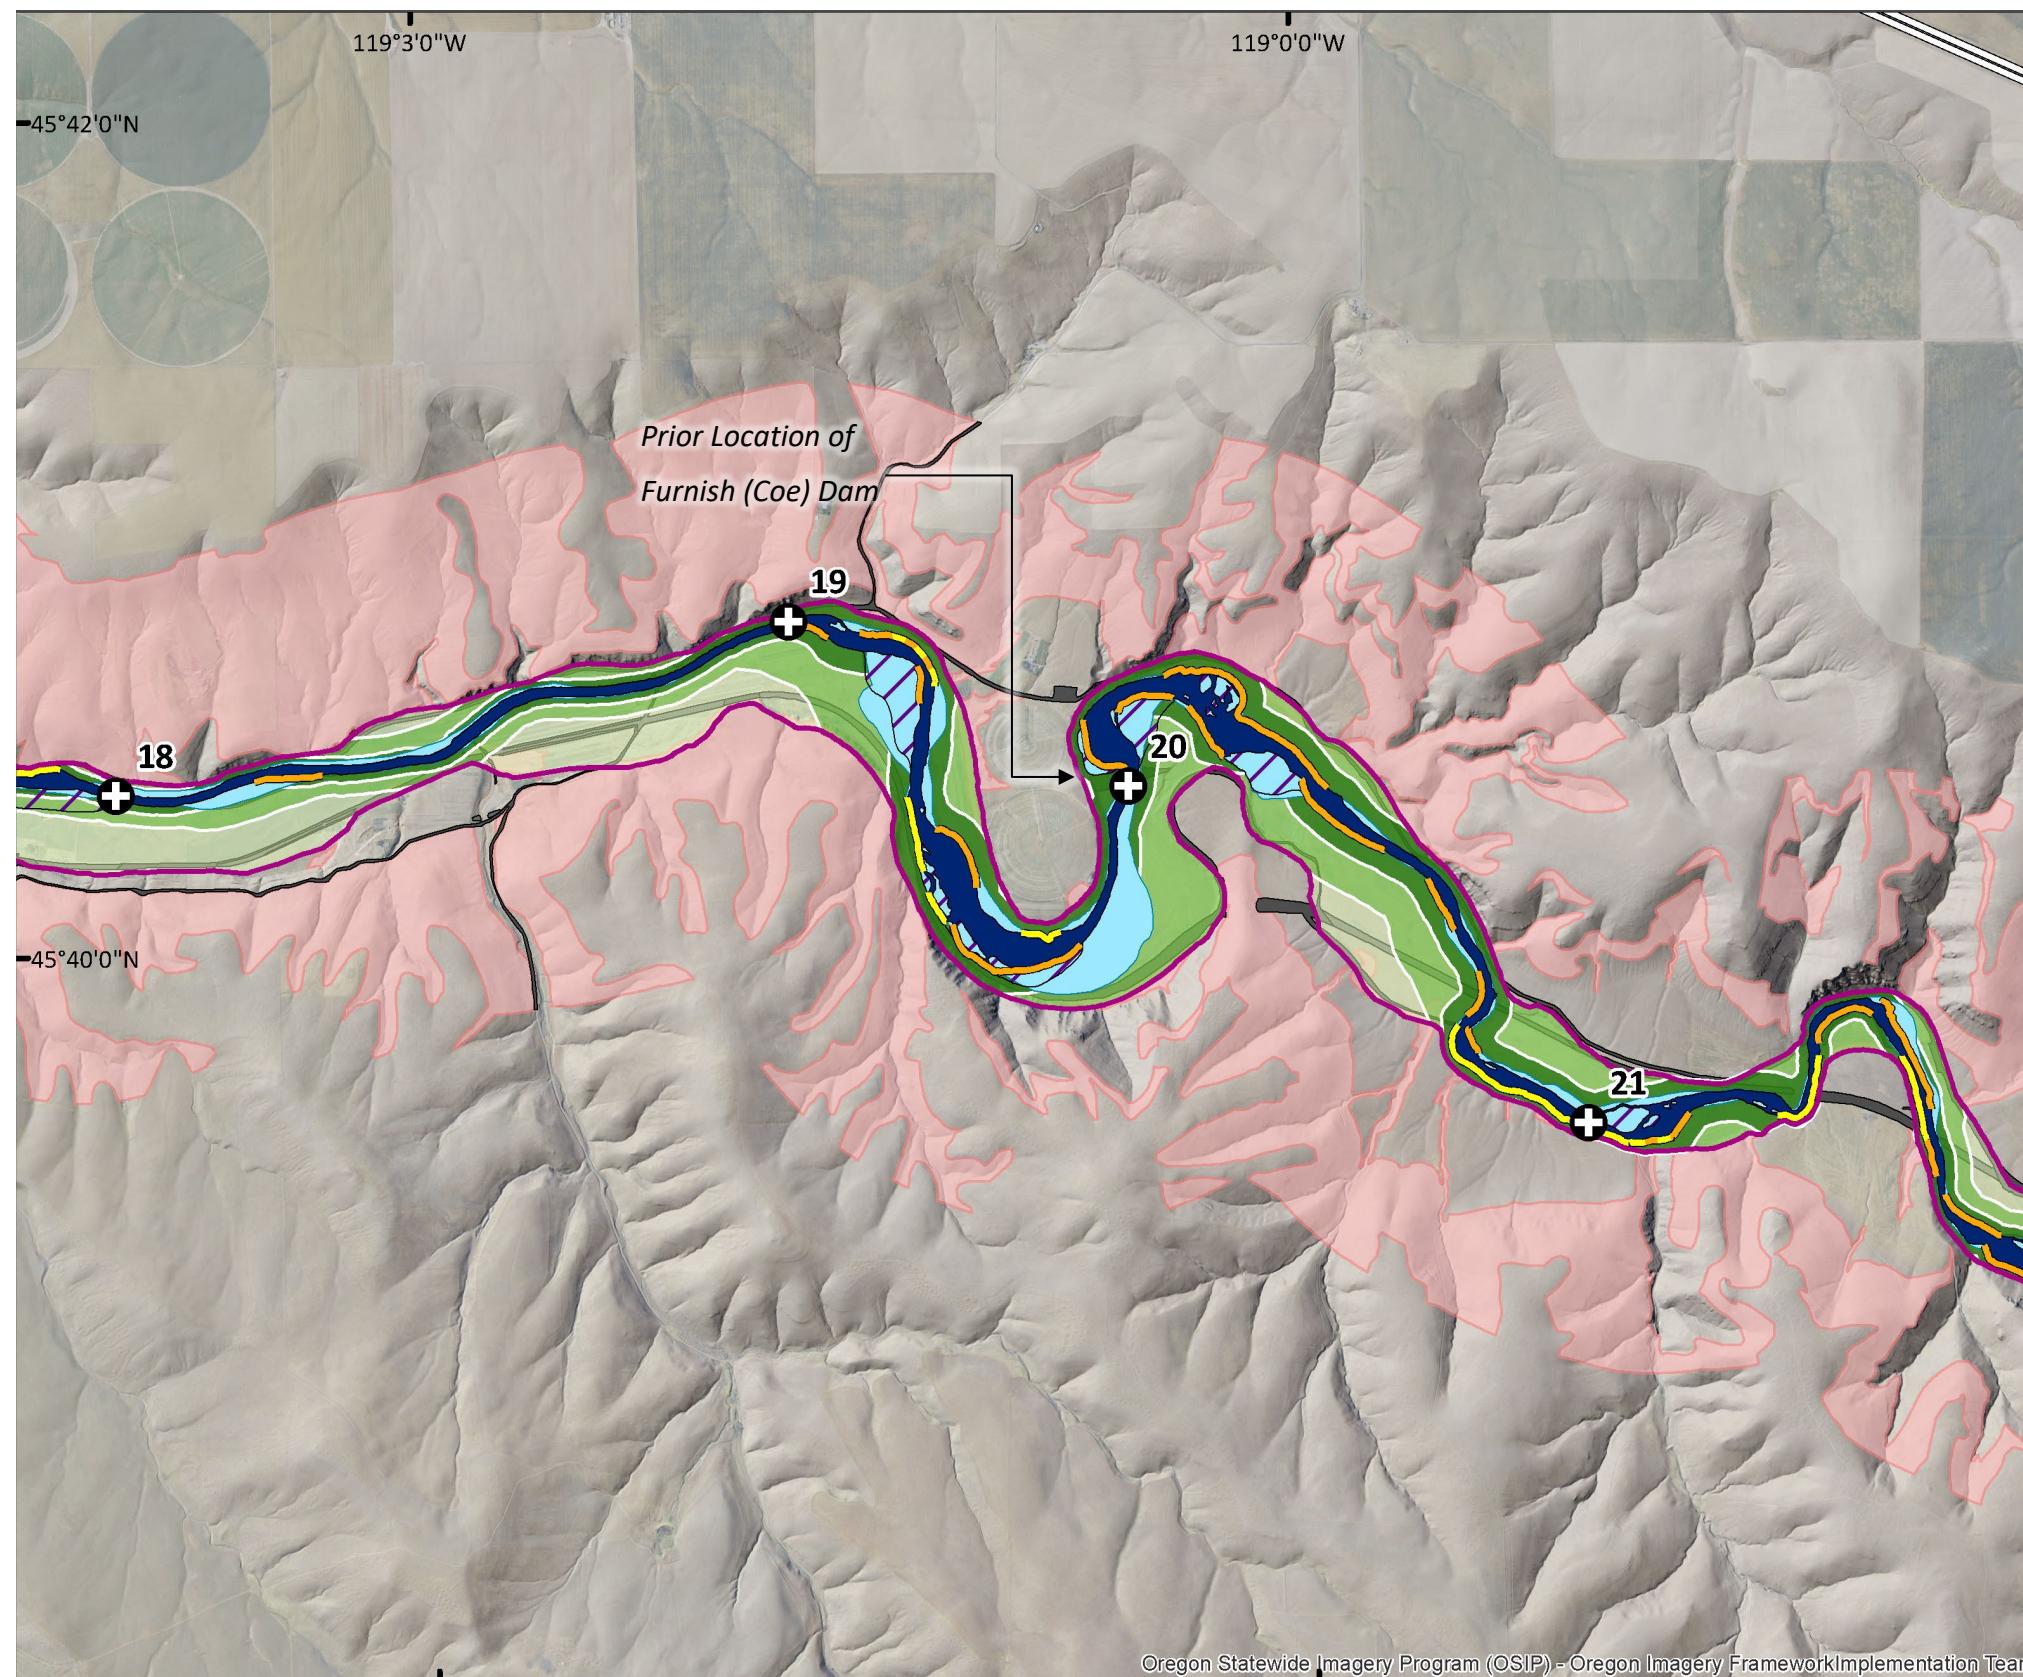
Figure 3-8. Umatilla River CMZ map, RS 18–20, Umatilla County, Oregon.

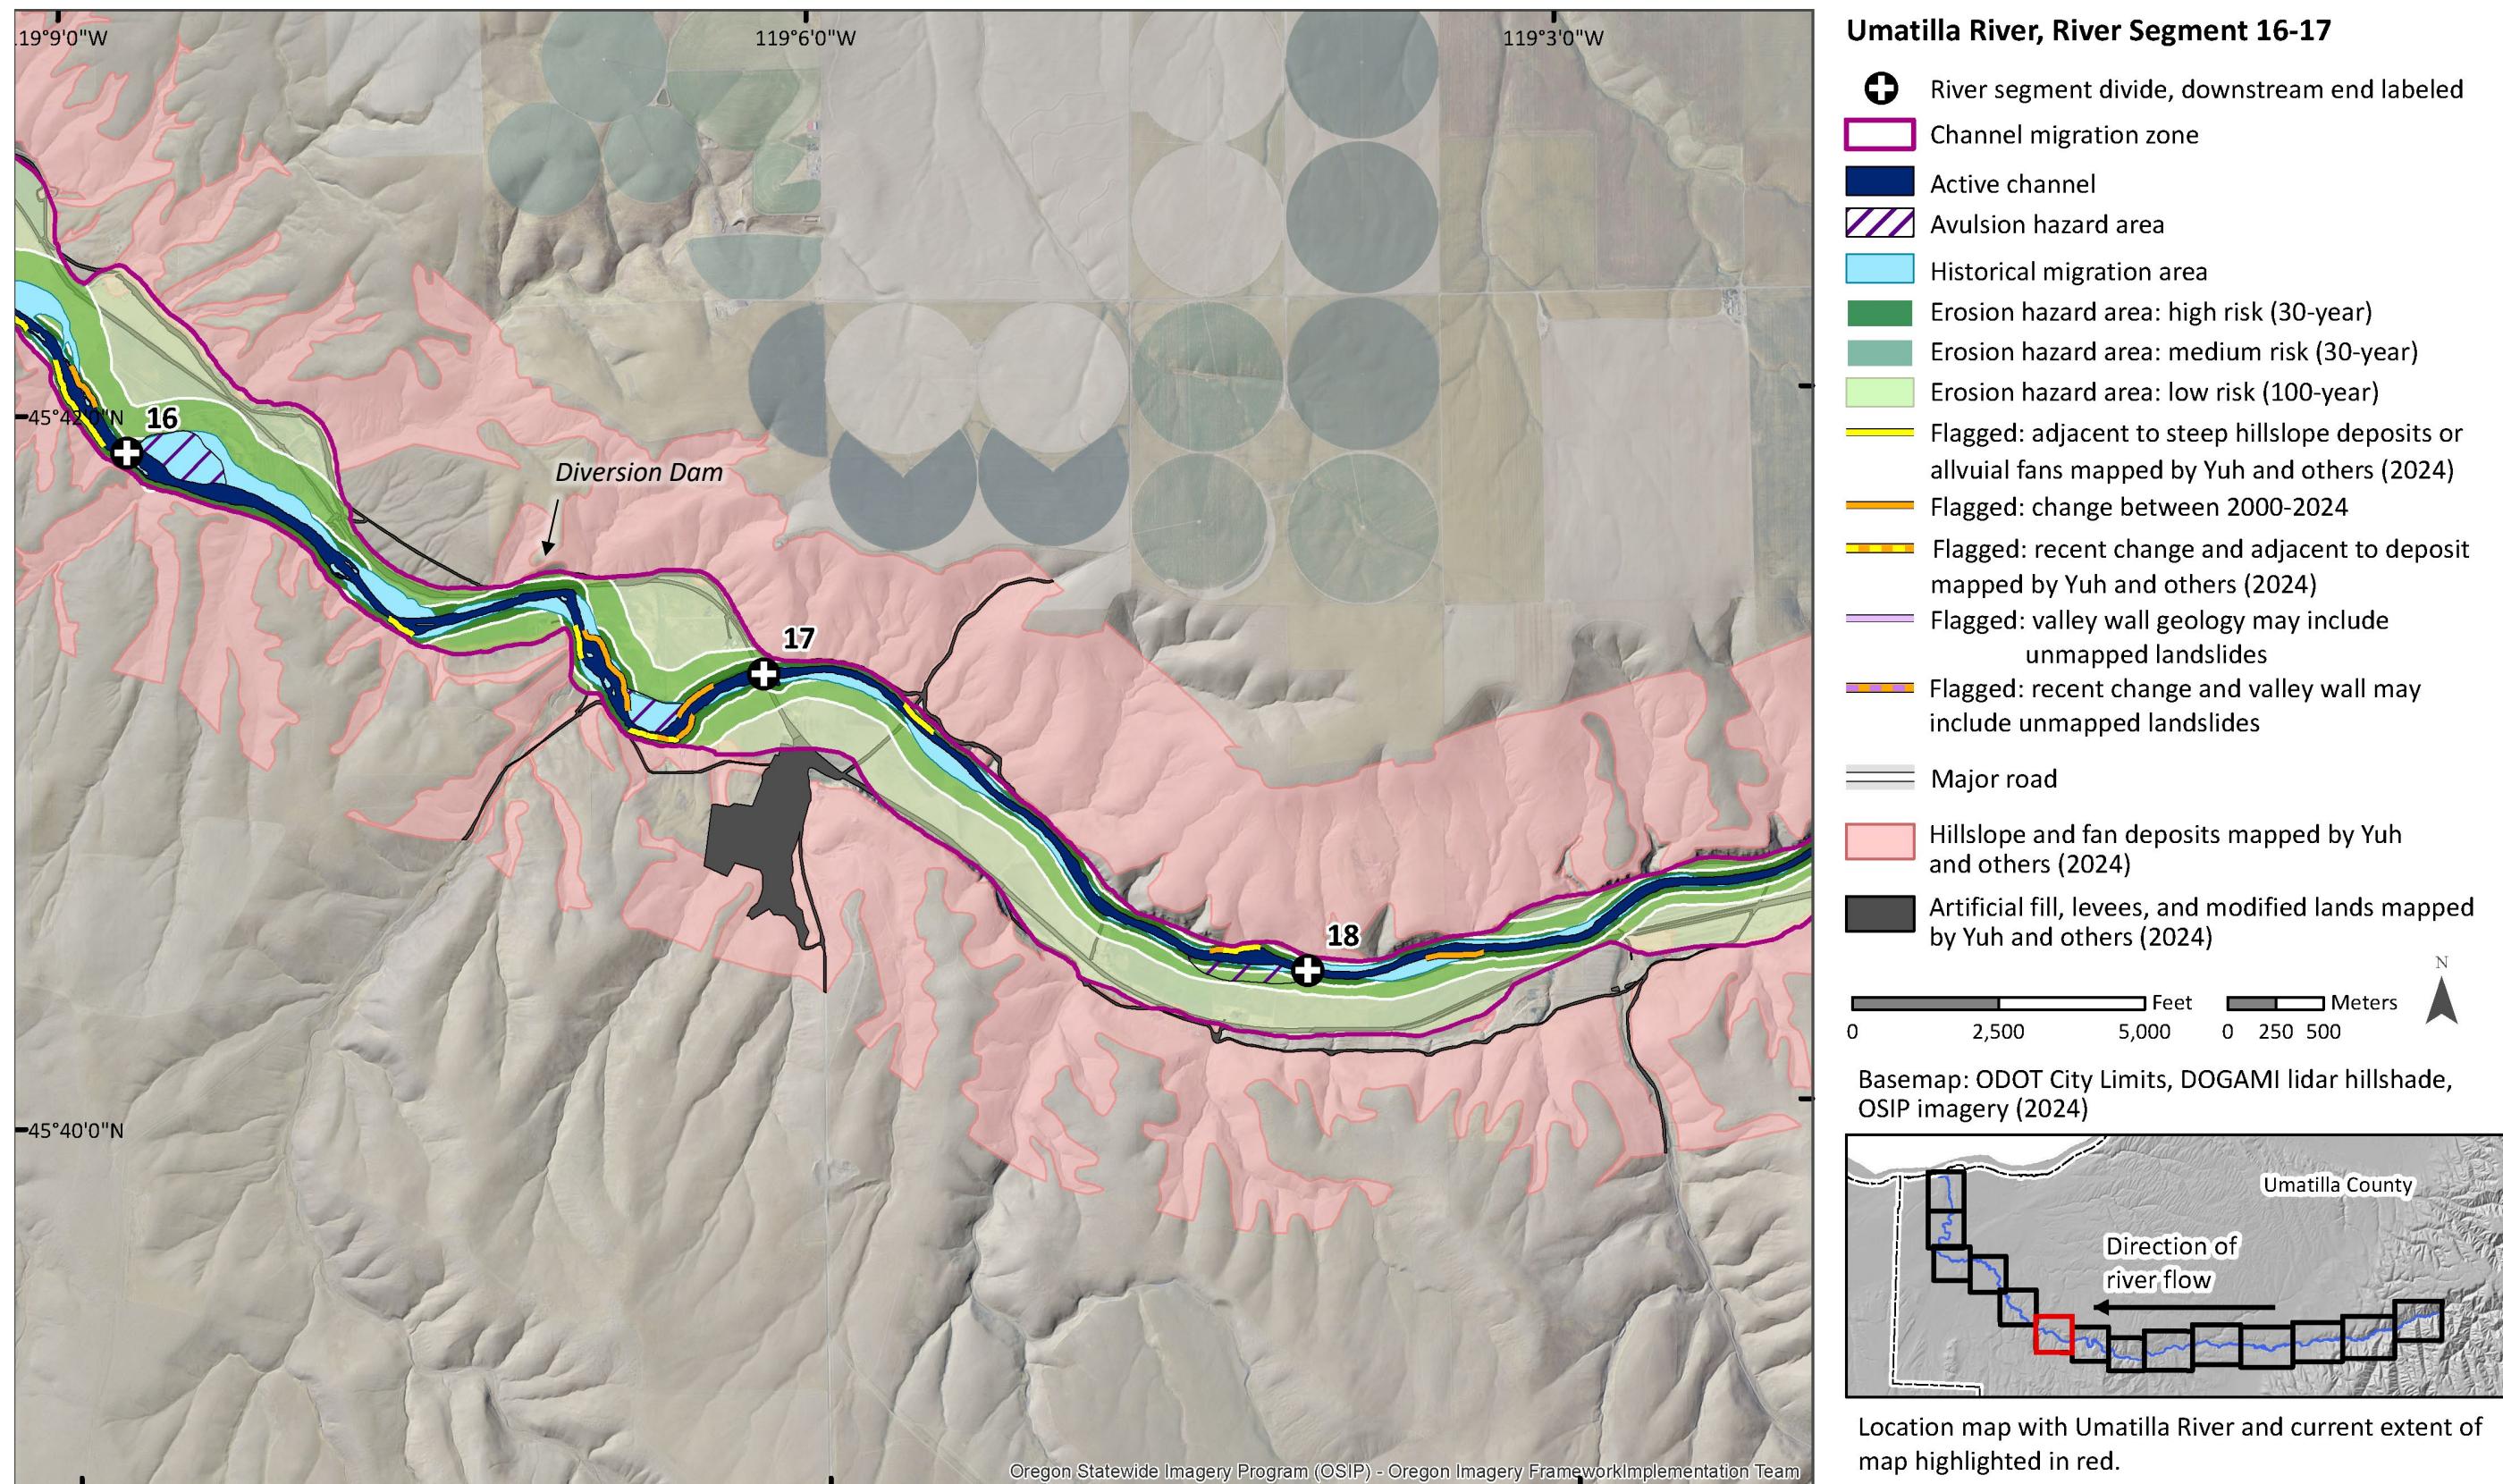
Figure 3-9. Umatilla River CMZ map, RS 16–17, Umatilla County, Oregon.

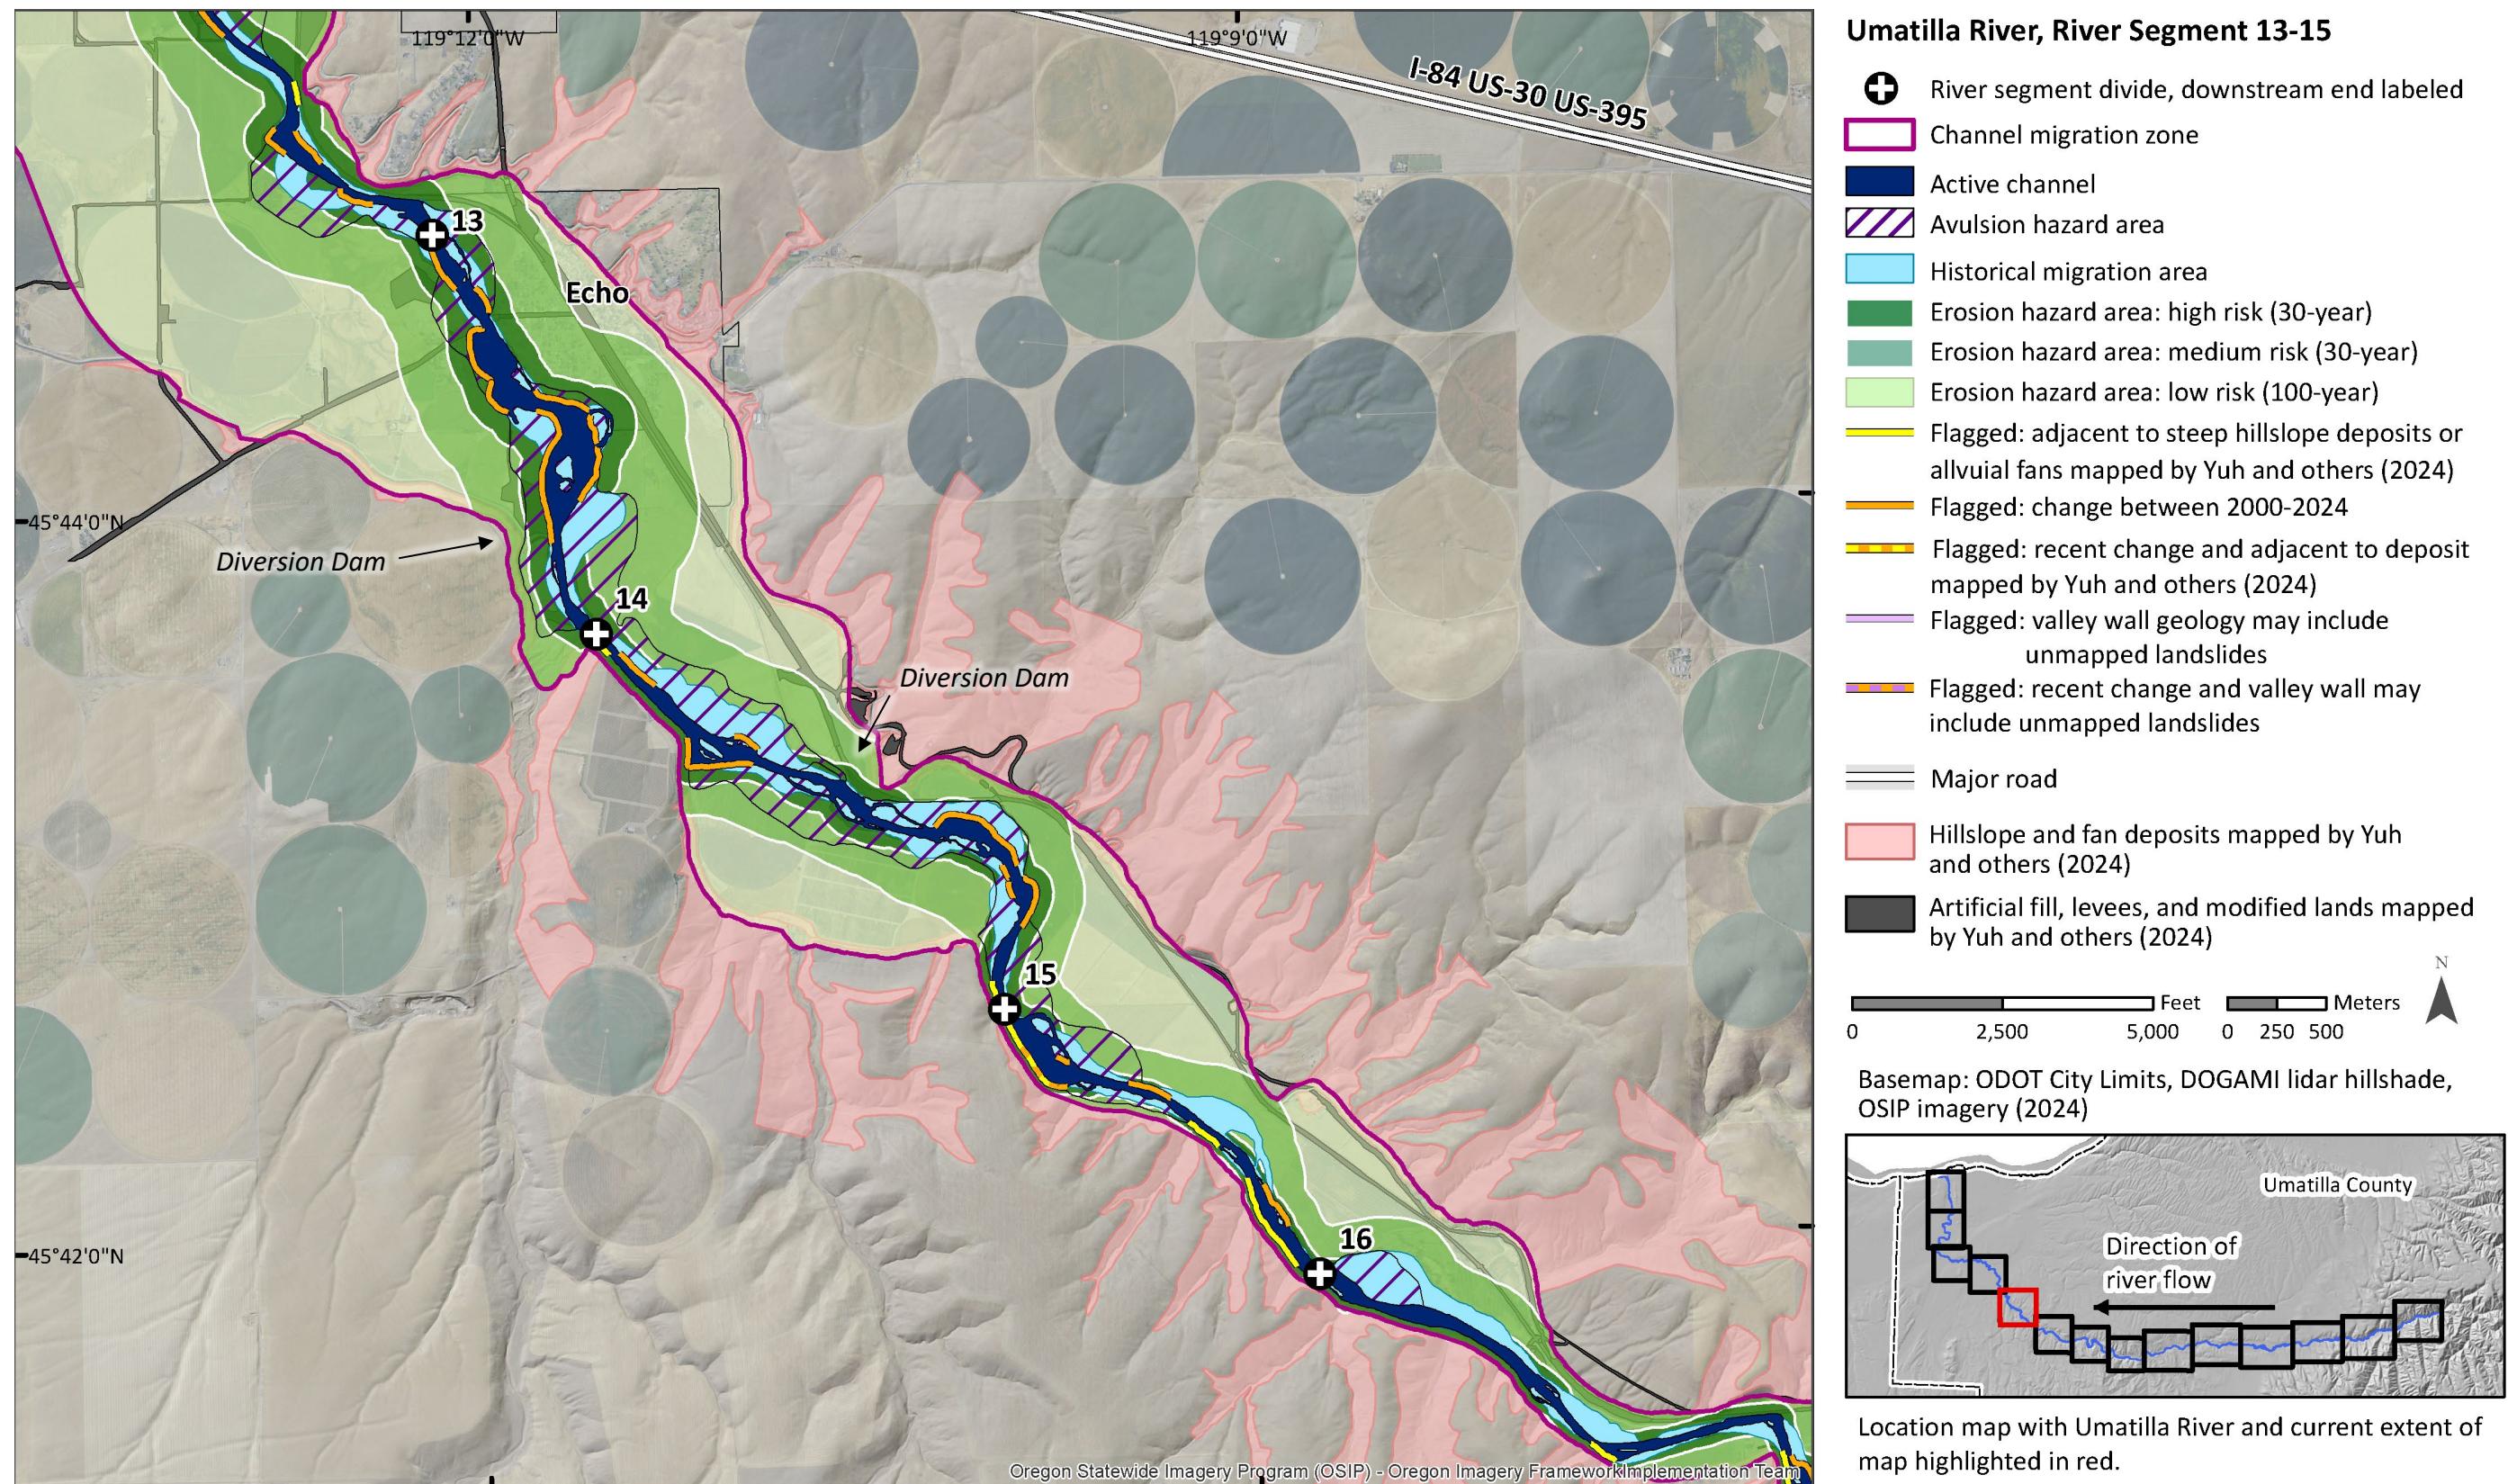
Figure 3-10. Umatilla River CMZ map, RS 13–15, Umatilla County, Oregon.

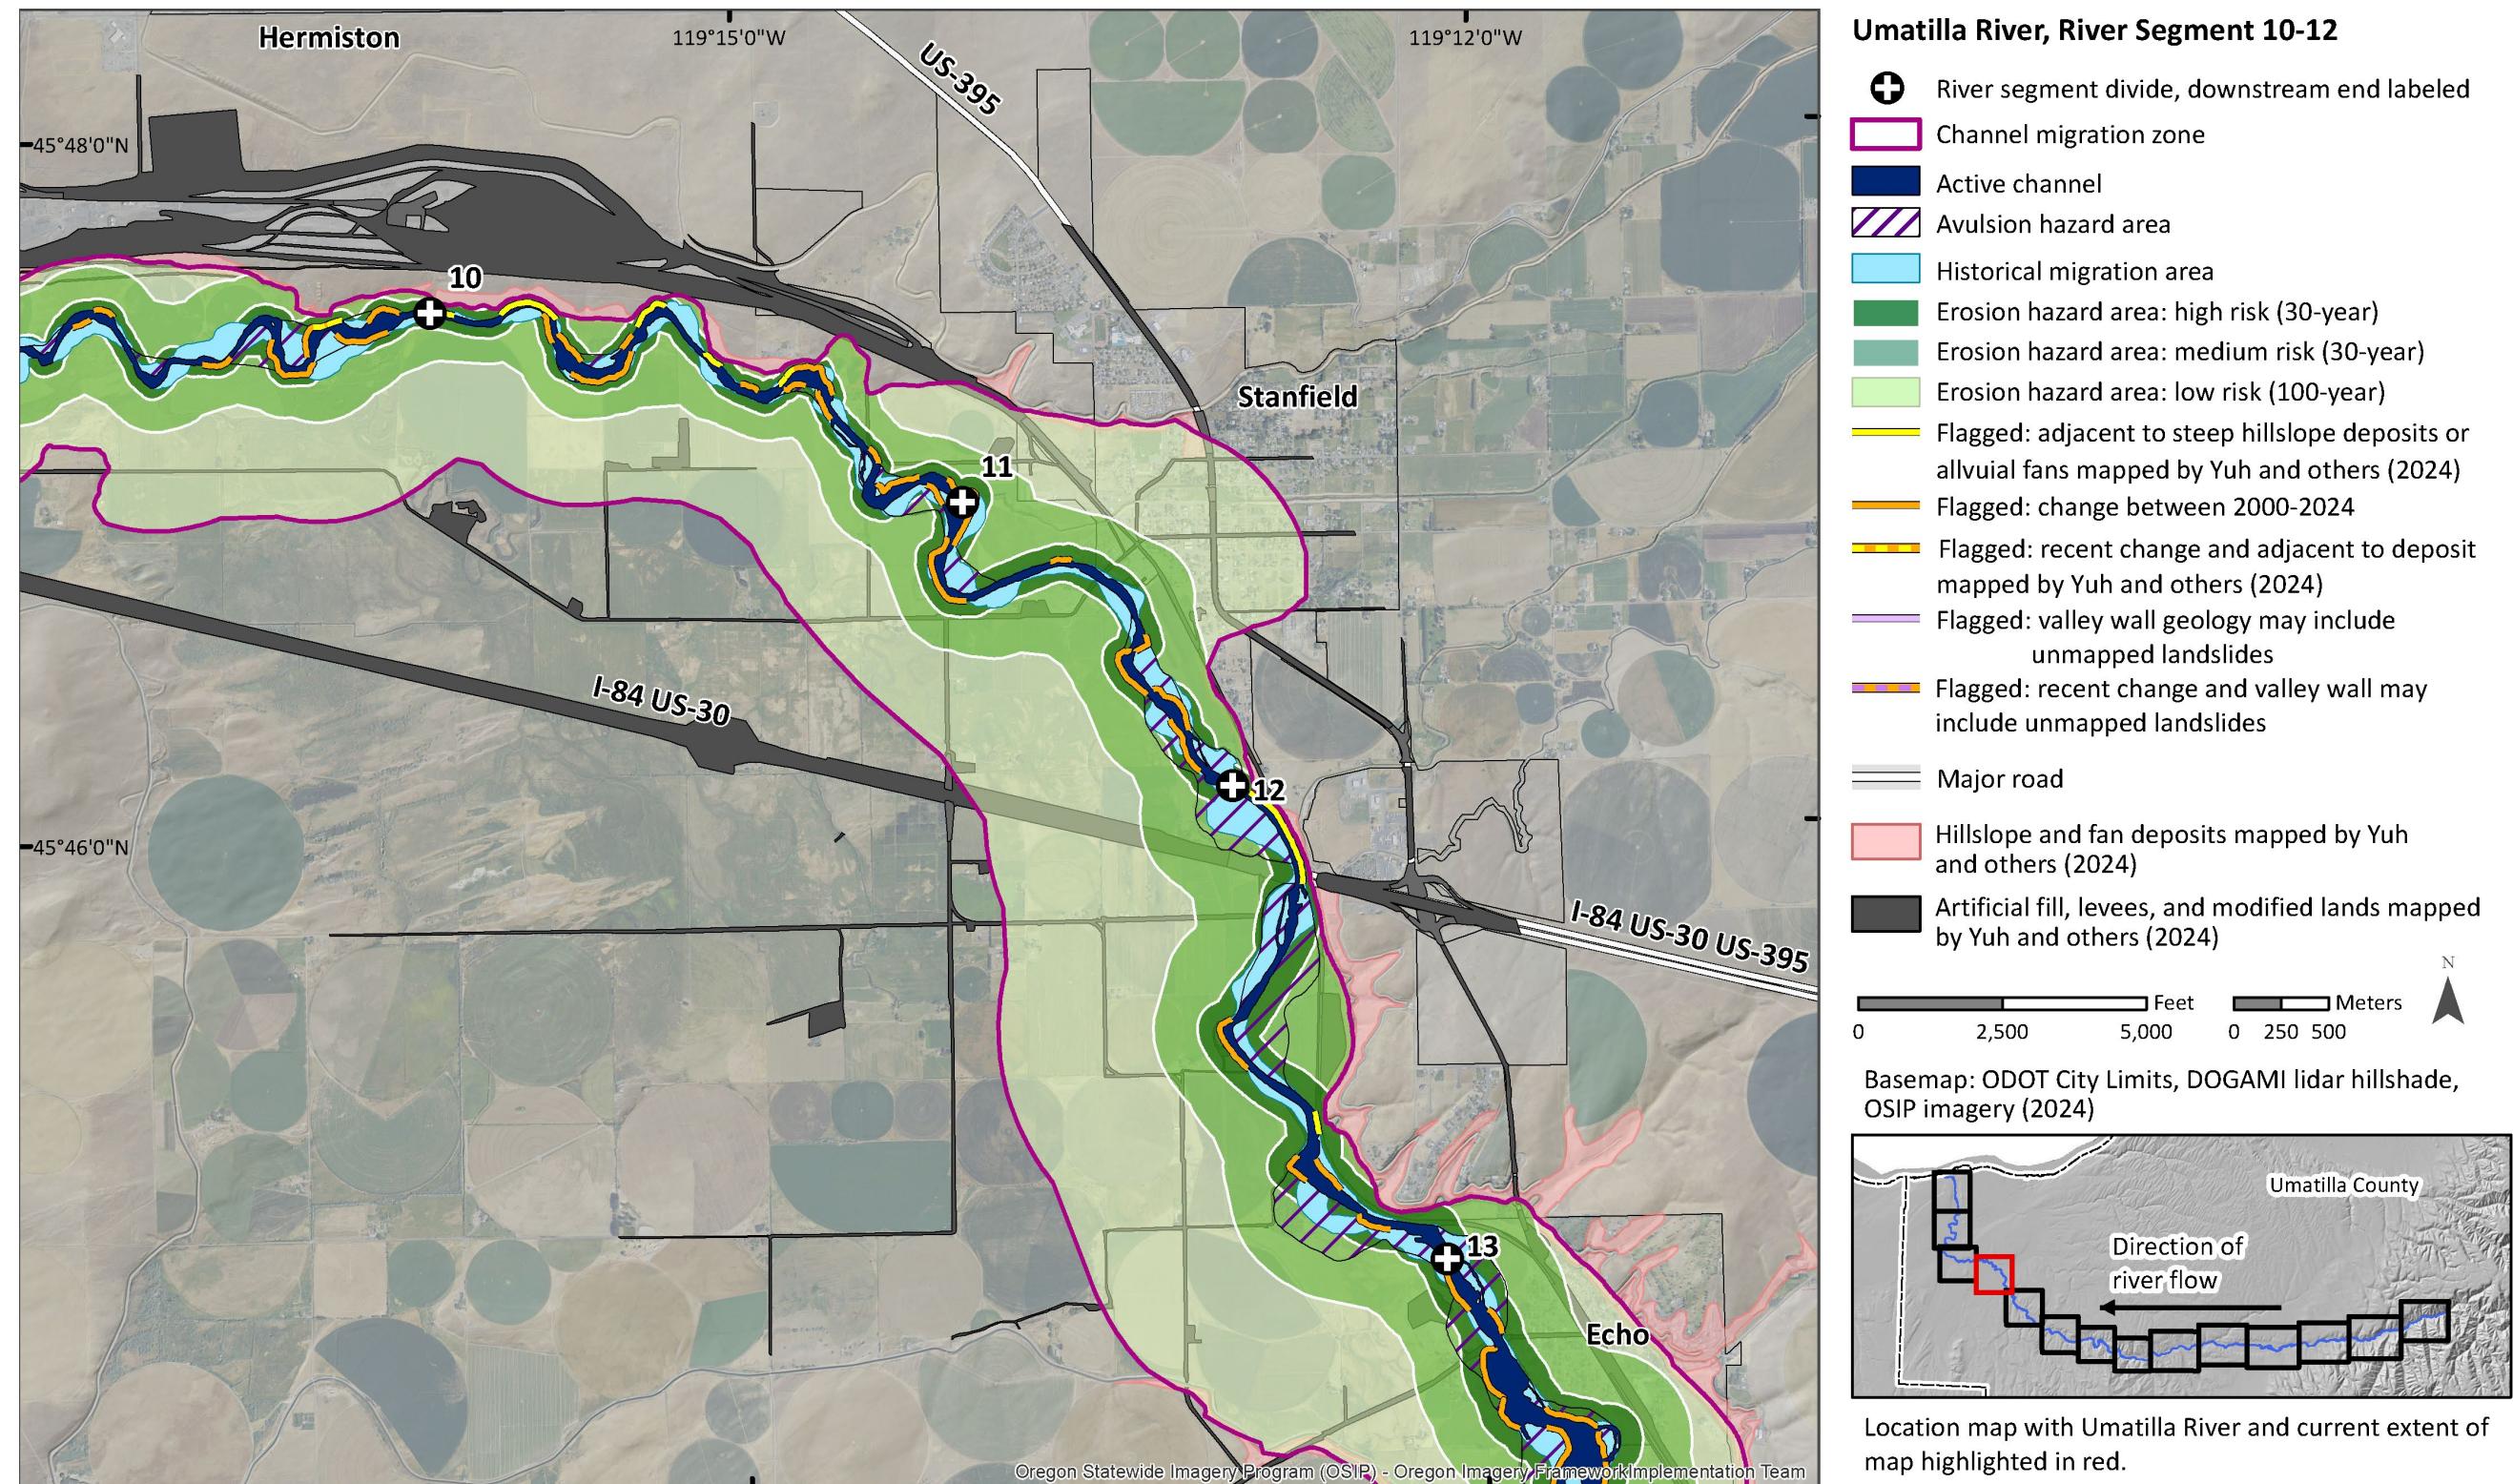
Figure 3-11. Umatilla River CMZ map, RS 10–12, Umatilla County, Oregon.

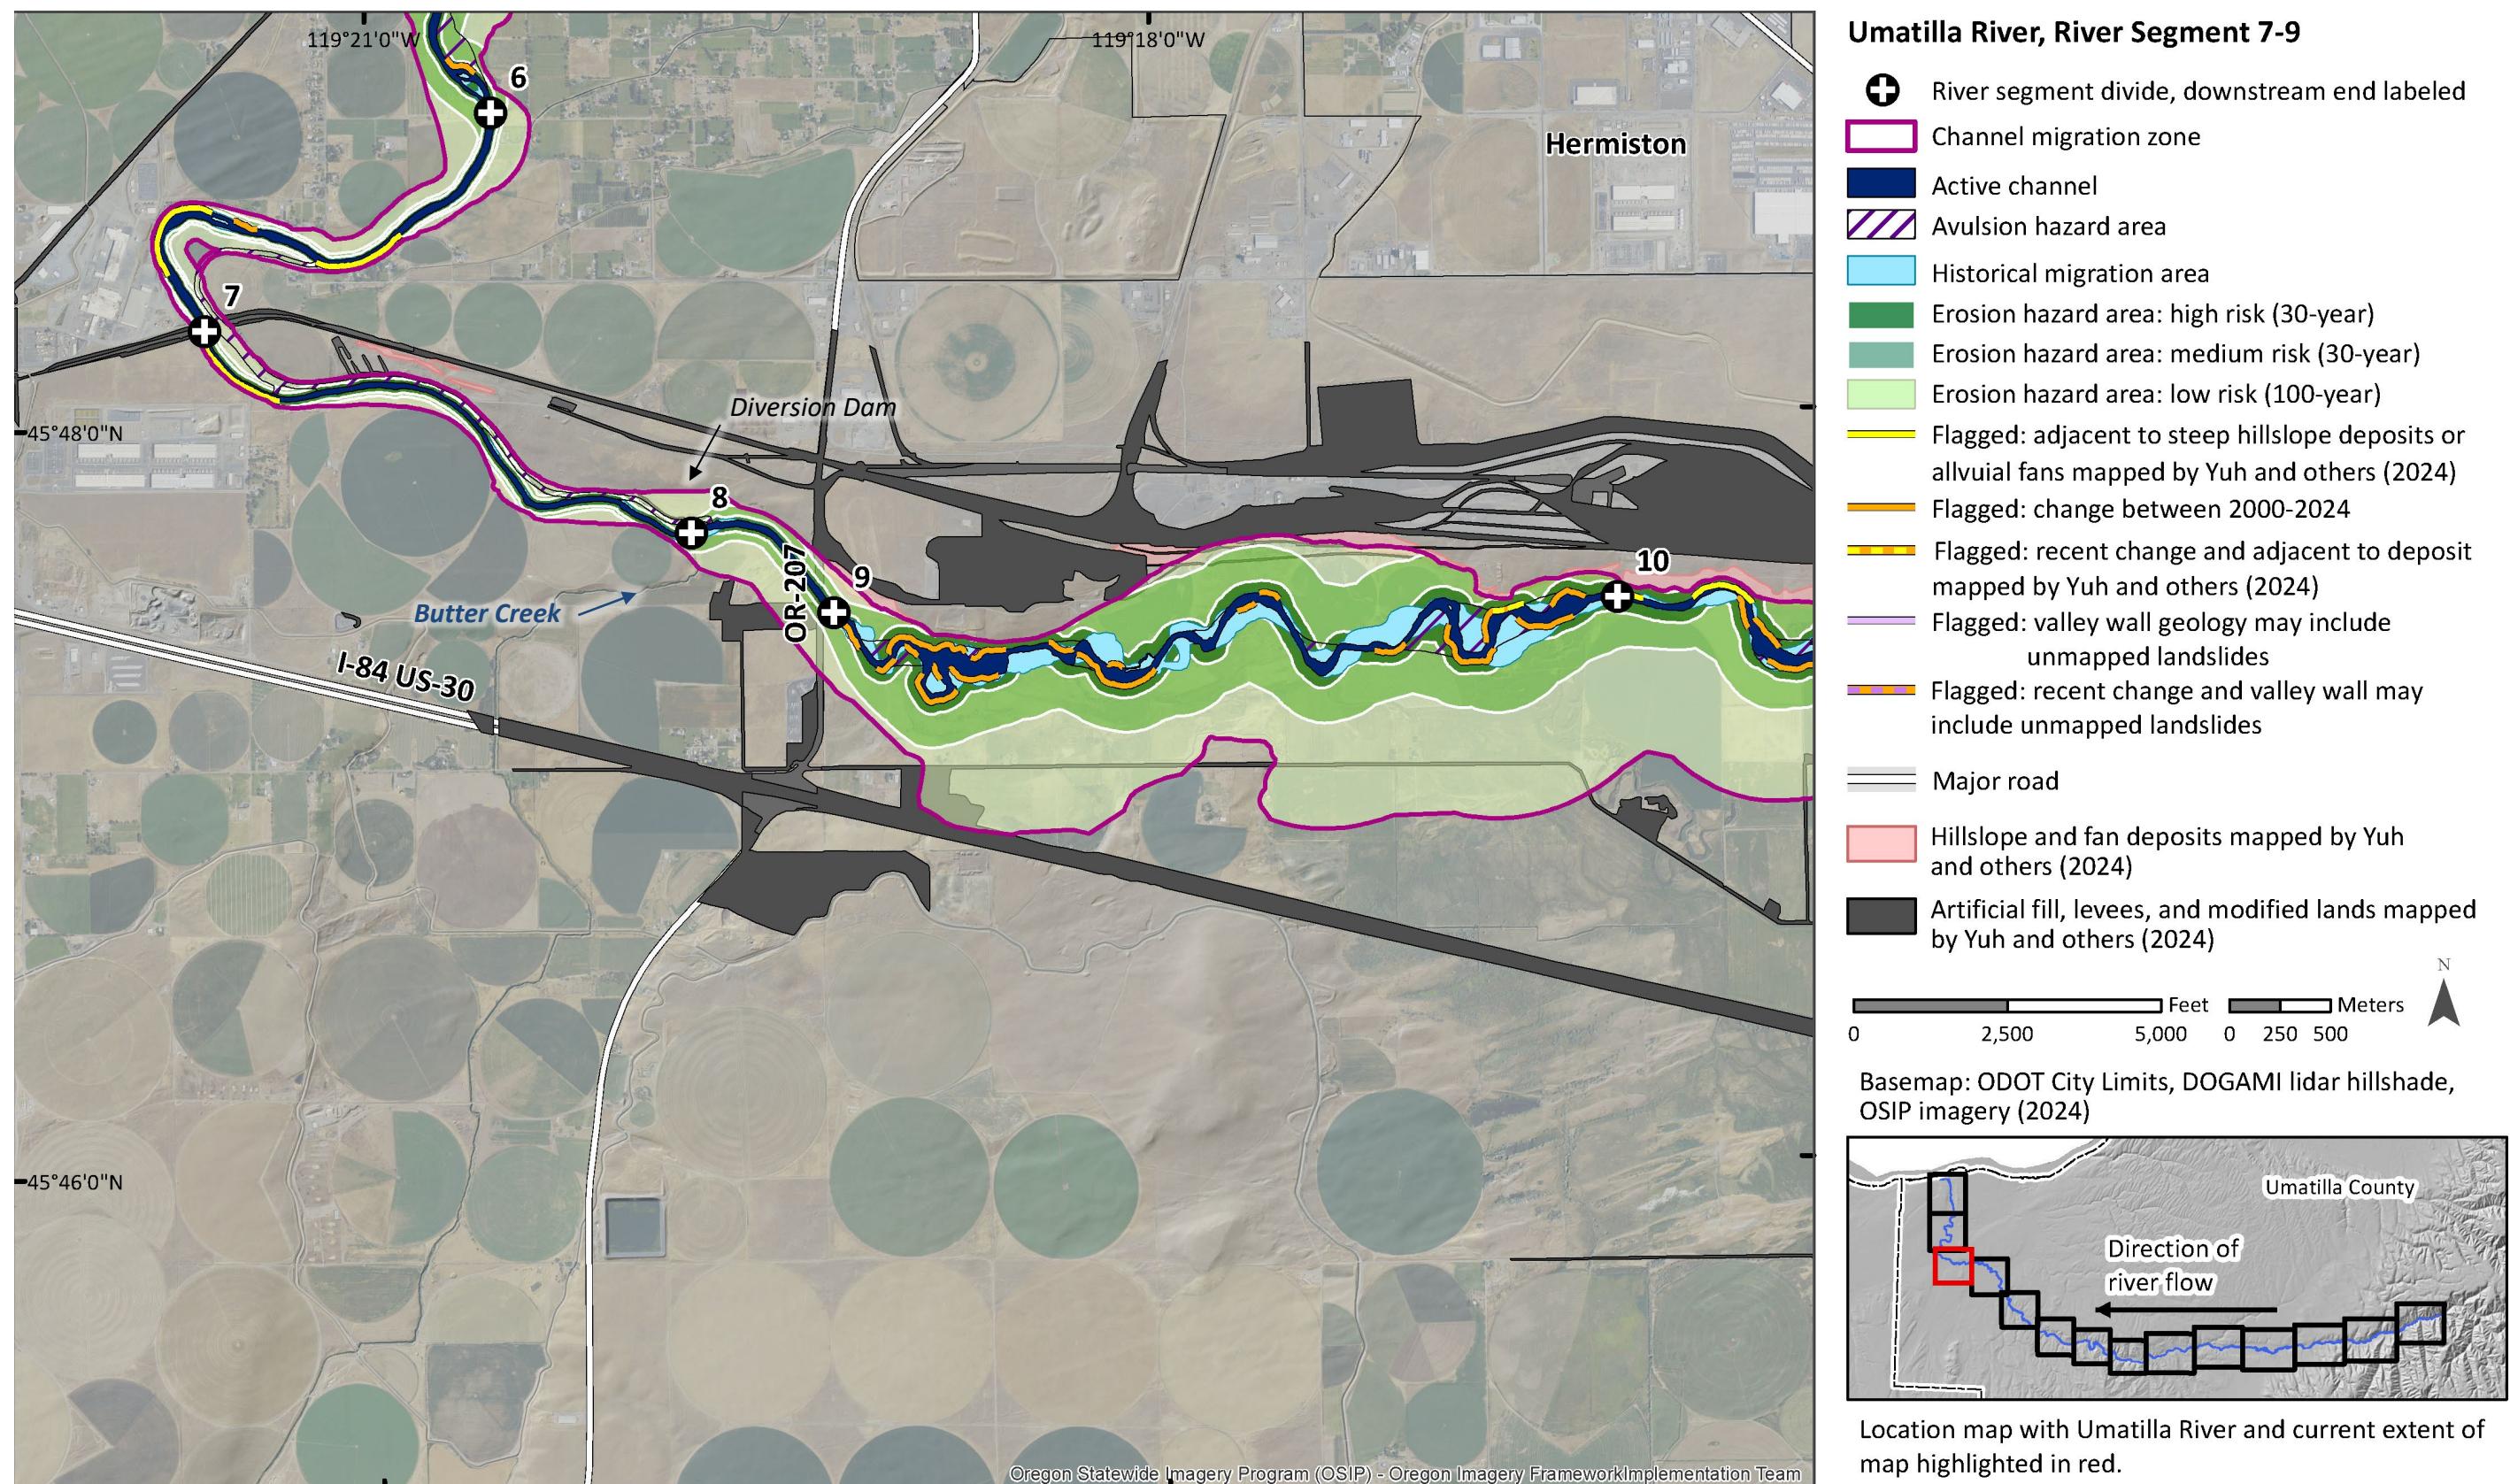
Figure 3-12. Umatilla River CMZ map, RS 7–9, Umatilla County, Oregon.
