**OPEN-FILE REPORT O-25-10**

**CHANNEL MIGRATION ZONE MAPS  
FOR UMATILLA RIVER AND LOWER MCKAY CREEK, UMATILLA  
COUNTY, OREGON**

by Christina A. Appleby<sup>1</sup>, Lowell H. Anthony<sup>1</sup>, and Jesse K. Noone<sup>2</sup>

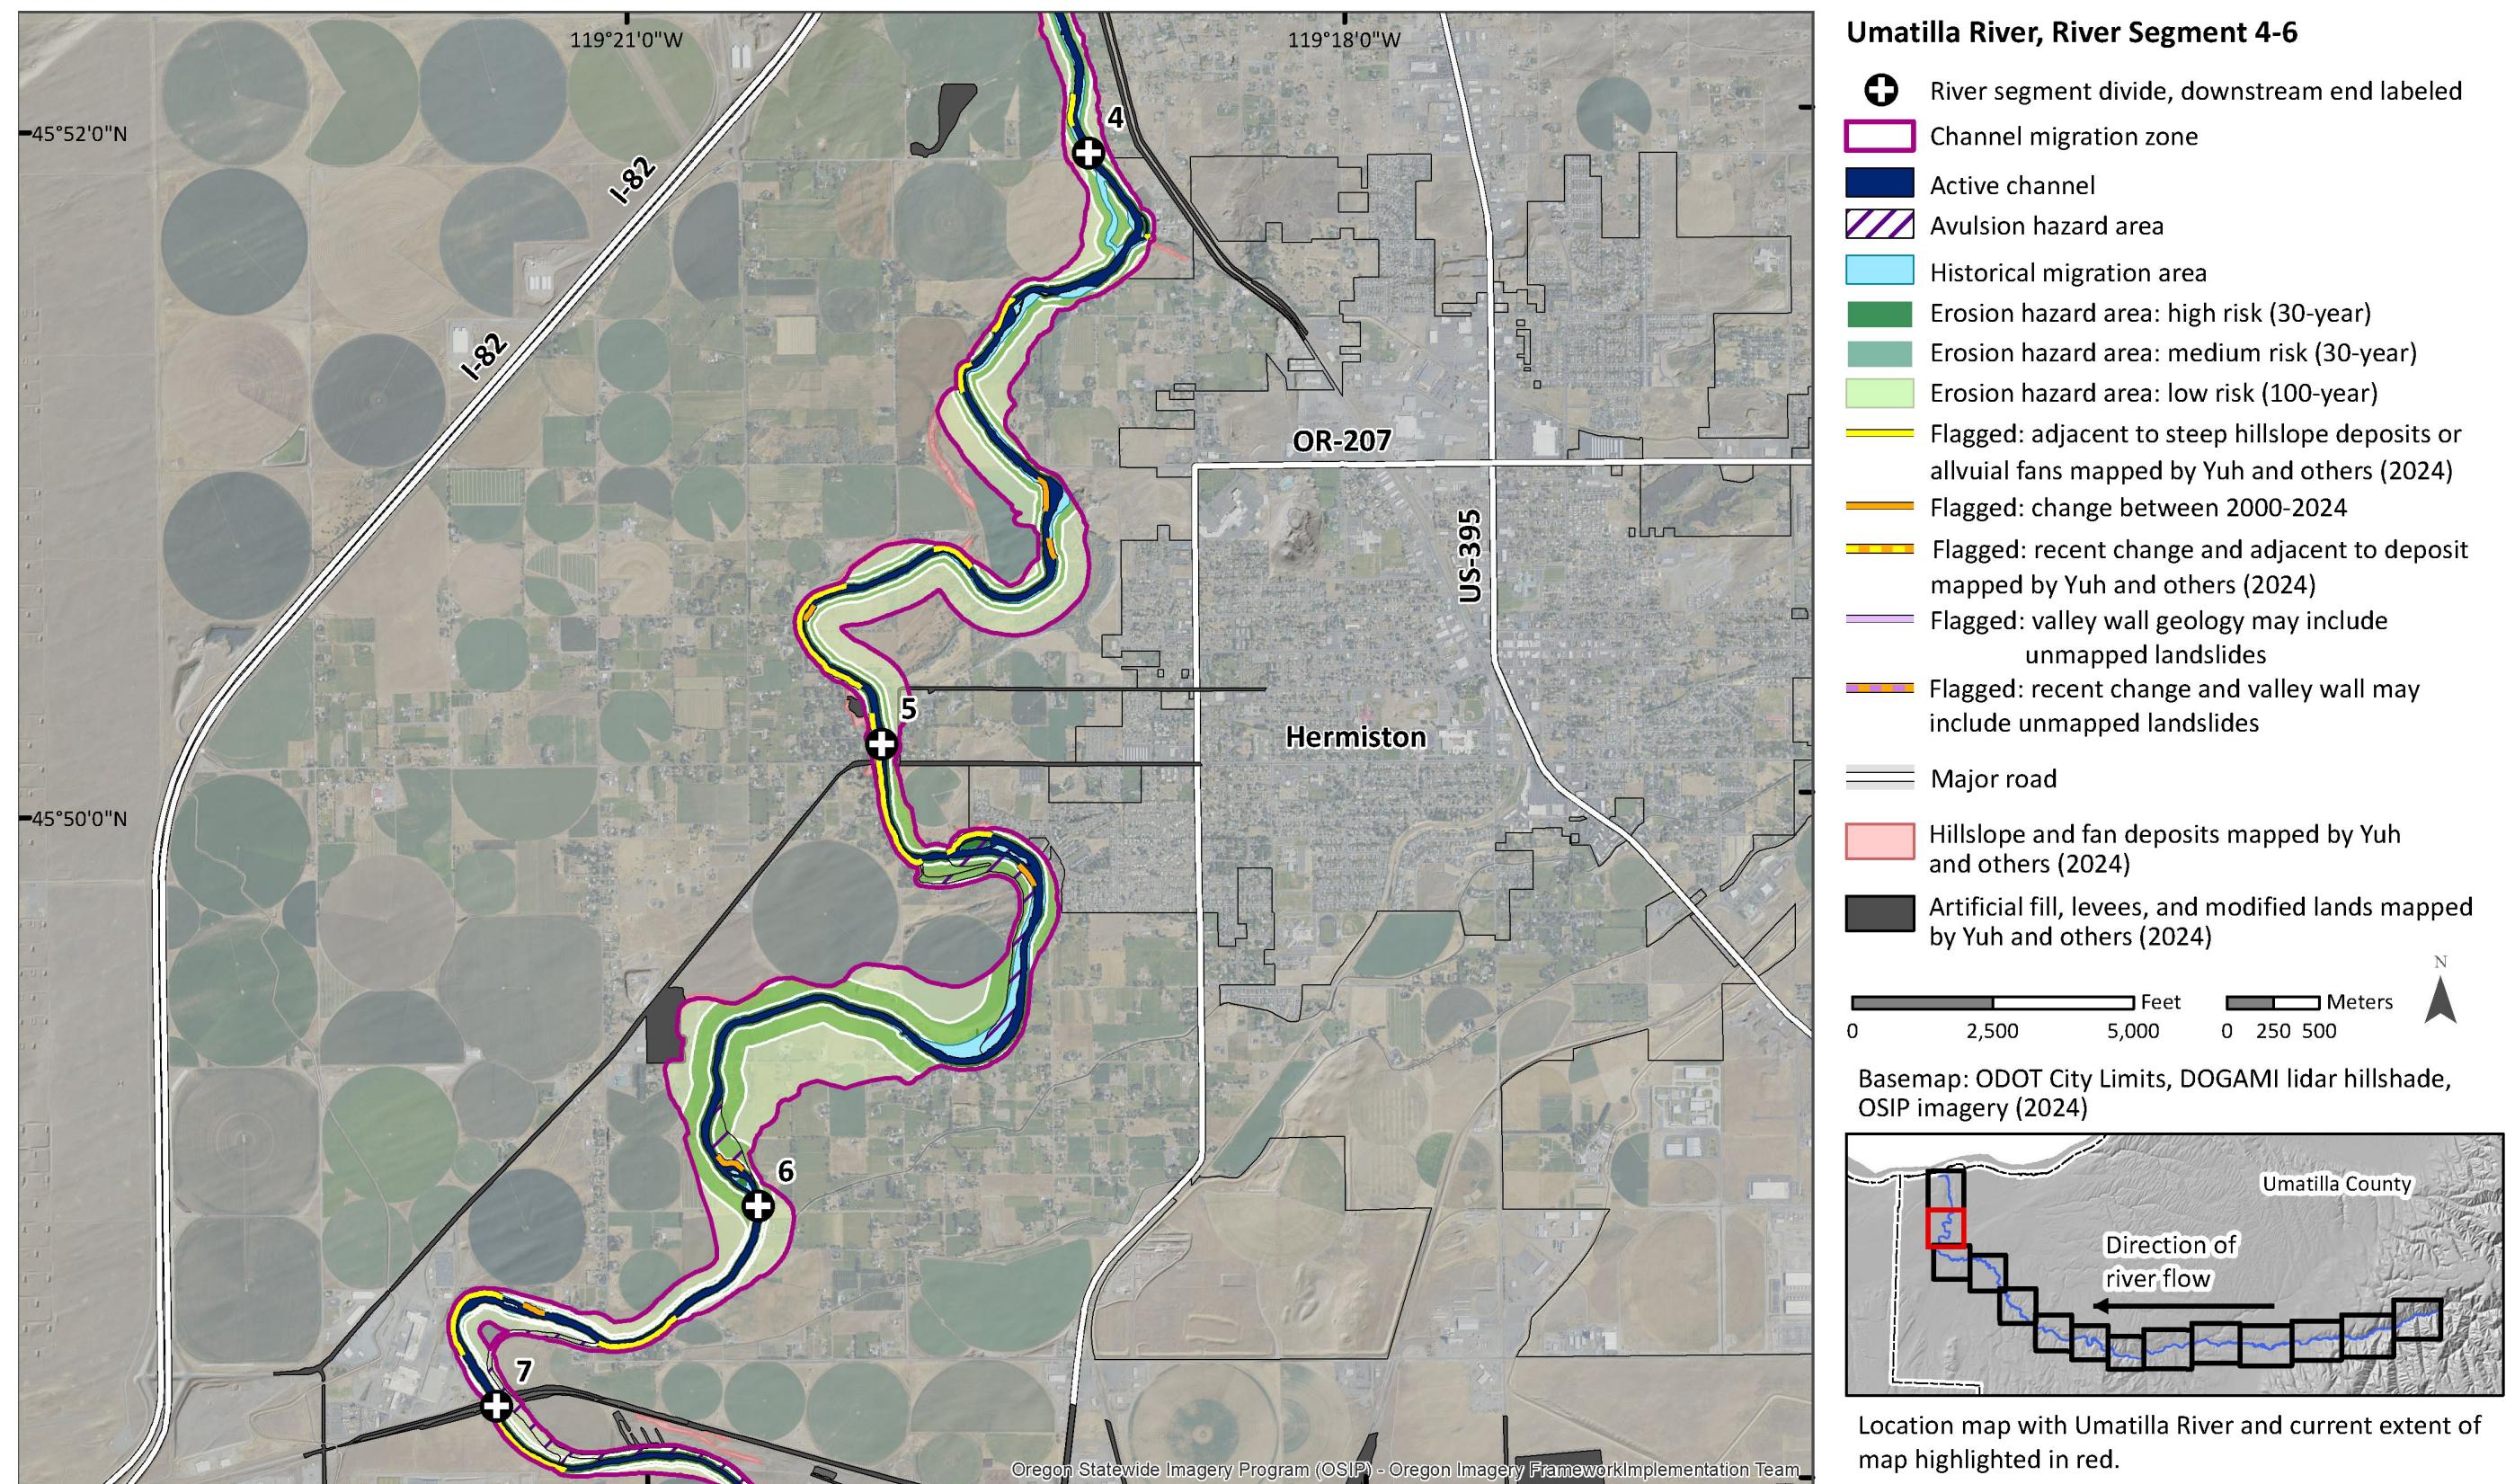
Figure 3-13. Umatilla River CMZ map, RS 4–6, Umatilla County, Oregon.

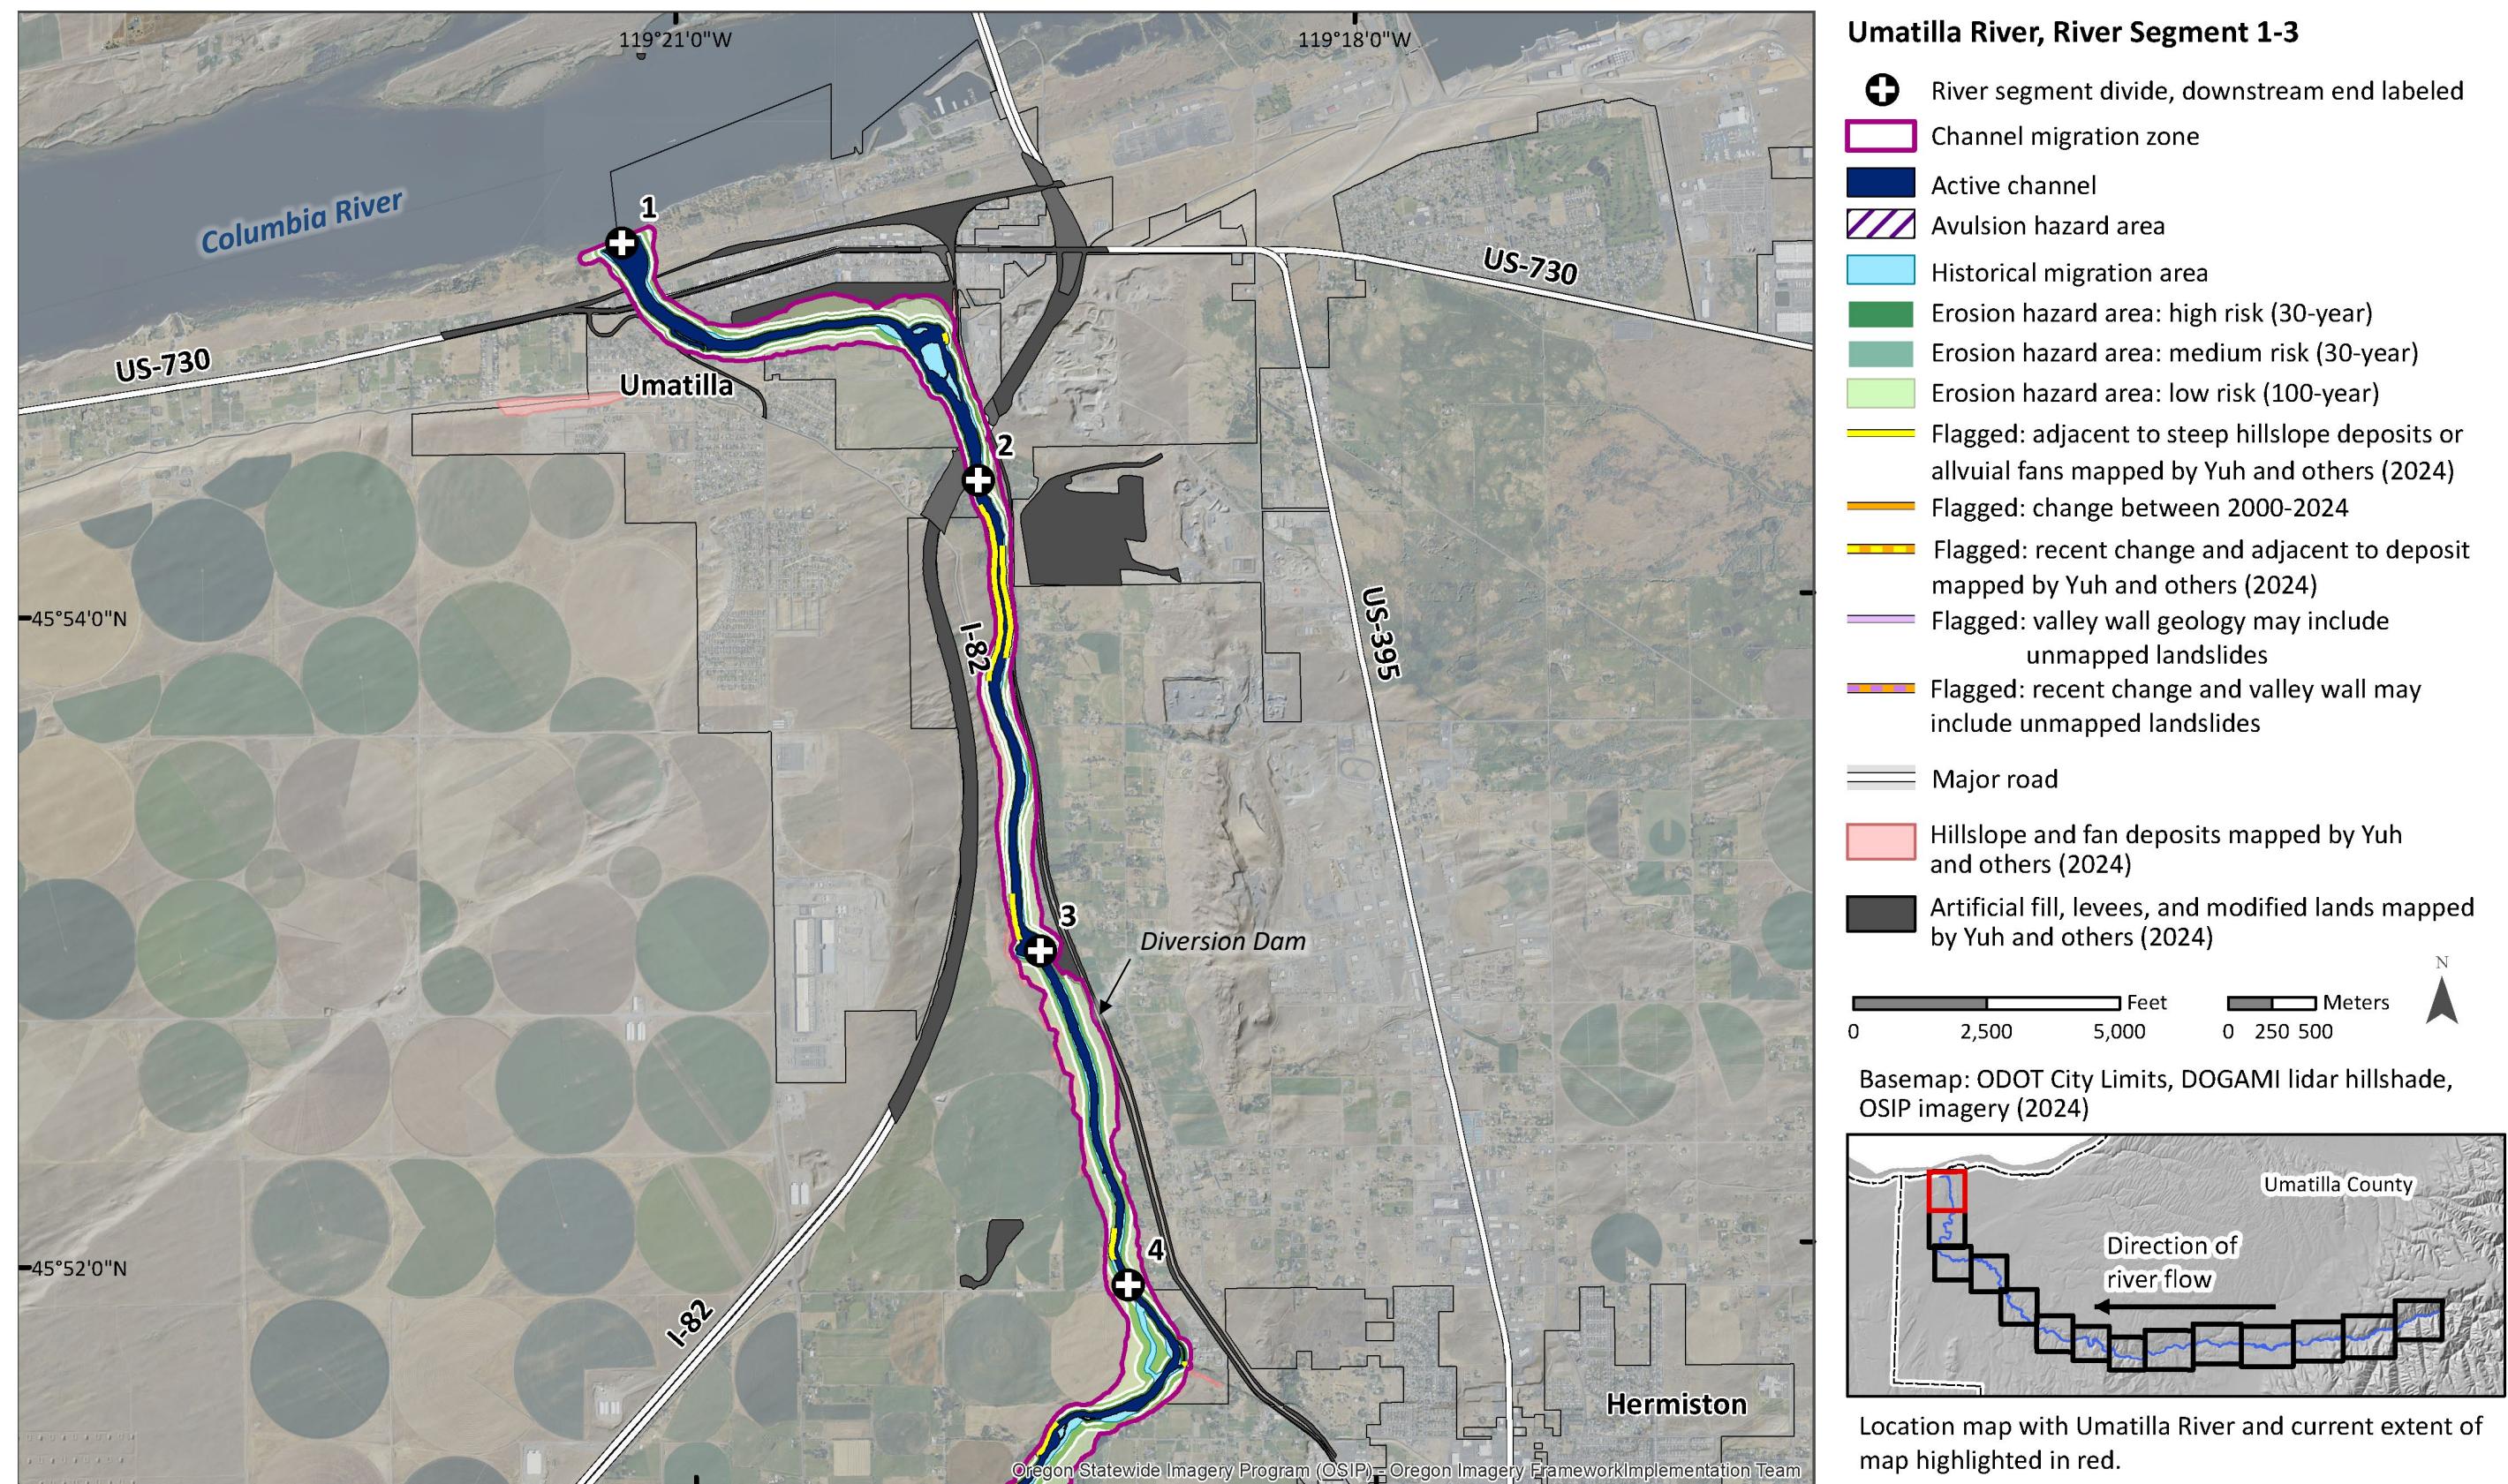
Figure 3-14. Umatilla River CMZ map, RS 1–3, Umatilla County, Oregon.

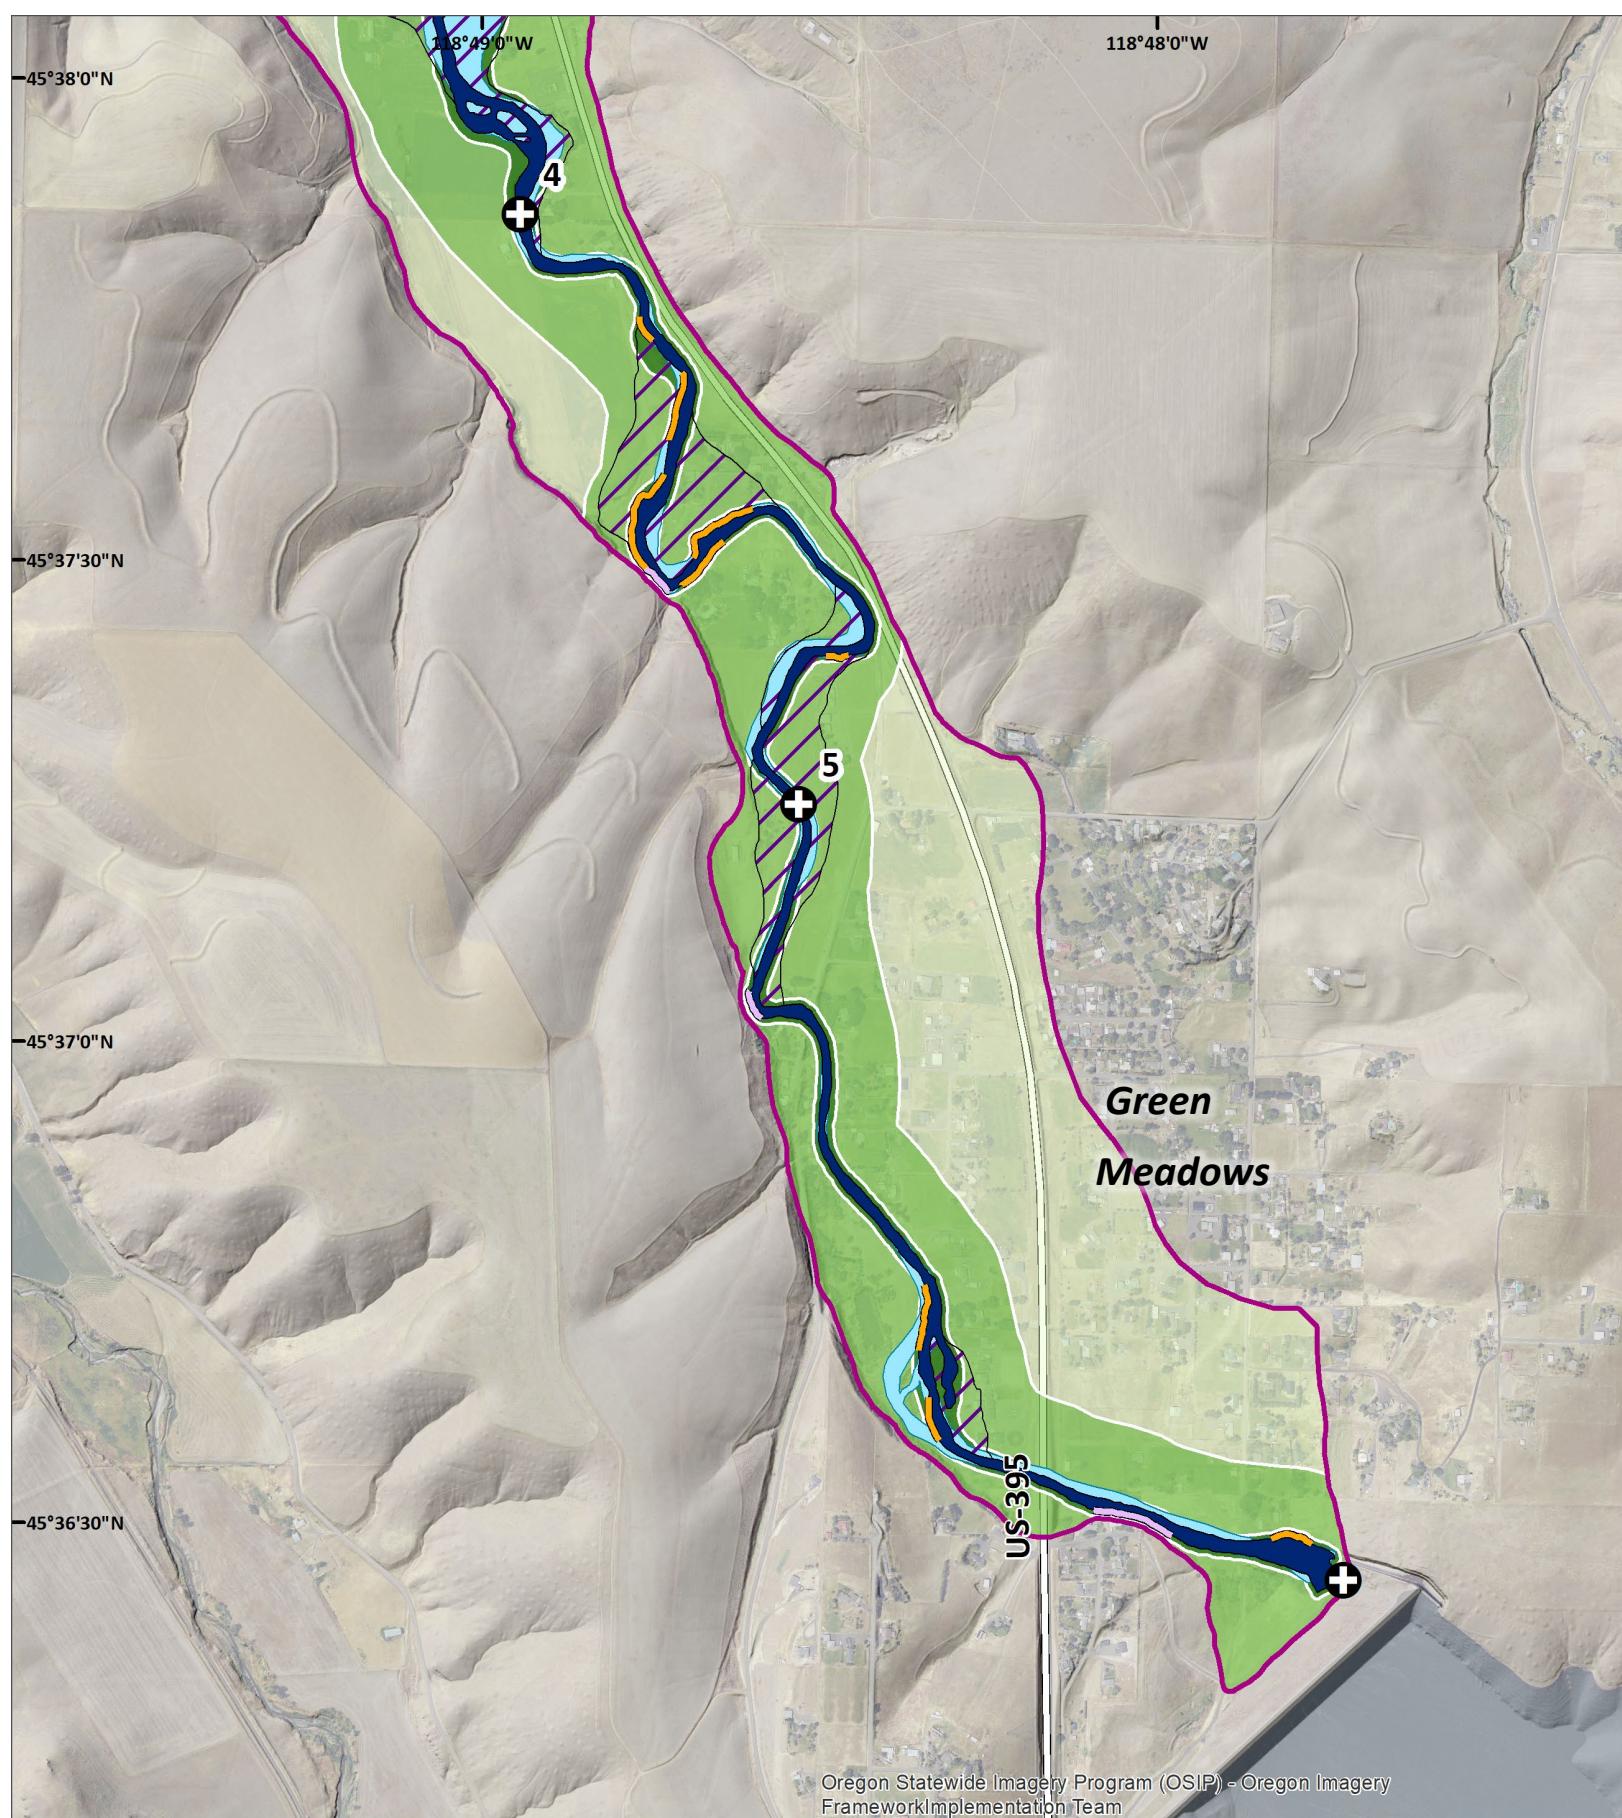
Figure 3-15. Lower McKay Creek CMZ map, RS 4-5, Umatilla County, Oregon.

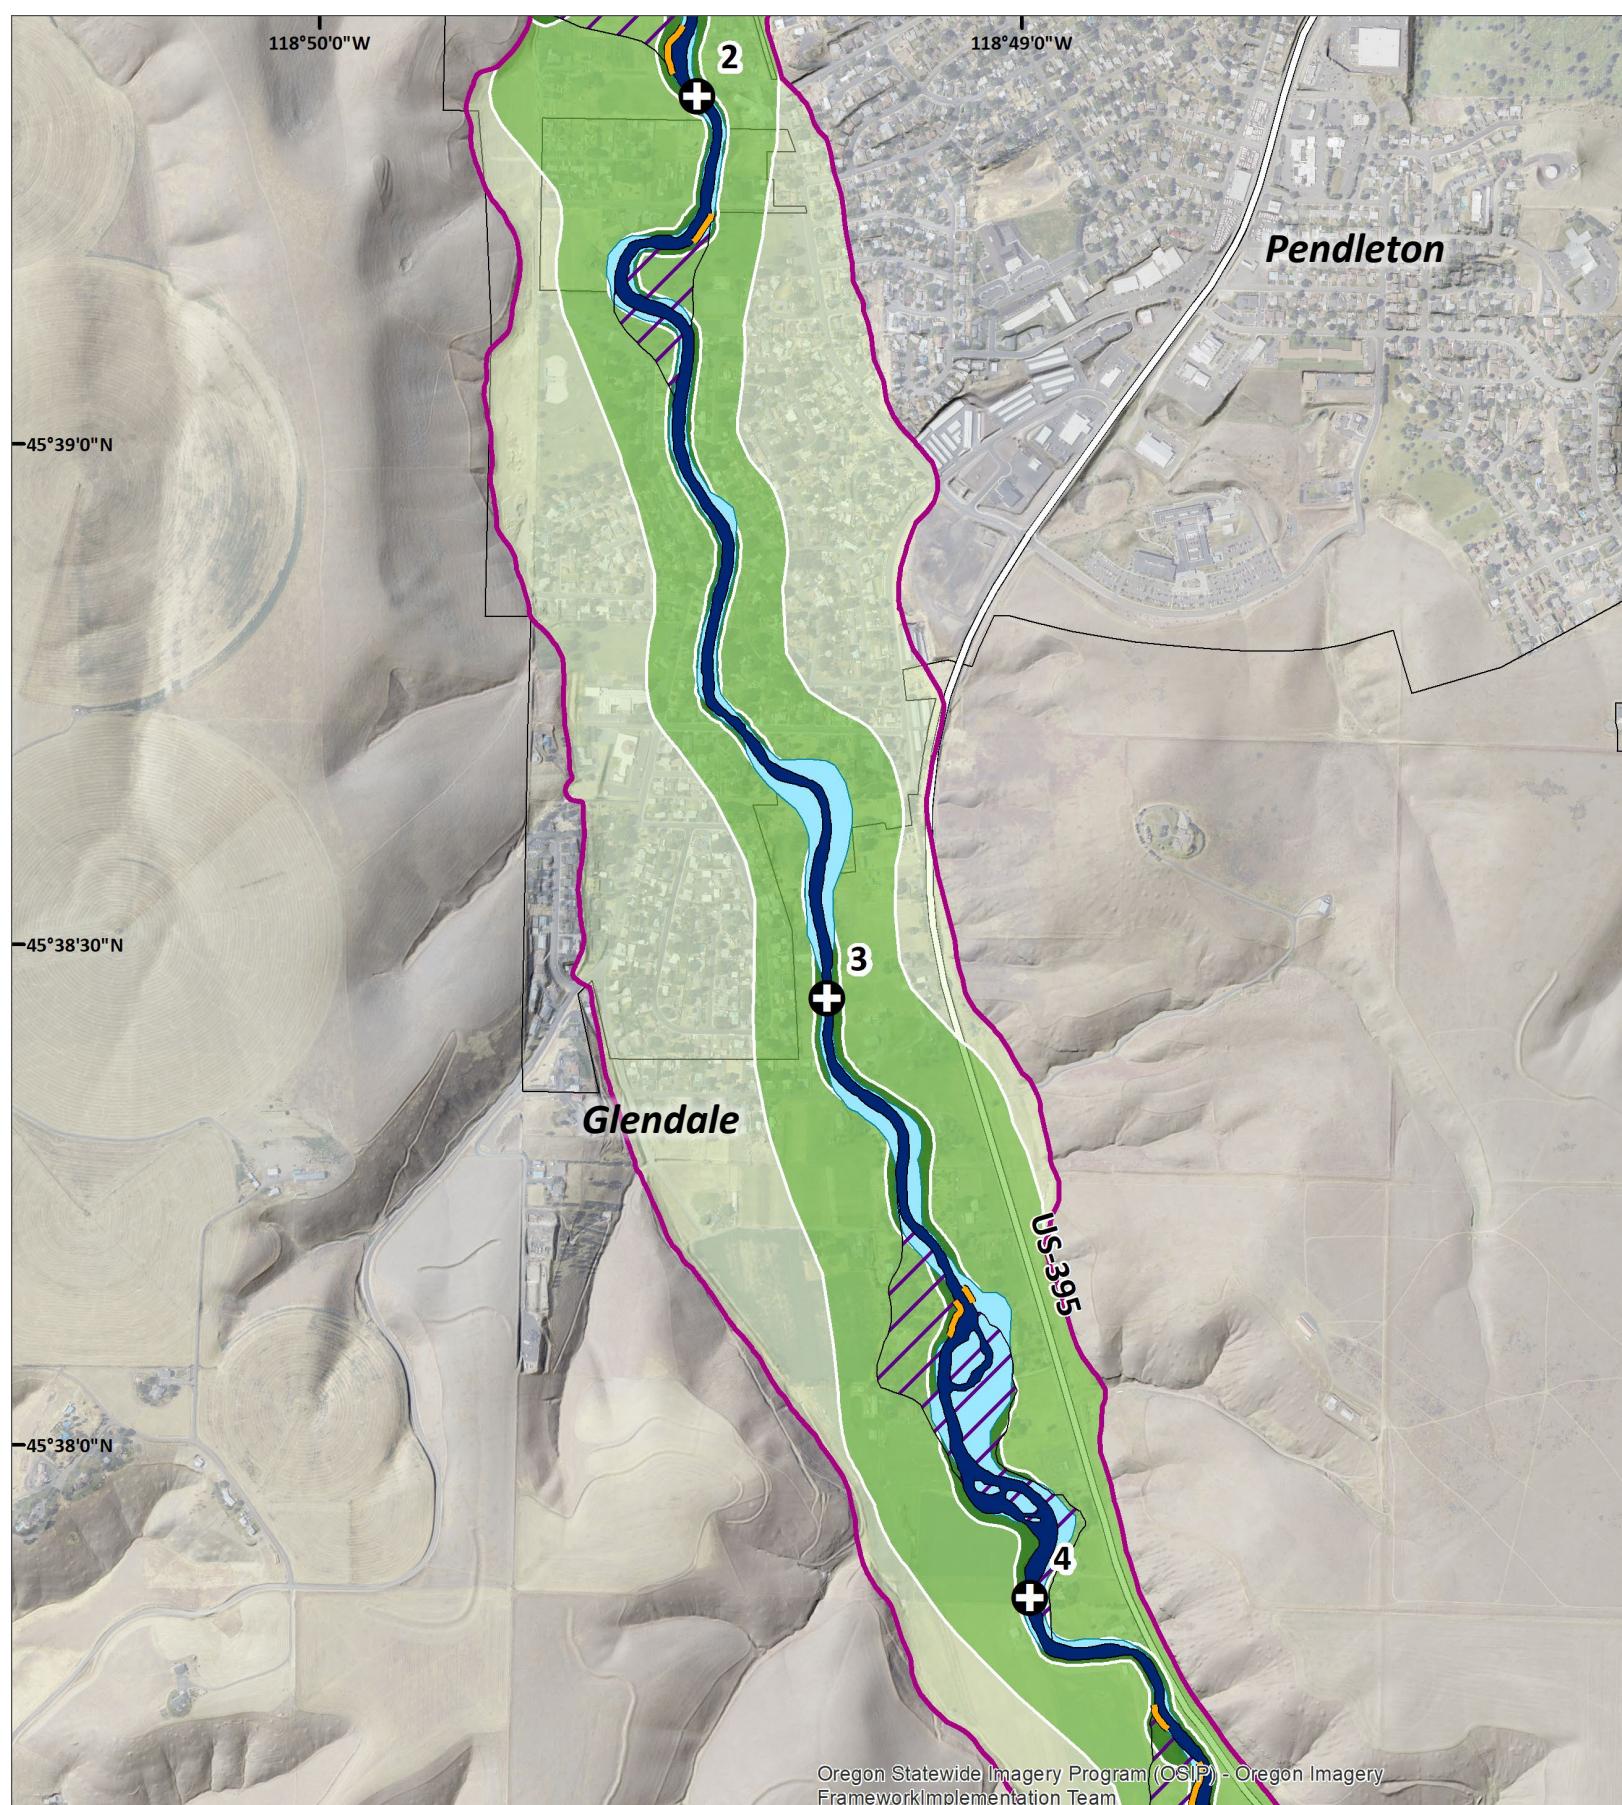
Figure 3-16. Lower McKay Creek CMZ map, RS 2-3, Umatilla County, Oregon.

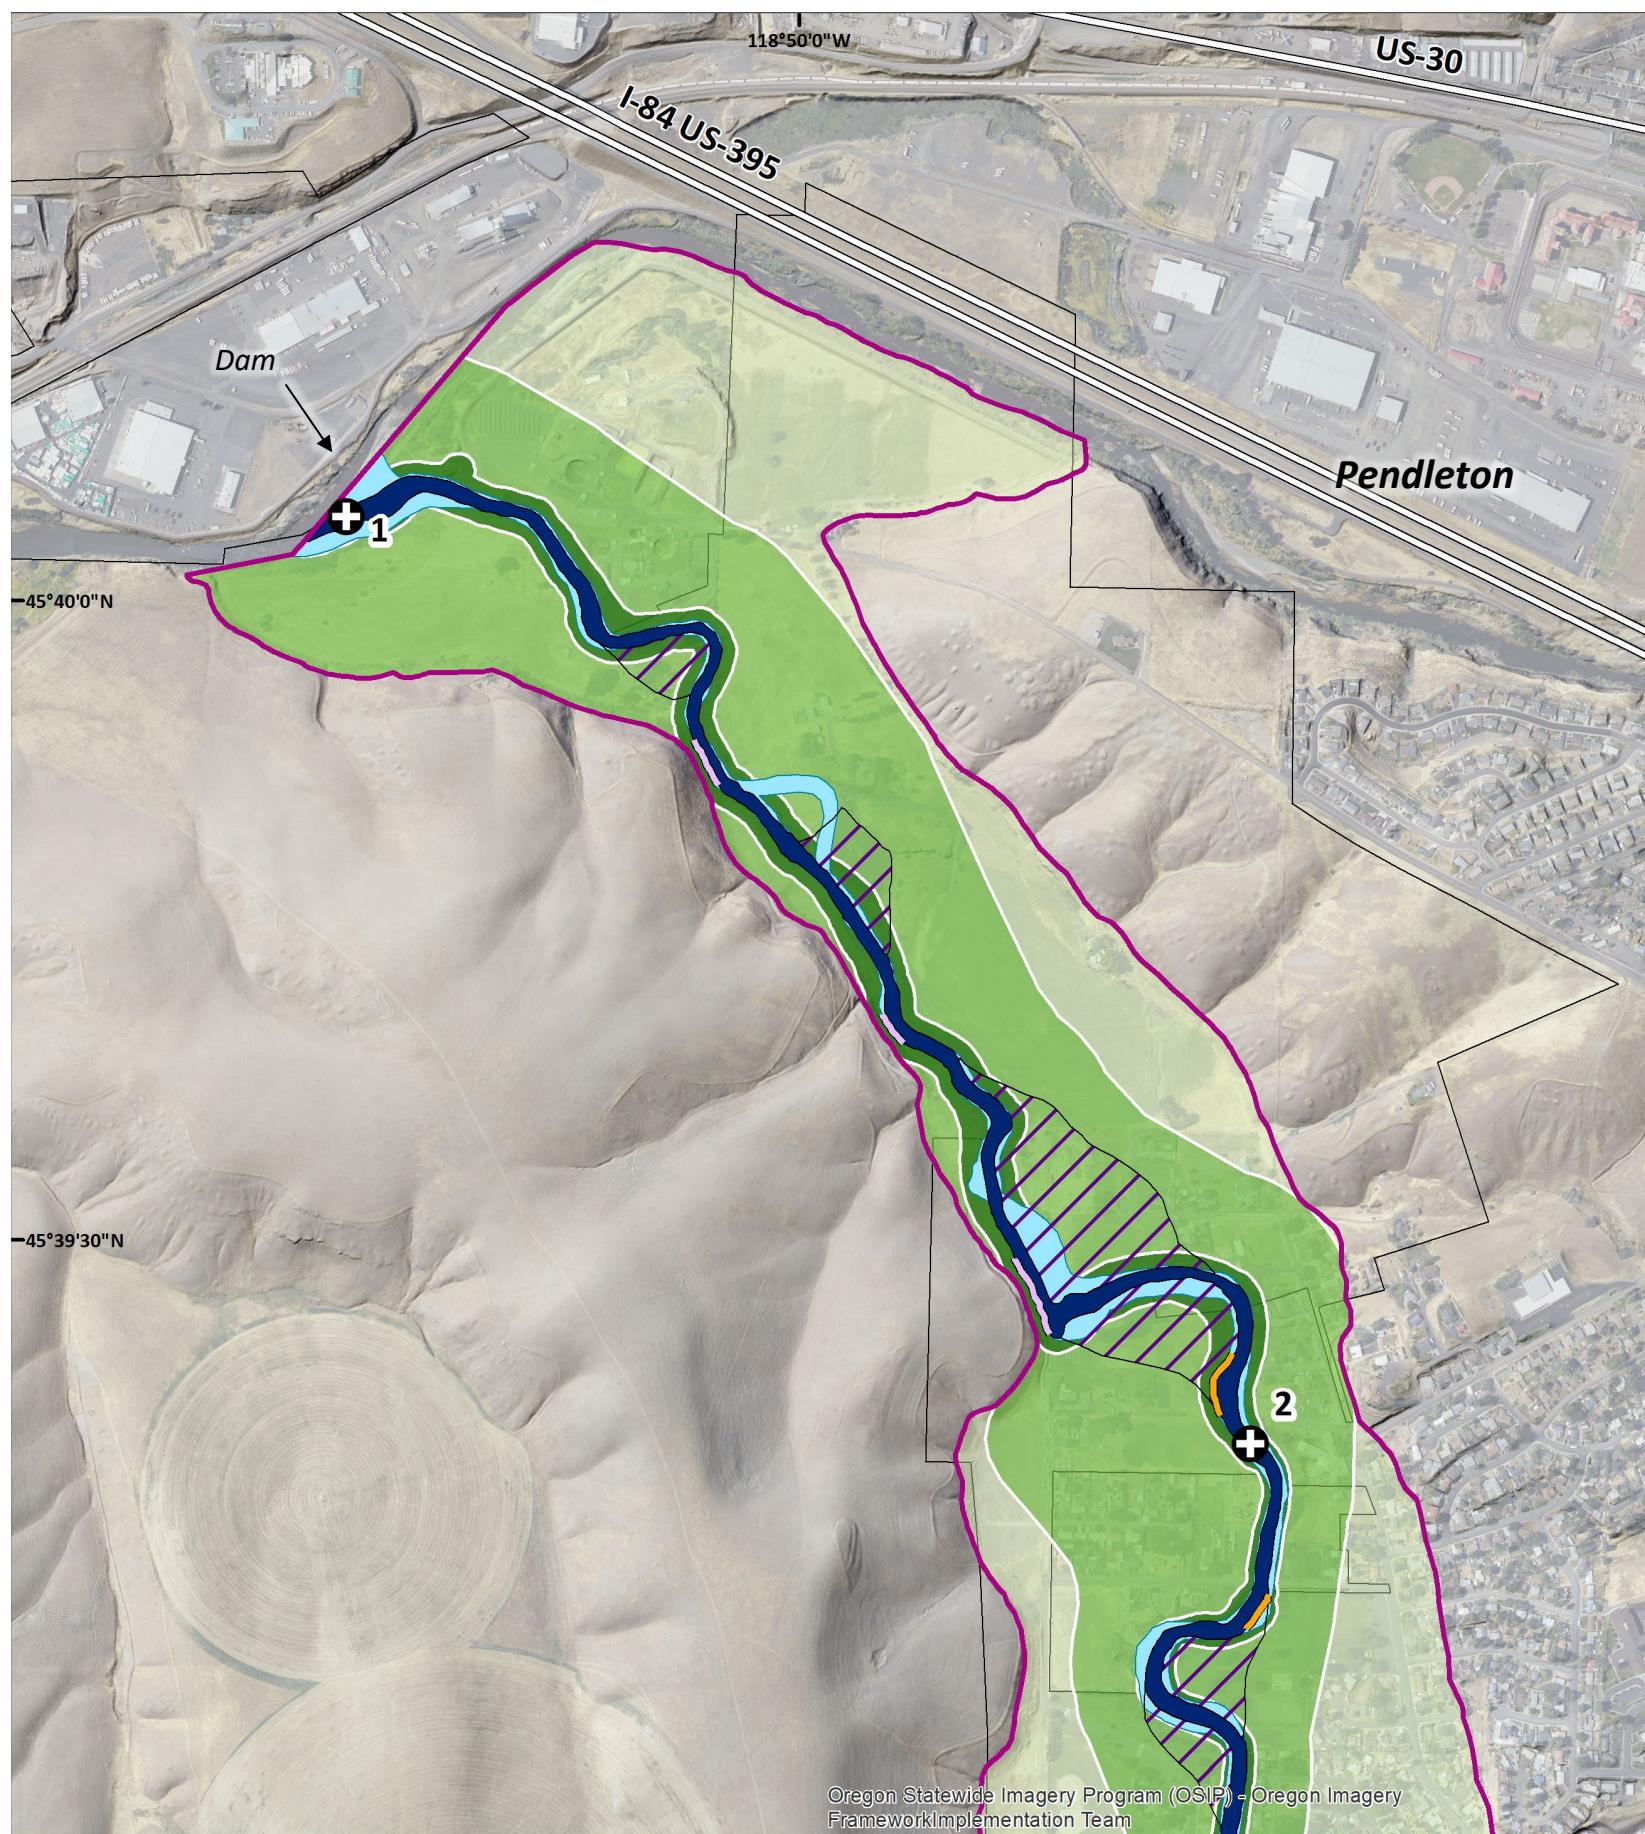
Figure 3-17. Lower McKay Creek CMZ map, RS 1, Umatilla County, Oregon.

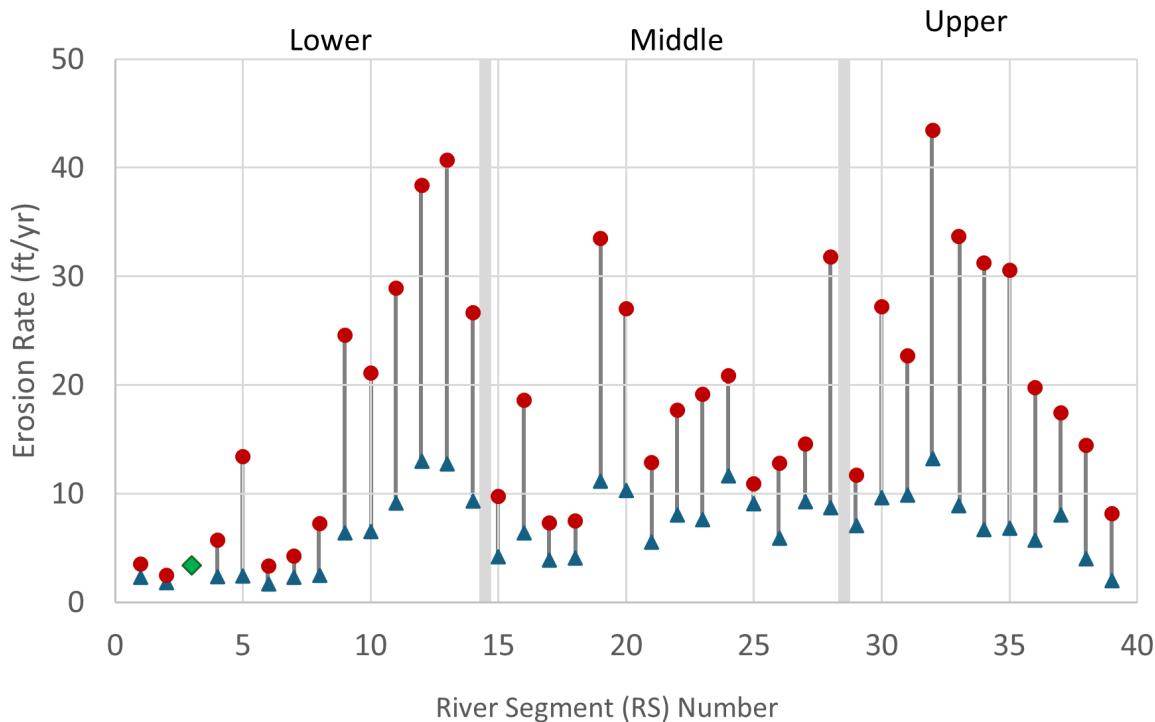
**Figure 4-1.** The observed, unmodified maximum (red circles) and median (blue triangles) rates of erosion within each RS observed along the Umatilla River, Umatilla County. Rates are based on the period 1950s to 2020s. RS 3 had no measurable erosion rate and was assigned a value using the method described in Section 2.3.5 (green diamond).

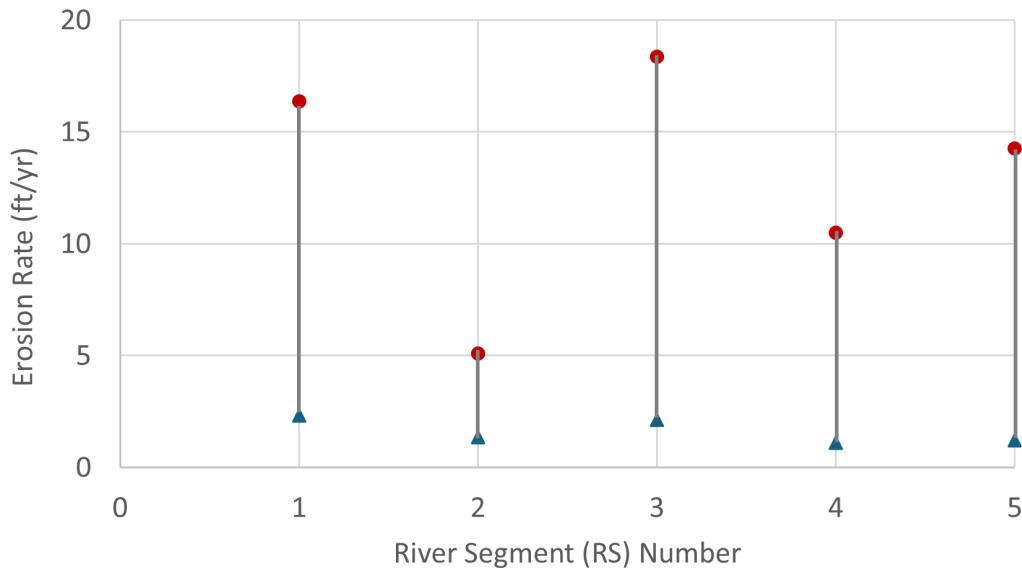
**Figure 4-2. The observed, unmodified maximum (red circles) and median (blue triangles) rates of erosion within each RS observed along lower McKay Creek.**
