OPEN-FILE REPORT O-93-10

George R. Priest, Ingmar Saul, and Julie Diebenow  
Oregon Department of Geology and Mineral Industries

**PILOT EROSION RATE DATA STUDY OF THE CENTRAL OREGON COAST,  
LINCOLN COUNTY**

**FINAL REPORT  
TO THE  
FEDERAL EMERGENCY MANAGEMENT AGENCY**

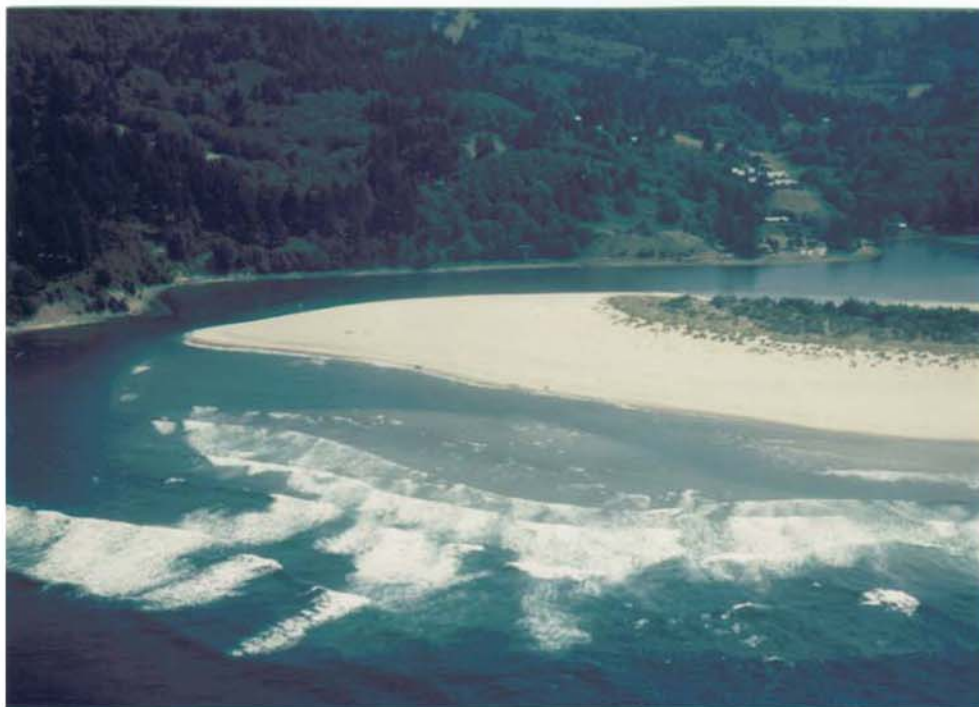
Figure 3. Salmon River spit, Segment 1.

By analogy to nearby Siletz Spit (Segment 8), the shoreline change rate on this spit should be relatively high, on the order of a few feet of accretion or erosion per year. The net change over a long period of time is probably near zero, since the spit is anchored to a resistant headland and is free of modification by anthropomorphic factors. High, vegetated dune areas are probably relatively safe for development, but the active dune area could be rapidly eroded on a 10 year time frame. Any erosion episode would likely be repaired by a

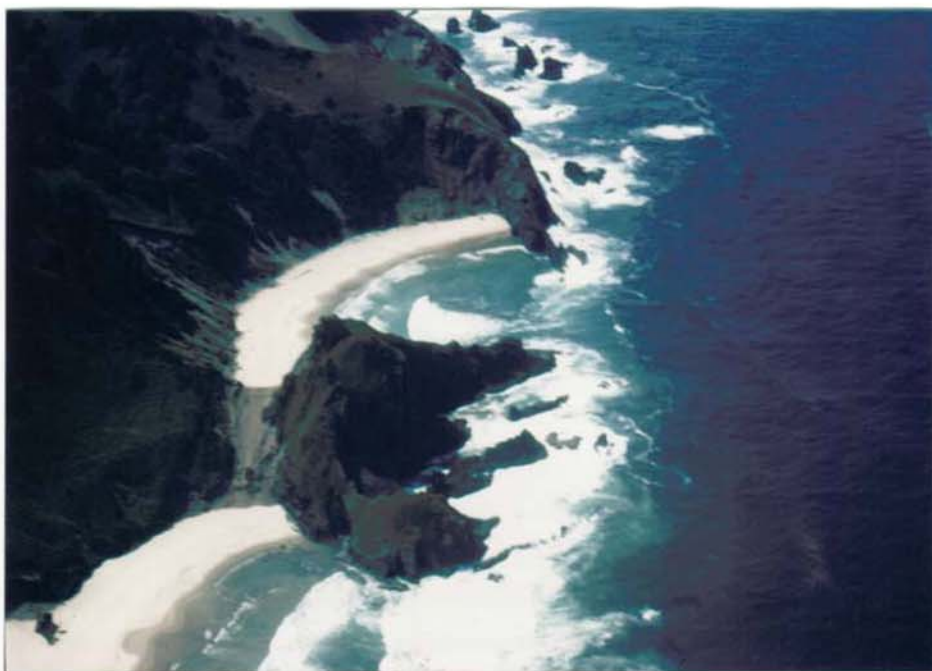
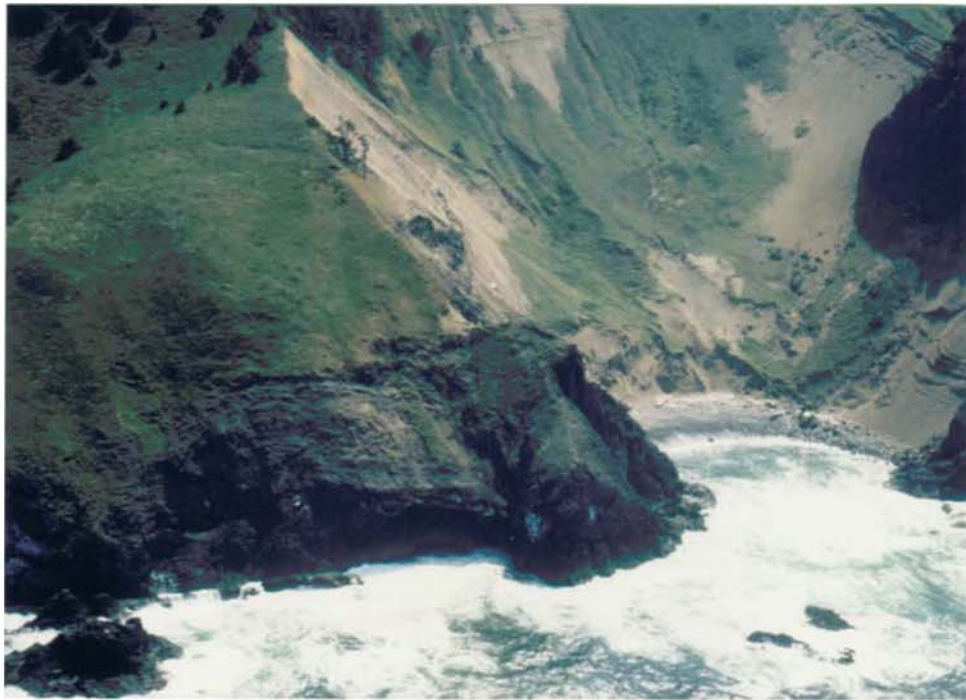
Figure 4. Segment 2 bluff in foreground; Segment 3 pocket beach in background (on south side of the Salmon River spit). Segment 4 headlands at the top of the picture.

Figure 5. Segment 2 bluff in foreground; Segment 3 pocket beach in background (on south side of the Salmon River spit). Segment 4 headlands at the top of the picture.

**Segment 4 (Headlands and Small Pocket Beaches Composed of Basalt):** This segment is composed chiefly of basaltic rocks with minor patches of sandstone cut by complex dikes of basalt (Figures 4 and 5). There are several very small pocket beaches where sandstone or fractured basalt create less resistant areas. There are no digital shorelines for this segment. A possible default rate of  $-0.09 \text{ ft} \pm 0.16 \text{ ft/yr}$  could be assumed, based on house-to-bluff data (Task 4) from areas with basalt bluffs.

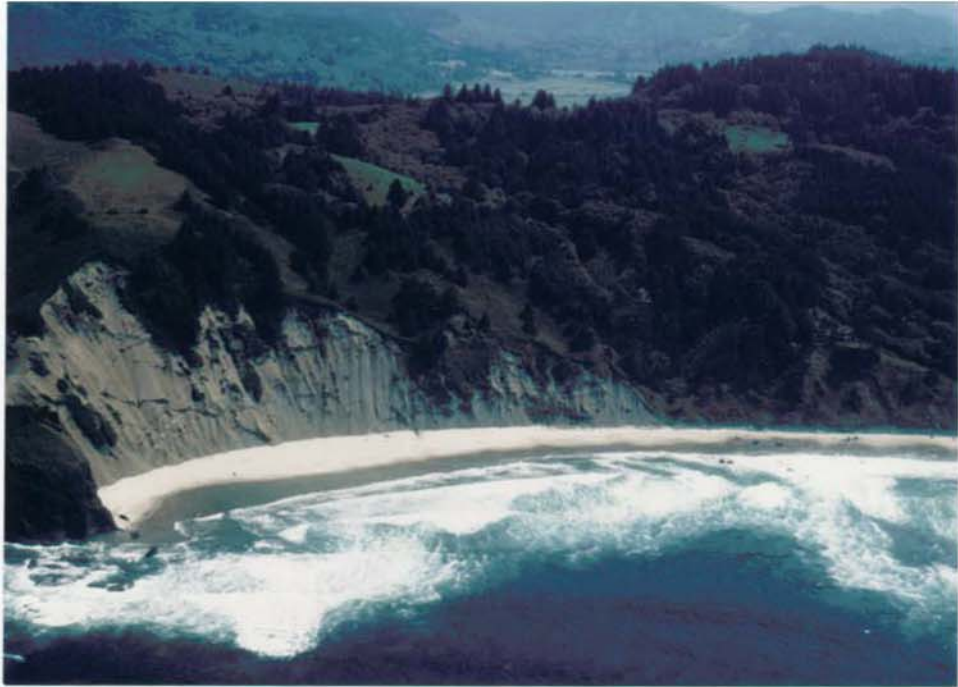
Figure 6. Basaltic headland bounding Segment 4 on left. Segment 4.5 cliffs transition southward to lower elevation, developed bluffs of Segment 5 (Roads End area).

**Segment 4.5 (Tertiary Sandstone/Mudstone Next to Basalt Headland):** This segment is bounded on the north by a basaltic headland and on the south by a low bluff composed principally of Quaternary colluvial units (Figure 6). The Nestucca mudstone and sandstone that form the high (100 ft) cliffs of the segment strike nearly perpendicular to the bluff trend. There are no house-to-bluff data, but the erosion rate is likely low, since there is little landsliding. The most similar segment with high precision house-to-bluff data is Segment 17 where the mean rate is  $-0.25 \pm 0.36 \text{ ft/yr}$ . The 0.8 ft/yr of

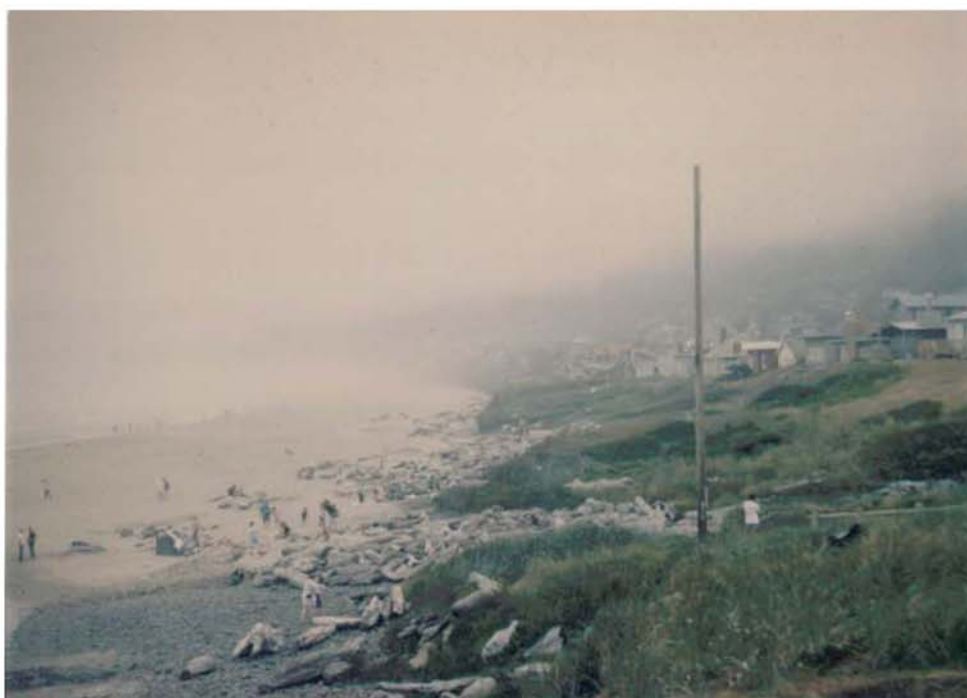
Figure 7. Segment 5 bluffs of armored colluvial deposits.

Development is very heavy with many areas armored with SPS, but a large percentage of the bluff remains unarmored. Considering the poorly consolidated nature of the terrace sands, the bluffs show surprisingly little evidence of erosion during the last 52 years. The histogram of rates from digital shorelines (Appendix D) show clustering about a zero rate. The data from historical digital shorelines has an uncertainty on the order of 1.2-1.4 ft/year. This is a large uncertainty compared to the mean rate of  $-0.27 \pm 0.34$  ft/yr determined from 14 measurements of the more precise house-to-bluff technique (see database BLUFF). Unusually high rates of -2.4 ft/yr (transect b128) and -2.5 ft/yr (transect b127) were measured from digital shorelines, but detailed examination of the photos revealed that these rates are apparently caused by fluctuations in the soft sand beach, not the bluff itself. A rate of  $-0.27 \pm 0.34$  ft/yr was assigned to all transects without SPS or bluff-to-house data.

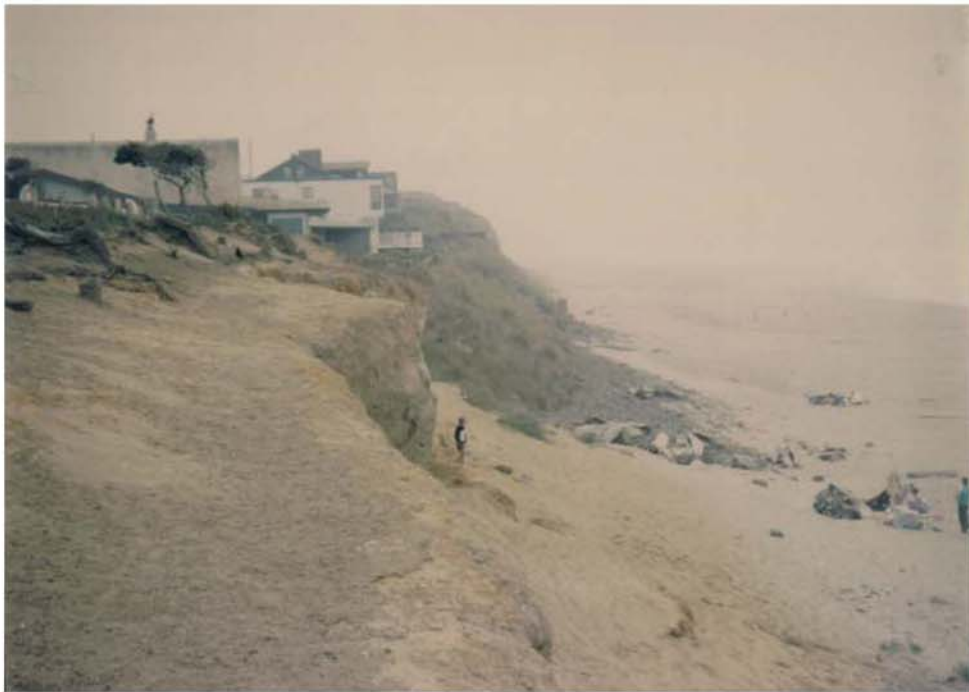
Figure 8. North boundary of Segment 6 at Roads End. Note that the Pleistocene terrace sand composing the cliff is better indurated than the colluvial deposits of Segment 5, so there is less armoring of the bluff.

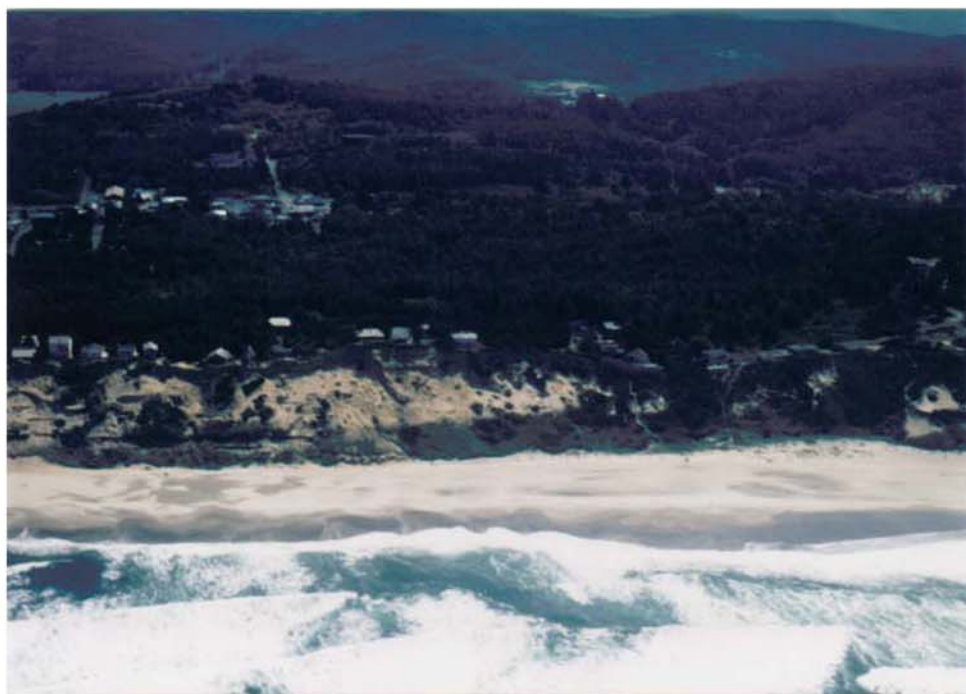
Figure 9. Typical bluffs of Segment 6 in the Lincoln City area.

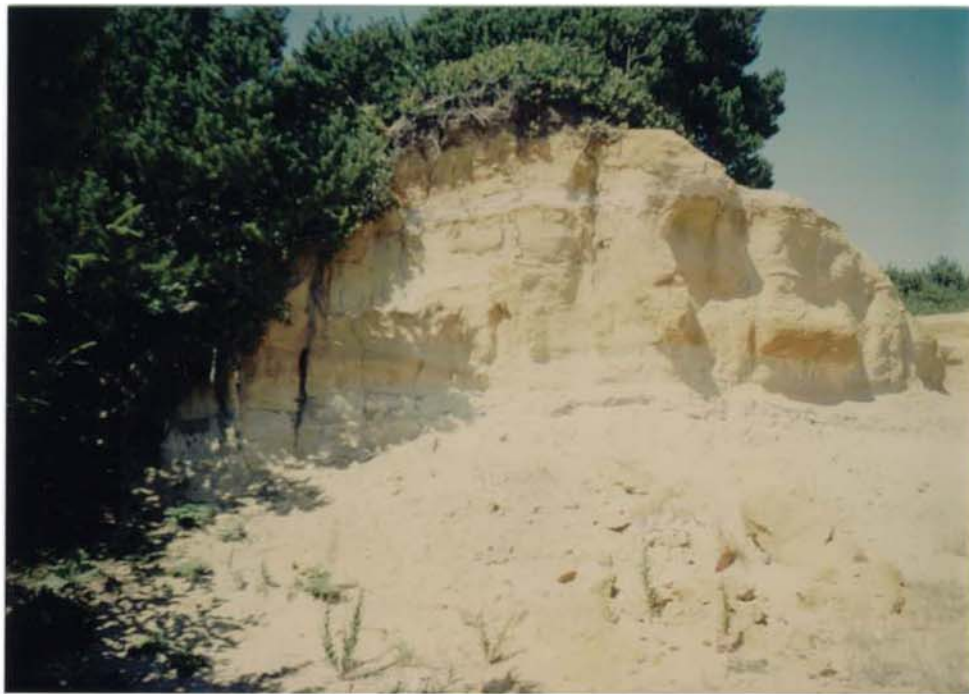
Figure 10. Pleistocene terrace sand that forms most of the bluff in Segment 6.

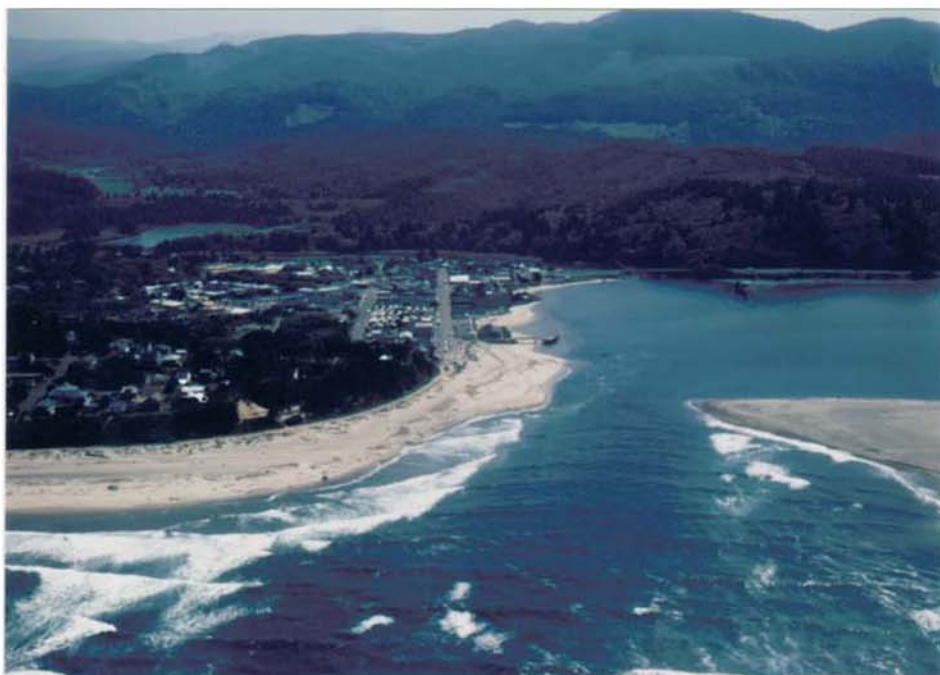
Figure 11. Wide duned beaches of Segment 7 on left.  
Tip of Siletz Spit (Segment 8) on the right  
side of Siletz Bay.

**Segment 7 (North Side of Siletz Bay - Wide Bluffed Beach of the Taft Area):** This segment has the same bluff lithology as Segment 6, but is fronted by a wide beach and by relatively stable dunes interwoven with buried logs at the mouth of Siletz Bay (Figure 11). The rate of retreat of the bluffs is caused entirely by weathering rather than by wave attack (Komar and Shih, 1991).

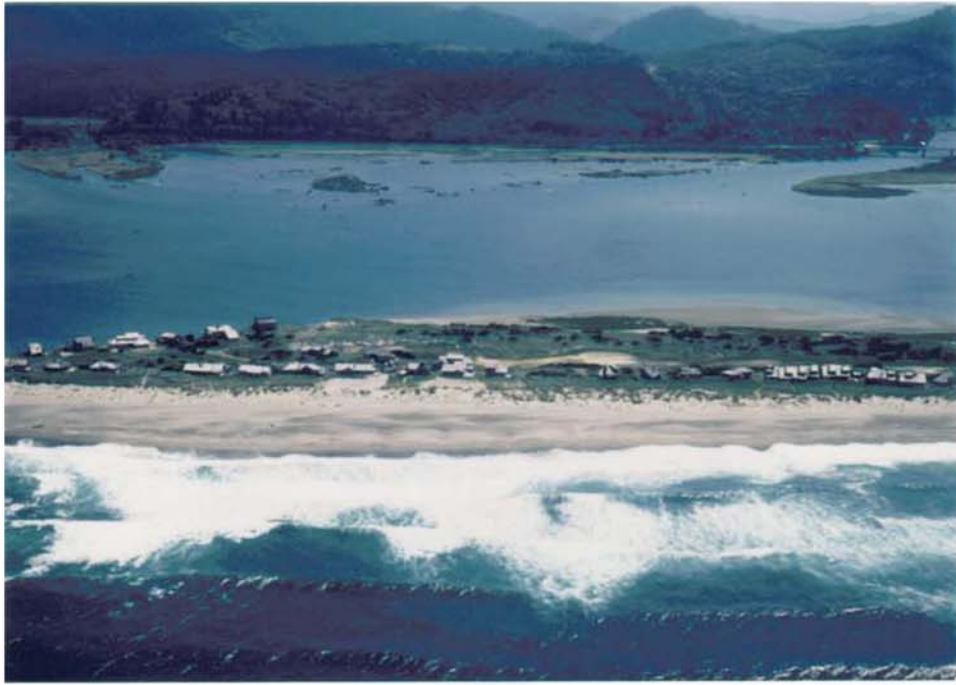
Figure 12. Siletz Spit where Siletz River (upper right) strikes the back side, narrowing the spit.

The bay side of the north half of the spit has suffered almost continuous erosion where the Siletz River channel banks up against the spit. The narrowest part of the spit occurs where the Siletz River channel first hits the middle of the spit (Figures 12 and 13). The width decreased at this point from 330 ft to 170 ft between 1939 and 1976 (Komar and Rea, 1976; Komar and McKinney, 1977). No digital shorelines were produced for the bay side, so no rates of erosion are assigned in the database.

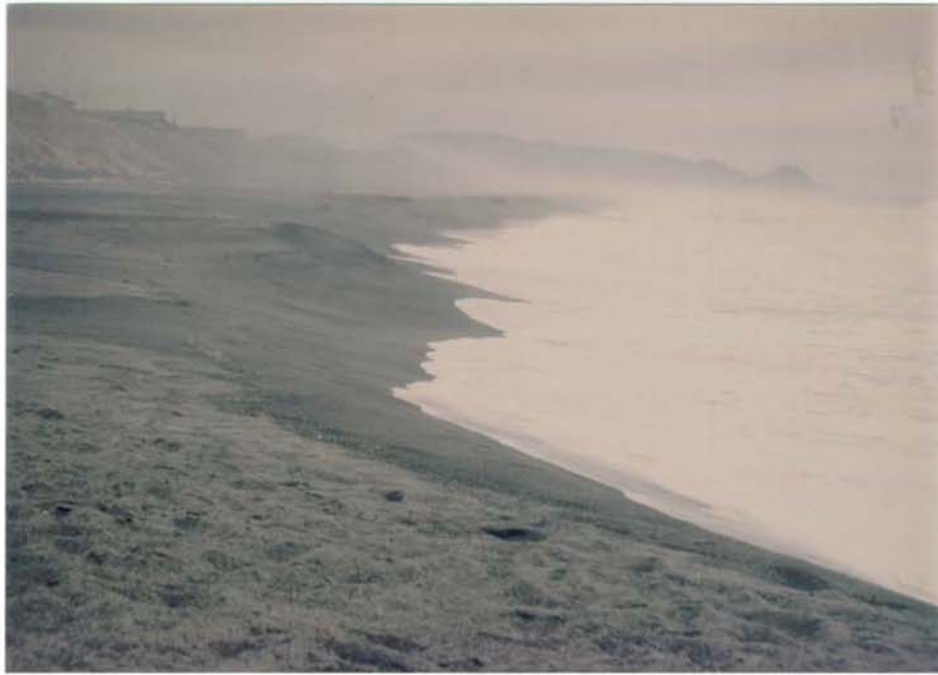
Figure 15. Gleneden Beach (Segment 9) is a steep, reflective beach with rip embayments.

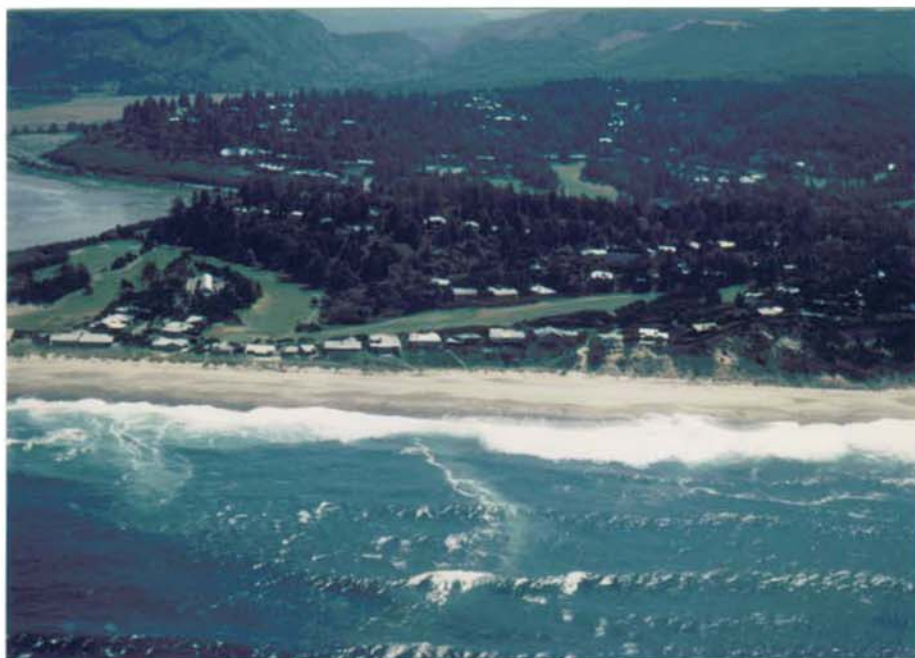
Figure 14. Contact of Siletz spit (Segment 8) with bluffs of Gleneden Beach (Segment 9).

**Segment 9 (Gleneden Beach to Fishing Rock - Bluffed Beach):** This segment is bounded by Siletz Spit on the north (Figure 14) and the basaltic headland of Fishing Rock on the south. Like the Lincoln City and Taft areas (Segments 6 and 7), the bluffs are composed of Pleistocene terrace sands. Like Siletz Spit (Segment 8), this is a steep reflective beach with rip embayments and coarse sands that can be removed quickly during severe winter storms (Figure 15). Erosion of the bluffs is therefore caused by both slow weathering and direct wave attack. Erosion rates should be higher than those on the low-sloping, dissipative beaches of Lincoln City.

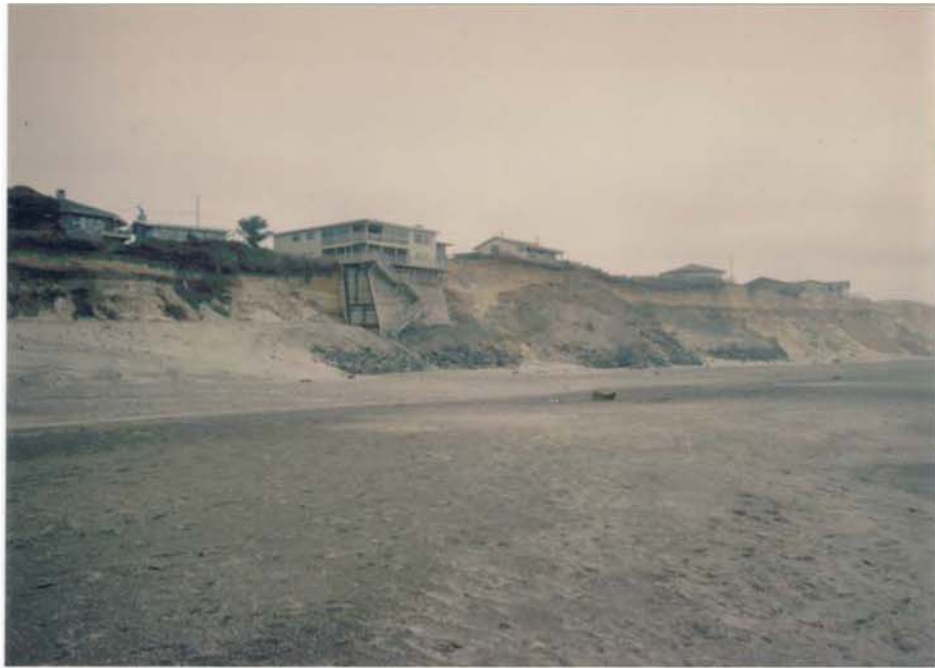
Figure 16. Coronado Shores development with rip rap on areas attacked by waves in winter storms of the early 1980s (Segment 9).

Two high-precision measurements of  $-2.33 \pm 0.11$  ft/yr at the Coronado Shores area in the middle of the segment were chiefly caused by 30 or more feet of erosion from a severe storm in 1982. Areas a few hundred feet north and south of these points did not experience such large losses of sea cliff. The highly eroded areas are now armored with extensive rip rap (Figure 16).

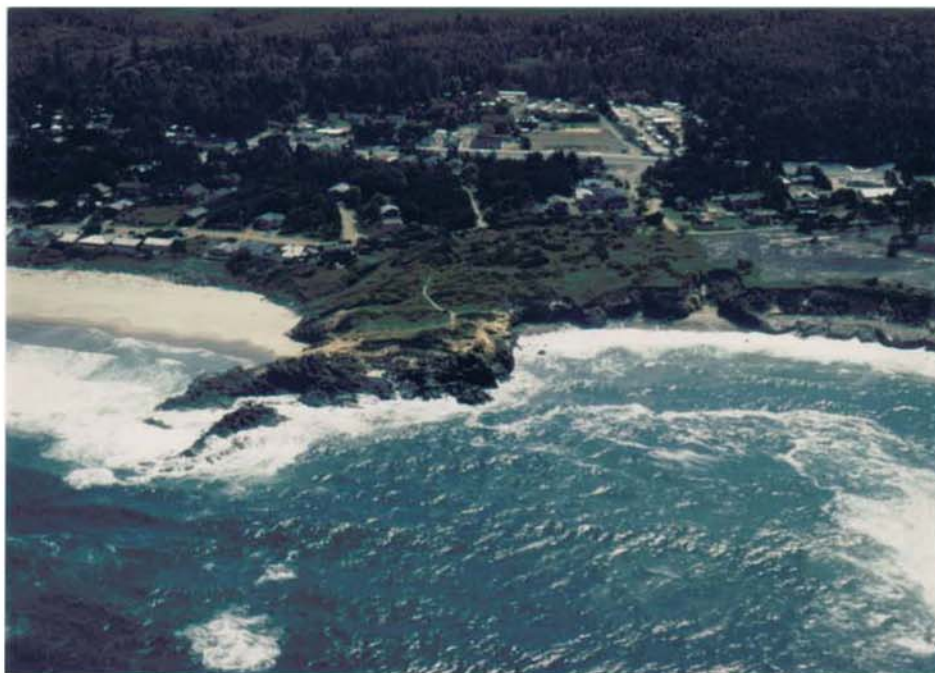
Figure 17. Fishing Rock is a basalt headland bounding Segment 9 on the left and the Fogarty Creek pocket beach (Segment 11) on the right.

**Segment 10 (Fishing Rock):** This is a basaltic headland (Figure 17) and lacks any digital shoreline data. A possible default rate of  $-0.09 \text{ ft} \pm 0.16 \text{ ft/yr}$  could be assumed, based on the mean of house-to-bluff data from basalt in other parts of the study area (Task 4).

**Segment 11 (Pocket Beach at Fogarty Creek):** This segment is bounded on both the north (Figure 17) and south (Figure 18) by small basaltic headlands. The bluff is composed principally of well indurated Tertiary sandstone and mudstone without landslides. The contact of the sandstone and basalt in the cliff on the south end of the segment is faulted and jointed in such a way that it is subject to failure by sliding and toppling of blocks.

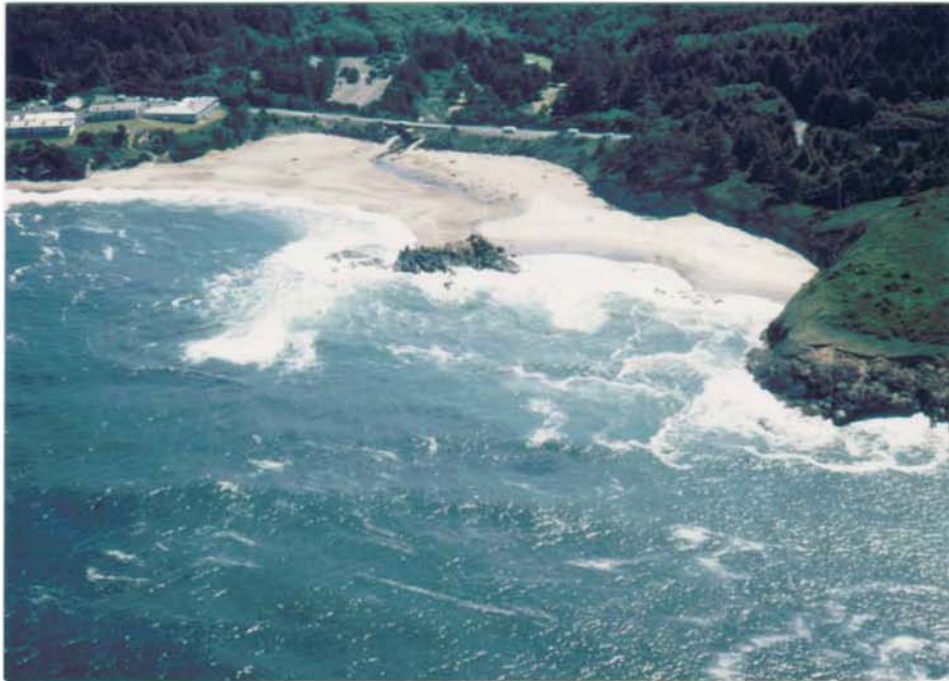
Figure 18. Fogarty Creek pocket beach (Segment 11)  
with basaltic headland on right.

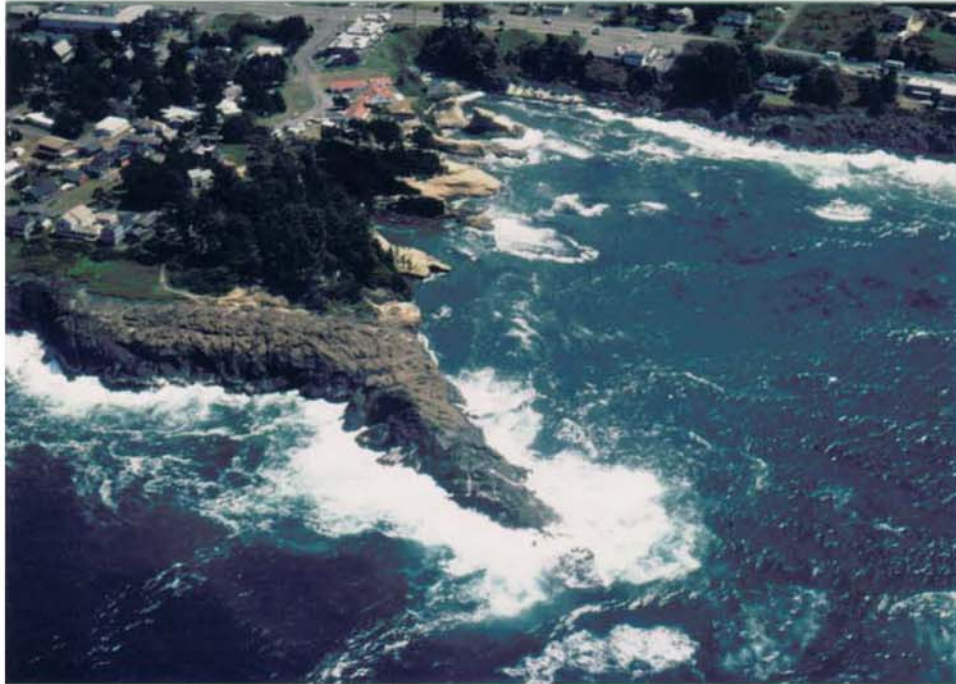
Figure 19. Segment 11.2 headlands on left. Mixed basalt and sandstone of Depoe Bay (Segment 11.3) on the right.

**Segment 11.2 (Government Point to Depoe Bay):** This segment is bounded by the Fogarty Creek pocket beach on the north and by the cliffy reentrant at Depoe Bay on the south (Figure 19). The segment is entirely composed of cliffs of basalt and basaltic hyaloclastites (Figure 20). Cementation by alteration minerals causes the hyaloclastite to be as resistant as basalt.

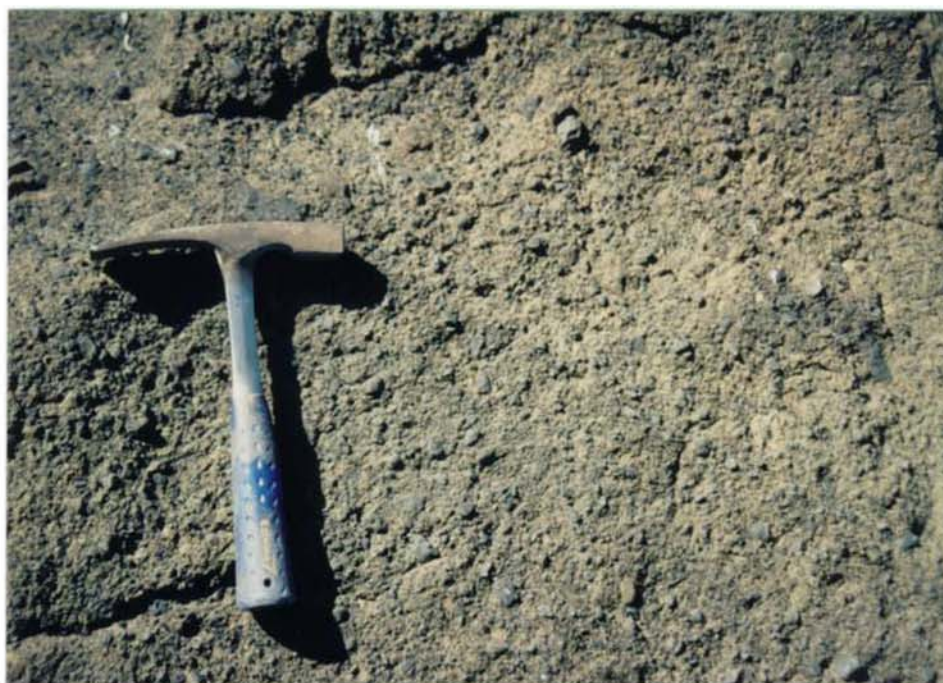
Figure 20. Typical basalt hyaloclastite of Segments 11.2 and 11.4.

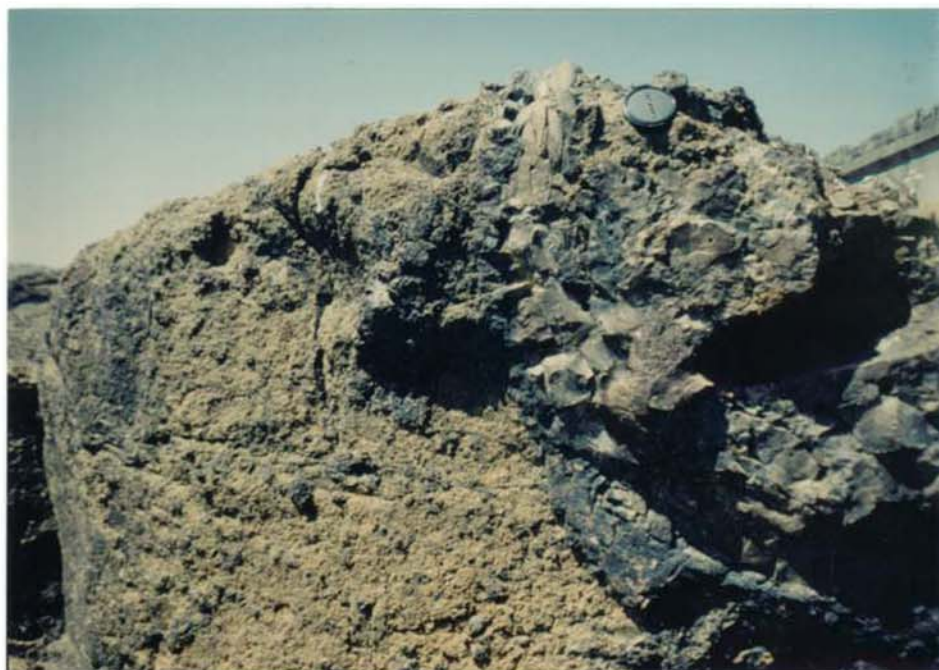
**Figure 21. Coarse hyaloclastic basalt breccia of Segment 11.3, Depoe Bay.**

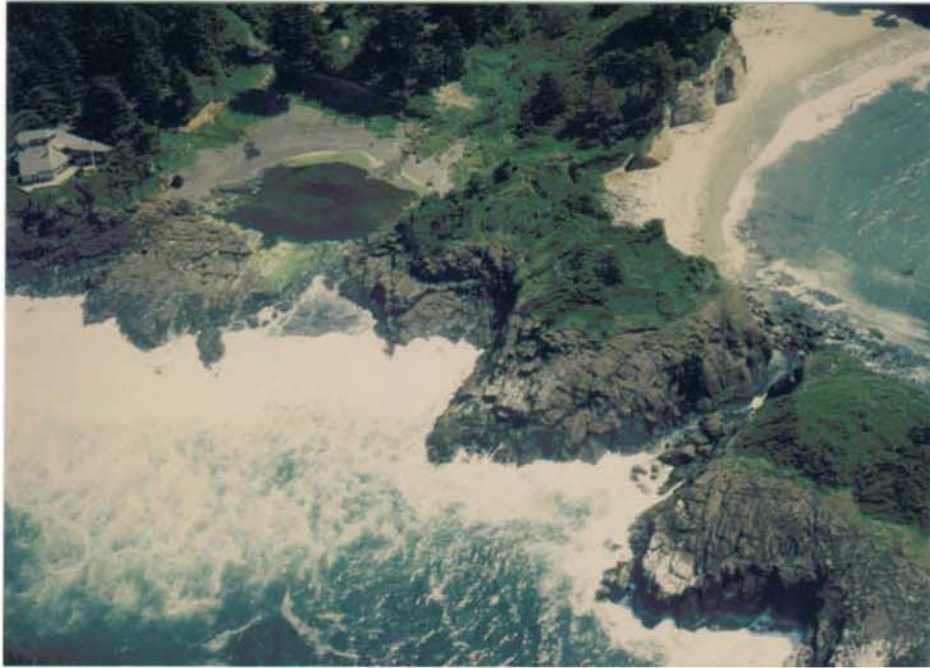
Figure 22. Typical Segment 11.4 basalt headlands and local pocket beaches composed of sandstone bluffs. Little Whale Cove area.

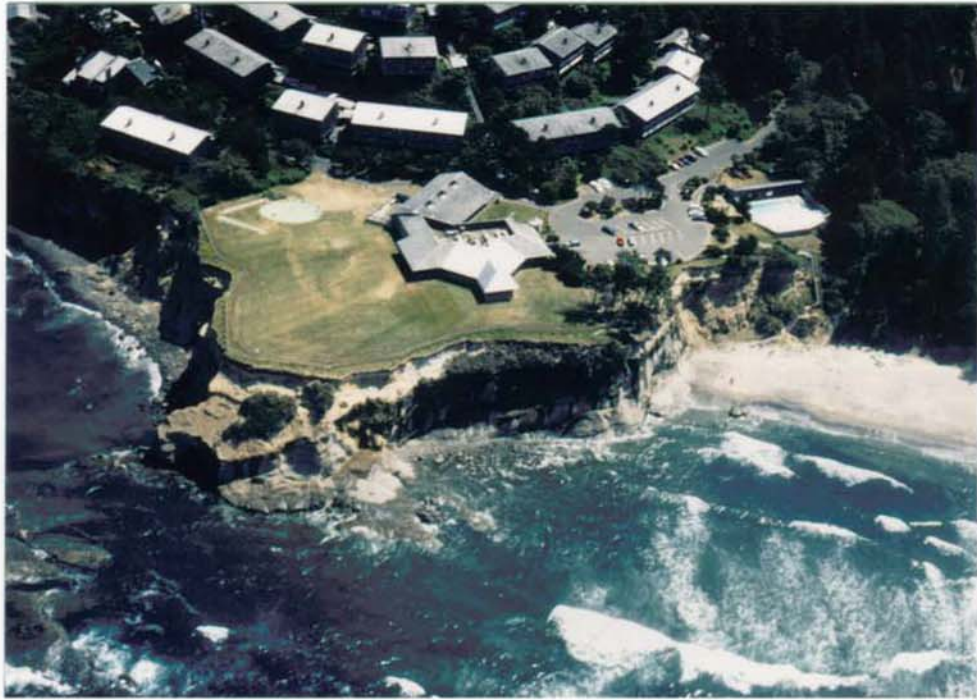
Figure 23. Ottercrest headland (Segment 11.5) with landslide-dominated pocket beach of Segment 12 on right.

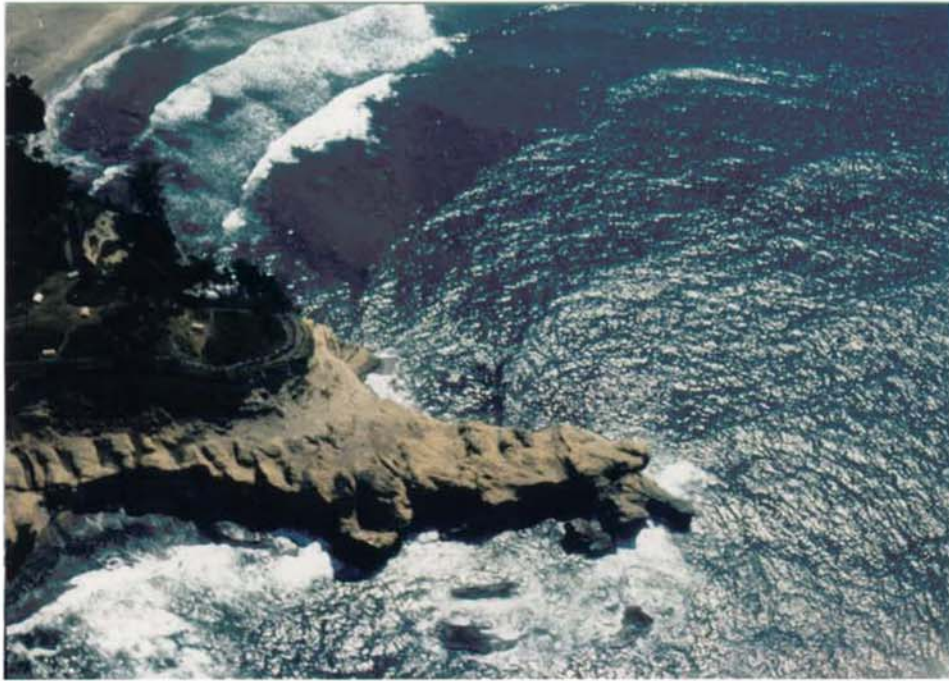
Figure 24. Sandstone headland of Devils Punch Bowl (Segment 13) with Beverly Beach (Segment 14) in the background.

**Segment 13 (Devils Punch Bowl Headland):** This segment is a headland composed of well indurated Tertiary sandstone (Figure 24). It is bounded on the north and south by the contact of the Tertiary sandstone with a sequence of Tertiary mudstones and interbedded sandstones. All of the Tertiary units are capped by several feet of poorly indurated Pleistocene terrace sands, and all dip seaward. The seaward dip produces some landsliding on either side of Segment 13 where mudstone is exposed in the cliff faces.

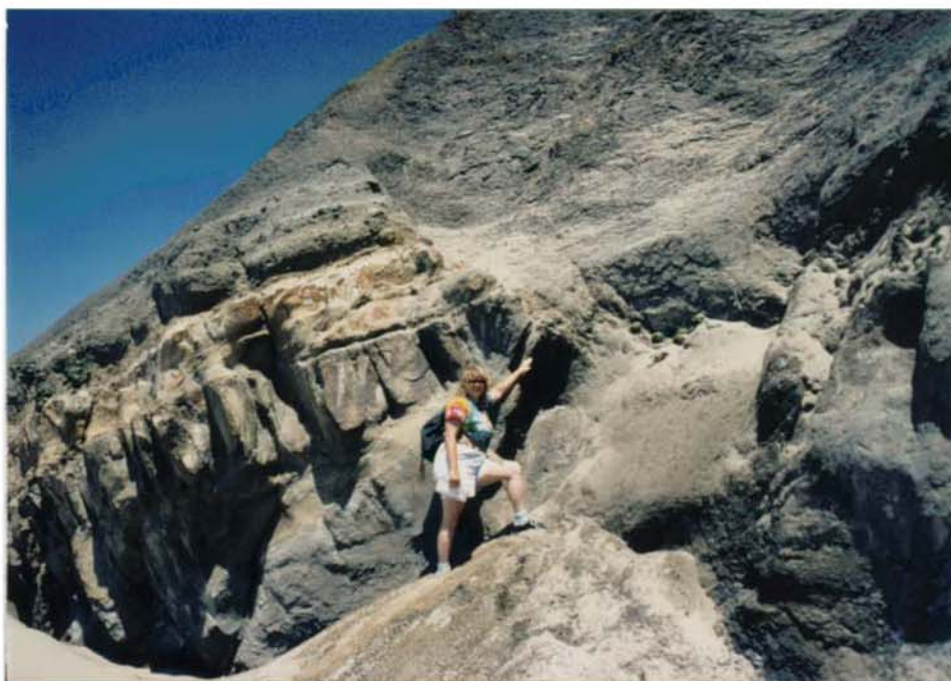
Figure 25. Segment 14 seaward dipping sandstone and mudstone. (Paula Priest in the foreground).

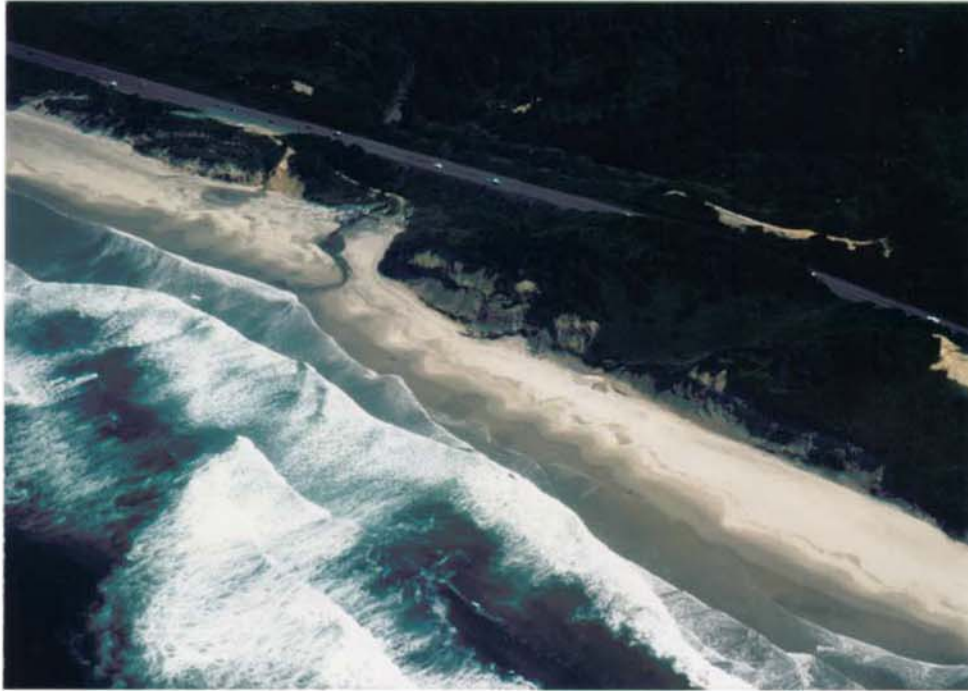
Figure 26. Beverly Beach with steep cliffs of Tertiary sandstone capped by Pleistocene terrace sand (Segment 14).

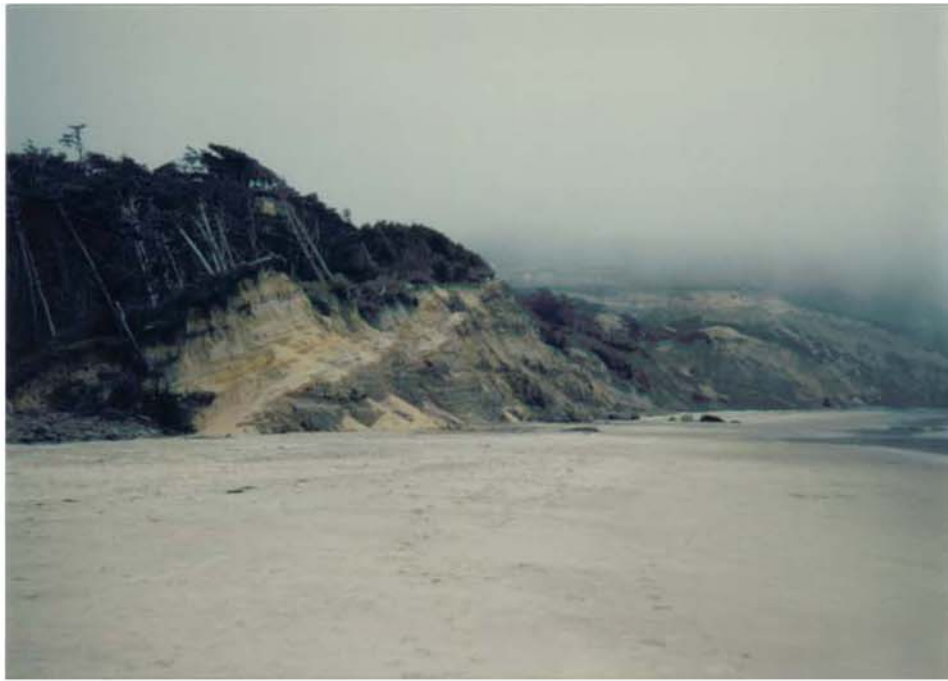
Figure 27. Back-tilted slide blocks of Moolack Beach  
(Segment 15).

**Segment 15 (Active Landslide Areas of Moolack Beach):** This segment is bounded on the north by the contact of an area of active landslides (Figure 27) with a more stable bluff. Yaquina Head bounds the segment on the south. Bluffs are composed of seaward dipping mudstone capped by several feet of poorly indurated Pleistocene terrace sands. The strike of the Tertiary rocks is almost exactly parallel to the trend of the bluff. Extensive active landslides and slide blocks affect the entire area. This segment is a geologic analogue of the Jumpoff Joe landslide area of Segment 18. However, it has not had significant development until very recent times, so precise data from the house-to-bluff method is lacking.

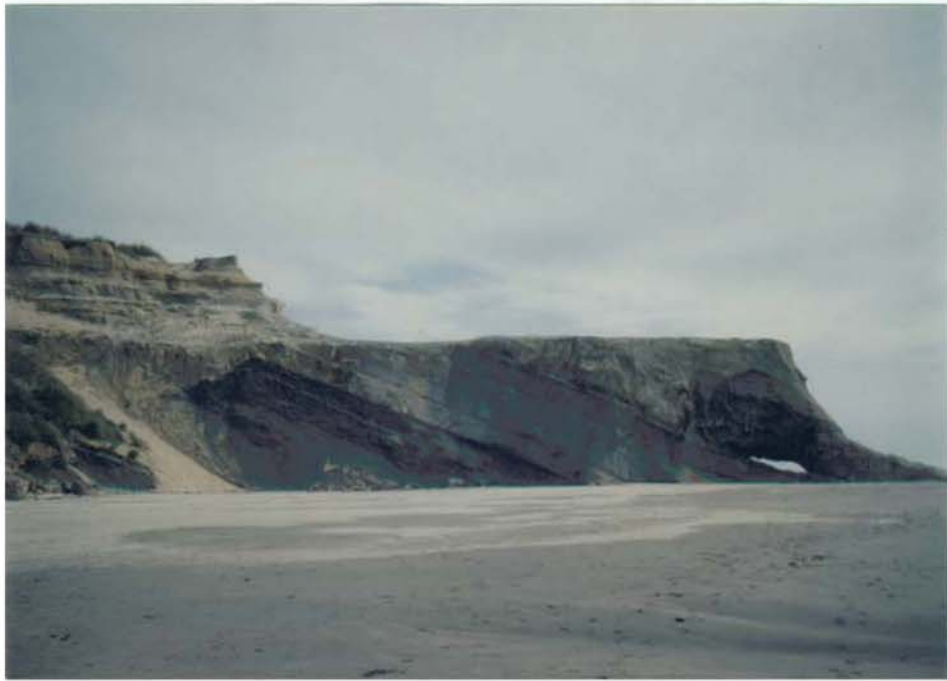
Figure 28. Horizontal Pleistocene terrace sands cap seaward dipping Astoria sandstone over darker Nye mudstone at Jumpoff Joe (Segment 18).

**Segment 18 (Landslide Areas of Newport, Including Jumpoff Joe):** This segment is bounded on the north and south by the contact of this massive area of landsliding with normal sea cliffs. The area lies at the contact between two seaward dipping Tertiary formations, the Astoria Sandstone and the underlying Nye Mudstone which are in turn capped by a 20-30 ft of Pleistocene terrace sands (Figure 28). In 1868 a large promontory called Jumpoff Joe was composed of the resistant Astoria Sandstone and formed a major landmark in the area. All that remains of this feature today is a small sandstone promontory immediately south of the old one (Figure 28a). Even that promontory is now sliding seaward as a block. The rest of the segment has Nye Mudstone in the lower part of the sea cliff. Jumpoff Joe was destroyed by massive landslides as erosion exposed the contact with the underlying Nye Mudstone. When this seaward dipping

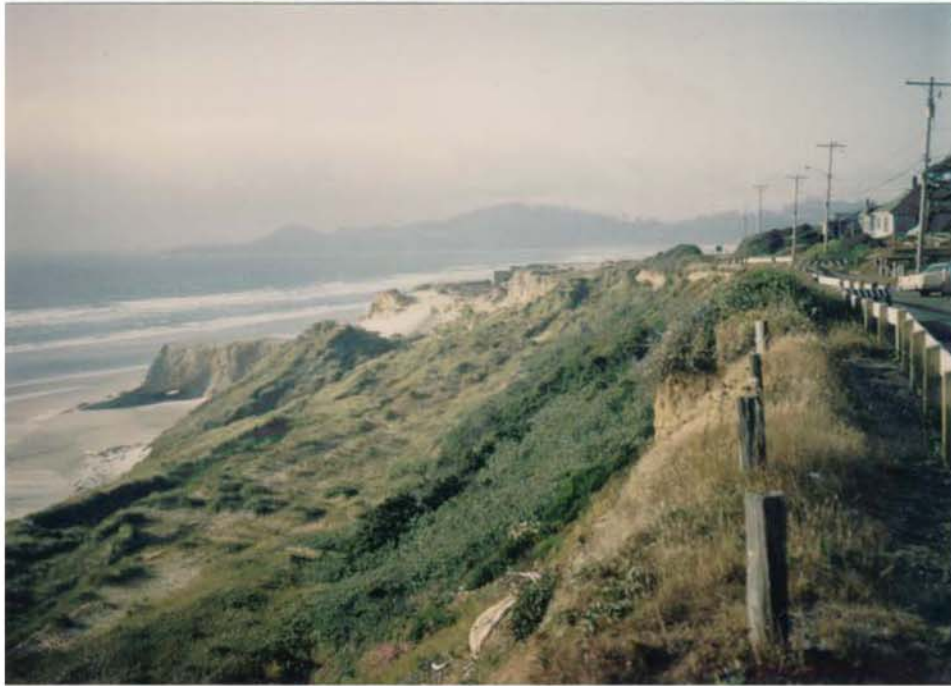
Figure 2 8a. Yaquina Head basalt in background; Jumpoff Joe landslide area in foreground; headwall near the railing on the right (Segment 18).

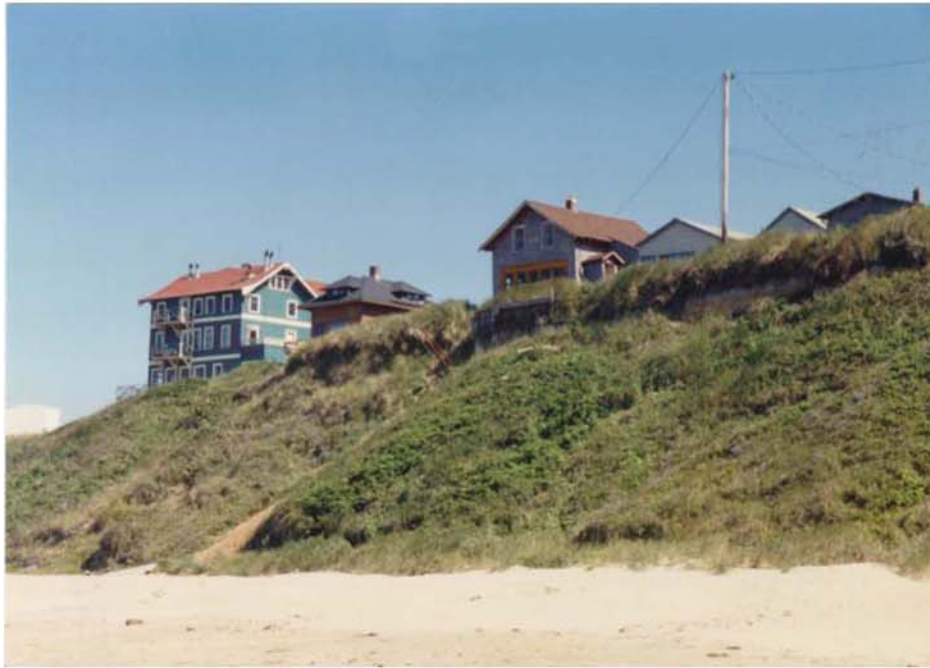
Figure 30. Segment 19 showing well vegetated bluffs at the Sylvania Beach Hotel (left). This area has an anomalously low erosion rate for the segment.

The rate of  $1.02 \pm 0.68$  ft/yr is assigned to all transects in the segment except the area at transects d263-d264 that lacks a high sea cliff. That area showed less bluff retreat in 122 years than the error (0.68 ft/yr) of the ZTS technique. The above observations of no erosion in the last 70 years confirm the low erosion rate. These

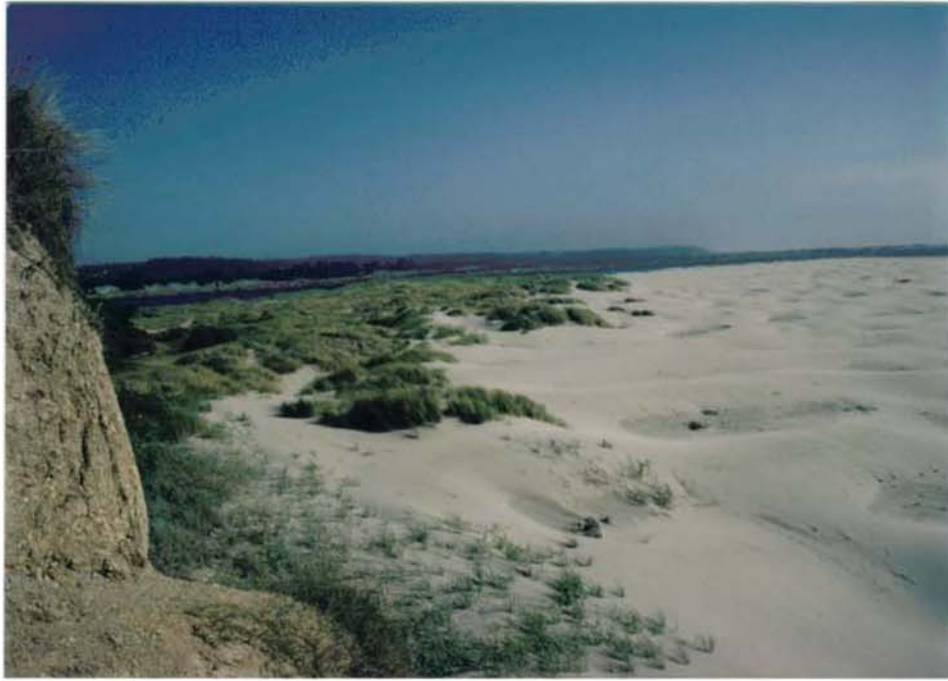
Figure 31. Wide duned beach of Segment 20 next to the north Yaquina Bay jetty (background).

**Segment 20 (Wide Beach on the North Side of the North Yaquina Bay Jetty):** This segment is bounded on the north by a sharp change in trend of the bluff and on the south by the north jetty at Yaquina Bay. A wide accretionary beach (Figure 31) was created by installation of jetties in 1830 and later extensions between 1940 and 1974 (Komar and others, 1976). The beach is quite wide next to the jetty because of sand accumulation during the summer, but general growth of the jetty beach is prevented by the obtuse angle that the jetty has with the mainland (Stembridge, 1975). This orientation exposes the beach to the vigorous storm waves that come in from the southwest in winter (Komar and others, 1976). The beach is backed by a bluff of seaward-dipping mudstone capped by Pleistocene terrace sands. This bluff is heavily vegetated and, because the cliff not parallel to the strike of the dipping mudstone, it is free of landslides. All development is on top of the bluff, the beach being accessible only for recreation.

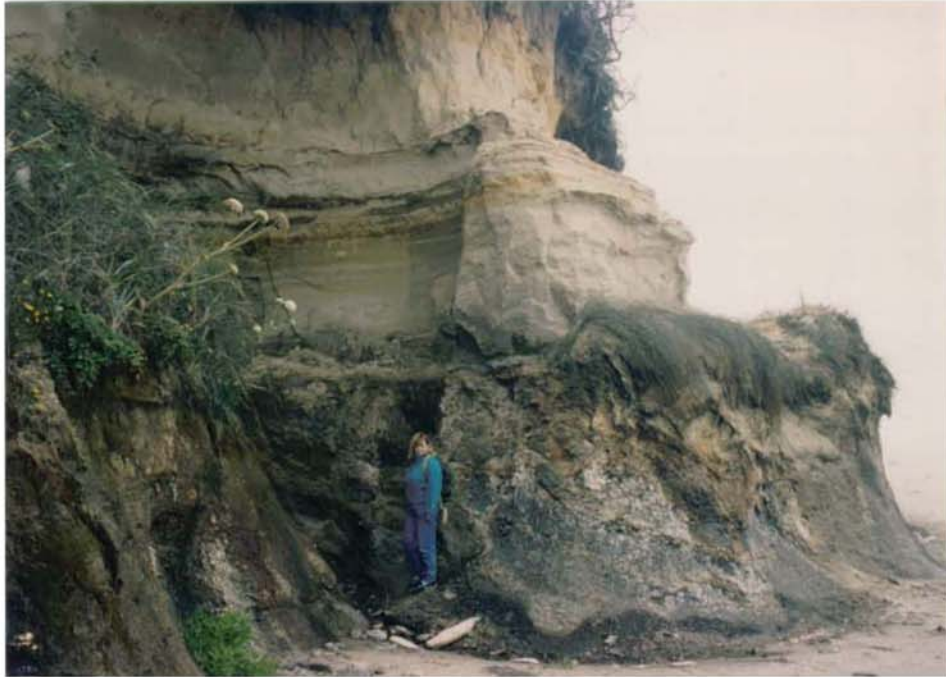
Figure 32. Thick Pleistocene terrace sand on Tertiary sandstone and mudstone. Typical bluff of Segment 22 near Lost Creek.

The large proportion of Pleistocene terrace sand in the bluffs makes it likely that the erosion rates are similar to areas with high proportion of this same unit. The bluffs of Segment 6 are also dominated by Pleistocene terrace sands. The low slope and narrowness of the beach in Segment 22 is very similar to the beach of Segment 6. house-to-bluff data for Segment 6 is therefore combined with the data
