OPEN-FILE REPORT O-93-10

George R. Priest, Ingmar Saul, and Julie Diebenow  
Oregon Department of Geology and Mineral Industries

**PILOT EROSION RATE DATA STUDY OF THE CENTRAL OREGON COAST,  
LINCOLN COUNTY**

**FINAL REPORT  
TO THE  
FEDERAL EMERGENCY MANAGEMENT AGENCY**

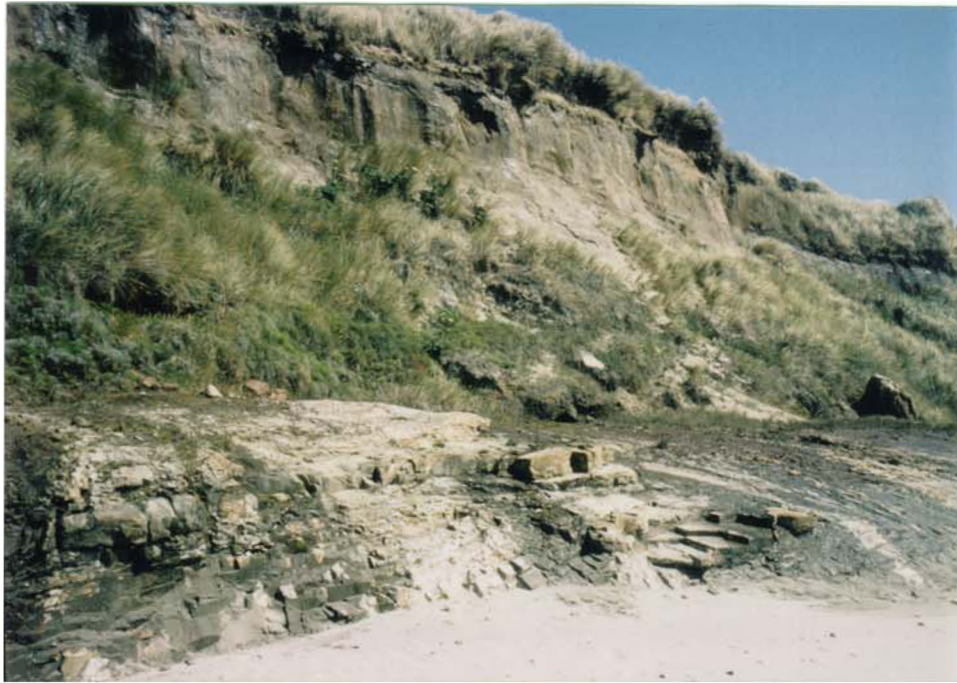
Figure 33. Segment 24 bluff. Note that there is only a few feet of Tertiary mudstone at the base of the softer Pleistocene sands; also typical of Segment 25.

**Segment 24 (Bluffed Beach South of the Ona Beach-Beaver Creek Area):** This segment is bounded on the north by the wide beaches at the mouth of Beaver Creek and on the south by a similar beach with basaltic sea stacks offshore. The bluffs are composed of less than 6 feet of seaward-dipping Tertiary mudstone and sandstone surmounted by 20-30 ft of Pleistocene terrace sands (Figure 33). One small landslide penetrates only a few tens of feet into the bluff; all other bluff retreat is by slow weathering and wave erosion. The area is sparsely populated, so there is little opportunity to utilize the house-to-bluff technique.

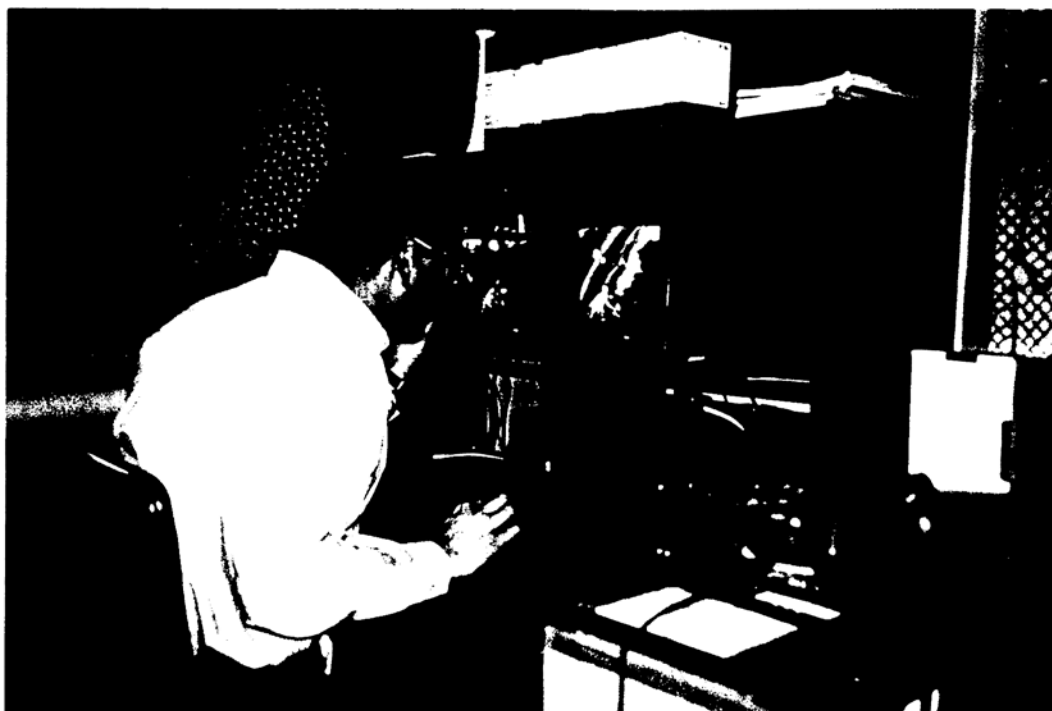
FIGURE 4:

INTERPRETER USING VIDEO EDITING SYSTEM FOR STEREO VIDEO TRACKING.  
DIGITAL CAMCORDER AT LOWER LEFT.

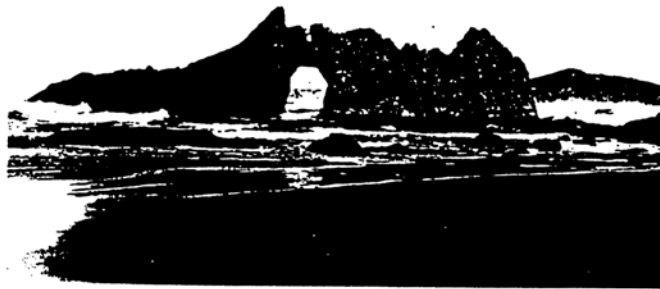
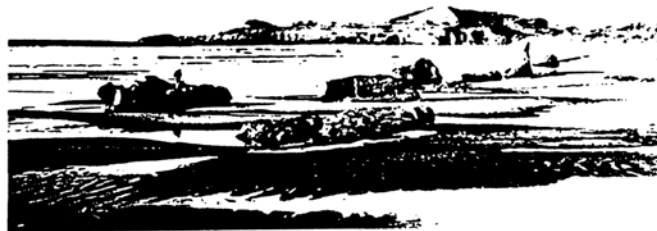
Figure 3: A series of old photographs showing the erosion of Jump-Off Joe in Newport. The erosion was initially part of the toe retreat of a large landslide, but left the sea arch in the surf zone which continued to erode. Recent bluff erosion in this area has similarly involved the cutting back of the toe of a large landslide, one that was most active during the 1940s (Sayre and Komar, 1988).

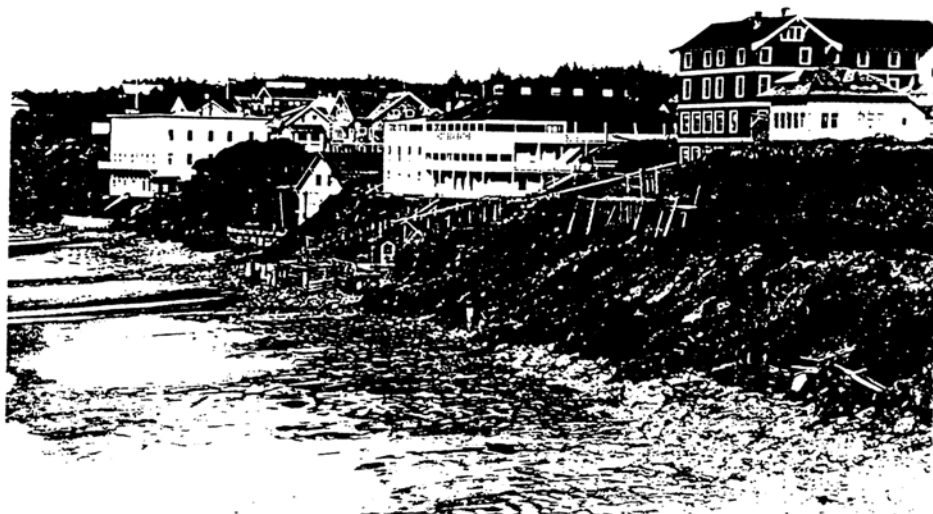
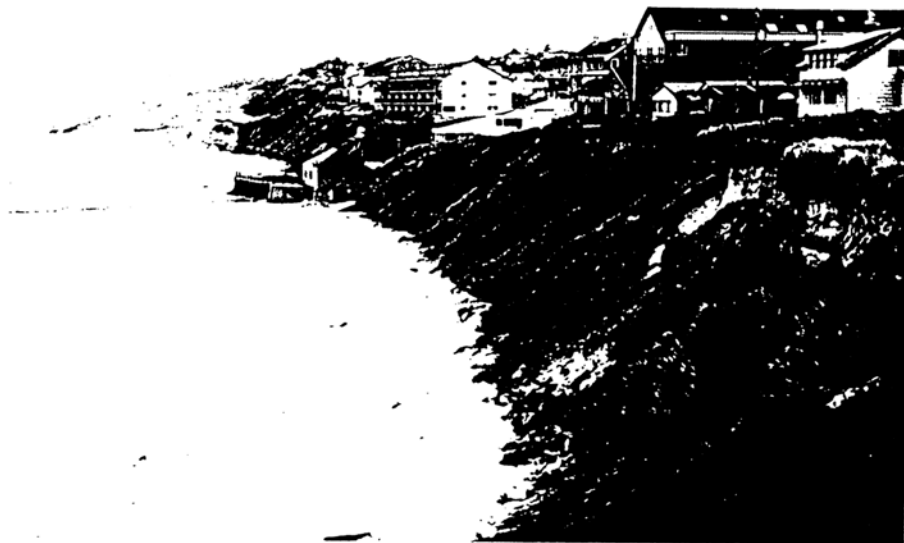
Figure 4: Historic and recent photographs of the Nye Beach area of Newport, showing that changes in the sea cliff have been negligible during this century. See the Newport Littoral Cell file for originals of photographs.

evident in the comparison of Figure 4 of a photograph taken early this century and one taken as part of this study. The cliff has remained vegetated throughout that time. There has also been no discernible change in the width or elevation of the beach.

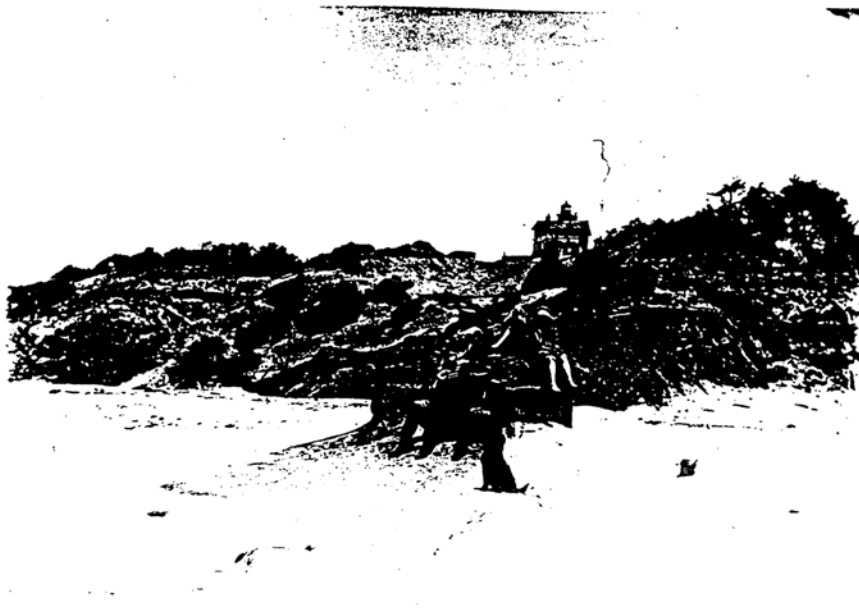
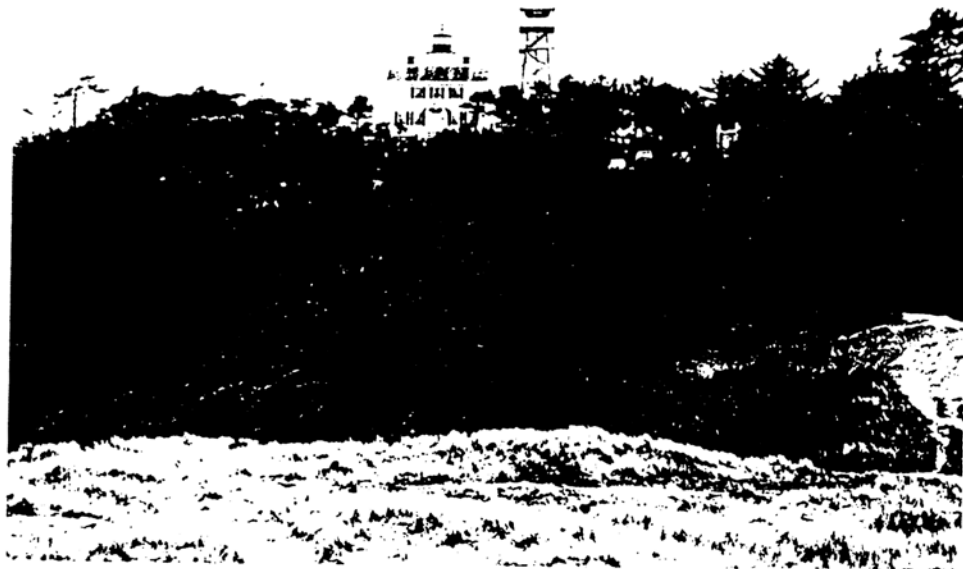
Figure 5: Historic and recent photographs of the old Newport lighthouse and fronting sea cliff. The cliff has developed a heavy cover of vegetation during this century, and an extensive field of dunes has been established fronting the cliff. See the Newport Littoral Cell file for originals of photographs.

Historic photographs are also available further to the south along the ocean shores of Newport, closer to the inlet of Yaquina Bay. The main object of the photography was the old lighthouse. Photographs from early in the century show a sea cliff relatively devoid of vegetation, Figure 5, indicating the existence of some erosion at that time, probably due to the close proximity of the bay inlet. The sea cliff in this area is now heavily vegetated, including large trees (Figure 5). The fronting beach is wide, with sizable sand dunes having built up at the back of the beach along the base of the sea cliff. These changes undoubtedly resulted from construction of the jetties at the bay mouth early in the century. A study of surveys associated with jetty construction demonstrated that sand accumulated to the immediate north and south of the jetties (Komar et al., 1976), and this beach accretion would have resulted in the protection of the sea cliffs from additional wave attack as well as the growth of sand dunes.

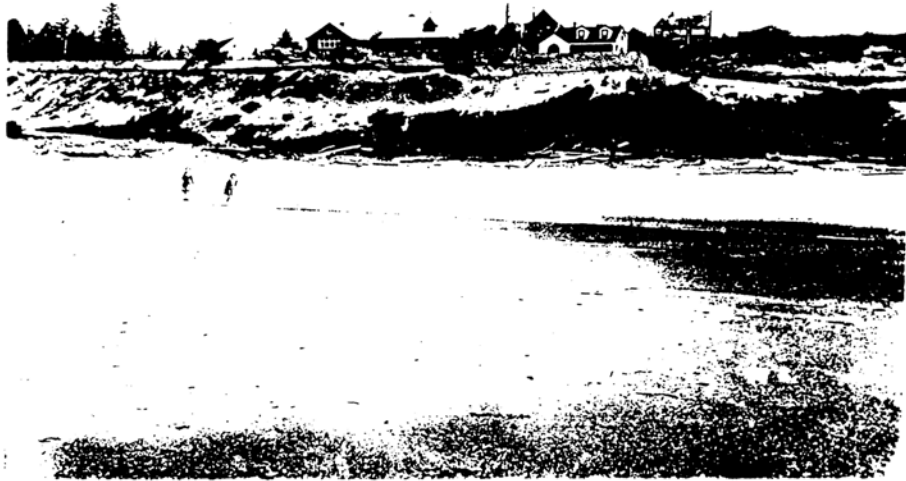
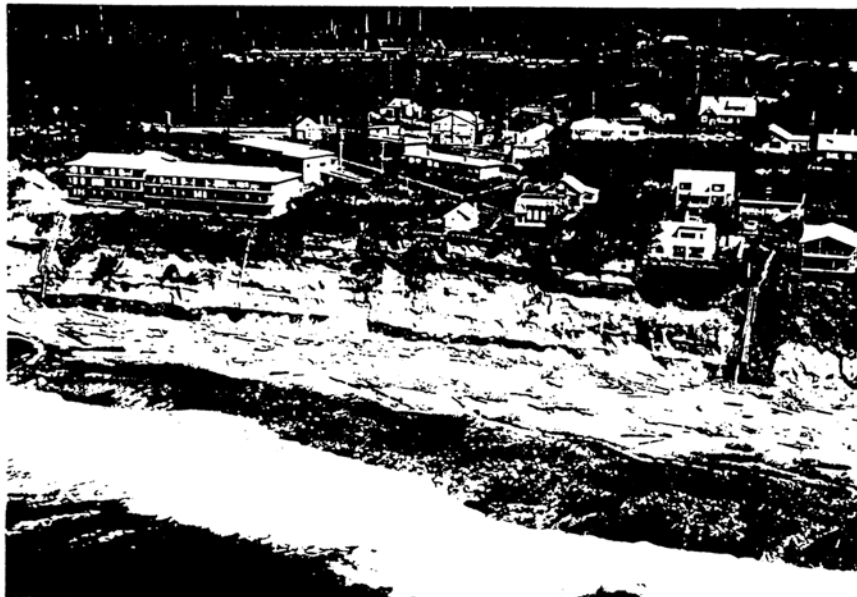
Figure 6: A photograph of Taft dating from the 1920s, compared with a more modern view. There has been little retreat of the bluff top relative to the stone wall during some 70 years. See the Lincoln City Cell file for originals of photos.

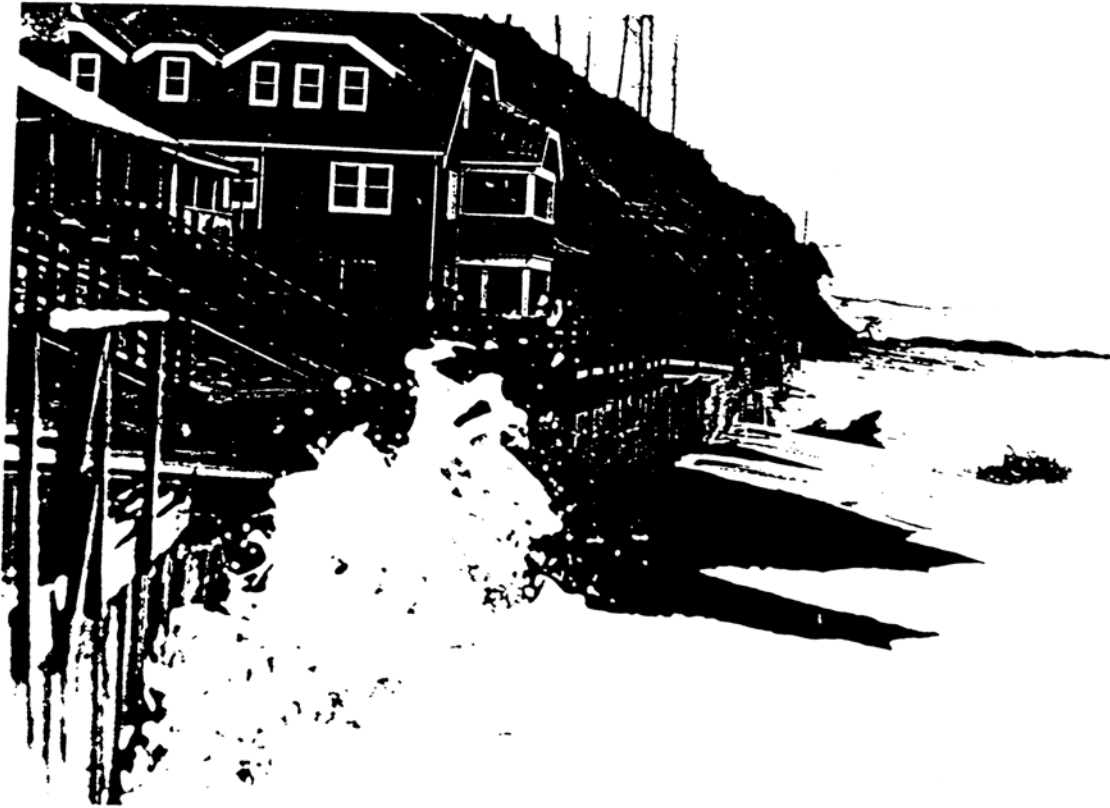
Figure 7: A 1939 photograph of the Nescott area of north Lincoln City, showing strong wave action against the bluff in an area that has not experienced wave attack in recent decades. See the Lincoln City Cell file for original photo.

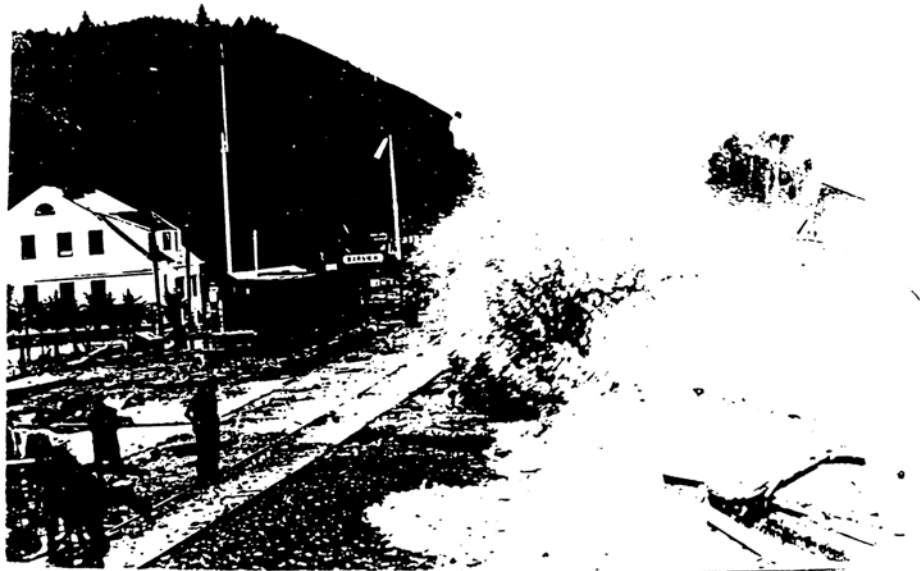
Figure 9: Wave attack at Barview along the north shore of the inlet to Tillamook Bay. See the Rockaway Cell file for the original photograph.

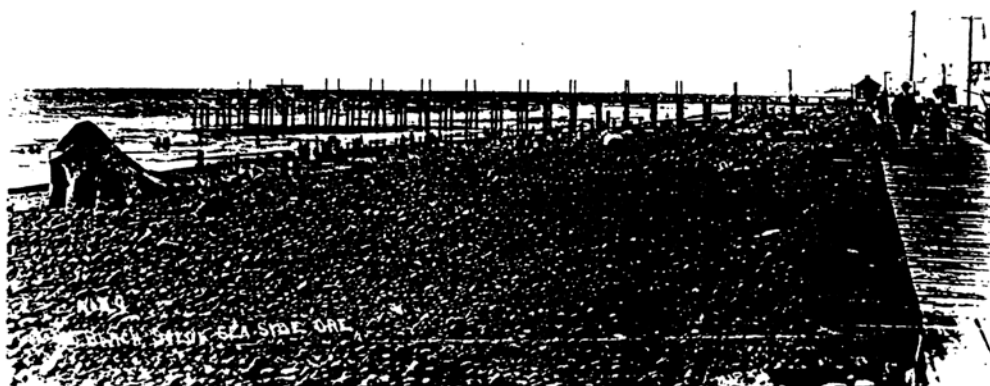
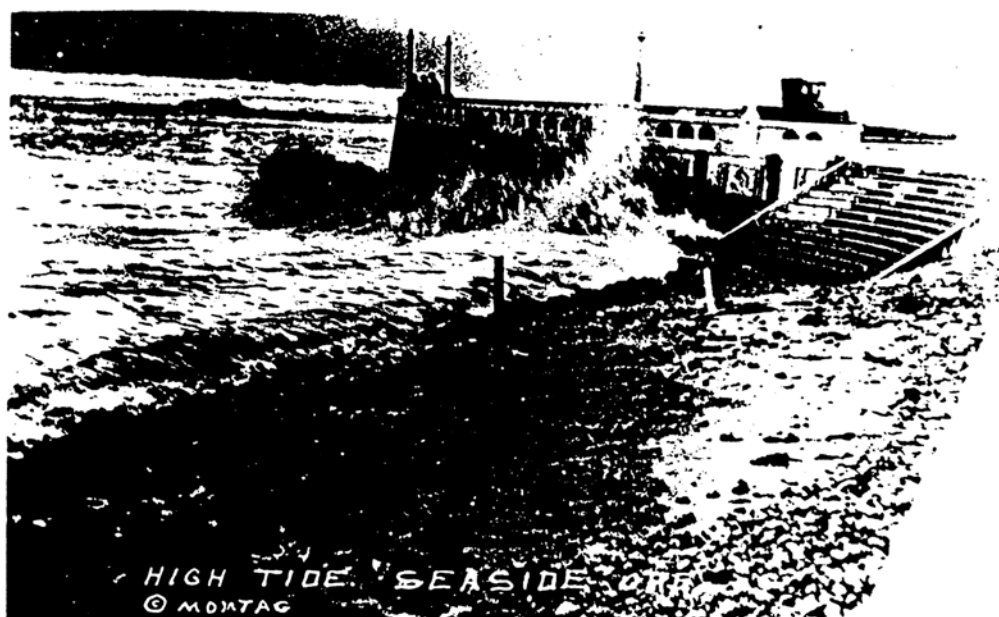
Figure 10: Historic photographs of Seaside, showing a narrow sandy beach with the exposure of gravels along the board walk, and the occurrence of waves breaking against the turn around. The area is now characterized by a wide sandy beach. See the Clatsop Plains file for originals of these photos.
