LIBRARY OPEN-FILE REPORT O-94-3

LANDSLIDE AND EROSION HAZARDS OF THE DEPOE BAY AREA, LINCOLN
COUNTY, OREGON

Prepared by
George R. Priest, Ingmar Saul, and Julie Diebenow
January 15, 1994

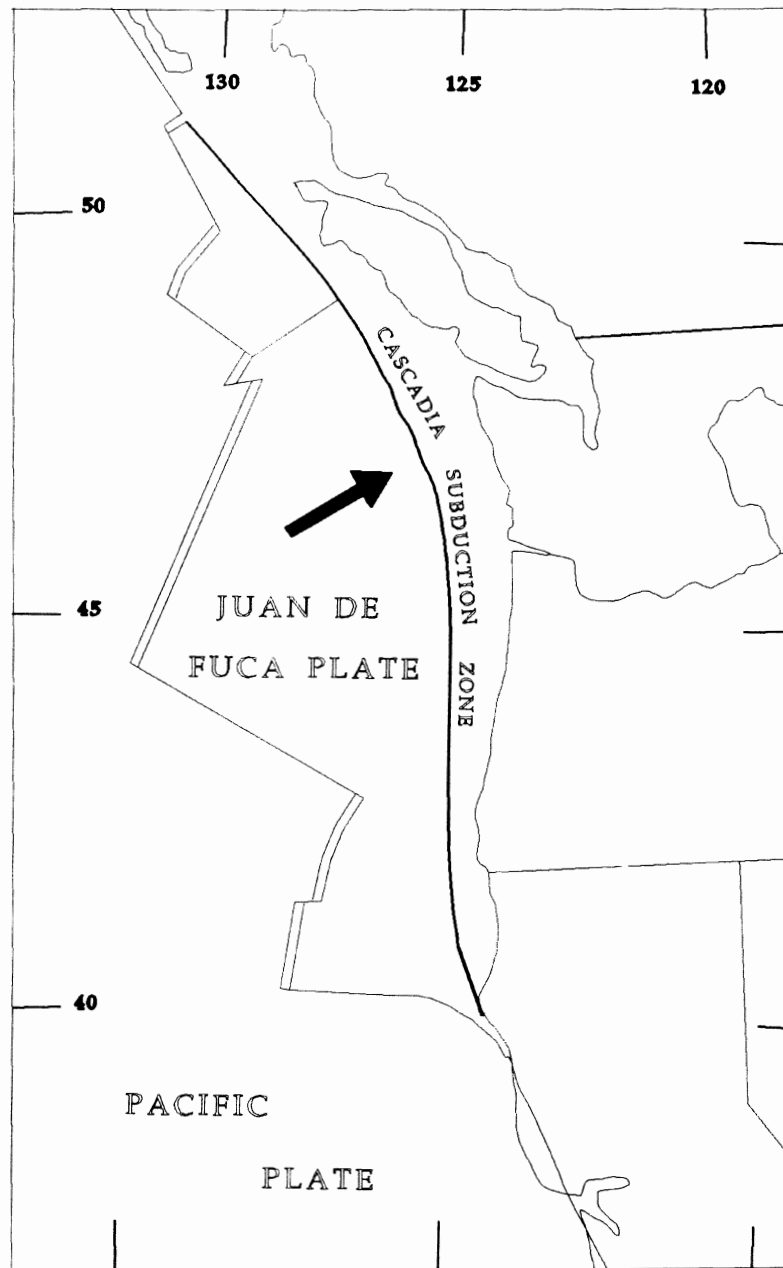
Figure 2. Plate tectonic map of the Pacific Northwest. Juan de Fuca Plate plunges beneath North America at the Cascadia Subduction Zone, one of the largest active faults in North America. Large arrow indicates direction of convergence of the Juan de Fuca Plate with North America.

The area is at risk from great (M8-9) earthquakes on the giant offshore fault known as the Cascadia subduction zone (Figure 2). Areas subject to tsunami (tidal wave) inundation, amplification of ground shaking, liquefaction (formation of quick sand or quick clay during shaking), and earthquake-induced landsliding should be mapped for land use and emergency planning. Note that historically earthquakes are more likely to cause new landslides than to reactivate old ones, so the map of previous mass movements presented here is not a proxy for a map of earthquake-induced landslide hazards.

About 100 miles offshore there is a giant highly active fault that forms the boundary between the oceanic crustal plate and the North American continental plate (Figure 2). This fault is termed the
