# Erosion and Flood Hazard Map of the Salmon River Area, Coastal Lincoln County, Oregon

OFR O-97-12

**OPEN-FILE REPORT O-97-11**

**COASTAL SHORELINE CHANGE STUDY  
NORTHERN AND CENTRAL LINCOLN COUNTY,  
OREGON**

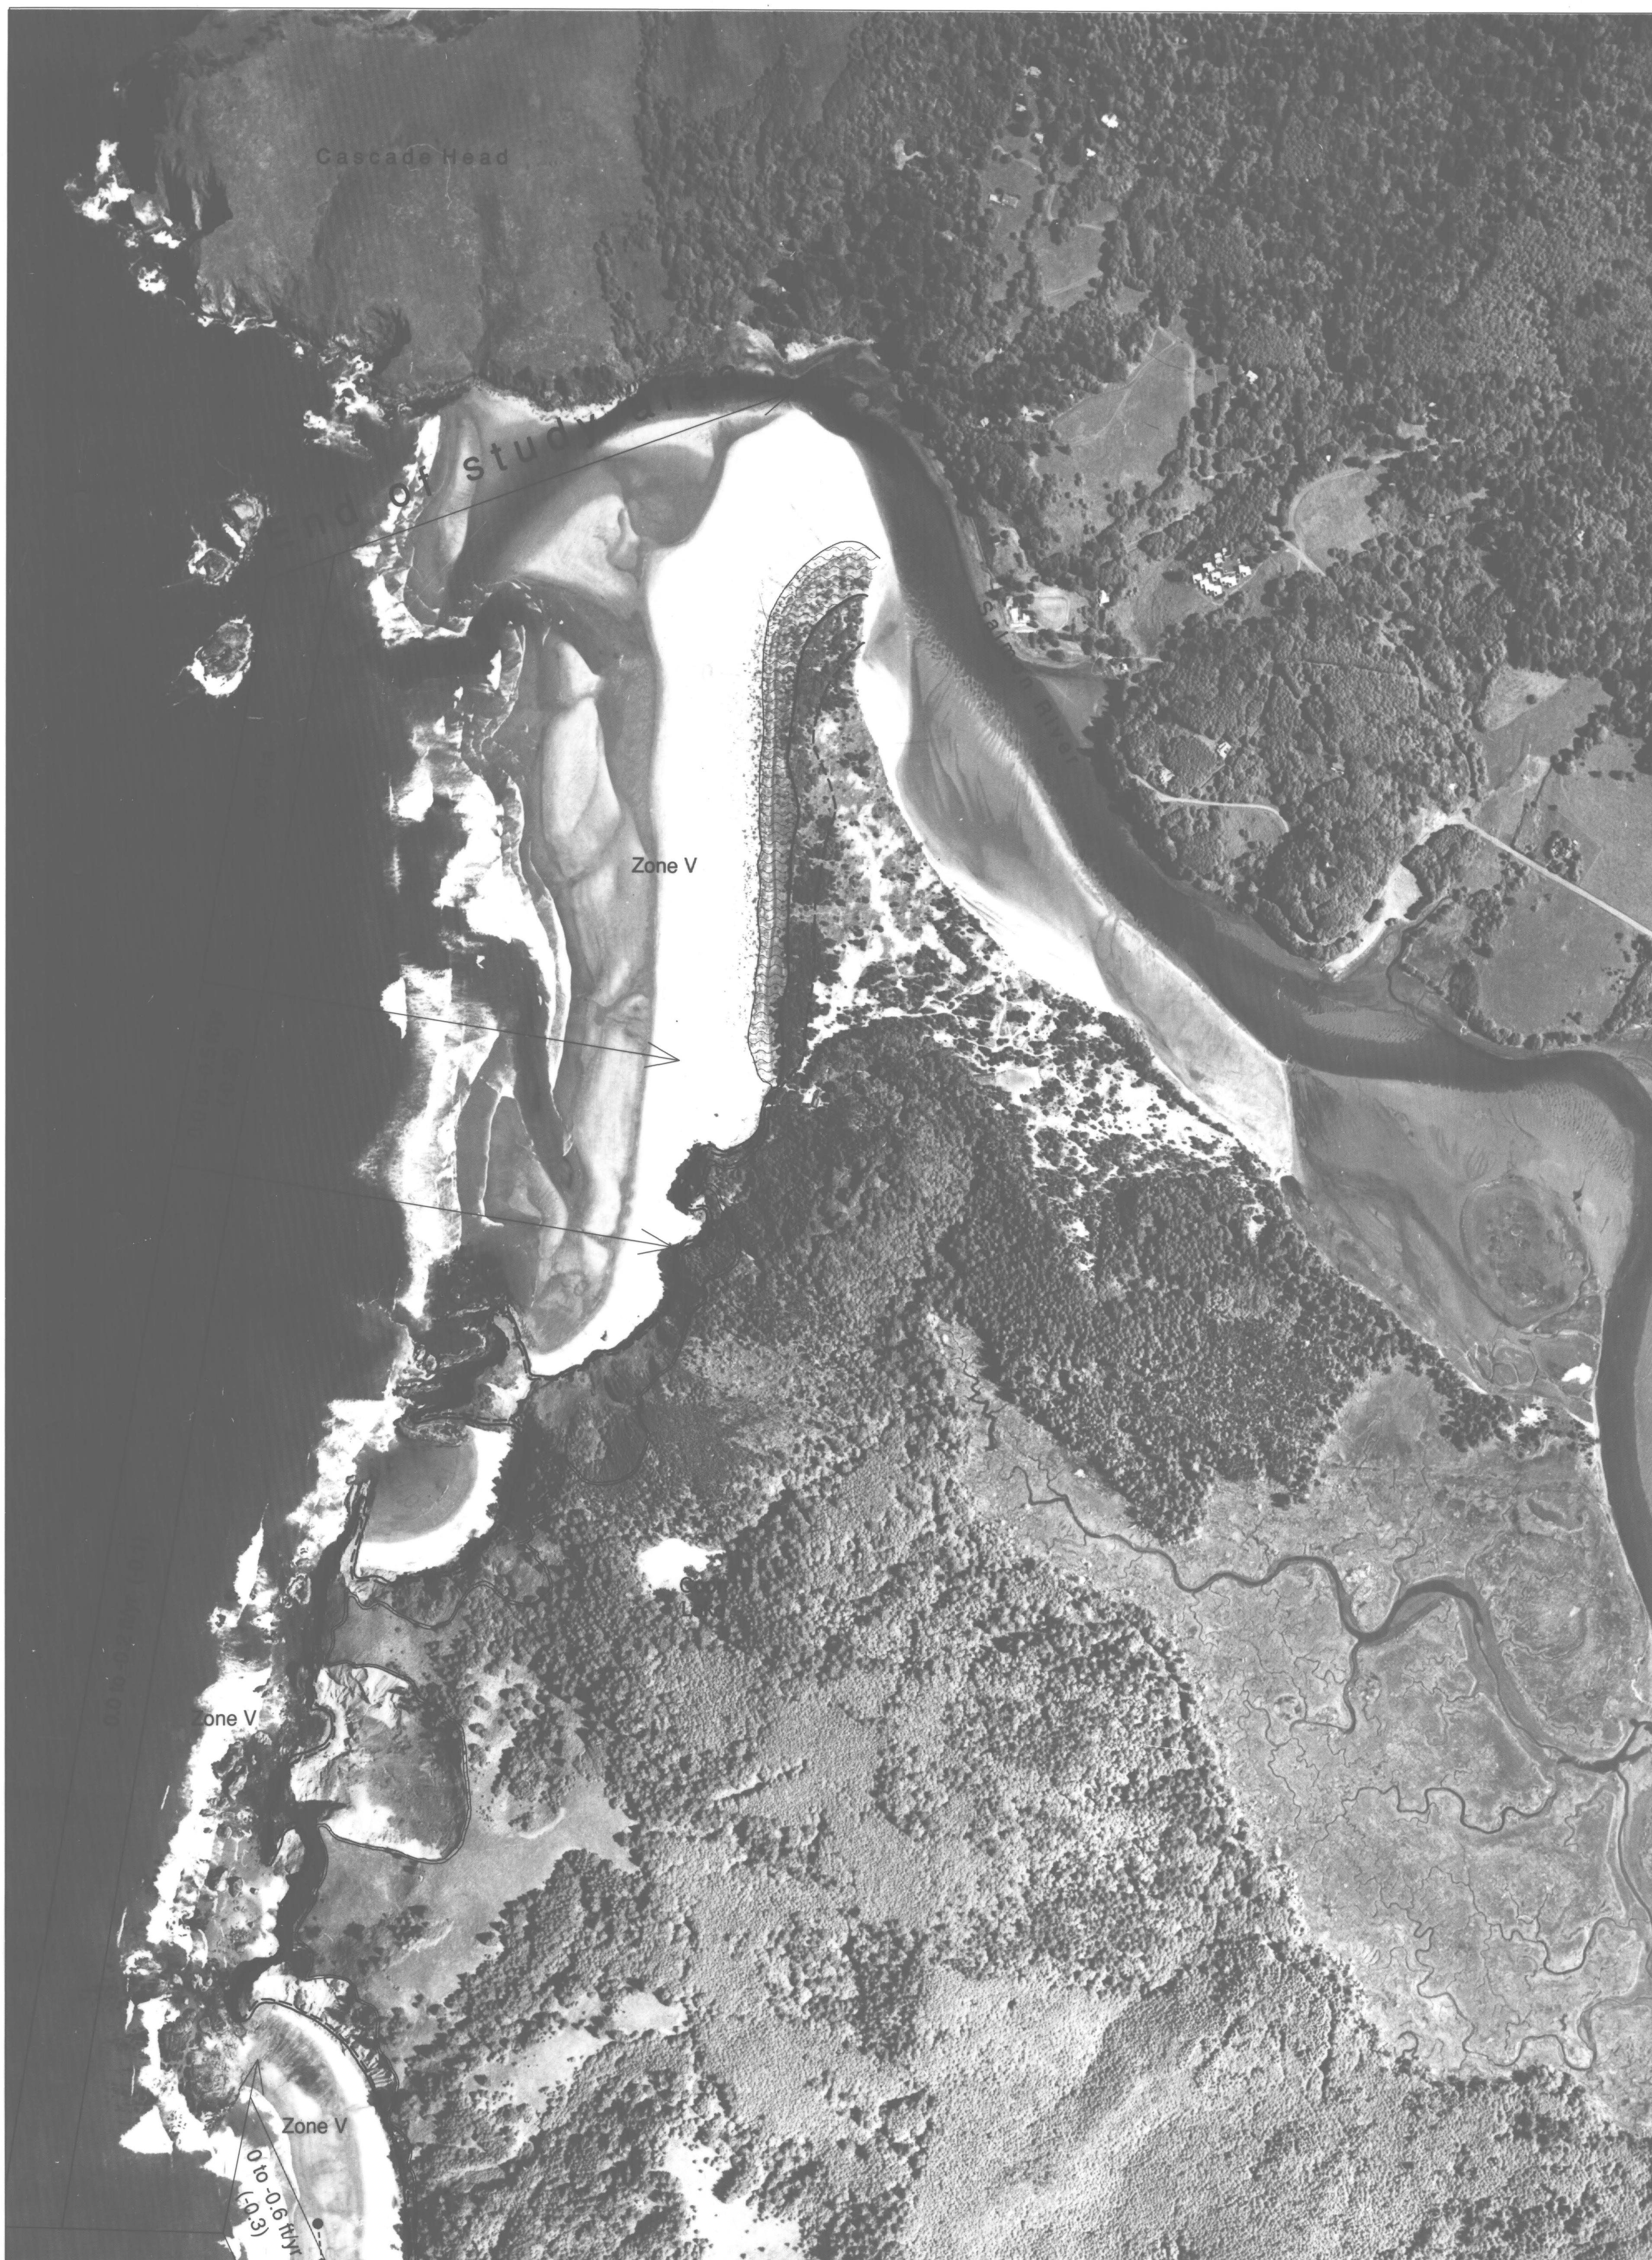
Erosion Hazard Area (EHA). Shows possible change of position during the next 50 years of an erosion reference feature (ERF) consisting of the seaward edge of a bluff, landscape headwall, or semi-permanent vegetation line on dunes or alluvium. The current position of the ERF is the seaward edge of the EHA. The EHA is directly related to coastal erosion processes. Where erosion rates are low, the width of the EHA may approach zero at the map scale and be indistinguishable from the ERF.

Indicates that the ERF is currently the headwall of an active or potentially active landslide. Note that the EHA in adjacent areas with the same mean erosion rate may reflect historical retreat of the headwalls of landslides now removed by erosion.

(EL 30) Base flood elevation in feet, where uniform within the flood zone.

Present day and 60-year positions of the 100-year flood zone boundary or V-zone boundary. Present day position is taken from Federal Insurance Rate Maps (FIRM) and Flood Hazard Boundary Map (FHBM) panels numbered 410129 00025 B (Sept. 3, 1980) of the Federal Emergency Management Agency, National Flood Insurance Program. Bold perpendicular lines separate areas of differing base flood elevations. Zone labels are as follows:

Generalized erosion rates -- Range of erosion rate (negative sign indicates erosion) at one standard deviation from the mean; mean is in parentheses; applicable to the shoreline segment marked by the arrows perpendicular to the shoreline. "No data" means there was no accurate shoreline erosion data. EHA established by other means (see "Notes to the User" below).

Mapped flood zones have been modified in some areas to better match the updated base maps of this study. The flood maps of this study should not be used in place of the official FEMA FIRMs or FHBM's. The flood boundaries mapped here were produced for a FEMA-sponsored statistical analysis of potential flood insurance losses; not for any other purpose.
