# Erosion and Flood Hazard Map of the Roads End Area, Coastal Lincoln County, Oregon

**OPEN-FILE REPORT O-97-11**

**COASTAL SHORELINE CHANGE STUDY  
NORTHERN AND CENTRAL LINCOLN COUNTY,  
OREGON**

November 1997

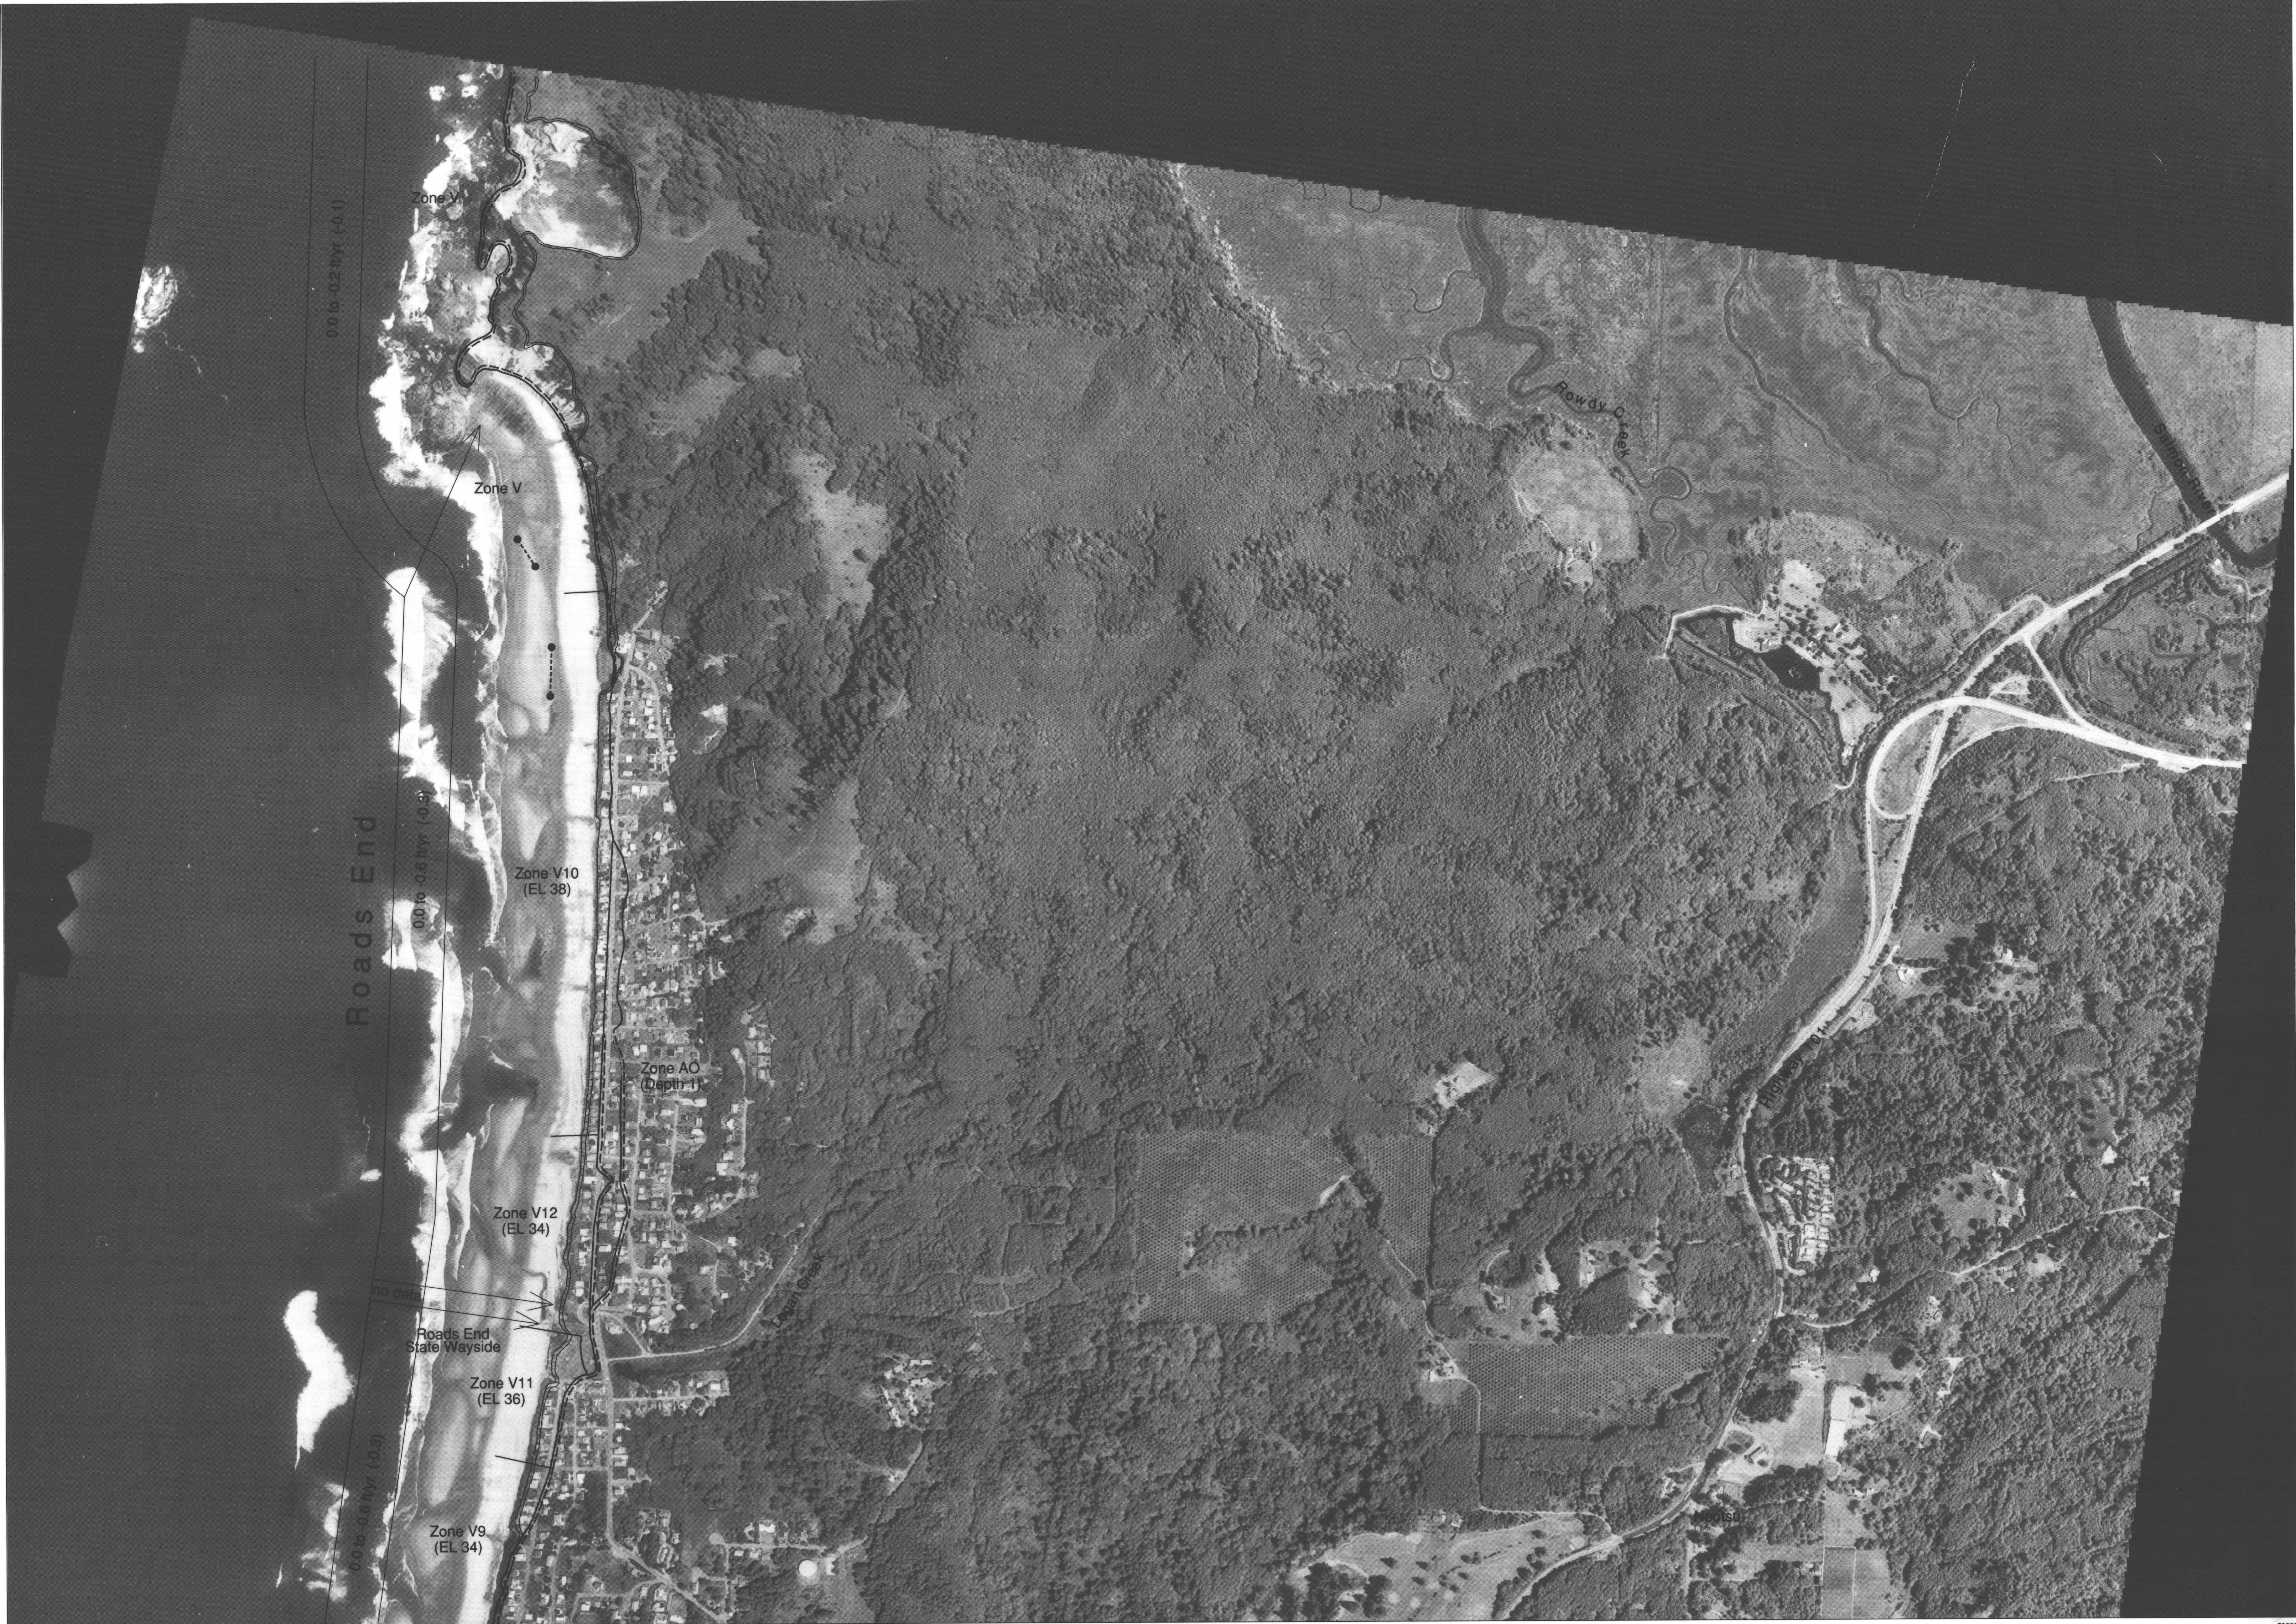
Erosion Hazard Area (EHA). Shows possible change of position during the next 60 years of an erosion reference feature (ERF) consisting of the seaward edge of a bluff, landslide headwall, or semi-permanent vegetation line on dunes or alluvium. The current position of the ERF is the seaward edge of the EHA. The EHA is directly related to coastal erosion processes. Where erosion rates are low, the width of the EHA may approach zero at the map scale and be indistinguishable from the ERF.

Indicates that the ERF is currently the headwall of an active or potentially active landslide. Note that the EHA in adjacent areas with the same mean erosion rate may reflect historical retreat of the headwall of landslides now removed by erosion.

Present day and 60-year positions of the 100-year flood zone boundary or V-zone boundary. Present day position is taken from Federal Insurance Rate Maps (FIRMs) and Flood Hazard Boundary Maps (FHBM) panels numbered 410125 00025 B (Sept. 3, 1980) of the Federal Emergency Management Agency, National Flood Insurance Program. Bold perpendicular lines separate areas of differing base flood elevations. Zone labels are as follows:

Generalized erosion rates - Range of erosion rate (negative sign indicates erosion) at one standard deviation from the mean; mean is in parentheses; applicable to the shoreline segment marked by the arrows perpendicular to the shoreline. "No data" means there was no accurate shoreline erosion data. EHA established by other means (see "Notes to the User" below).
