Erosion and Flood Hazard Map of the Lincoln City-Wecoma Beach Area, Coastal Lincoln County, Oregon

**OPEN-FILE REPORT O-97-11**

**COASTAL SHORELINE CHANGE STUDY  
NORTHERN AND CENTRAL LINCOLN COUNTY,  
OREGON**

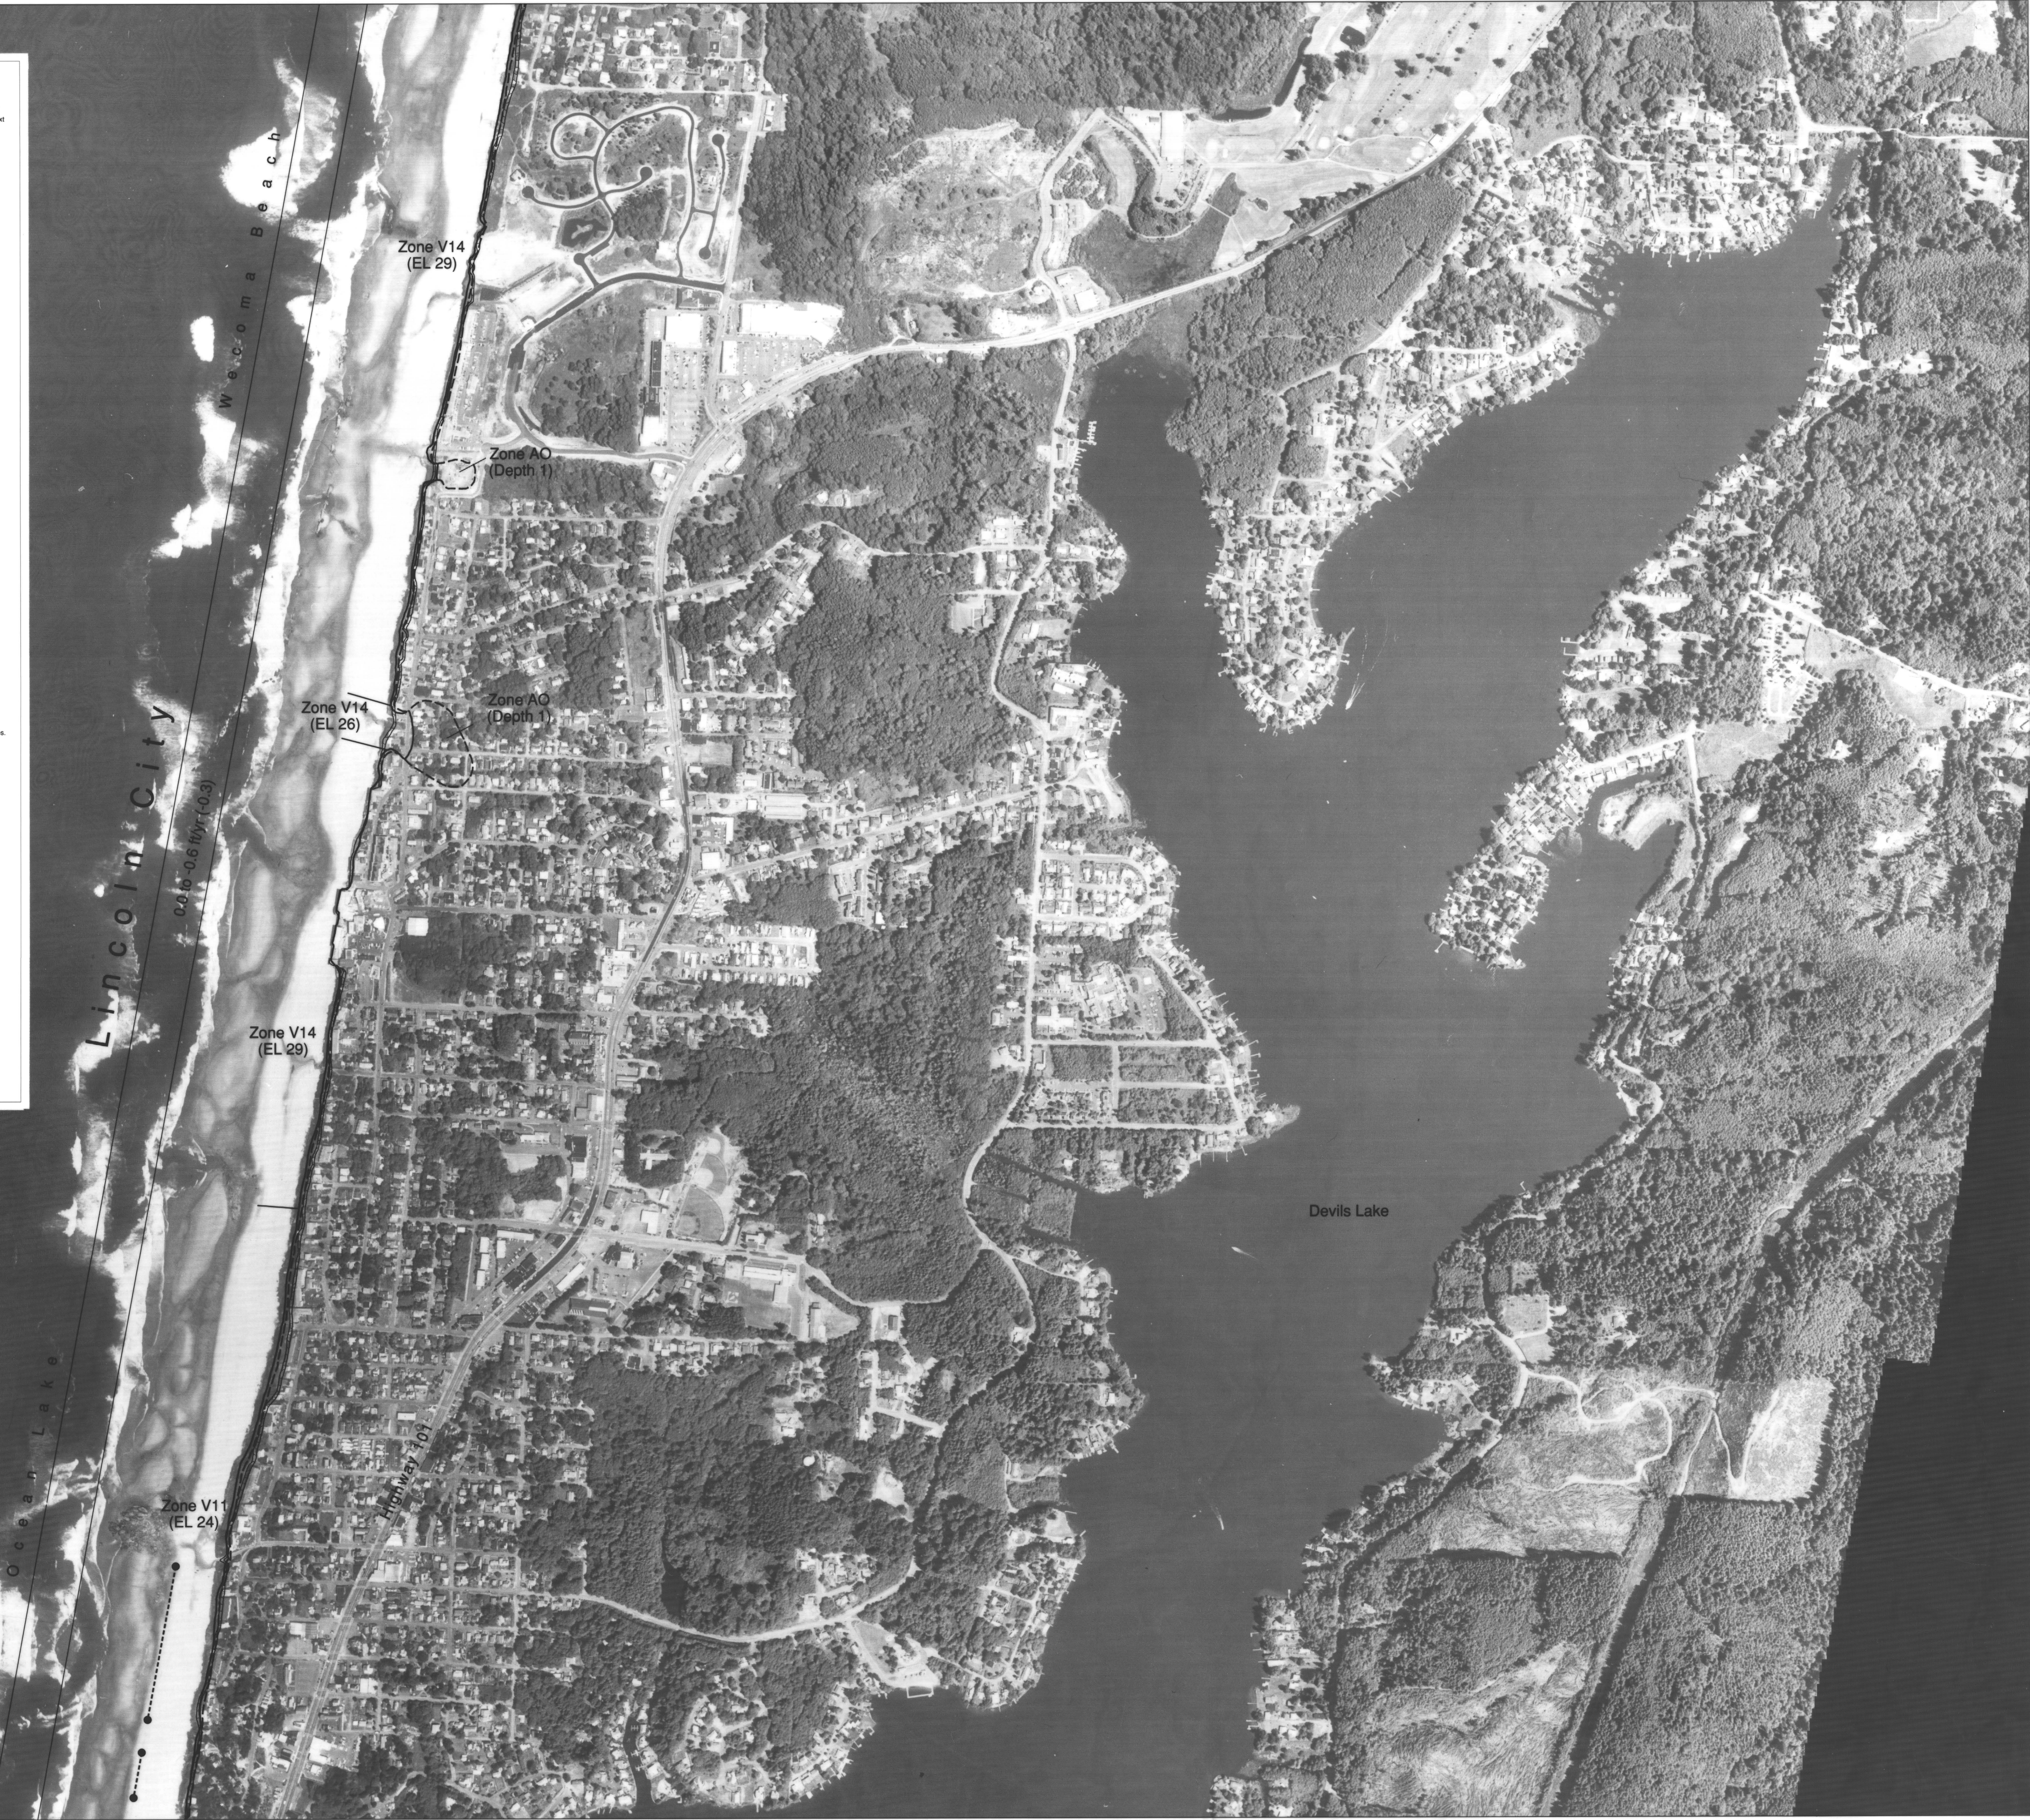
Erosion Hazard Area (EHA). Shows possible change of position during the next 60 years of an erosion reference feature (ERF) consisting of the seaward edge of a bluff, landslide headwall, or semi-permanent vegetation line on dunes or alluvium. The current position of the ERF is the seaward edge of the EHA. The EHA is directly related to coastal erosion processes. Where erosion rates are low, the width of the EHA may approach zero at the map scale and be indistinguishable from the ERF.

Indicates that the ERF is currently the headwall of an active or potentially active landslide. Note that the EHA in adjacent areas with the same mean erosion rate may reflect historical retreat of the headwall of landslides now removed by erosion.

Present day and 60-year positions of the 100-year flood zone boundary or V-zone boundary. Present day position is taken from Federal Insurance Rate Maps (FIRM) and Flood Hazard Boundary Map (FHBM) panels numbered 10150 001 B (April 17, 1976) of the Federal Emergency Management Agency, National Flood Insurance Program. Bold perpendicular lines separate areas of differing base flood elevations. Zone labels are as follows:

Generalized erosion rates. -- Range of erosion rate (negative sign indicates erosion) at one standard deviation from the mean; mean is in parentheses; applicable to the shoreline segment marked by the arrows perpendicular to the shoreline. "No data" means there was no accurate shoreline erosion data. EHA established by other means (see "Notes to the User" below).

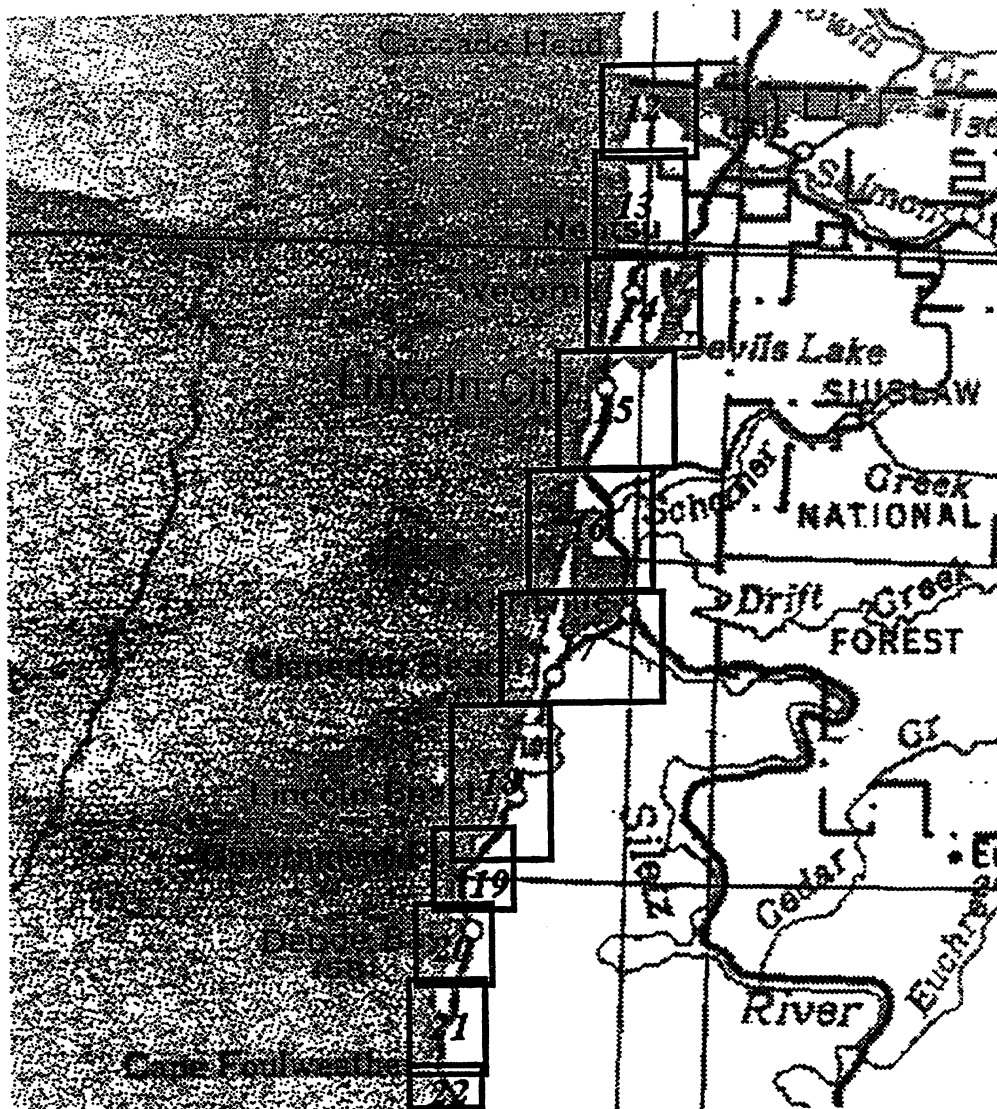
Figure 1. Location index for maps numbered O-97-12 through O-97-21.

The Oregon Department of Geology and Mineral Industries (DOGAMI) used coastal erosion rate data to produce maps of current and 60-year positions of the coastline and 100-year coastal flood zones in northern and central Lincoln County, Oregon. Nineteen 1:4800 (1" = 400')-scale maps illustrate the current and 60-year positions of an erosion reference feature (ERF) and the 100-year coastal flood zone or storm wave velocity zone (V zone) (Appendix B; Figures 1 and 2). The 60-year positions were estimated from a 1991-1993 study of coastal erosion (Priest and others, 1993; 1994) supported by the Federal Emergency Management Agency (FEMA). National Flood Insurance Program (NFIP), and the Department of Land Conservation and Development (DLCD) under the auspices of the National Oceanographic and Atmospheric Administration (NOAA) Coastal 309 program. The 1991-1993 study was published as 19 geologic hazard maps (Open-File Reports O-94-12 to O-94-30) and as a report (DOGAMI Open-File Report O-94-11; Priest and others, 1994). These same map bases are used here with the same numbering system (Figures 1 and 2).

An erosion reference feature (ERF) was mapped along 31 miles of the Oregon coast from Cascade Head on the north to Seal Rocks on the south (Figures 1 and 2). The ERF on bluffed shorelines is defined as the break in slope that results directly from wave erosion or from mass movements triggered by wave erosion (Figure 3). On bluffed shorelines with zones of mass movement (i.e. earth flows, landslides, slumps, or translational slide blocks) the ERF is the top of the headwall (Figure 3).

Submitted separately from this report are nineteen 1:4800-scale orthophotographic and non-rectified photographic maps showing the EHA and projected change in the 100-year flood zone over the next 60 years. Corner coordinates for the orthophotographs are given in Table 1. Locations of the all maps are given in Figures 1 and 2. Field data for the maps is summarized by Priest and others (1993; 1994).

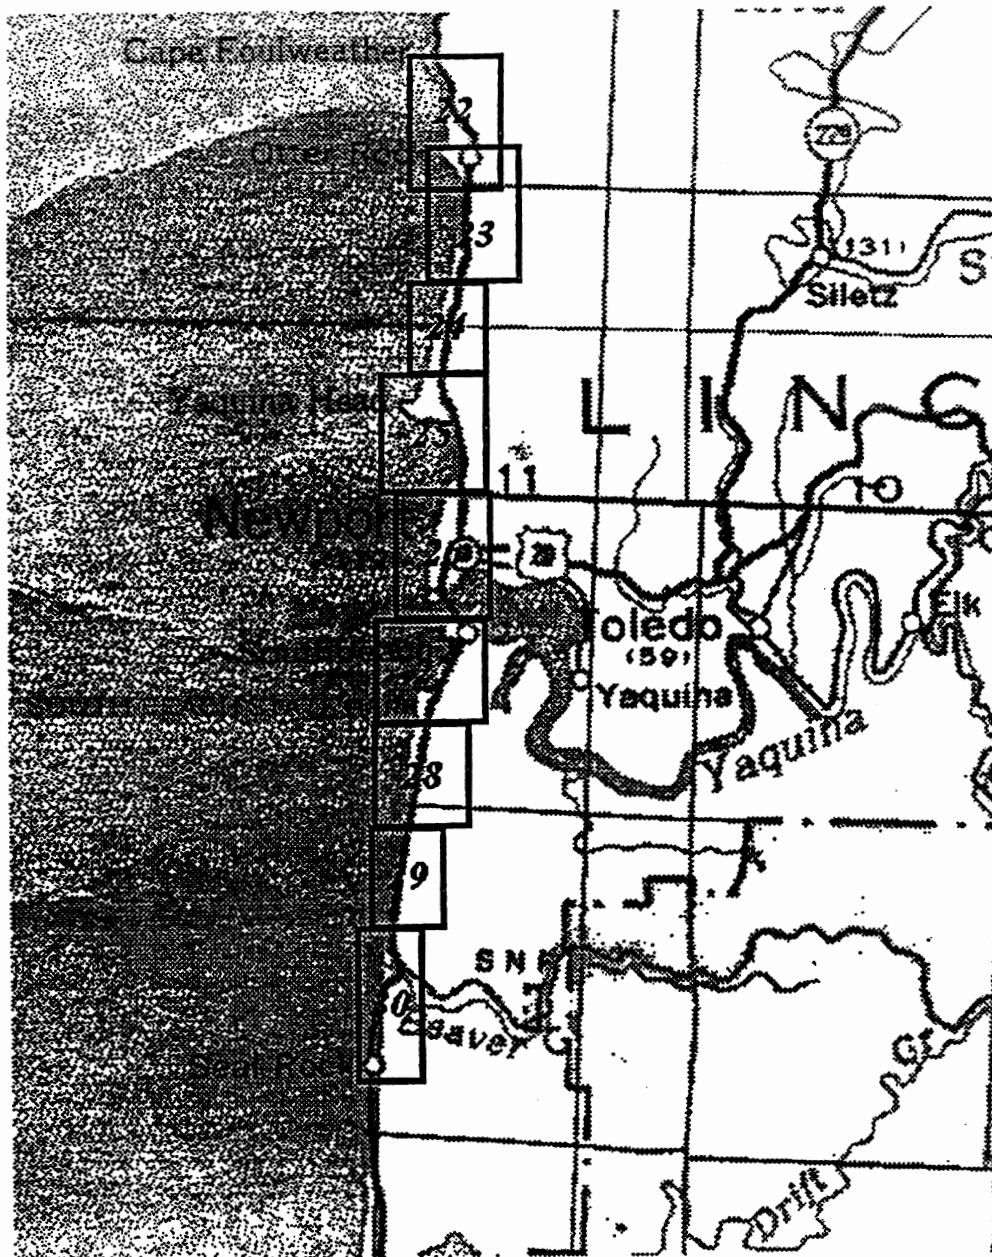
Figure 2. Location index for Open-File Report maps numbered O-97-22 through O-97-30.

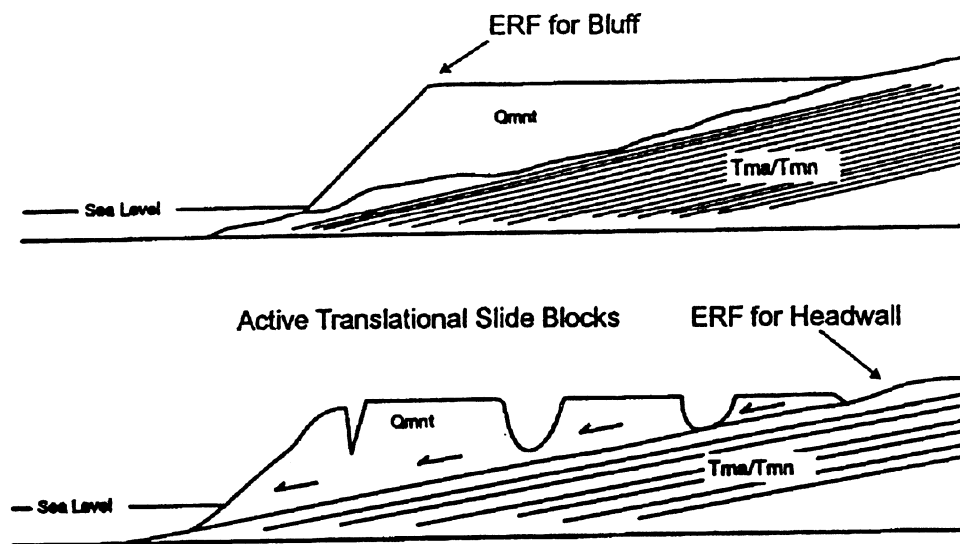
Figure 3. Erosion reference feature (ERF) for a bluff (top) and a landslide (bottom). Figure is modified from Rinne (1992).

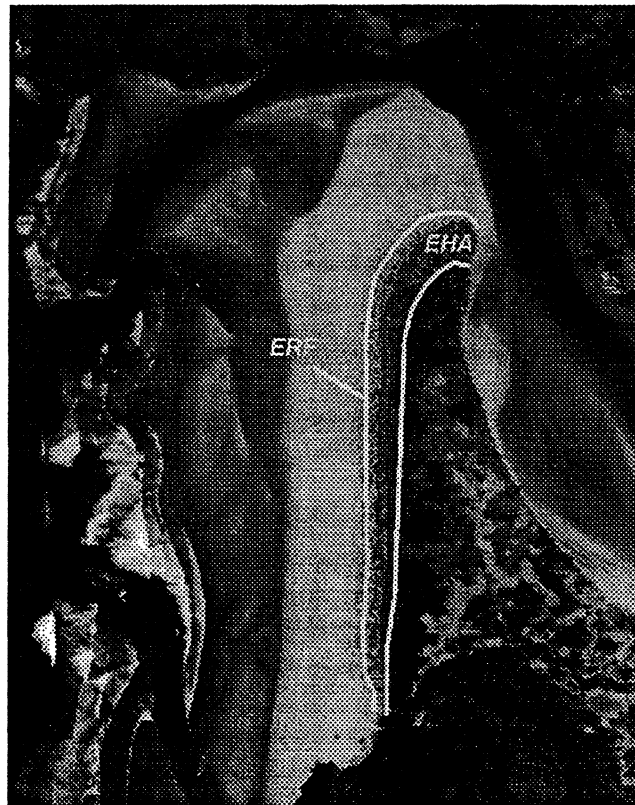
*Figure 4. Salmon River estuary showing the EHA defined by placing the ERF at the seaward edge of stable beach grass and the 60-year ERF at the edge of the zone of stable trees and shrubs. The assumption is that the shrub and tree zone took decades to develop and will persist.*

The zone of instability at dune-backed shorelines was in general inferred from erosion rate data based on changes in position of the storm surge penetration line between historical aerial photography flown in 1939, 1967, and 1991 (Priest and others, 1993; 1994). This data was supplemented by qualitative observations of the density of vegetation and the presence or absence of an indurated or semi-indurated bluff behind the duned area. Sharp decreases in the density of vegetation from grasses to more permanent shrubs and trees frequently mark the current landward boundaries of zones of shoreline instability. The grassy areas are zones of shoreline change on unknown time scales in many cases difficult to judge from the observation window afforded by the historical photography. In some cases the zones of vegetation were the best data available. In these cases, an EHA was mapped by assuming that the ERF was at the seaward edge of the grassy zone and the EHA the same width as the current zone of grassy dune (Figure 4). The assumption is that the tree and shrub zone takes decades to develop and will persist for 60 years.

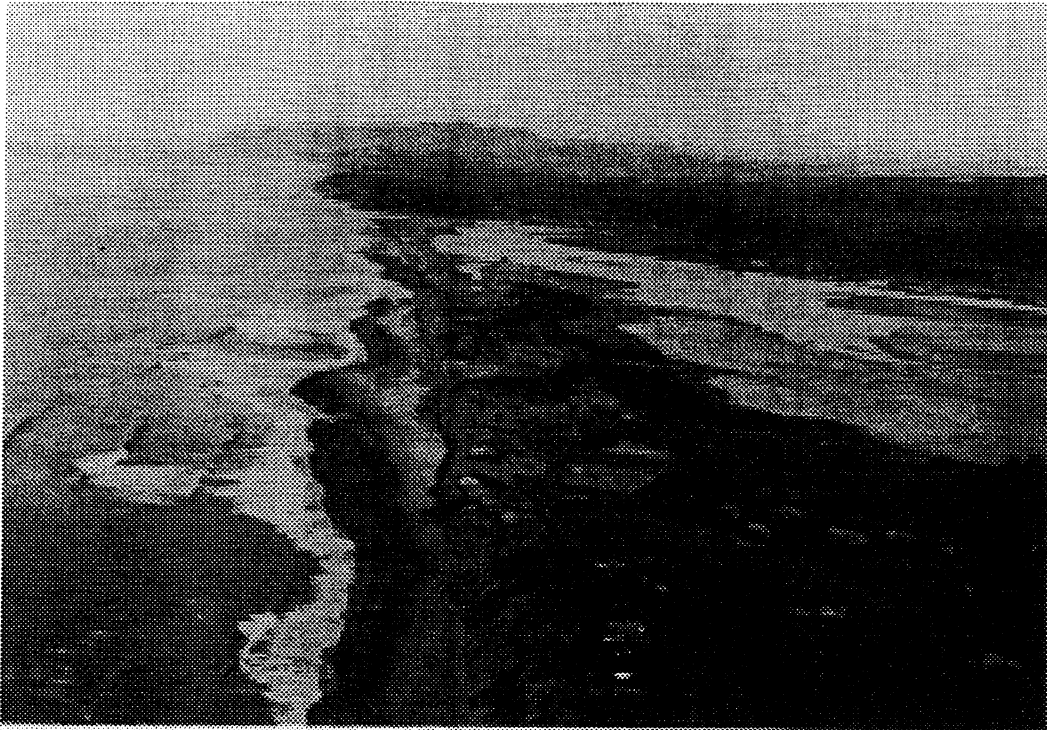
*Figure 5. Oblique aerial photograph of Salishan Spit in 1972 illustrating the stable forested portion versus the unstable, nearly barren end, where erosion occurs from both sides. The reflective beach is characterized by many deep rip current embayments, where most erosion occurs (photograph taken from Komar (1992a)).*

The widest EHA's occurred on dune-backed shorelines, which comprise about 19 percent of the study area. The zone of shoreline instability in these areas varied from widths on the order of 25 feet for very stable areas to several hundred feet at the end of Salishan Spit. The large zone of variability on the Spit is caused by erosion from both sides. The estuarine channel of the Siletz River lies on the back side, while a steep reflective beach lies on the seaward side (Figures 5 and 6; Komar and Rea, 1976).

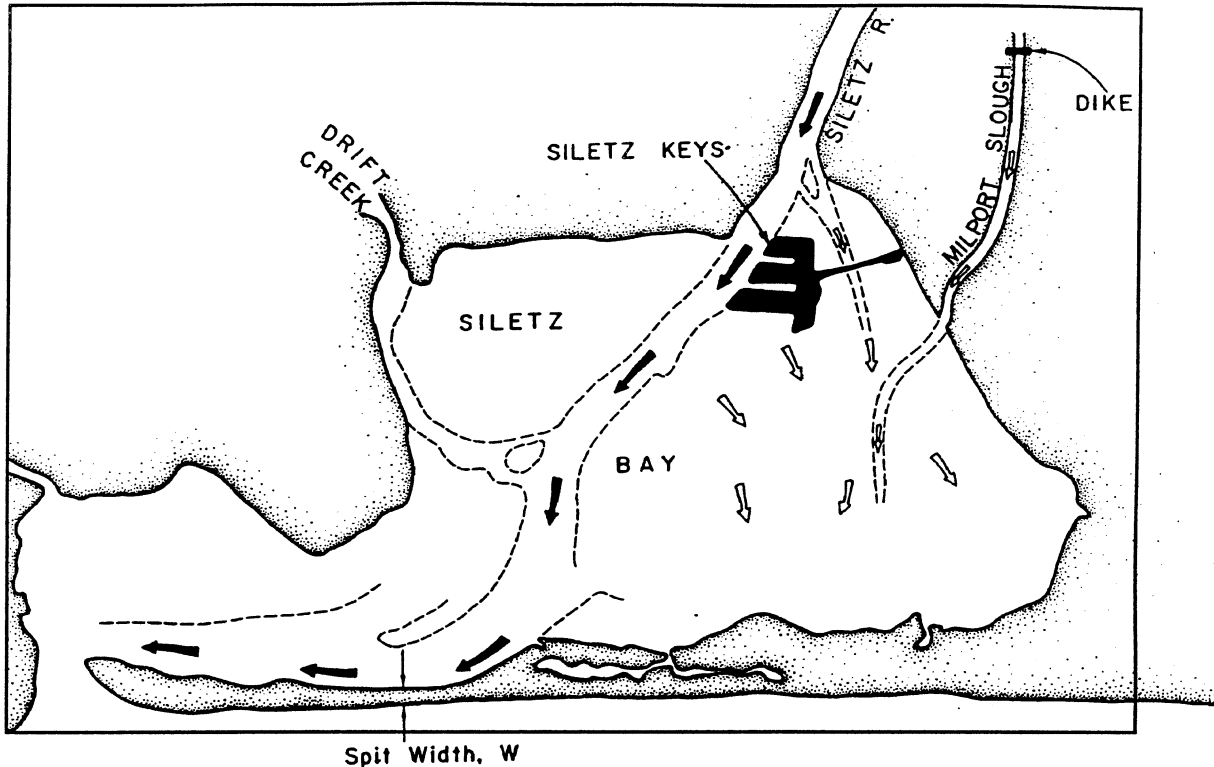
*Figure 6.* Circulation within Siletz Bay showing how erosion is focused on the thinnest part of the spit. Fills and dikes in the Siletz Keys-Millport Slough area aggravate the problem by preventing flood waters from spilling over into the south Bay. Figure from Komar and Rea (1976).

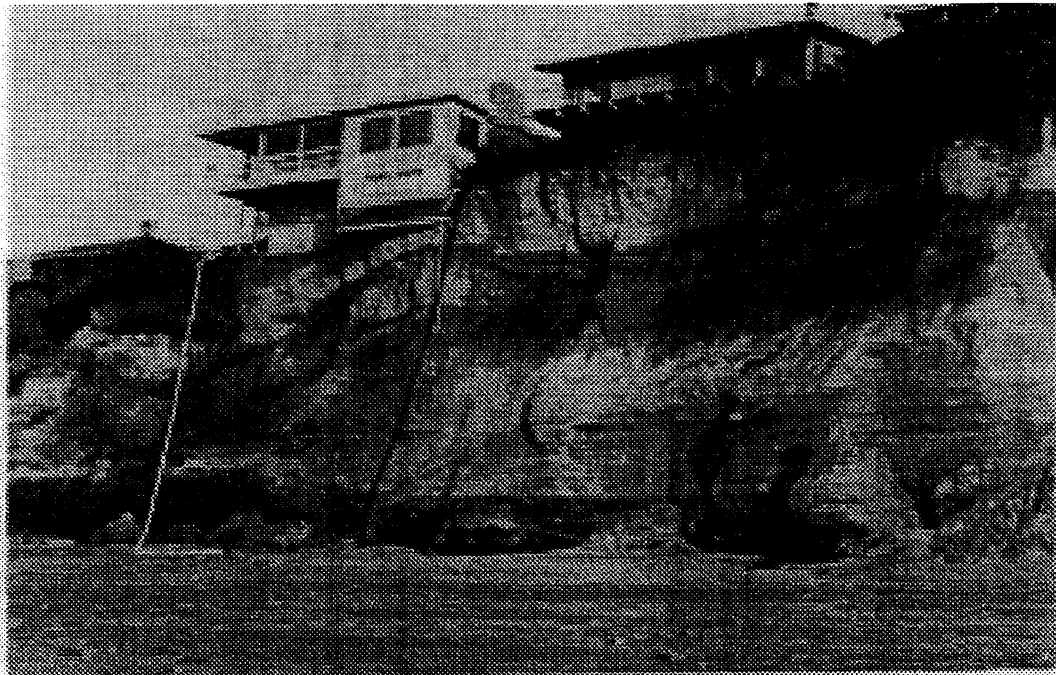
*Figure 7. Gleneden Beach houses (northern part of the study area) built so close to the sea cliff that an episode of erosion nearly caused collapse of one structure during a single winter storm. Photograph taken from Komar (1992b).*

that there is no risk involved in these areas, because many buildings are within a few feet or tens of feet from the edge of sea cliffs (Figure 7). Likewise, the error (68 percent confidence) on the mean EHA width is on the order of 80-100 percent, so local property losses could be much higher or lower than the mean.

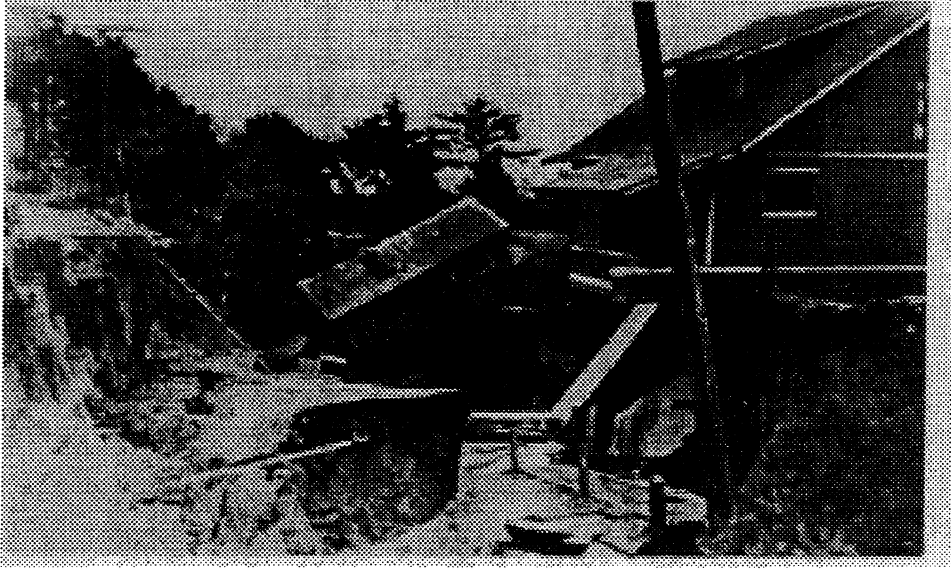
*Figure 8. The 1942-43 landslide at Jumpoff Joe, Newport, Oregon showing destruction of homes at the headwall of the landslide. Photo taken from Lincoln County Historical Society.*

the block. This block movement is on the same scale as block failures affecting the geologically similar Jumpoff Joe area, where whole neighborhoods began to slide seaward in the 1940's (Figures 8 and 9; Priest and others, 1993). The mean 60-year EHA at Jumpoff Joe is  $81 \pm 38$  feet. These data illustrate the potential problem with using mean erosion rates to predict episodic processes.

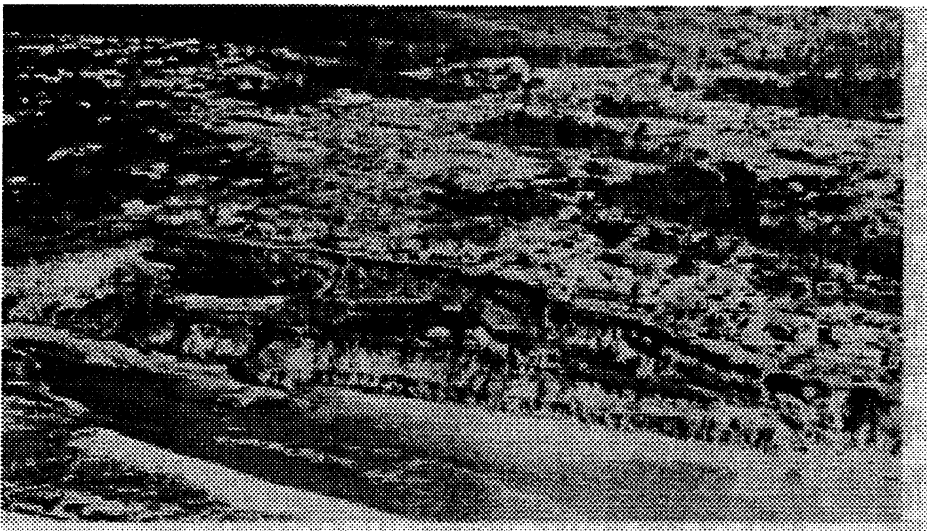
*Figure 9. Oblique aerial photograph of central Newport taken in 1961 after the Jumpoff Joe slide block had moved further down slope and seaward than the initial movements in the 1940's. Photograph taken from the Lincoln County Historical Society.*

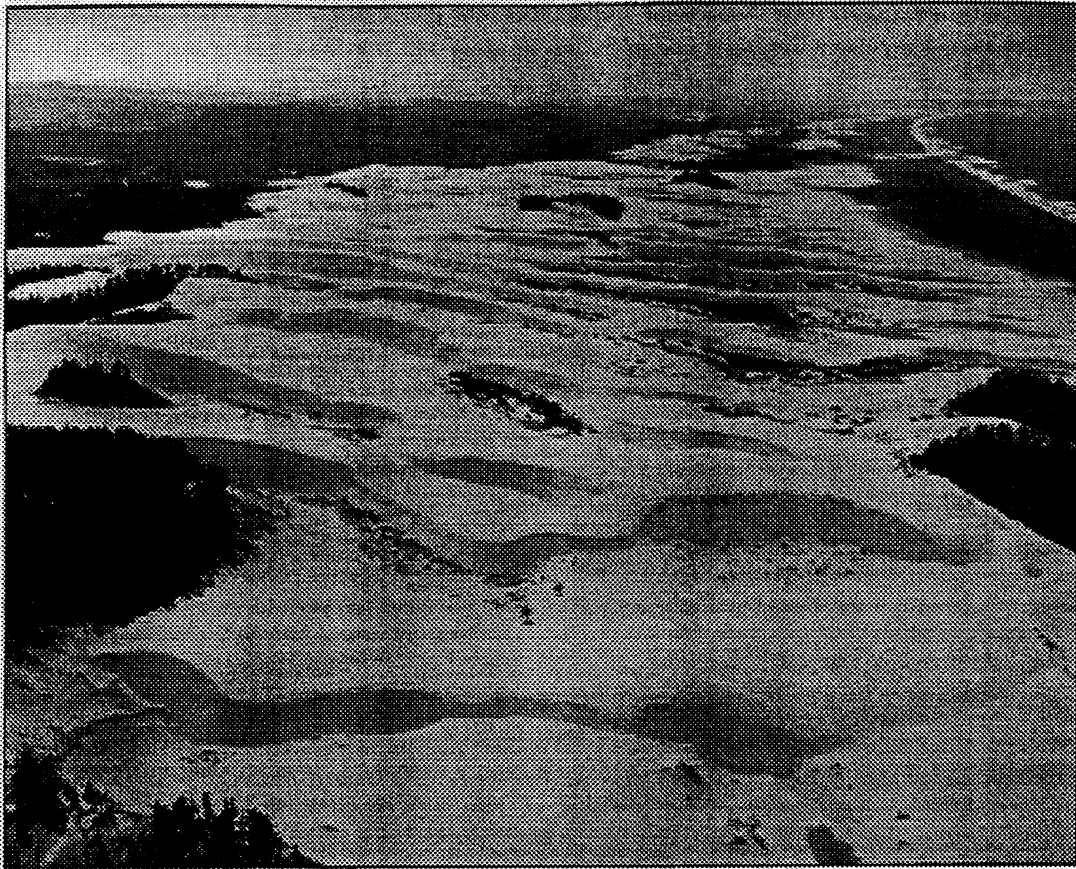
*The central Oregon coast dune sheet extends nearly 50 miles and includes dunes up to 700 feet high (ODOT photo).*

*Figure 10. Oblique aerial photograph taken from Oregon Department of Transportation archives, showing a typical undeveloped dune-backed shoreline of the south central Oregon coast.*
