# Erosion and Flood Hazard Map of the Cape Foulweather-Whale Cove Area, Coastal Lincoln County, Oregon

OFR O-97-21  
By George R. Priest

**OPEN-FILE REPORT O-97-11**

**COASTAL SHORELINE CHANGE STUDY  
NORTHERN AND CENTRAL LINCOLN COUNTY,  
OREGON**

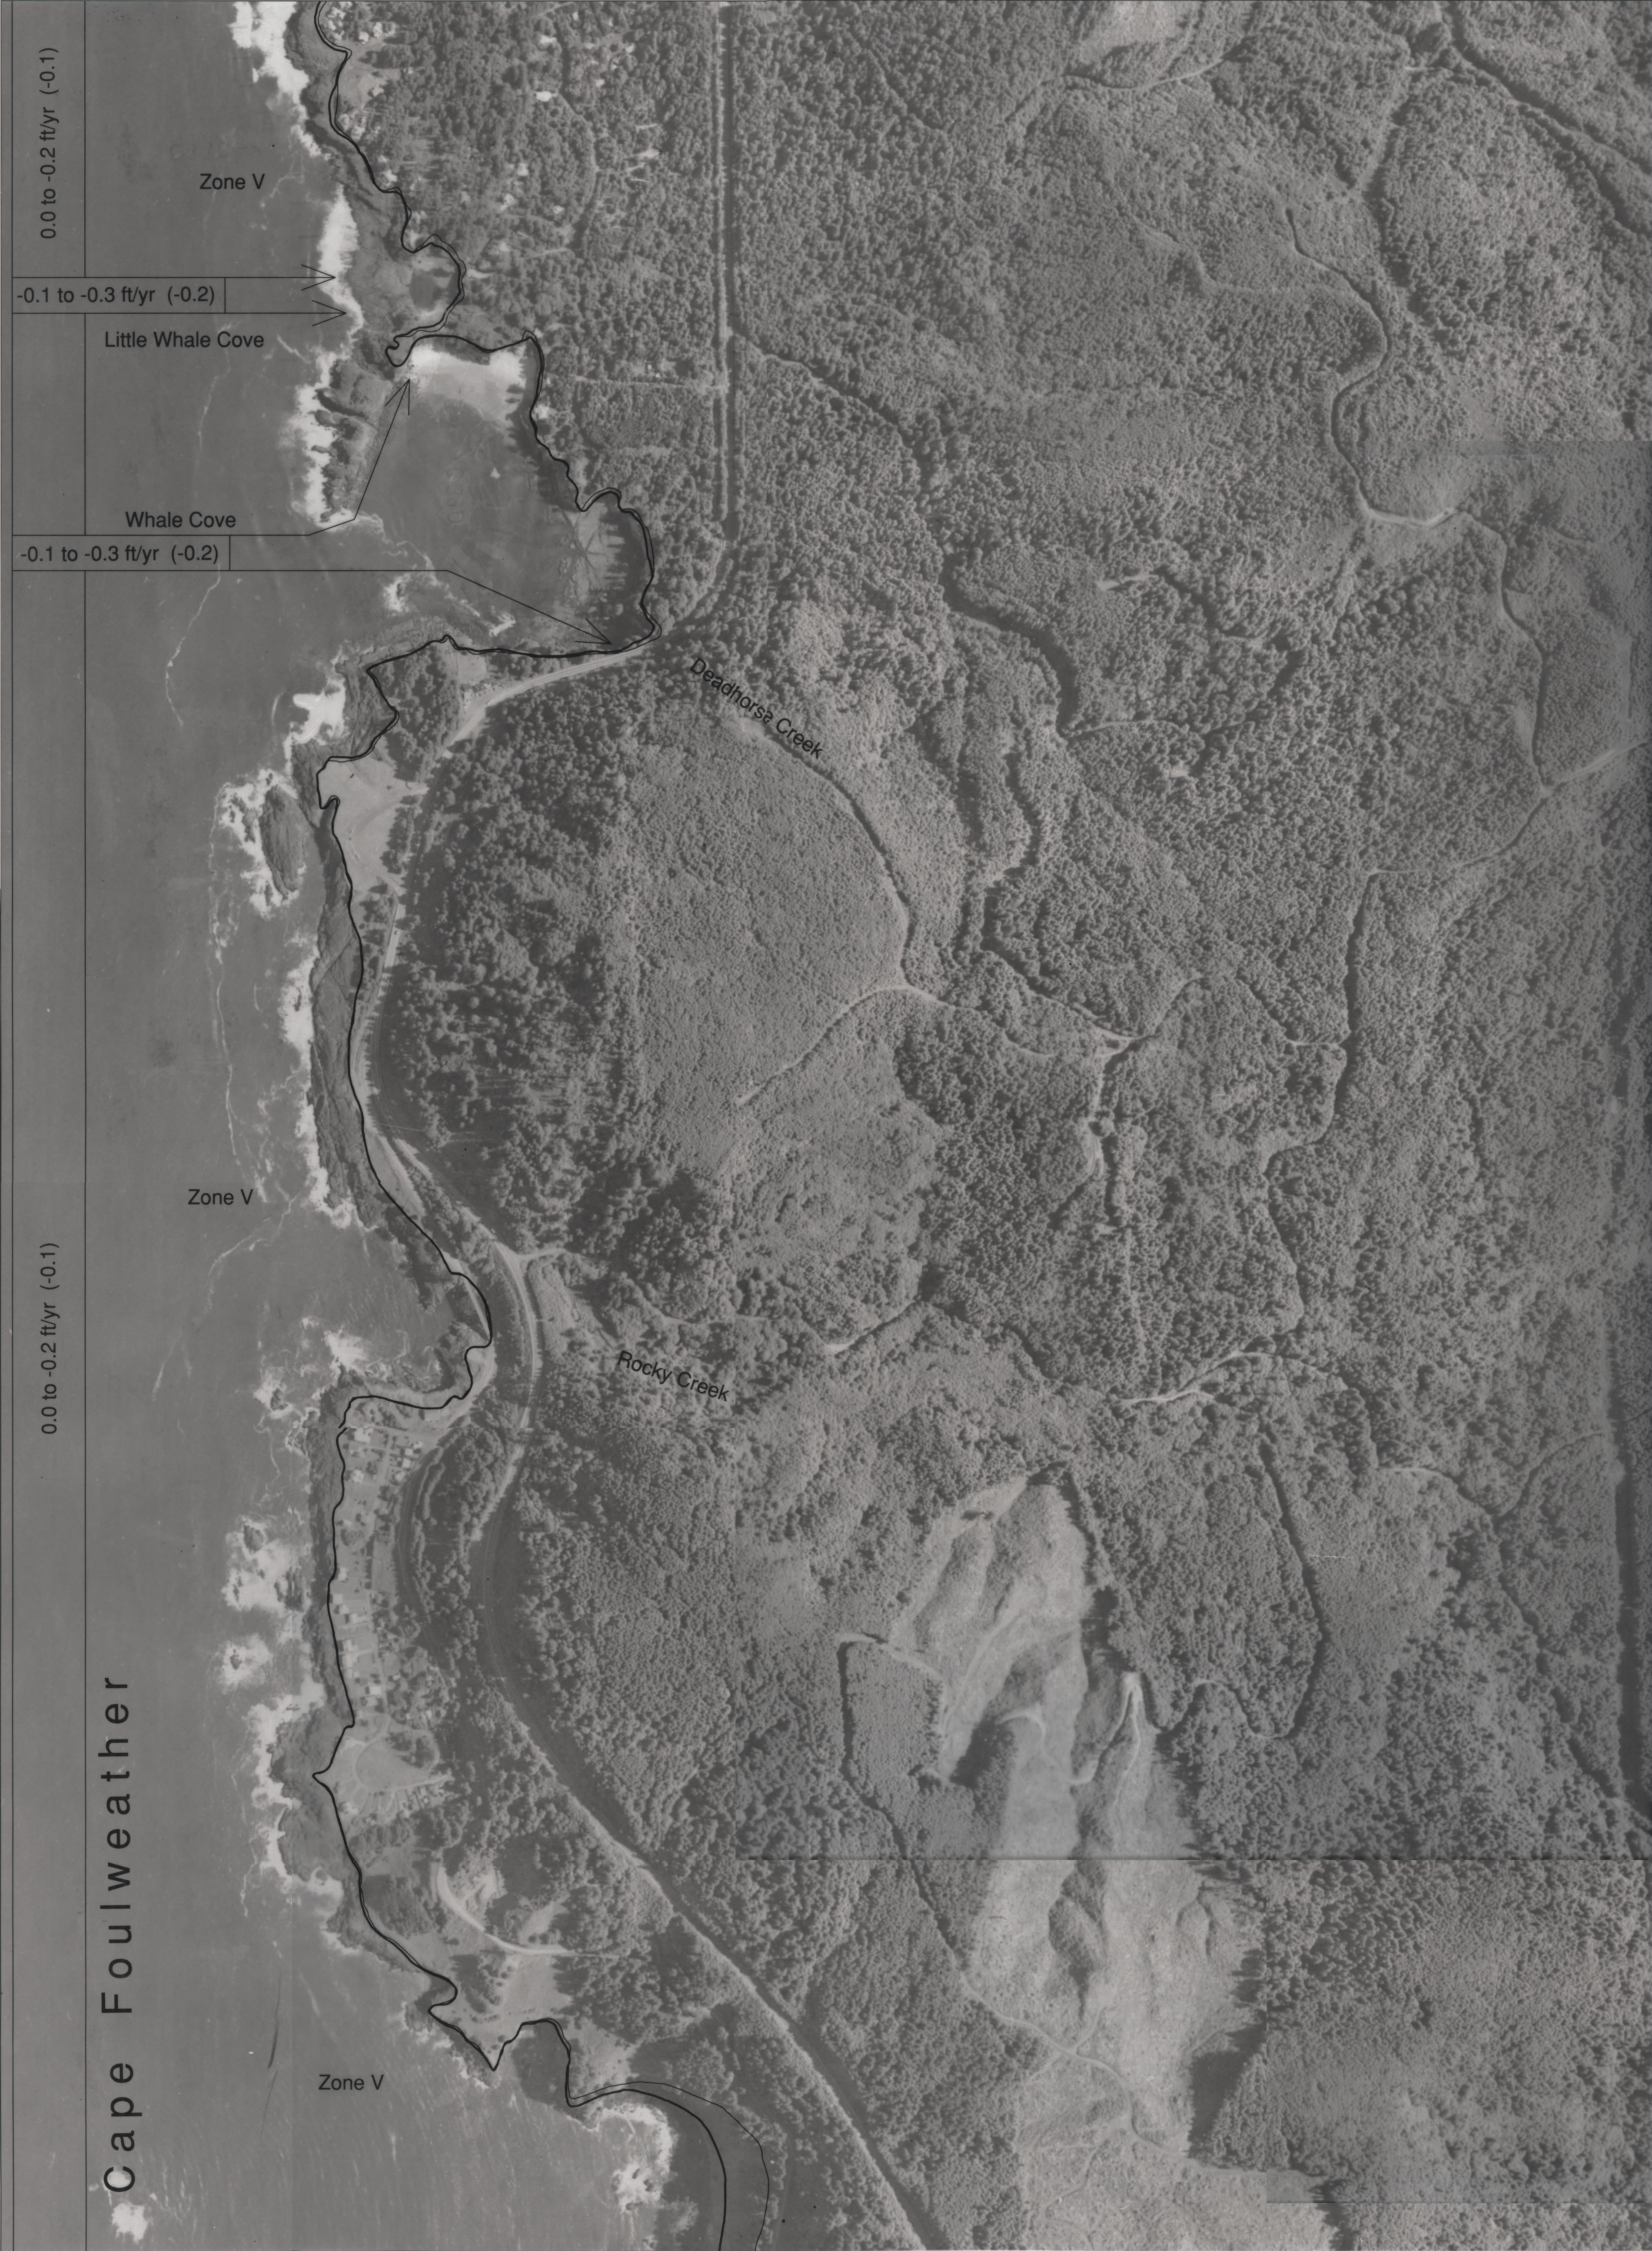
Erosion Hazard Area (EHA). Shows possible change of position during the next 60 years of an erosion reference feature (ERF) consisting of the seaward edge of a bluff, landslide headwall, or semi-permanent vegetation line on dunes or alluvium. The current position of the ERF is the seaward edge of the EHA. The EHA is directly related to coastal erosion processes. Where erosion rates are low, the width of the EHA may approach zero at the map scale and be indistinguishable from the ERF.

●---● Indicates that the ERF is currently the headwall of an active or potentially active landslide. Note that the EHA in adjacent areas with the same mean erosion rate may reflect historical retreat of the headwalls of landslides now removed by erosion.

Present day and 60-year positions of the 100-year flood zone boundary or V zone boundary. Present day position is taken from Federal Insurance Rate Maps (FIRM) and Flood Hazard Boundary Map (FHBM) panels numbered 410125 0125 B (Sept. 3, 1980) of the Federal Emergency Management Agency, National Flood Insurance Program. Bold perpendicular lines separate areas of differing base flood elevations. Zone labels are as follows:

Generalized erosion rates -- Range of erosion rate (negative sign indicates erosion) at one standard deviation from the mean; mean is in parentheses; applicable to the shoreline segment marked by the arrows perpendicular to the shoreline. \*No data\* means there was no accurate shoreline erosion data. EHA established by other means (see \*Notes to the User\* below).

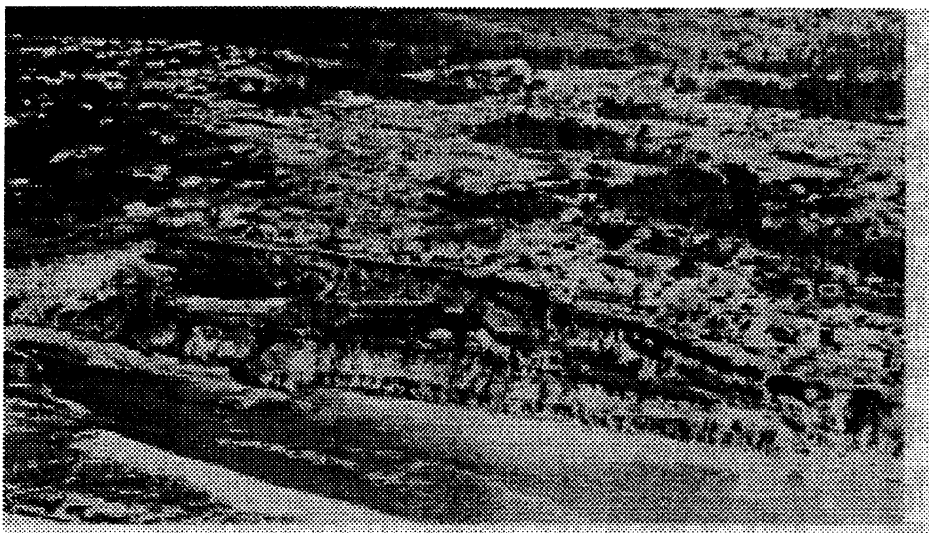
*Figure 9. Oblique aerial photograph of central Newport taken in 1961 after the Jumpoff Joe slide block had moved further down slope and seaward than the initial movements in the 1940's. Photograph taken from the Lincoln County Historical Society.*
