# Erosion and Flood Hazard Map of the Otter Crest Area, Coastal Lincoln County, Oregon

OFR O-97-22  
By George R. Priest

**OPEN-FILE REPORT O-97-11**

**COASTAL SHORELINE CHANGE STUDY  
NORTHERN AND CENTRAL LINCOLN COUNTY,  
OREGON**

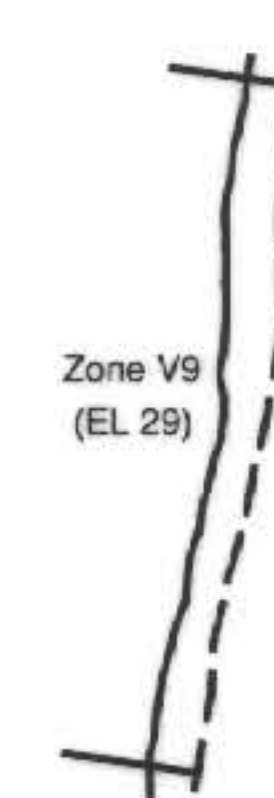
Present day and 60-year positions of the 100-year flood zone boundary or V-zone boundary. Present day position is taken from Federal Insurance Rate Maps (FIRM) and Flood Hazard Boundary Map (FHB) panels numbered 410125 0125 B (Sept. 3, 1980) of the Federal Emergency Management Agency, National Flood Insurance Program. Bold perpendicular lines separate areas of differing base flood elevations. Zone labels are as follows.
