**OPEN-FILE REPORT O-97-11**

**COASTAL SHORELINE CHANGE STUDY  
NORTHERN AND CENTRAL LINCOLN COUNTY,  
OREGON**

George R. Priest  
Oregon Department of Geology and Mineral Industries

November 1997

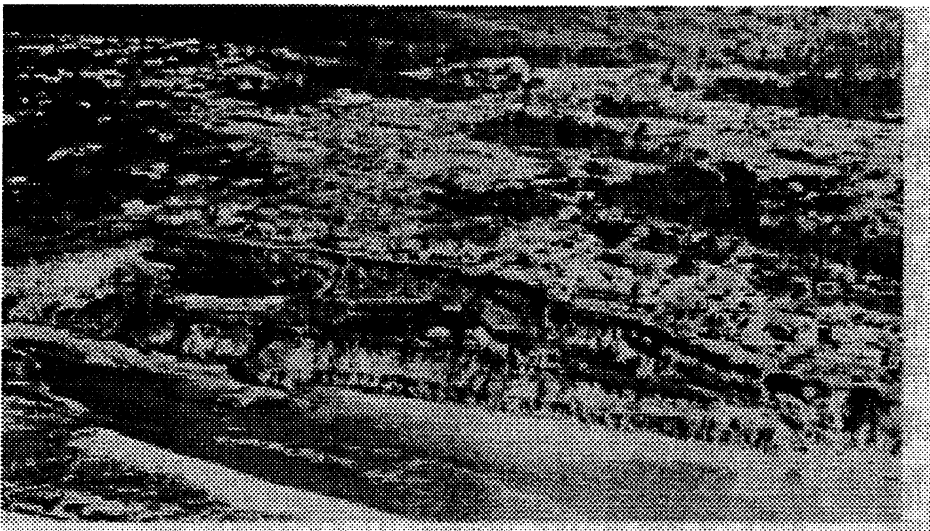
*Figure 9. Oblique aerial photograph of central Newport taken in 1961 after the Jumpoff Joe slide block had moved further down slope and seaward than the initial movements in the 1940's. Photograph taken from the Lincoln County Historical Society.*
