Erosion and Flood Hazard Map
of the South Beach Area,
Coastal Lincoln County, Oregon

OFR O-97-27
By George R. Priest

OPEN-FILE REPORT O-97-11

**COASTAL SHORELINE CHANGE STUDY
NORTHERN AND CENTRAL LINCOLN COUNTY,
OREGON**

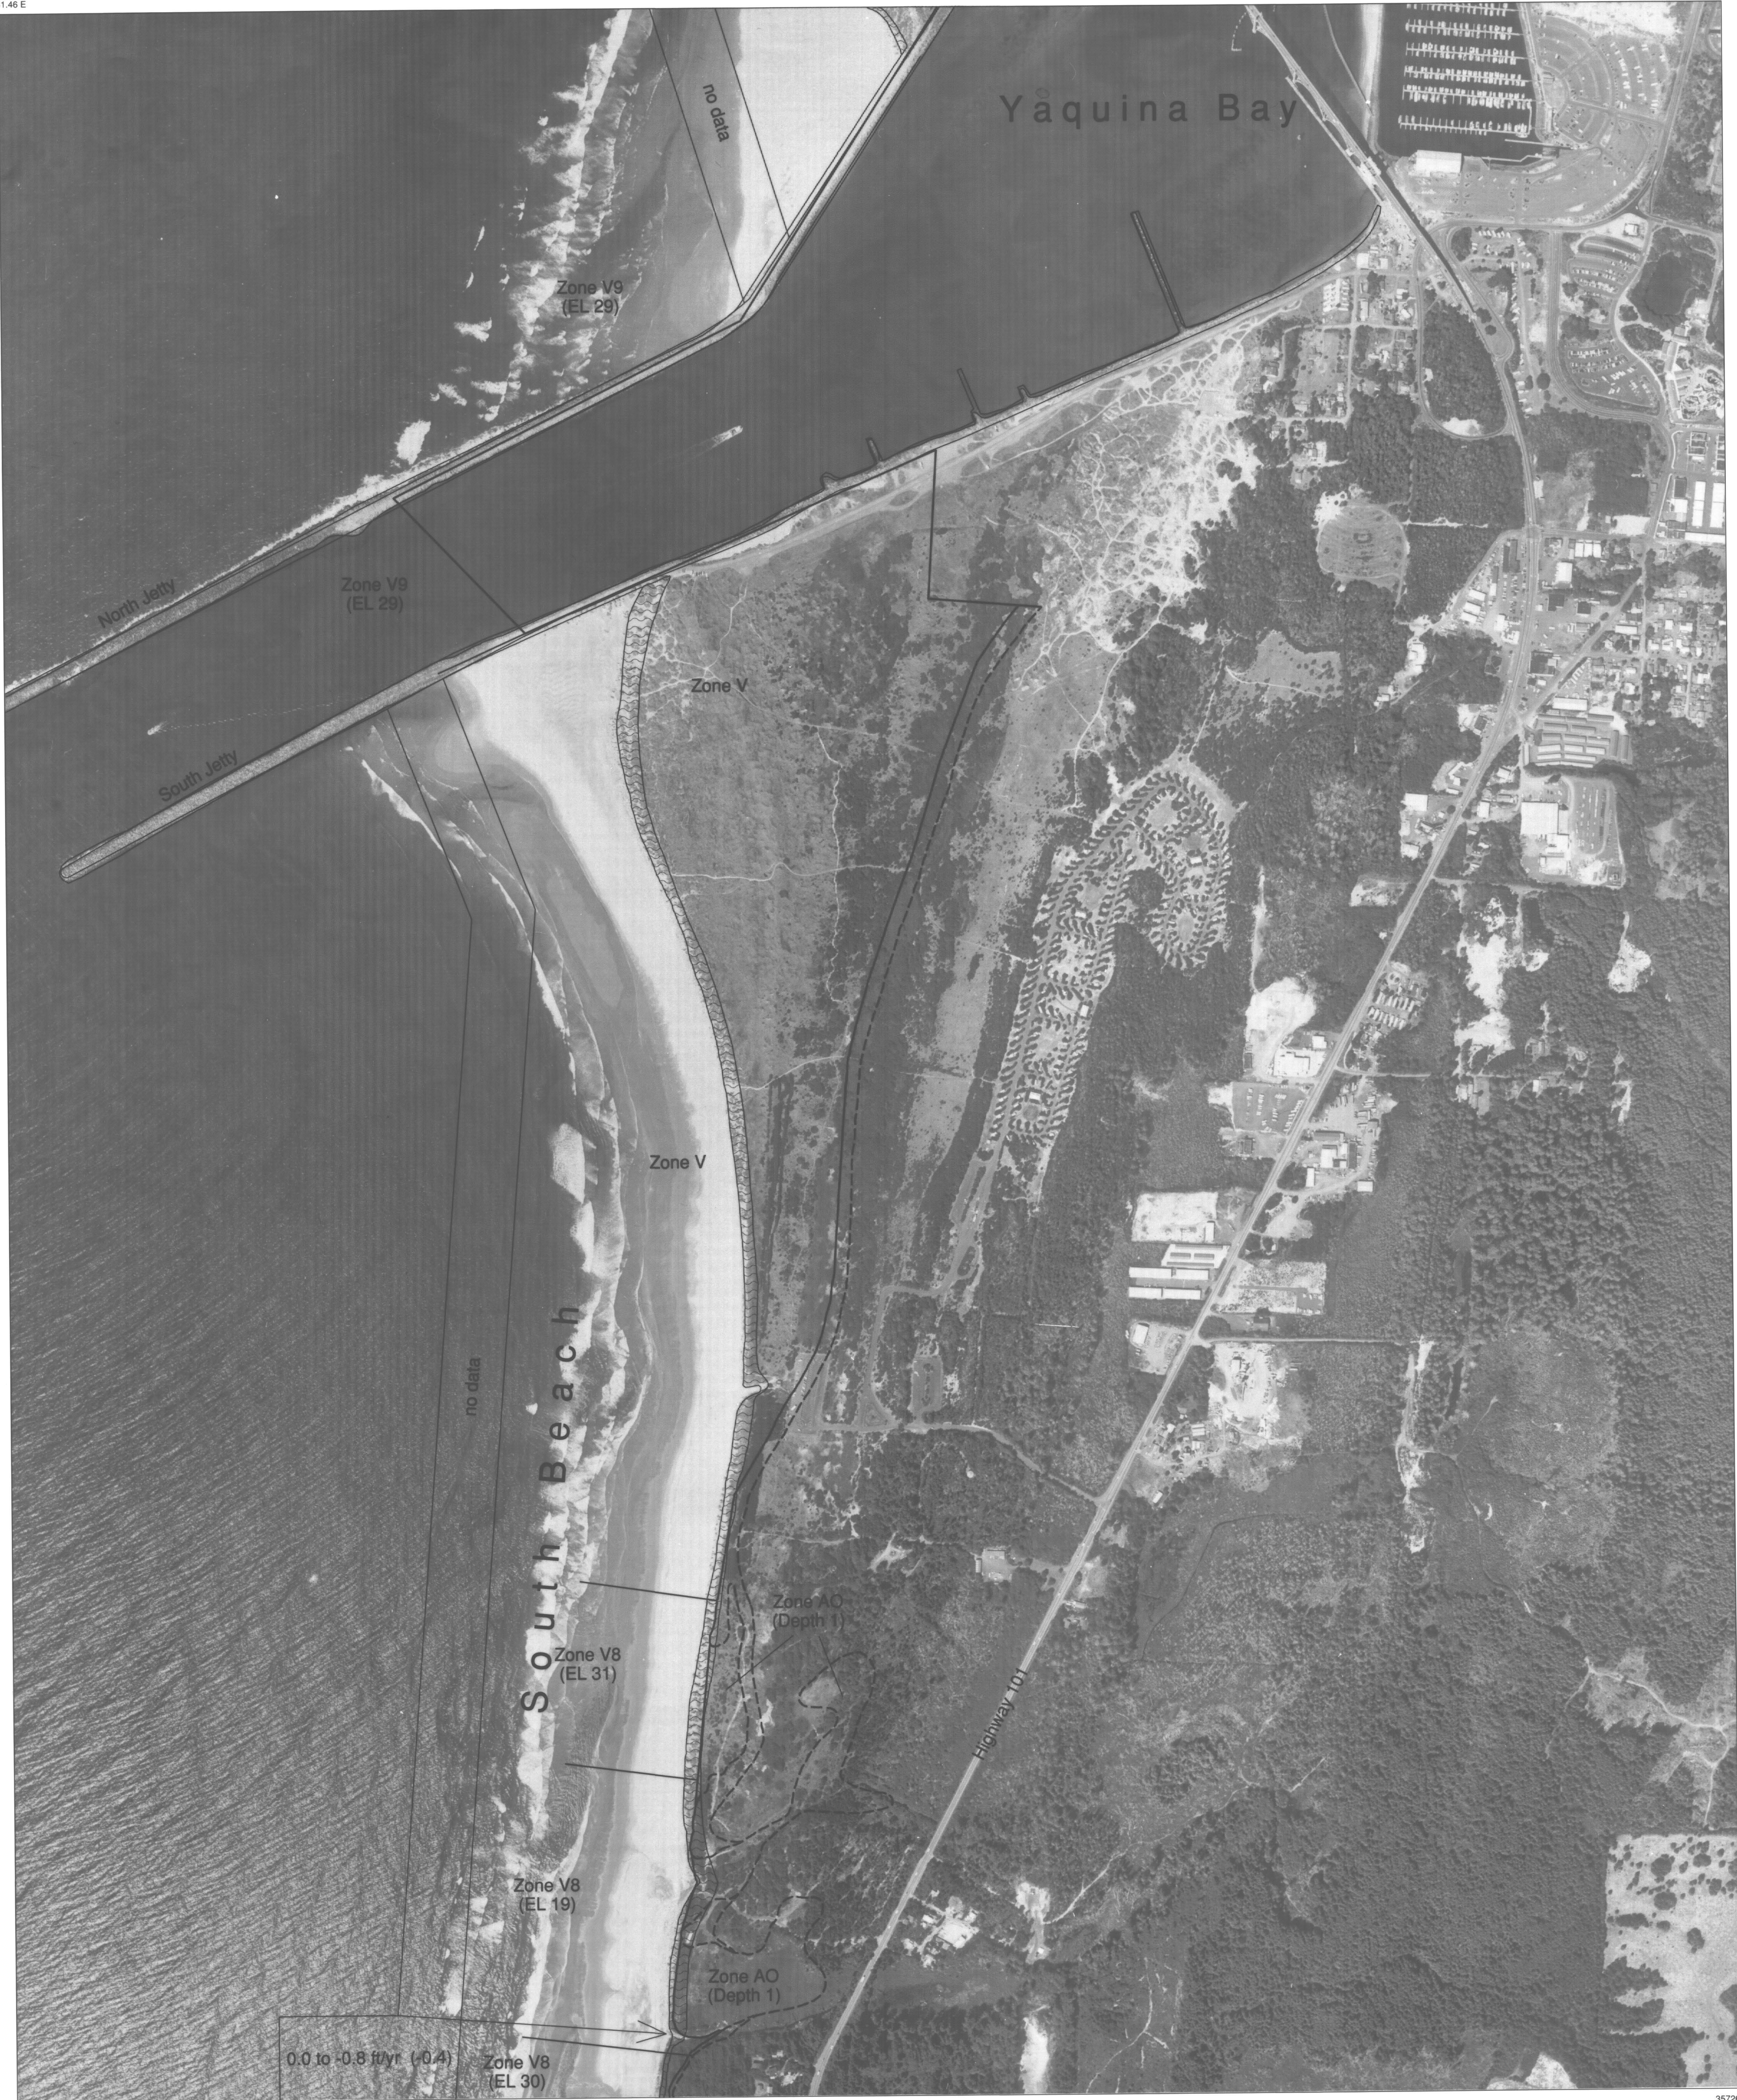
Erosion Hazard Map
50 years of
edge of a
on dunes or
of the EHA
Where ero
the map sc

Indicates t
active land
erosion rat
removed b

(EL 30) Base flood

Zone
A
AO
A1-A30
V
V1-V30

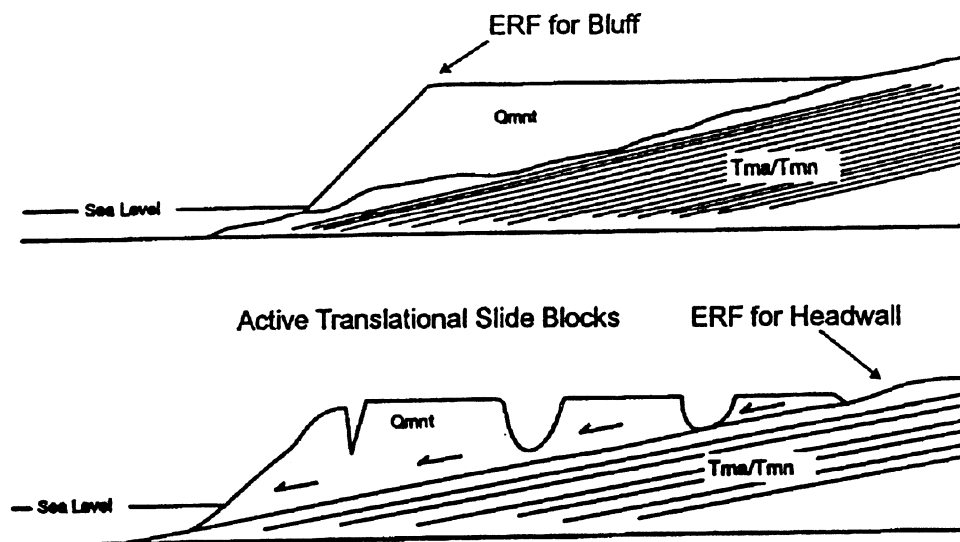
Figure 3. Erosion reference feature (ERF) for a bluff (top) and a landslide (bottom). Figure is modified from Rinne (1992).

An erosion reference feature (ERF) was mapped along 31 miles of the Oregon coast from Cascade Head on the north to Seal Rocks on the south (Figures 1 and 2). The ERF on bluffed shorelines is defined as the break in slope that results directly from wave erosion or from mass movements triggered by wave erosion (Figure 3). On bluffed shorelines with zones of mass movement (i.e. earth flows, landslides, slumps, or translational slide blocks) the ERF is the top of the headwall (Figure 3).

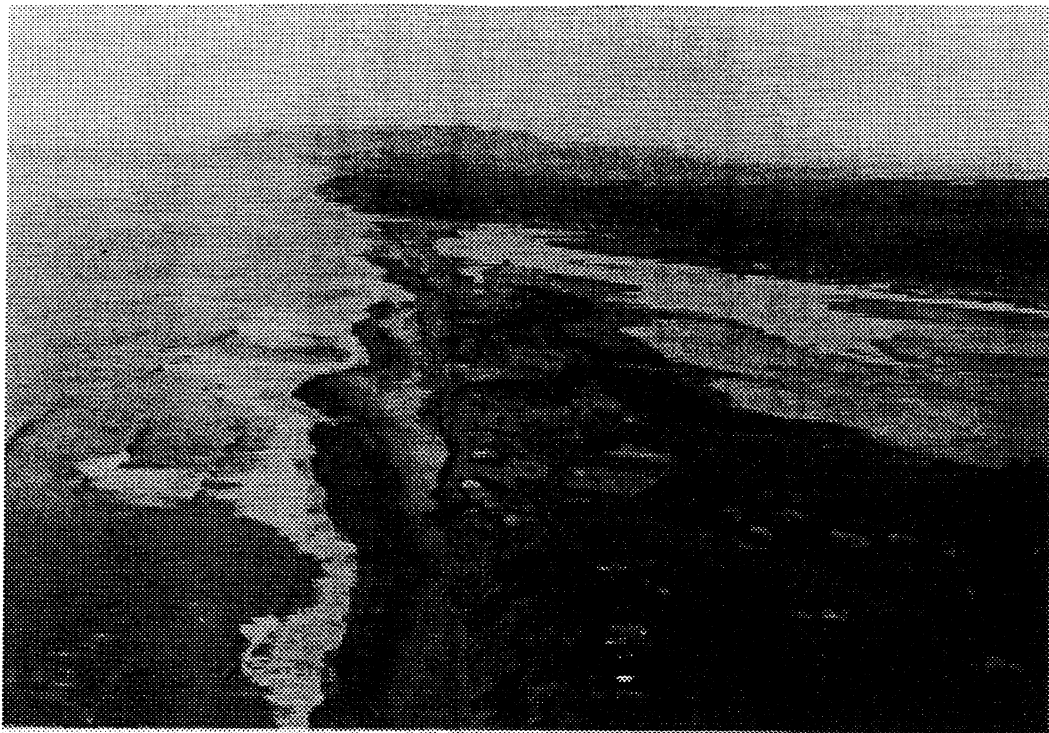
Figure 5. Oblique aerial photograph of Salishan Spit in 1972 illustrating the stable forested portion versus the unstable, nearly barren end, where erosion occurs from both sides. The reflective beach is characterized by many deep rip current embayments, where most erosion occurs (photograph taken from Komar (1992a)).

The widest EHA's occurred on dune-backed shorelines, which comprise about 19 percent of the study area. The zone of shoreline instability in these areas varied from widths on the order of 25 feet for very stable areas to several hundred feet at the end of Salishan Spit. The large zone of variability on the Spit is caused by erosion from both sides. The estuarine channel of the Siletz River lies on the back side, while a steep reflective beach lies on the seaward side (Figures 5 and 6; Komar and Rea, 1976).

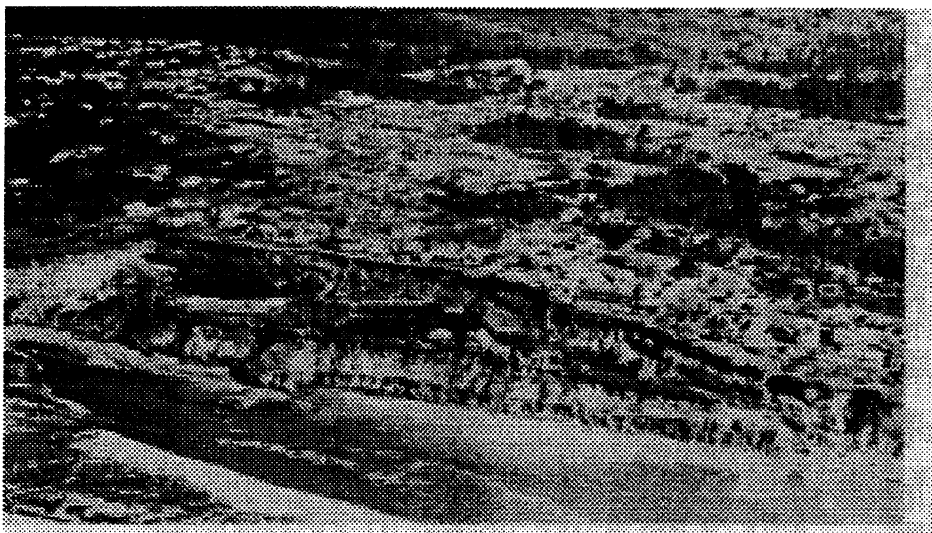
Figure 9. Oblique aerial photograph of central Newport taken in 1961 after the Jumpoff Joe slide block had moved further down slope and seaward than the initial movements in the 1940's. Photograph taken from the Lincoln County Historical Society.
