# Erosion and Flood Hazard Map of the Newport Airport Area, Coastal Lincoln County, Oregon

**OPEN-FILE REPORT O-97-11**

**COASTAL SHORELINE CHANGE STUDY  
NORTHERN AND CENTRAL LINCOLN COUNTY,  
OREGON**

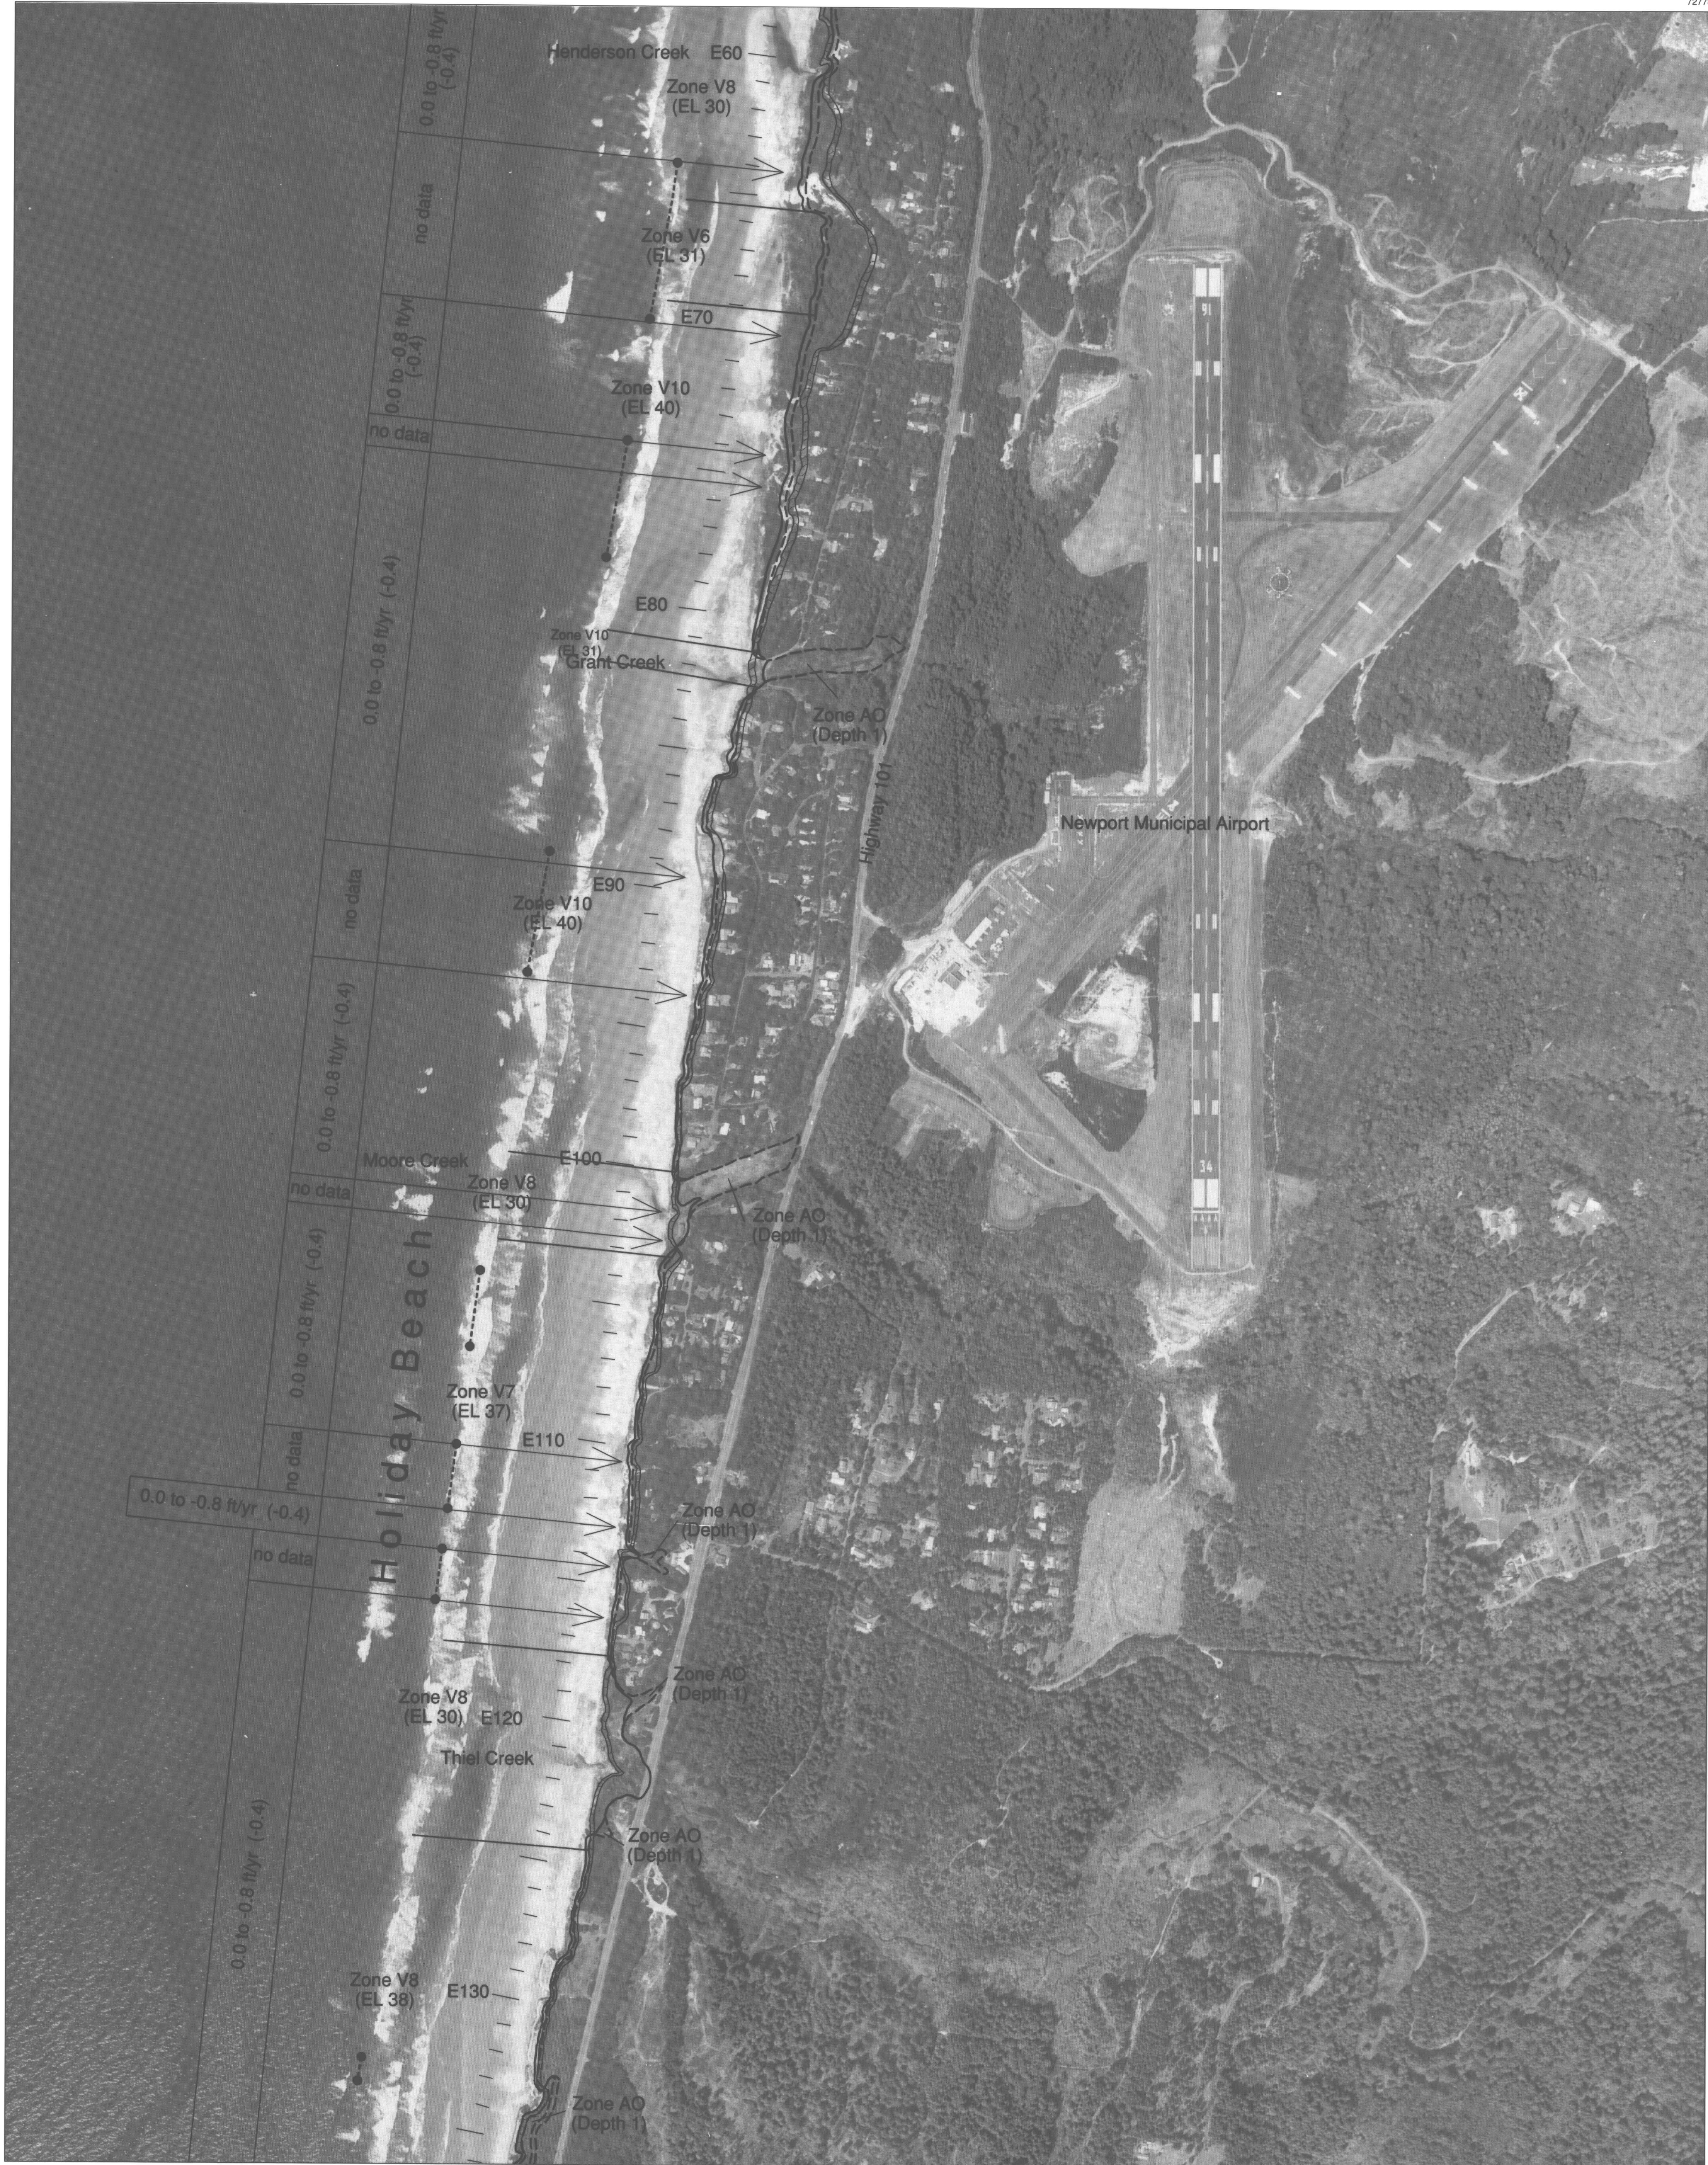
**EXPLANATION**

Erosion Hazard Area (EHA). Shows possible change of position during the next 60 years of an erosion reference feature (ERF) consisting of the seaward edge of a bluff, landslide headwall, or semi-permanent vegetation line on dunes or alluvium. The current position of the ERF is the seaward edge of the EHA. The EHA is directly related to coastal erosion processes. Where erosion rates are low, the width of the EHA may approach zero at the map scale and be indistinguishable from the ERF.

Indicates that the ERF is currently the headwall of an active or potentially active landslide. Note that the EHA in adjacent areas with the same mean erosion rate may reflect historical retreat of the headwalls of landslides now removed by erosion.

Present day and 60-year positions of the 100-year flood zone boundary or V-zone boundary. Present day position is taken from Federal Insurance Rate Maps (FIRM) and Flood Hazard Boundary Map (FHBM) panels numbered 410131 0023 C (June 15, 1982) and 410129 0250 B (Sept. 3, 1980) of the Federal Emergency Management Agency, National Flood Insurance Program. Bold perpendicular lines separate areas of differing base flood elevations. Zone labels are as follows:

Generalized erosion rates -- Range of erosion rate (negative sign indicates erosion) at one standard deviation from the mean; mean is in parentheses; applicable to the shoreline segment marked by the arrows perpendicular to the shoreline.
