# Erosion and Flood Hazard Map of the Lost Creek Area, Coastal Lincoln County, Oregon

# OFR O-97-29

**OPEN-FILE REPORT O-97-11**

**COASTAL SHORELINE CHANGE STUDY  
NORTHERN AND CENTRAL LINCOLN COUNTY,  
OREGON**

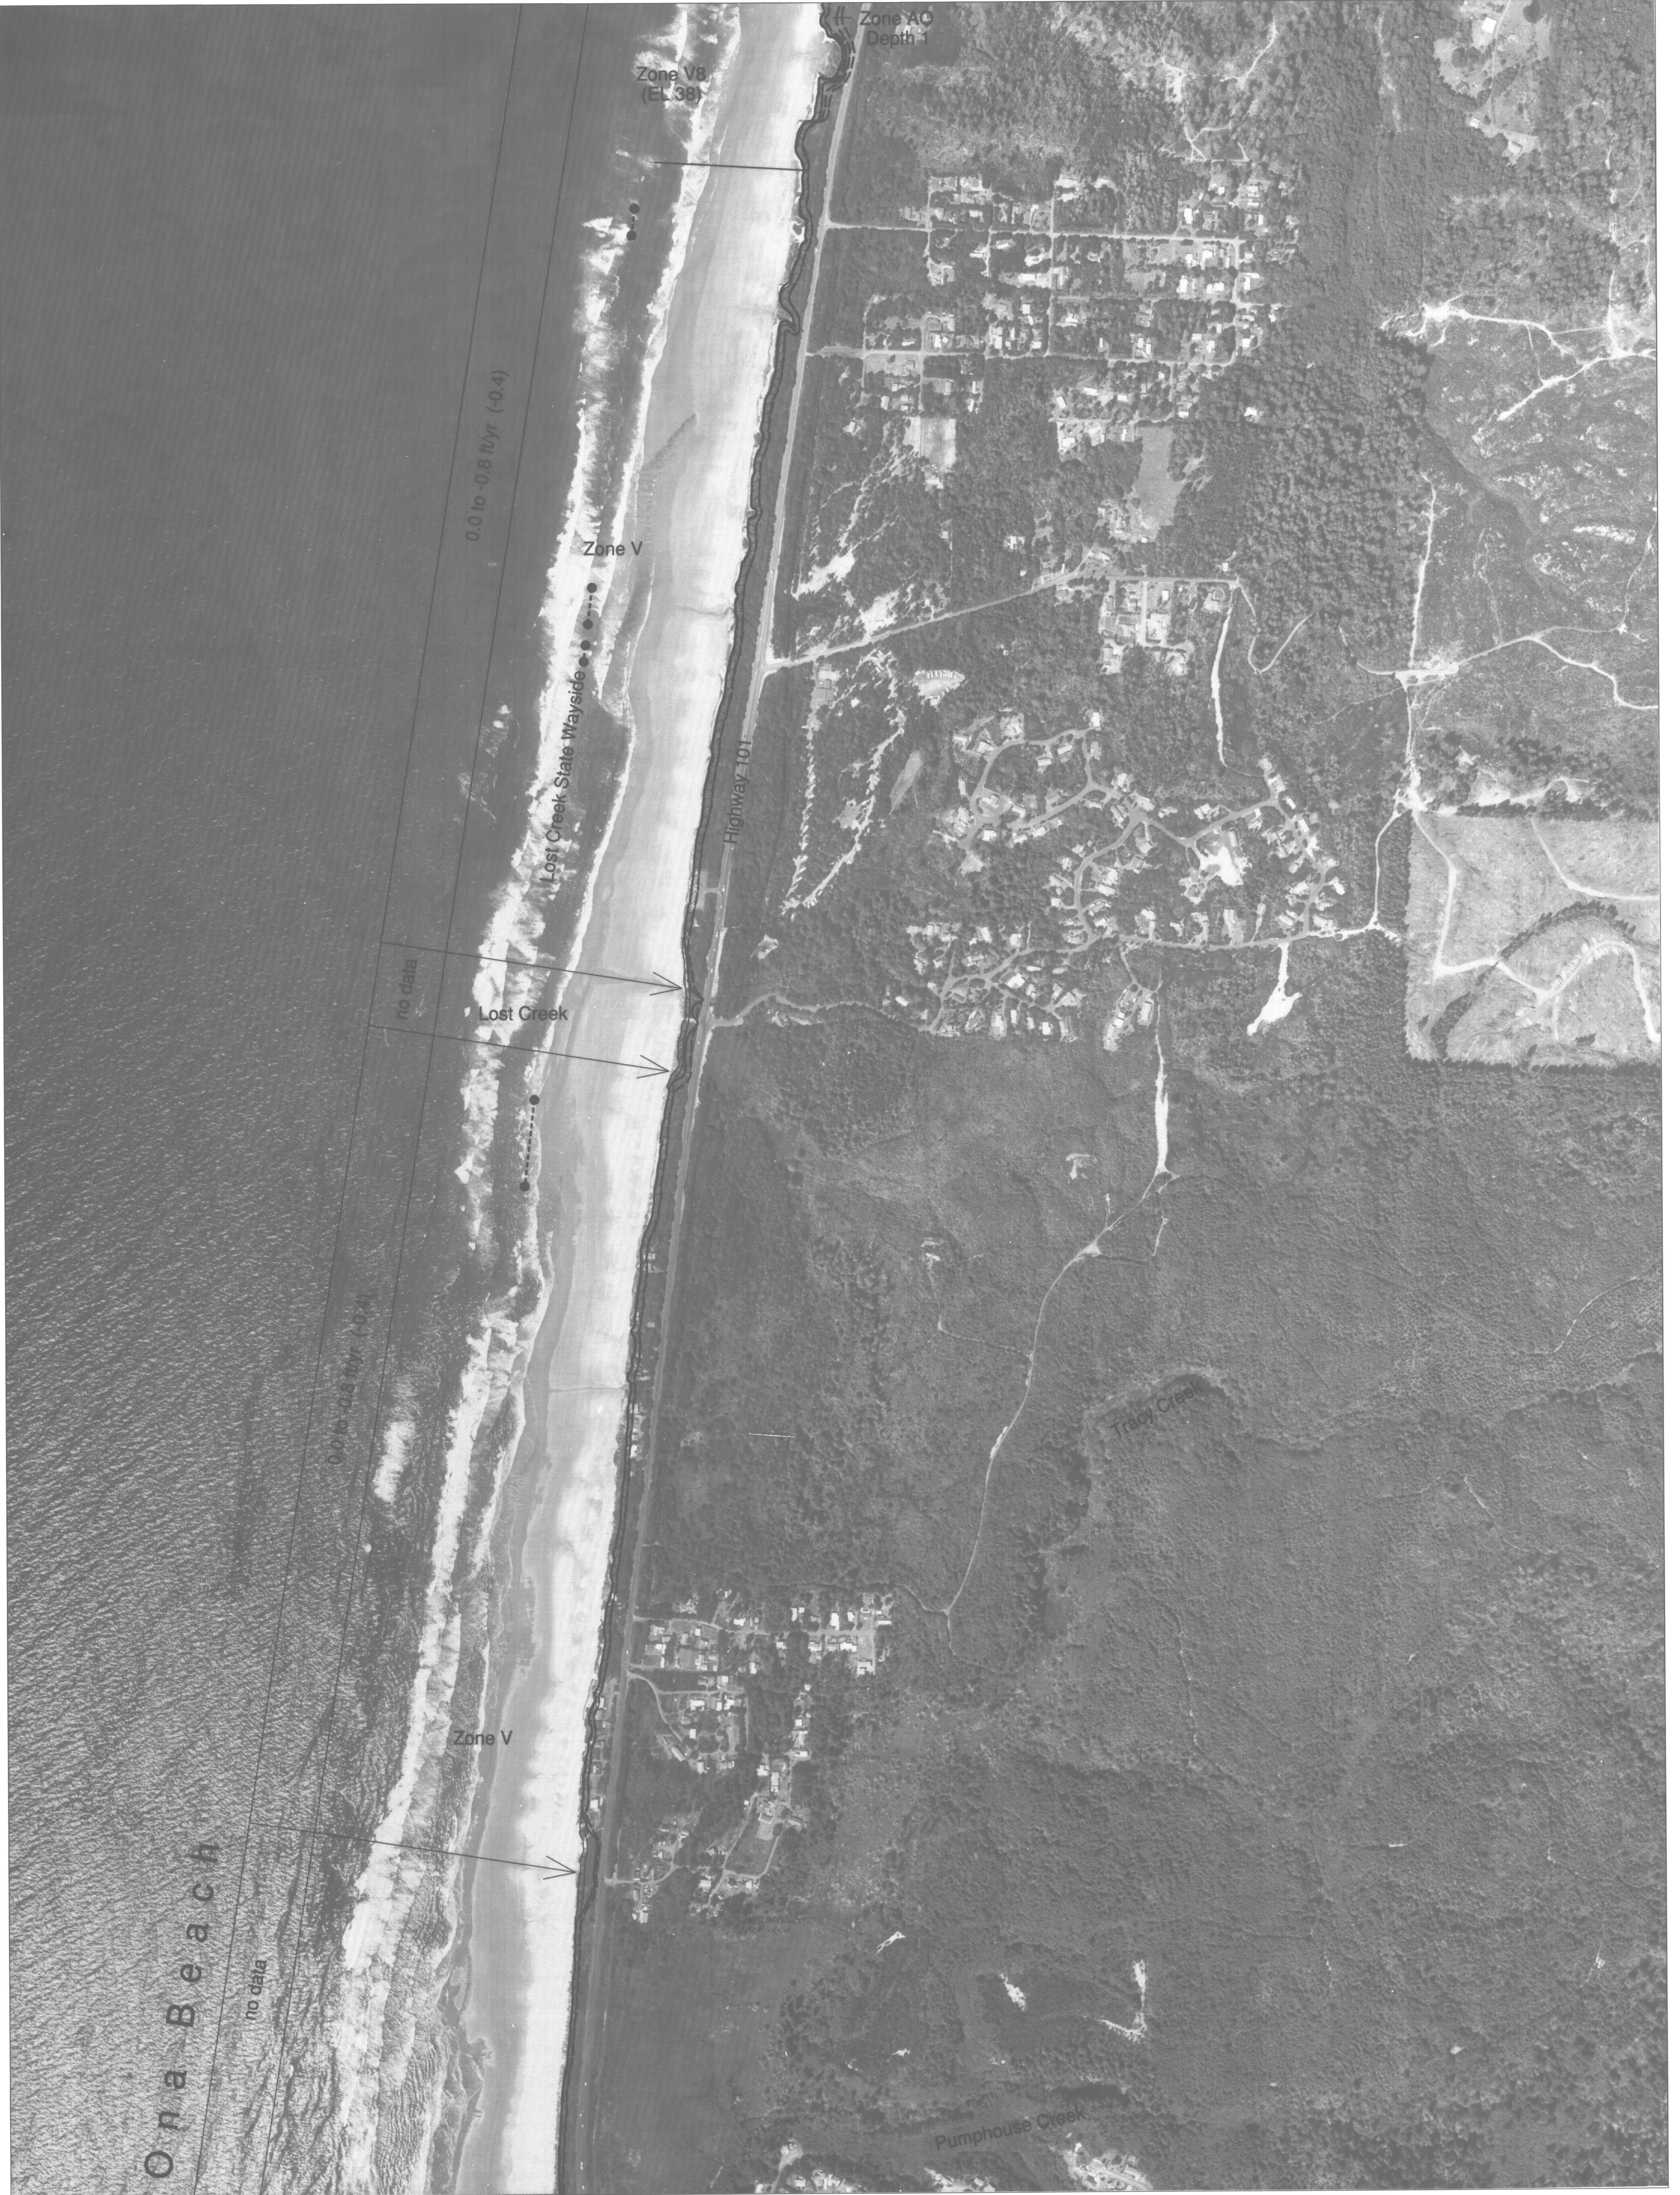
Erosion Hazard Area (EHA). Shows possible change of position during the next 50 years of an erosion reference feature (ERF) consisting of the seaward edge of a bluff, landslide headwall, or semi-permanent vegetation line on dunes or alluvium. The current position of the ERF is the seaward edge of the EHA. The EHA is directly related to coastal erosion processes. Where erosion rates are low, the width of the EHA may approach zero at the map scale and be indistinguishable from the ERF.

● --- ● Indicates that the ERF is currently the headwall of an active or potentially active landslide. Note that the EHA in adjacent areas with the same mean erosion rate may reflect historical retreat of the headwalls of landslides now removed by erosion.

Present day and 60-year positions of the 100-year flood zone boundary or V-zone boundary. Present day position is taken from Federal Insurance Rate Maps (FIRM) and Flood Hazard Boundary Map (FHBM) panels numbered 410129 0250 B and 410129 0325 B (Sept. 3, 1980) of the Federal Emergency Management Agency, National Flood Insurance Program. Bold perpendicular lines separate areas of differing base flood elevations. Zone labels are as follows:

Generalized erosion rates -- Range of erosion rate (negative sign indicates erosion) at one standard deviation from the mean; mean is in parentheses; applicable to the shoreline segment marked by the arrows perpendicular to the shoreline.

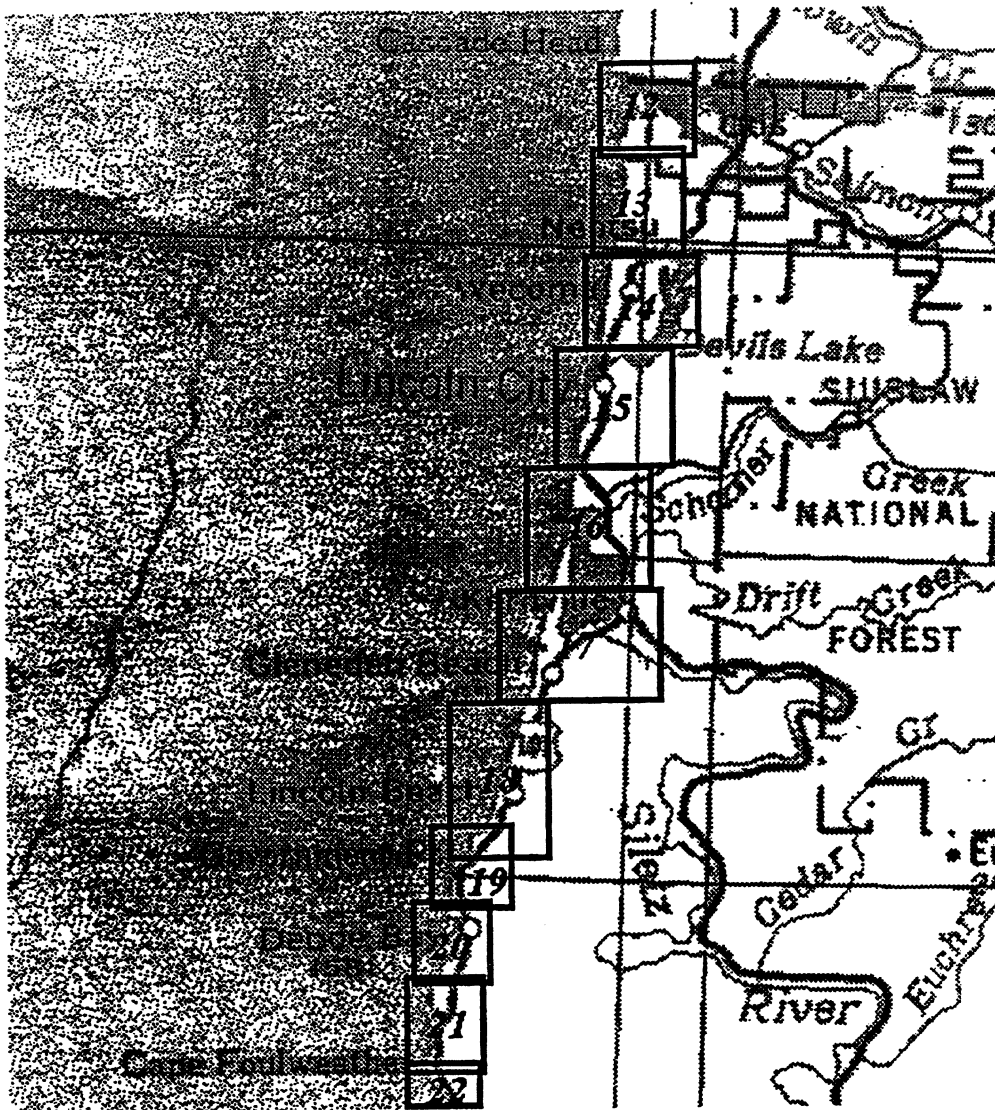
Figure 1. Location index for maps numbered O-97-12 through O-97-21.
