# Erosion and Flood Hazard Map of the Seal Rock Area, Coastal Lincoln County, Oregon

**OPEN-FILE REPORT O-97-11**

**COASTAL SHORELINE CHANGE STUDY  
NORTHERN AND CENTRAL LINCOLN COUNTY,  
OREGON**

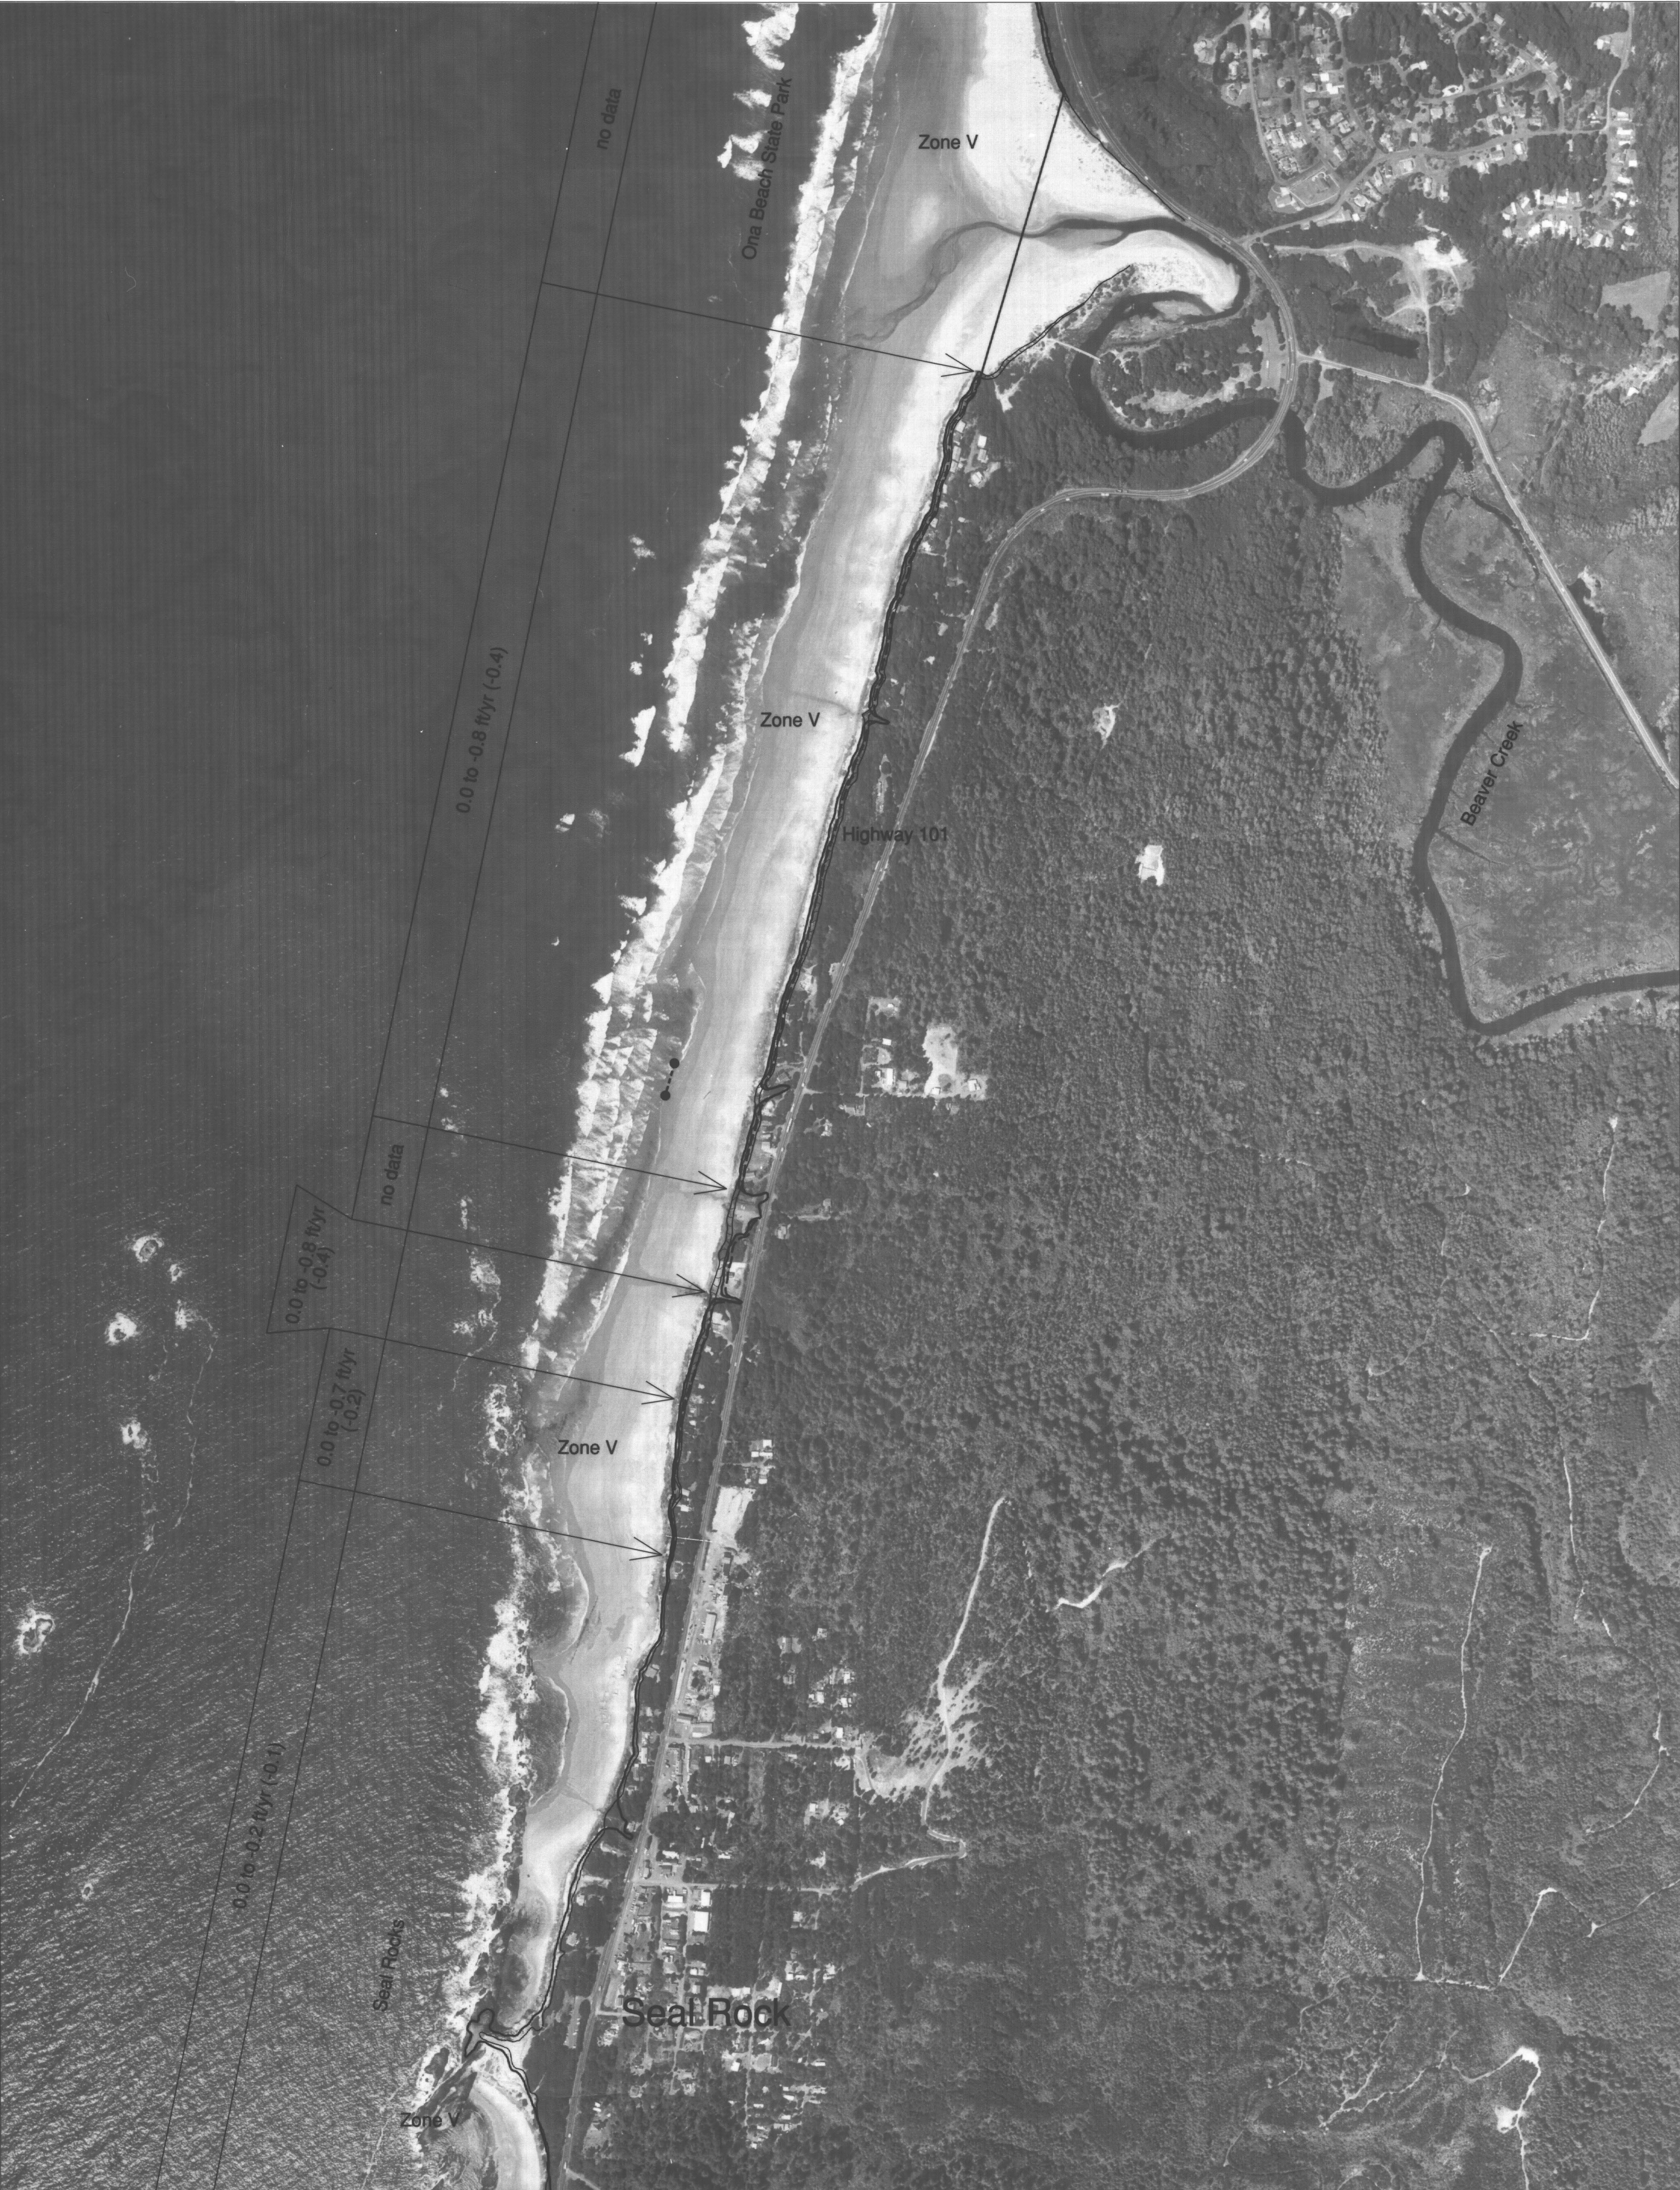
Erosion Hazard Area (EHA). Shows possible change of position during the next 60 years of an erosion reference feature (ERF) consisting of the seaward edge of a bluff, landslide headwall, or semi-permanent vegetation line on dunes or alluvium. The current position of the ERF is the seaward edge of the EHA. The EHA is directly related to coastal erosion processes. Where erosion rates are low, the width of the EHA may approach zero at the map scale and be indistinguishable from the ERF.

Indicates that the ERF is currently the headwall of an active or potentially active landslide. Note that the EHA in adjacent areas with the same mean erosion rate may reflect historical retreat of the headwalls of landslides now removed by erosion.

Present day and 60-year positions of the 100-year flood zone boundary or V-zone boundary. Present day position is taken from Federal Insurance Rate Maps (FIRM) and Flood Hazard Boundary Map (FHBM) panels numbered 410129 0325 B (Sept. 3, 1980) of the Federal Emergency Management Agency, National Flood Insurance Program. Bold perpendicular lines separate areas of differing base flood elevations. Zone labels are as follows:

Generalized erosion rates -- Range of erosion rate (negative sign indicates erosion) at one standard deviation from the mean; mean is in parentheses; applicable to the shoreline segment marked by the arrows perpendicular to the shoreline. "No data" means there was no accurate shoreline erosion data. EHA established by other means (see "Notes to the User" below).
