## COASTAL LANDSLIDES OF NORTHERN OREGON

By

William B. North\*  
Department of the Army, Washington, D. C.

John V. Byrne  
Department of Oceanography, Oregon State University

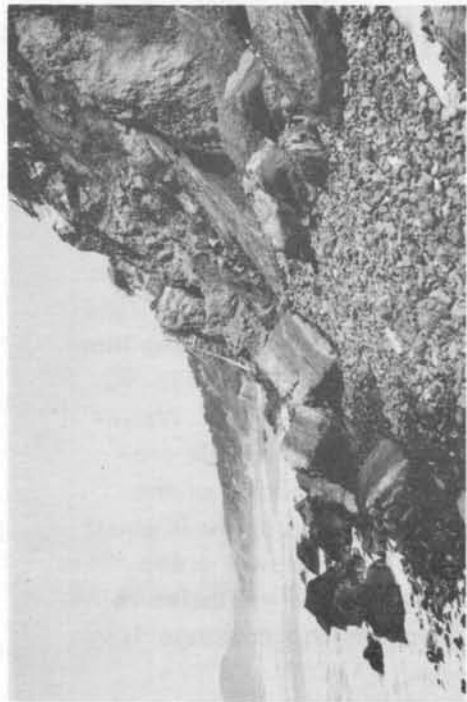
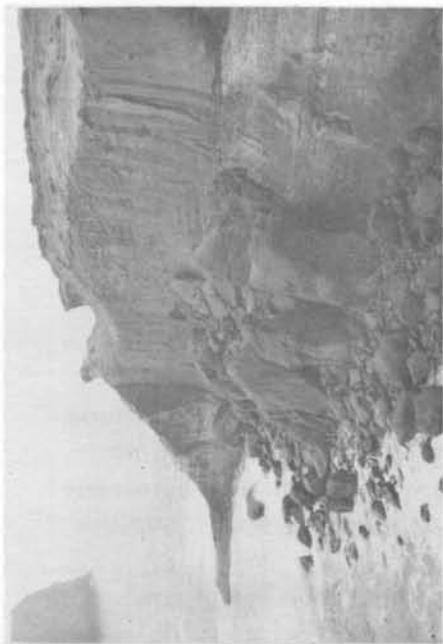
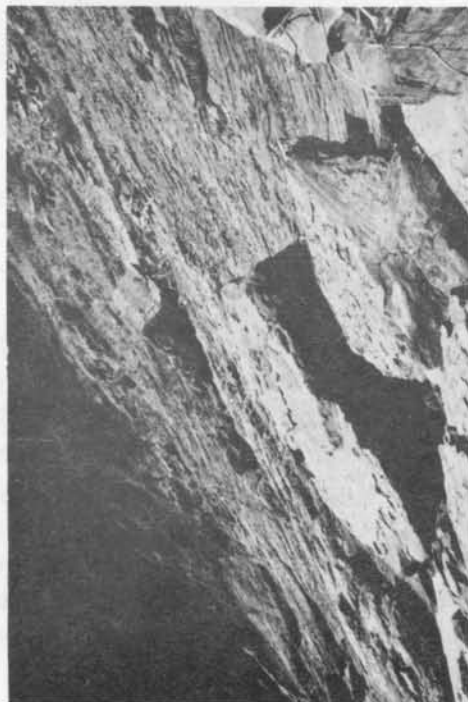
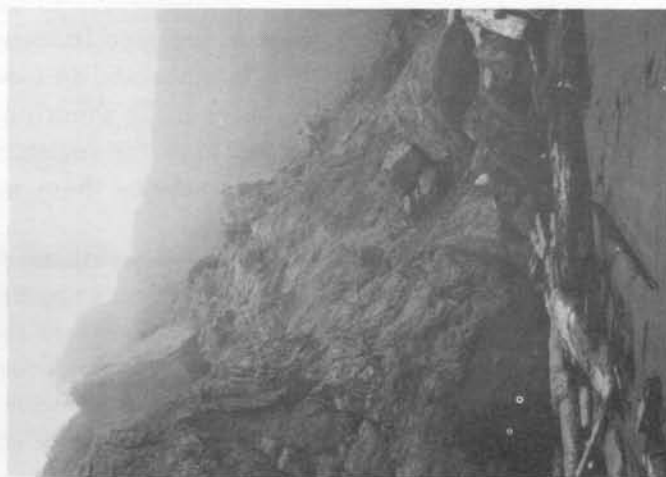
Figure 3. Landslide types: A, rock and debris slump; B, block and rubble slide; C, rock fall; D, debris shift.

The simplified classification used in this paper is a modification of the classification used by Eckel (1958). Four categories based on the nature of the slip surface constitute the classification. These basic types are summarized in Table 2 and are depicted in Figure 3.

Landslide type*	Nature of slip surface
Slump	Concave
Slide	Planar
Fall	Indeterminate - movement essentially vertical
Shift	Indeterminate - movement indeterminate

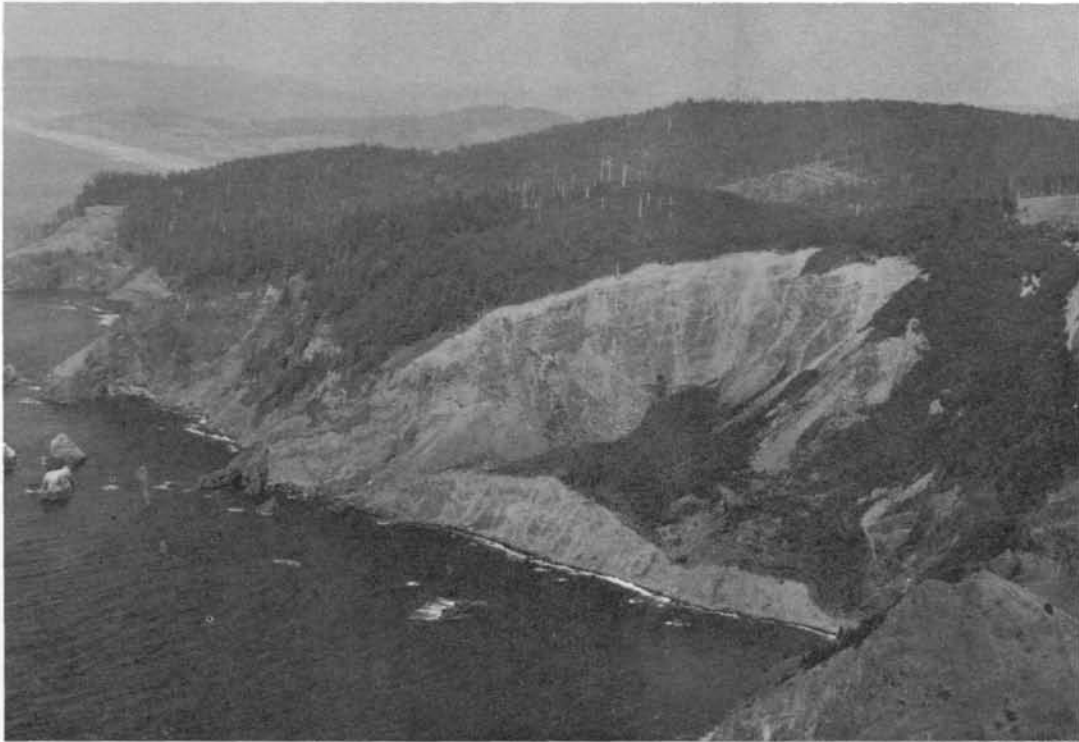
Figure 5. Rock-terrace slump which has destroyed 20 acres of land on Cascade Head.

Twenty acres of pasture have slumped to the sea in the largest landslide on Cascade Head (Figure 5). This slide is 0.1 mile north of the Salmon River and contributes soil and boulder debris to a narrow crescent beach at the base of the sea-cliff. The whole feature is about 2,500 feet wide, but consists of two slides partly separated by a dike that diverts the smaller of two movements. Residents of the area report that the main slide occurred in 1934. Trees and low brush now cover the gently-sloping slump bench. The crown scarp, at an approximate elevation of 600 feet, is 8 feet high. A series of sub-parallel fractures, 2 to 6 feet deep, are present up-slope from the crown. The toe of the slide has been eroded by waves, producing a cliff 30 to 60 feet high in the slide debris.

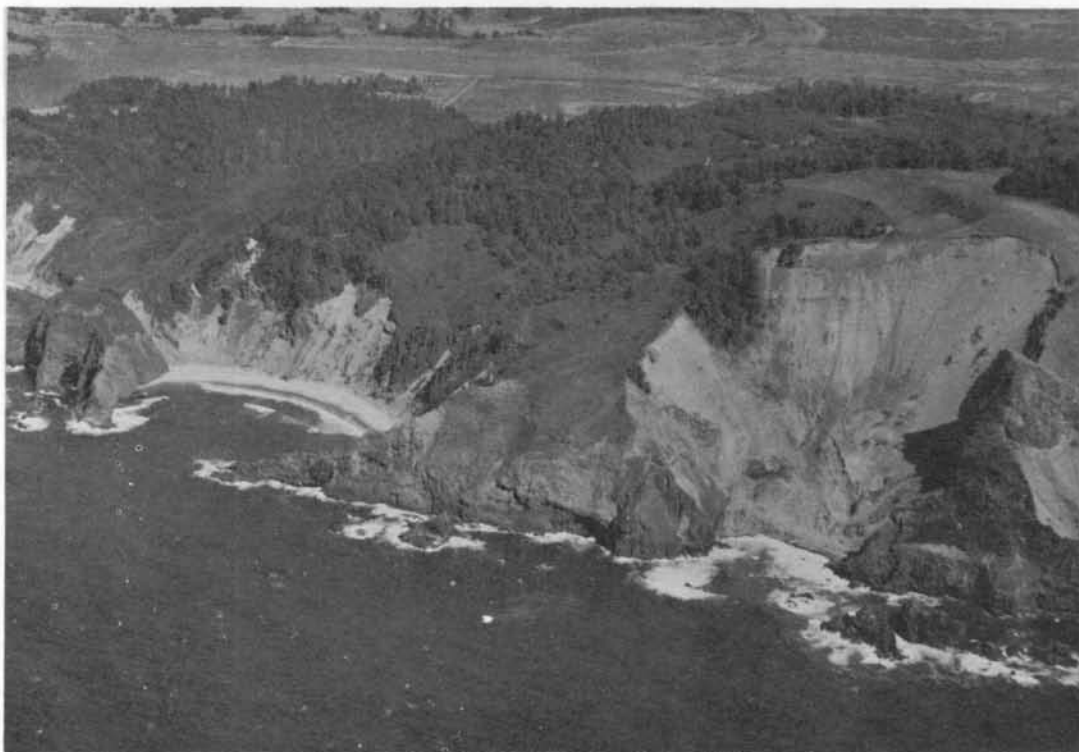
Figure 6. Slumping of Eocene shale south of the Salmon River. Where basalt cap has been breached, landsliding has been most rapid.

Between the mouth of the Salmon River and the village of Roads End, landsliding takes place along a series of crescent-shaped bays (Figure 6). The bays have been eroded in siltstones and shales of the upper Eocene Nestucca Formation. The points of the crescents consist of more resistant basalt. The bays have developed as a result of slumping of the shales following erosion of the north-trending basalt cap which protected the shales. Lack of vegetation on the slumps indicates that they are active. Rock falls are common in the basalt areas.

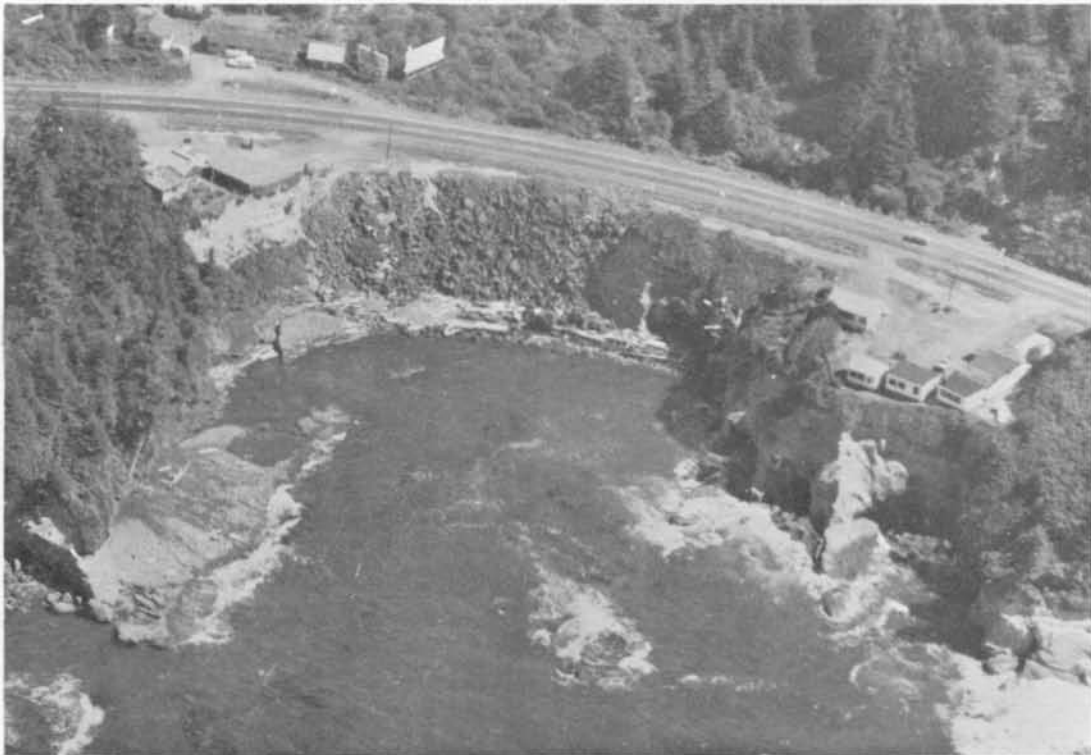
Figure 7. Riprap at Boiler Bay helps to slow down landsliding and to protect U.S. Highway 101.

On U.S. Highway 101 at Boiler Bay, north of Depoe Bay, a successful attempt has been made to prevent waves from undercutting the highway on the east edge of the bay (Figure 7). The entire exposure of Astoria Formation and overlying terrace sand has been covered by riprap. This inexpensive measure has retarded cliff recession and probably has saved a section of the highway.

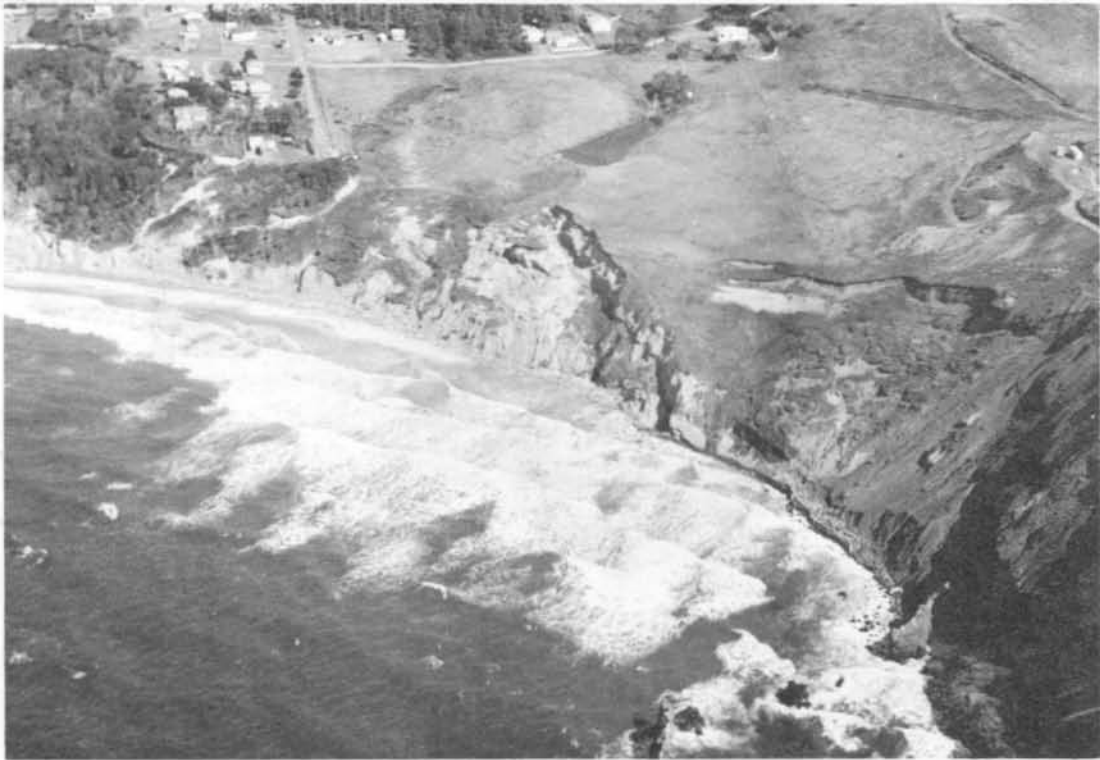
Figure 9. Slumping of Astoria Formation and overlying terrace deposits adjacent to north side of Yaquina Head.

On the north end of the village of Agate Beach, severe cliff slumps and subsidence have resulted in extensive property damage. Immediately north of Yaquina Head is a 1,000-foot-long benched debris slump. The bench is well vegetated. Evidence for continued cutting back of the cliff can be seen on the crown edge from a trail over the south side of the bench. Partially coherent blocks of terrace sands have calved off the edge of the slump. Rocks underlying the terrace deposits dip southwest with an average inclination of  $14^{\circ}$ . Adjacent to Yaquina Head, about one acre of land at the foot of Fossil Street in Agate Beach has been destroyed by cliff-block slumping (Figure 9). A ragged 15-foot-deep crack has opened at the crown where a large block of Astoria Formation and terrace sands have pulled away from the land. This fissure has been widened by erosion. Seaward, blocks become progressively broken and skewed from original attitudes and finally accumulate as debris shift on the beach. Reorientation of the blocks increases seaward as the removal of cliff debris by waves makes the leading edge of the slide less stable and hence prone to further downward movement. Mass movement just north of Yaquina Head is much more severe than erosion in areas of similar lithology and rock attitude within two miles of the headland. Interpretation of U.S. Coast and Geodetic Survey Chart 6056 (1962) shows that underwater contours effecting changes in approaching wave-front directions would greatly concentrate wave energy within 0.3 mile of the headland. Convergence of wave energy is an additional erosional factor near headlands. Basalt

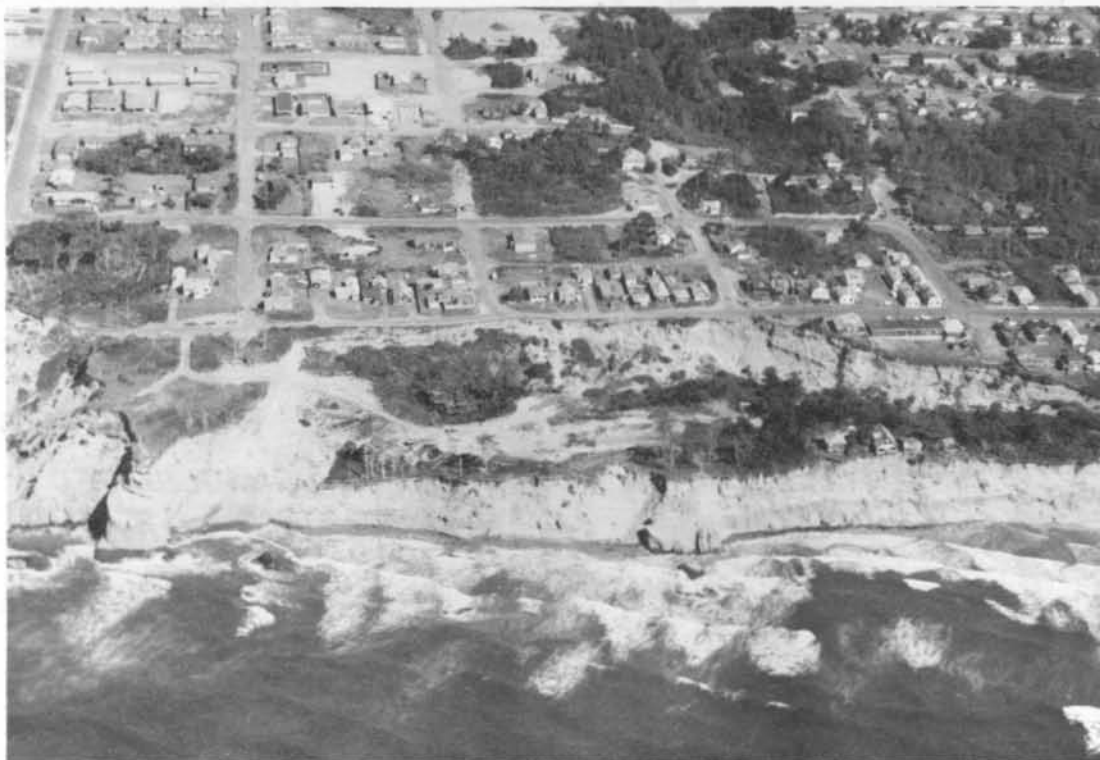
Figure 10. Terrace slump in an area of seaward-dipping Miocene sandstones and shales at Newport.

From Yaquina Head to Yaquina Bay, wave-cut cliffs rise to about 80 feet with debris slumps, rock-terrace slumps, and rock falls dominating mass movement. At Jump-off-Joe, on the north end of Newport, a number of large rock-terrace slumps have abruptly terminated several roads and have moved houses and associated property down and toward the sea. Subsidence of loosely consolidated Pleistocene terrace sands and underlying Tertiary sediments has affected an area 1,000 feet long and 200 feet wide on the north side of the point called Jump-off-Joe and an equivalent area on the south side (Figure 10). Sandy shales and argillaceous sandstones of the Astoria Formation and mudstones of the Nye Formation underlie terrace deposits and dip seaward about  $21^{\circ}$ . Land movement has been attributed to ground-water lubrication and slippage along bedding planes of the Astoria and Nye (Allen and Lowry, 1944). More than 16 acres of property have been involved in the Newport subsidences.
