# The Ore Bin

Volume 38, No. 8  
August 1976

## BEACH EROSION ON SILETZ SPIT, OREGON

Paul D. Komar and C. Cary Rea  
School of Oceanography, Estuarine and Coastal Research Program  
Oregon State University

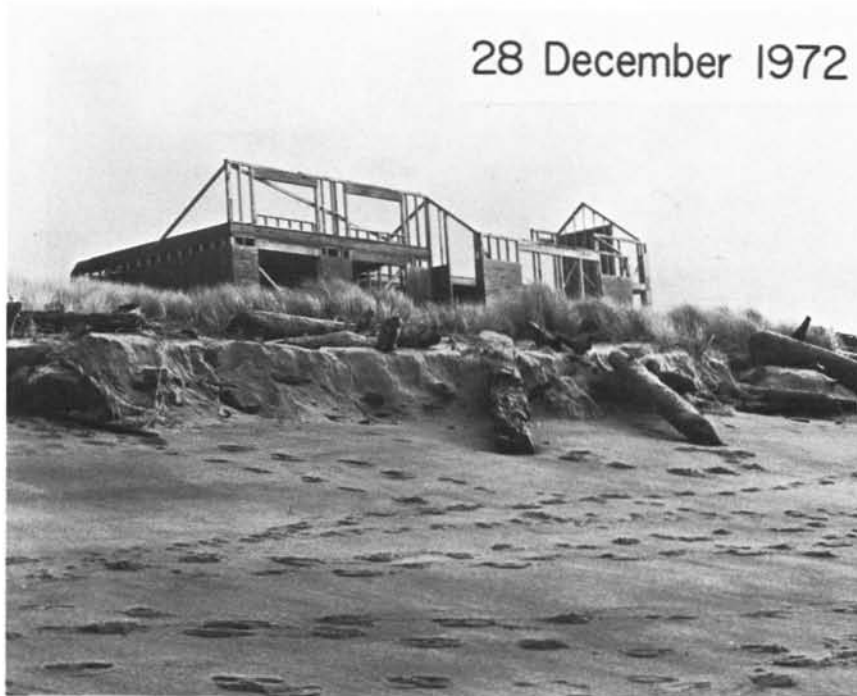
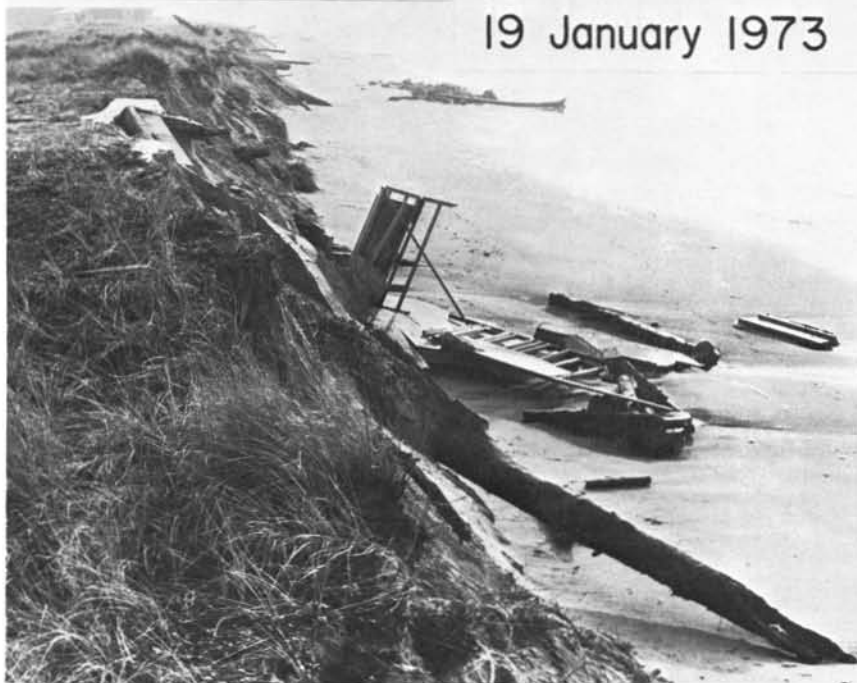
Figure 2. Erosion and destruction of the house under construction on lot 226 of Siletz Spit.

The severest episode of erosion occurred during the winter of 1972-73. One partially built home was destroyed (Figure 2), and others had to be protected by riprap on three sides (Figures 3 and 4). The worst erosion took place along a 650-meter stretch of the central spit, opposite the artificial lagoons cut into the bay side of the spit. Figure 5 diagrams the erosion to the base of the foredunes, the maximum recession amounting to 30 meters in a 3-week period. Individual homeowners placed riprap in front of their properties, but unprotected vacant lots continued to erode. Flank erosion in the empty lots made it necessary to protect the sides of houses so that the group of three houses ended on a promontory supported by riprap (Figures 3, 4, and 5).

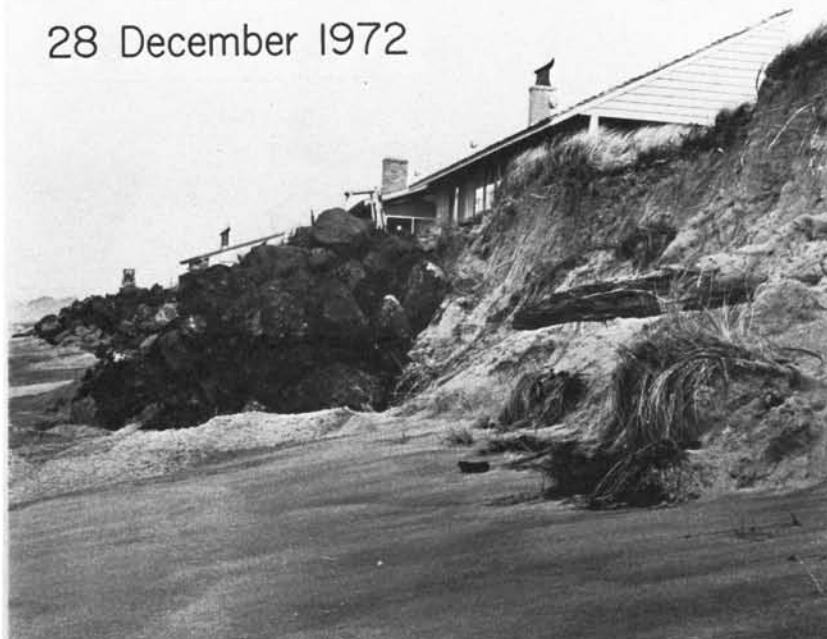
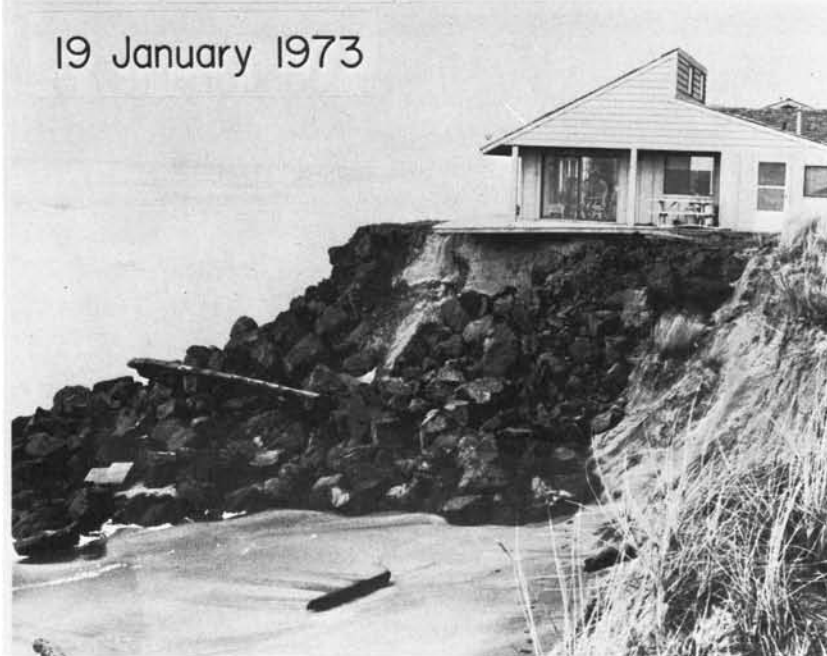
Figure 3. Erosion around the house on lot 229-A. Rapid erosion required placement of riprap fronting home in upper photo; but no riprap was installed in adjacent vacant lot, so erosion continued along the side as seen in lower photo.

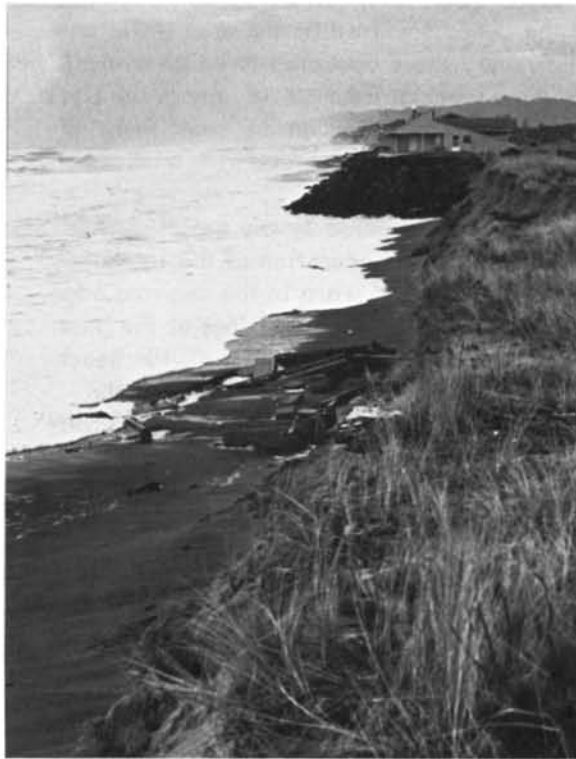
Figure 4. View of both houses of Figures 2 and 3.

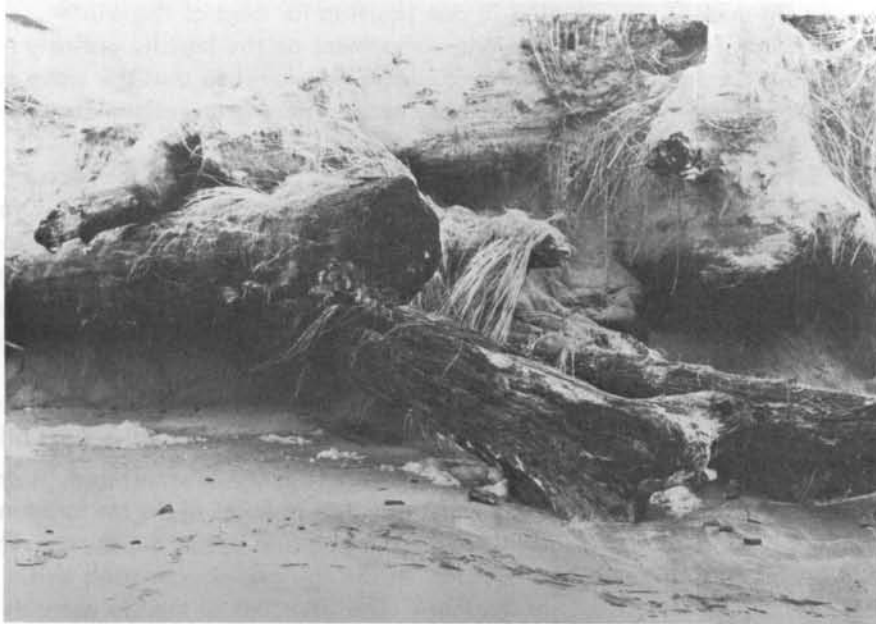
Figure 6. Logs exposed within the eroded dune bluff, many of which had been sawed.

Erosion of the dunes of the spit exposed numerous drift logs, many of which had been sawed (Figure 6). This indicates that spit development was contemporaneous with logging along the Oregon Coast. The influx of settlers and logging started about 1895. Sawed logs within the spit indicate that the portion on which the houses had been built suffered previous erosion some time after 1895. The dunes must have then built back out, incorporating sawed logs in the process, and become re-established.

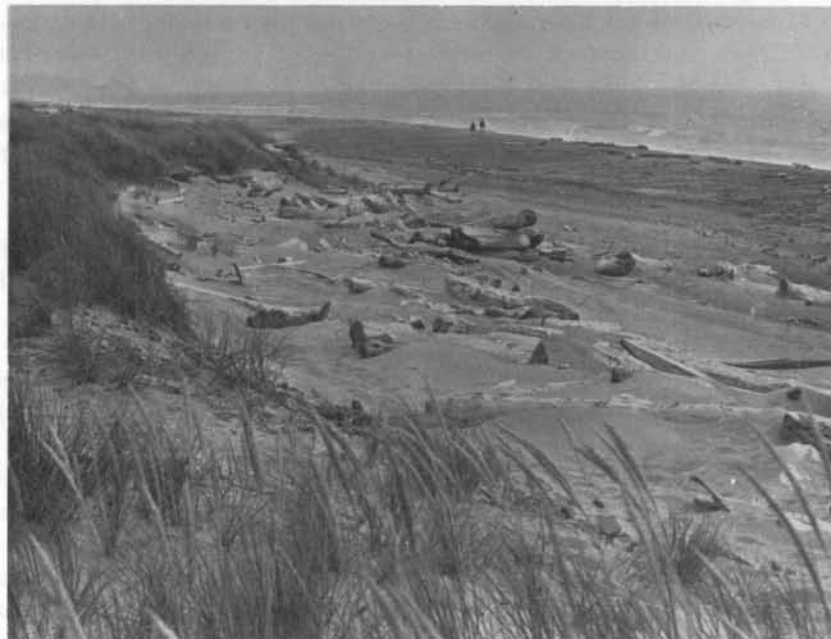
Figure 7. Logs deposited within small embayments eroded into the foredunes trap sands and help reestablish the foredunes.

This study also demonstrates that drift logs play an important role in the natural rebuilding of the foredune areas on spits (Figure 7). Large-scale removal of logs from these areas may be harmful.

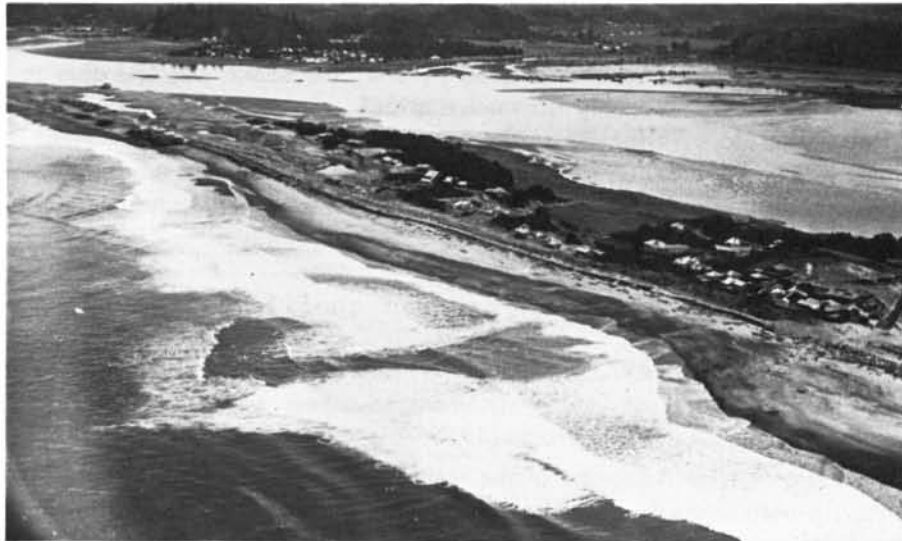
Figure 8. Irregular shoreline of bays and cusps are due to rip currents, one of which is shown in this photograph taken February 8, 1973.

The shoreline along Siletz Spit is typically very irregular (Figure 8) due to rip currents carrying sand offshore, hollowing out small bays on the beach with large cusps between them. At the time of erosion in 1972-73

a strong rip current was situated in one position for most of the winter. This rip current hollowed out a large embayment on the beach, entirely removing the portion of the beach above high tide level so that the wave swash was able to reach the dunes. The loose sand, offering no resistance to the waves, was easily eroded.

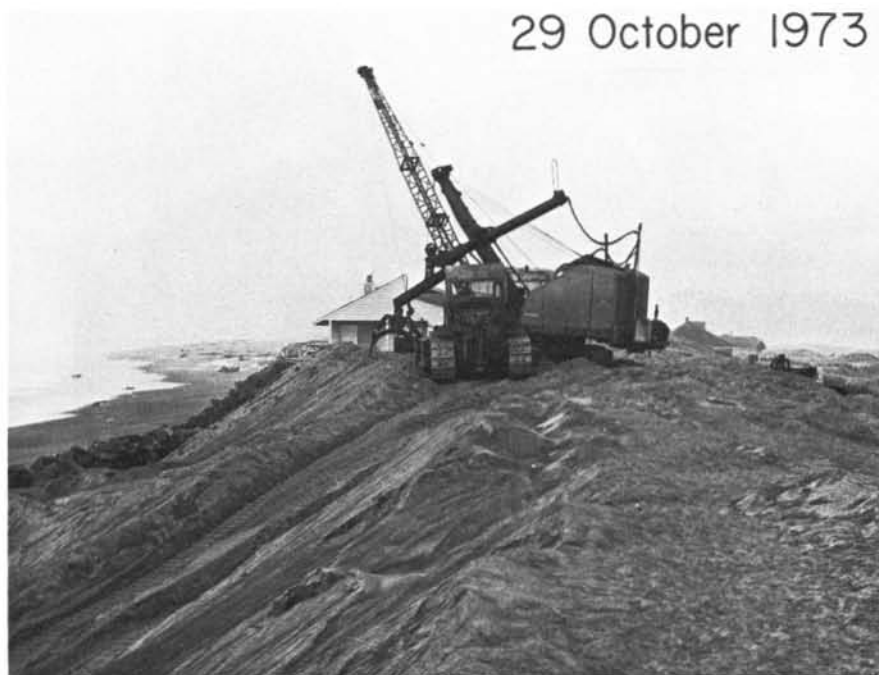
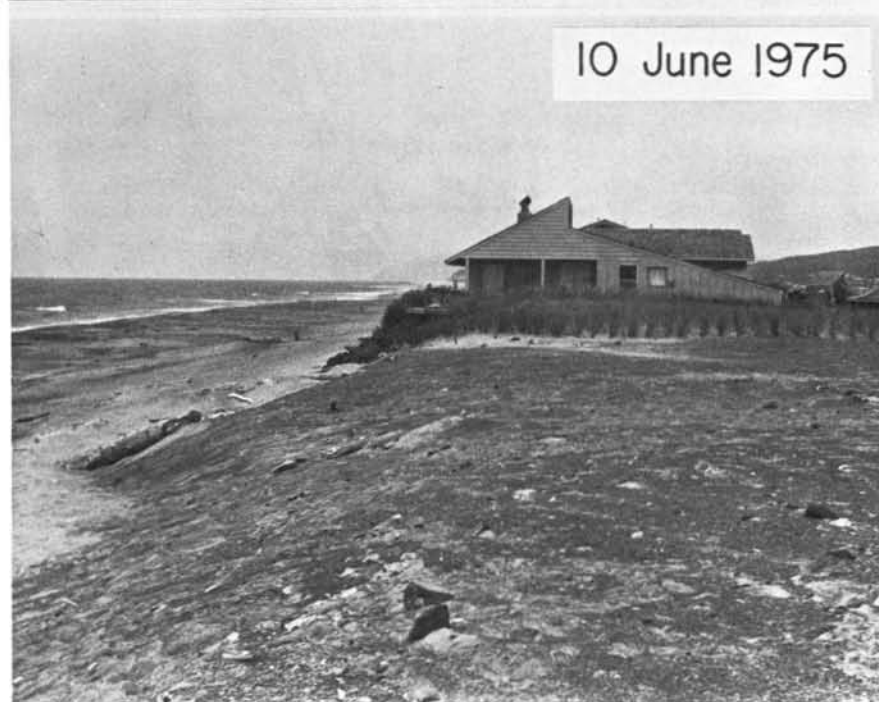
Figure 10. Restoration of the lots 228 and 229. Compare with Figures 3 and 4.

Some of the lots that were eroded in 1972-73 have been subsequently restored (Figure 10). These are either not protected or are inadequately protected: another winter of intense storms could bring renewed erosion. During this winter (1975-76) no rip current is located offshore from this area, and there is no erosion.

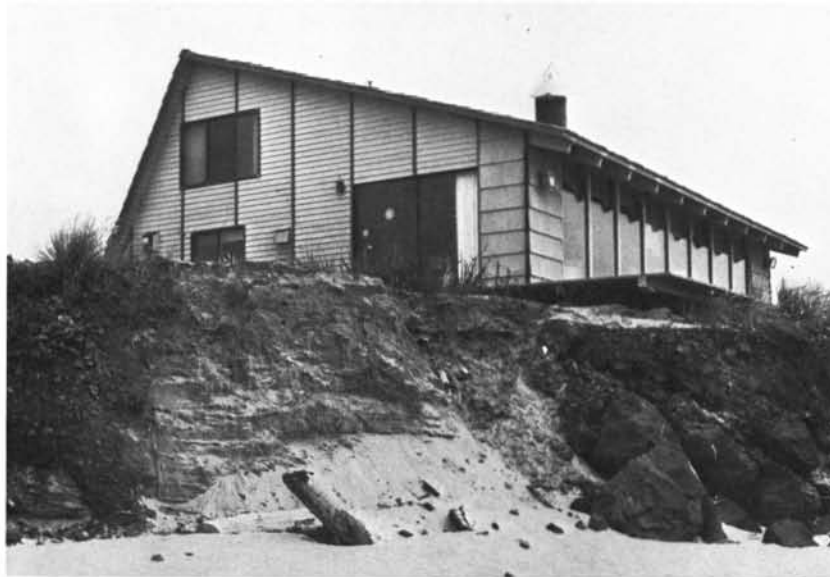
Figure 11. Erosion of the riprap fronting one of the homes, exposing some of the dune sands. Note small size of the rocks, which are easily removed by erosion.

Some houses for which riprap was installed in 1972-73 could be endangered by future erosion because the riprap protection is inadequate. In some cases the riprap has partially eroded, exposing the dune sands (Figure 11). This riprap was installed hastily in order to save the houses at the time of severe erosion in 1972-73, and installation did not follow the established engineering procedures for riprap construction. Even more important, stones of inadequate size were used because of their availability: these are easily washed away by waves.

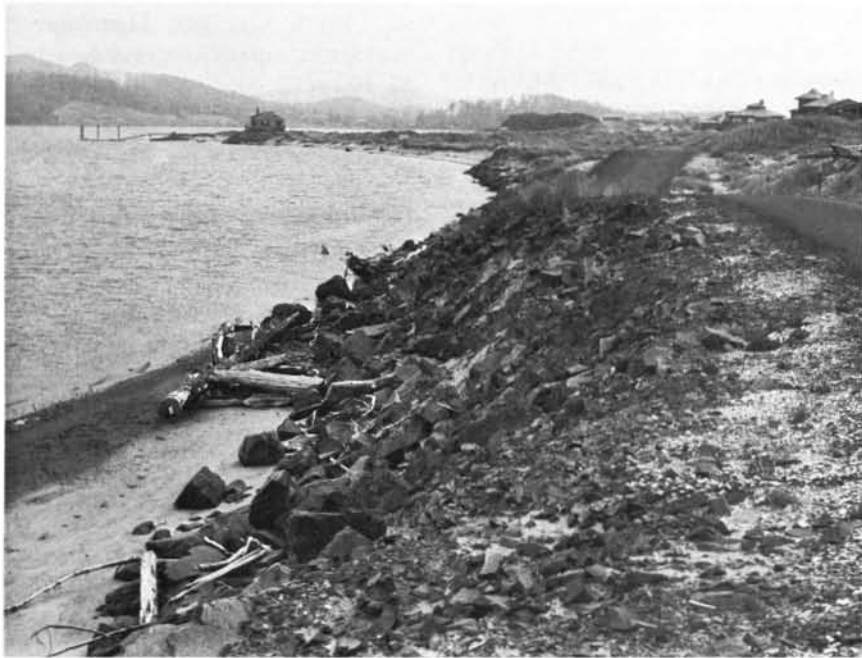
Figure 14. Riprap placed on the bay side of the spit to prevent or decrease erosion.

In 1875 the width of the spit, C, was 163 meters. By 1939 it had decreased to 102 meters. Now it is only 52 meters wide. The progressive increase in the distance B across Siletz Bay shows that the 111-meter decrease in the spit width was due entirely to erosion on the bay side. The edge of the foredunes (taken as the seaward limit of the spit width) fluctuated somewhat in position due to the cycles of erosion and dune reformation discussed above but did not change its overall position in those 100 years. This is reflected in the irregularity of the distance D in Figure 13. The erosion on the bay side appears to have been fairly steady until recently when riprap was installed to stop the erosion (Figure 14).

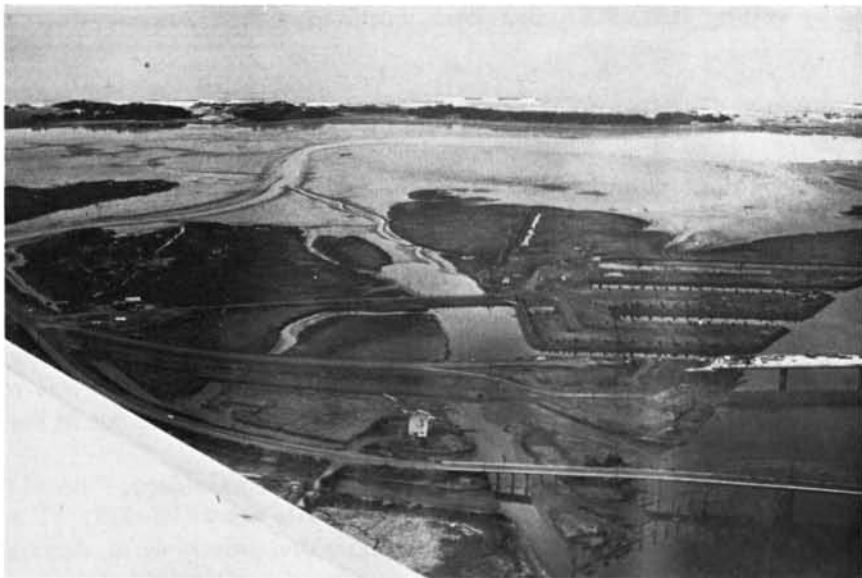
Figure 15. Aerial view of the Siletz Keys fill and the approaches to the old and the new highway bridges. Note how the access road to the Siletz Keys and the approach to the new bridge both block the channel leading to the south bay.

Recent landfills in Siletz Bay (Figures 12 and 15) have probably aggravated the erosion problem. Both the Siletz Keys fill and the dike on the Millport Slough prevent flood discharge spill into the south bay. Prior to these fills, flood waters flowed in part into the south bay, dissipating their energy. Now that the fills prevent this spill, the full flood discharge of the Siletz River is directed toward the back of the spit into the area that is eroding. Riprap has reduced the expected increase in erosion, but whether the riprap will continue to be effective is questionable.

Removal of the dike on the Millport Slough would partly eliminate this aggravation and would improve water circulation in the south part of the bay. Removal of the dike-entrance to Siletz Keys is no longer sufficient because the recent construction of a new bridge for Highway 101 over the Siletz River has also blocked that spill channel (Figure 15). A conduit under the approach to the bridge would also be necessary.
