OREGON GEOLOGY

Volume 61, Number 6, November/December 1999

The other face of Oregon: The geologic processes that shape our state

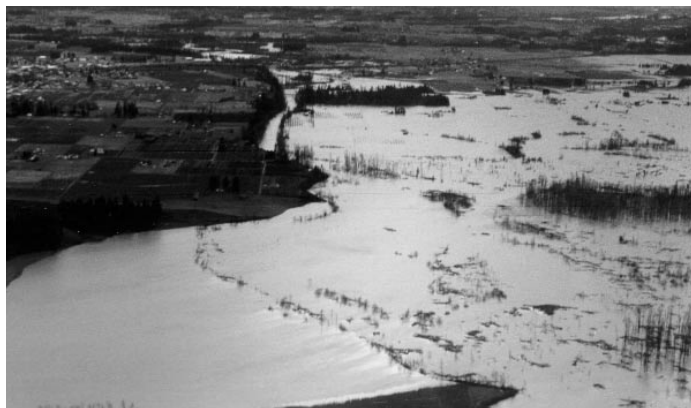
The 1964 flood at the confluence of the Pudding and Molalla rivers in the northern Willamette Valley near Canby.

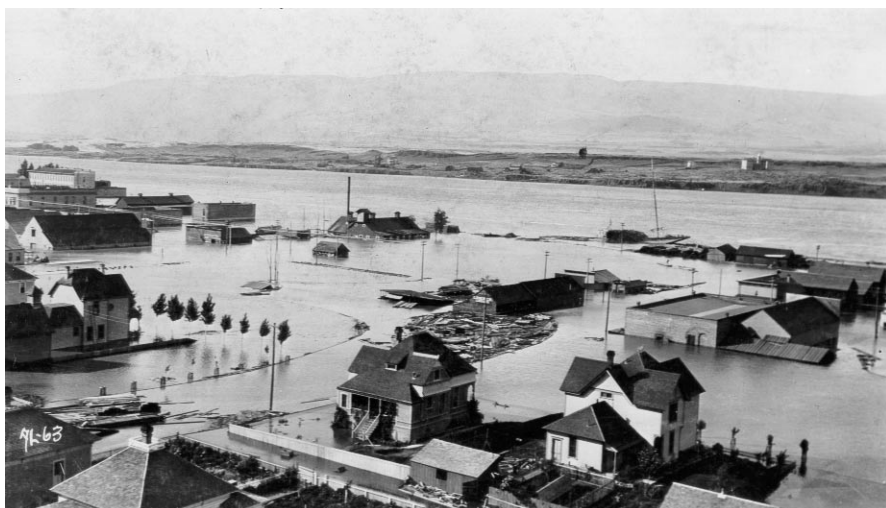
At the height of the 1894 flood, the entire business district at The Dalles was under 10 ft of water.

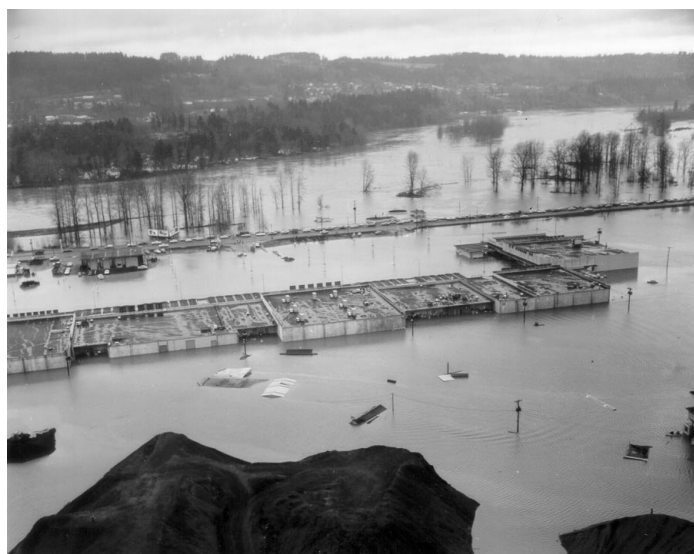
In this view to the west at the business district, up to six feet of water from the Willamette River covered Oregon City during the 1964 flood.

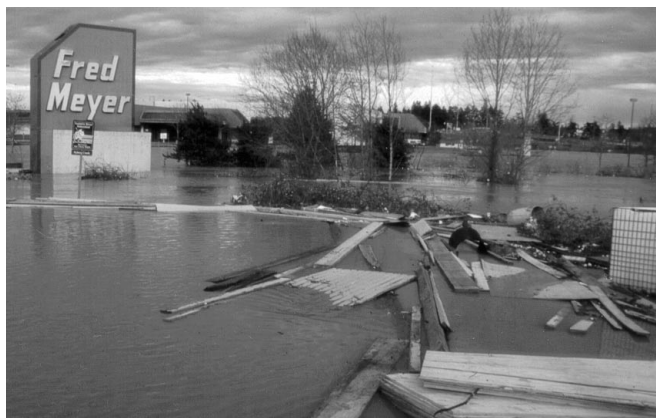
Tualatin shows water still standing five days after the rains of the 1996 flood. Photo courtesy of Scott Burns.

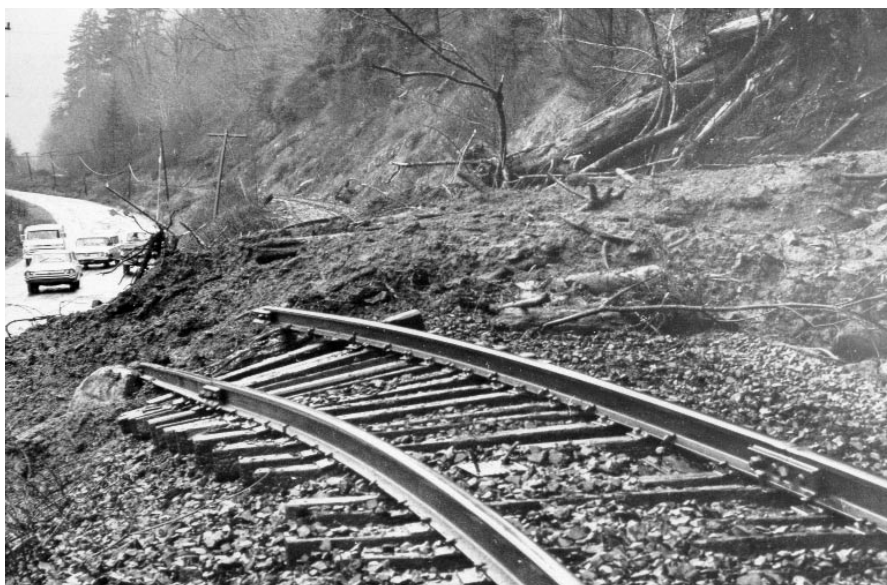
Bent railroad tracks and blocked coastal road at Mapleton, Oregon, reflect the power of a mudflow there in 1964.

blocks of downtown Corvallis were under water, and 1,000 families were evacuated. The Mapleton highway was blocked by sliding debris. Homes and businesses at Oregon City were evacuated. Interstate 84 west of Cascade Locks was closed by two major landslides, one 300 yards wide. Even as cleanup was taking place, a third slide tumbled down the unstable slope. In eastern Oregon, rain-swollen streams washed out roads and isolated families and even entire communities as highways in Wallowa County were covered by mudslides.

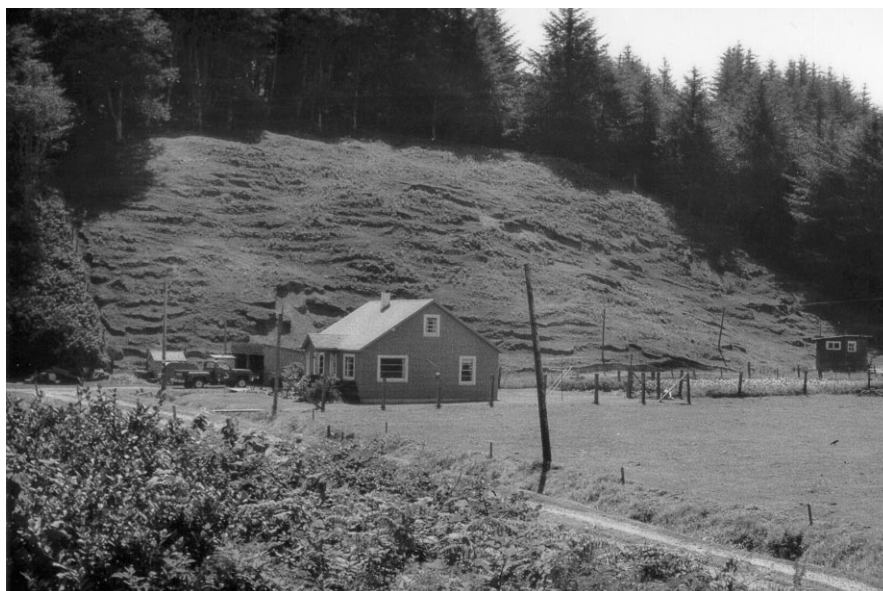
Both scenes in the southern Willamette Valley near Sweet Home show how clear-cutting initiates landslides. The rumpled appearance of the slope behind the house is a shallow earth-flow above bedrock that began to slide shortly after the trees were removed.

Agricultural irrigation and forestry practices such as clear-cutting and stripping vegetation from naturally oversteepened slopes have been shown to be responsible for a spate of landslides. Highway construction on similar slope conditions awaits only the first good rain to provoke earth movement.

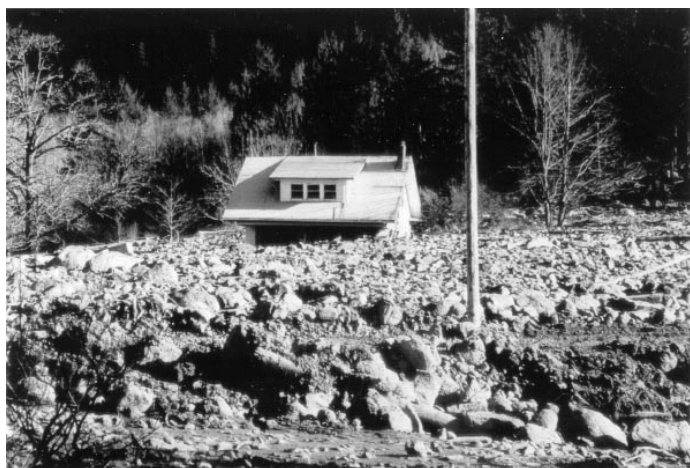
The Royce home still sits on its foundation, surrounded by a rock garden of flow debris. Looking out of a back window, Ms. Royce saw a line of huge rocks rolling toward the house at about five miles per hour. She and her husband barely escaped before mud from the flow poured into the house and filled most of the lower floor. Photo courtesy of Scott Burns.

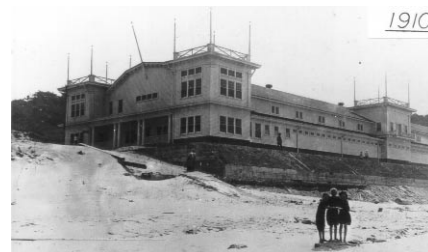
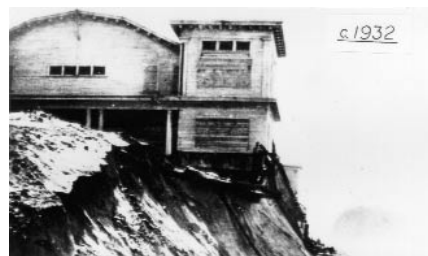
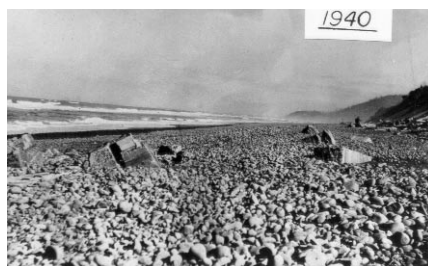
The community of Bay Ocean, constructed on a spit in Tillamook County, was completely destroyed by erosion.

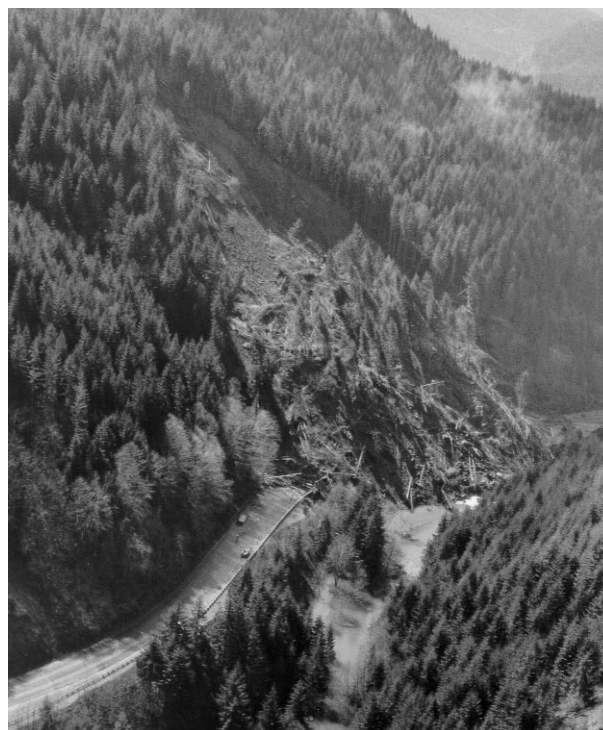
On the Wilson River in Tillamook County, a 1991 landslide completely covered Highway 6 and dammed the stream. Clean-up took two months. Photo courtesy of Oregon Dept. of Transportation.

A large landslide in Tillamook County blocked 600 feet of Highway 6 on April 4, 1991, with 500,000 cubic yards of rock and soil partly damming the Wilson River. This highway has been closed annually by mudslides or rock-falls, and the 1991 episode took nearly two months for debris removal at a cost exceeding \$2 million. The slide occurred when soils on the steep slope became saturated from nine inches of winter rain in two days. Cracks appeared along the upper planar slide and permitted infiltration of runoff to satu-

rate soils. The soil liquefied immediately before movement. When the event took place, the slide was being monitored, and an attempt was being made to drain the slide block.

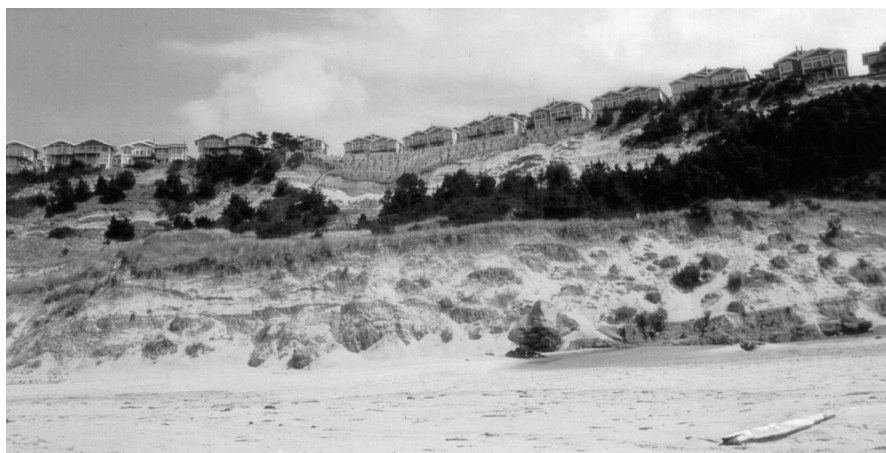
Erosion of dune sand at The Capes development led to landsliding which endangered homes.

A currently active landslide at The Capes, in Tillamook County near Netarts, was first noticed in 1997 by local home owners. A small slope failure on the seaward side of a steep hill indicated that minor but steady movement was accelerating. The slide began with small problems when a stairway to the beach was damaged and had to be removed. Ground cracks opened, and lawns dropped vertically some 18 inches in

The main area of movement is presently 900 feet long and 500 feet wide, endangering 10 houses, with 10 more at risk. Because the slide is now moving so rapidly, assessment of hazards is ongoing.

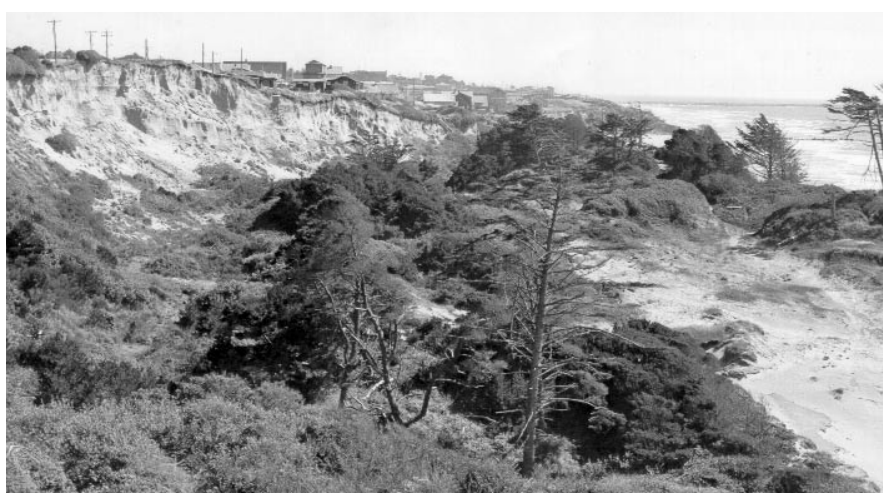
Beginning in 1922, the Jump-off Joe landslide at Newport in Lincoln County moved dramatically in 1942. Despite its known instability, attempts to build houses here have been made as late as the 1960s and 1970s.

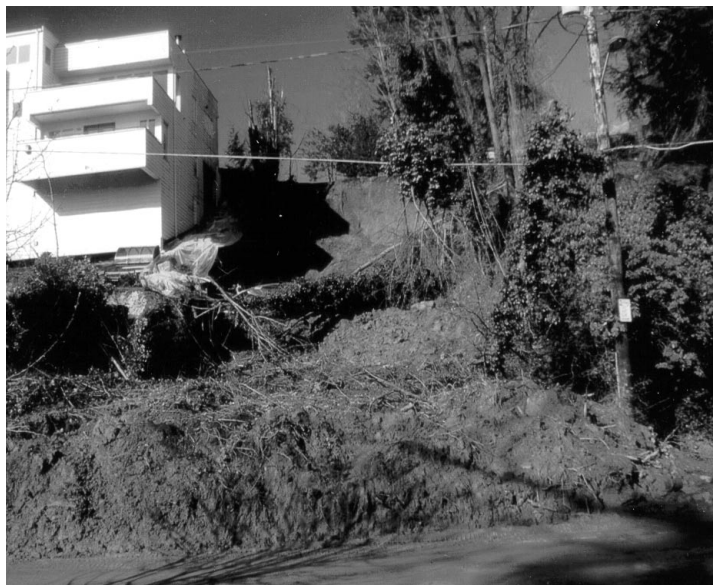
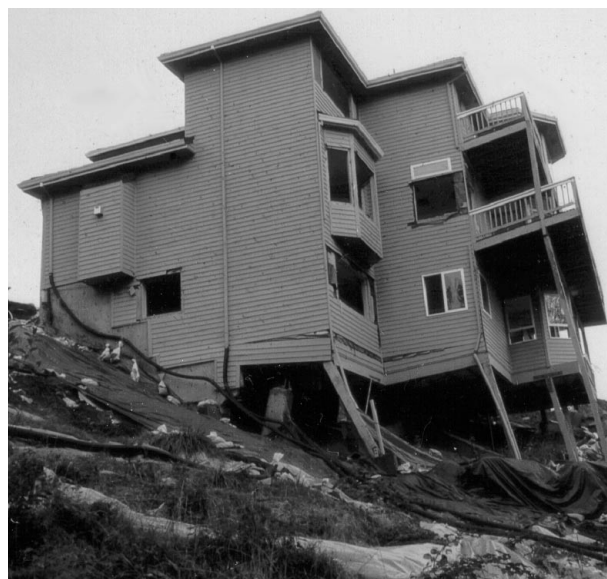
Both houses in Portland were damaged by the 1996 floods and subsequent landslides. The white house on Fairview Street is threatened by sliding on the adjacent vacant lot. The land movement here is due to runoff from the road above. A sheer wall of Portland Hills Silt can be seen at the top of the slide, while the toe has moved onto the road. The three-story house with the failing foundation has rotated as a result of sliding. Situated on the toe of an ancient landslide on Bull Mountain in Tigard, mass movement was reactivated by the 1996 floods. Incredibly, today new houses are being placed on the same slide surface. Photos courtesy of Scott Burns.

During the intense rains of February 1996, Portland officials estimated there were 168 slides, 90 percent of which were in the West Hills. Almost 40 homes were rendered uninhabitable, and total damage to public facilities alone was \$33 million. Super-saturated soils, steep slopes, and natural water drainage diverted by streets and gutters, sent the soil downslope during the February storms. Most slides in the West Hills take place in the Portland Hills Silt, a wind-blown loess deposit dating from dry intervals of the Ice Ages.

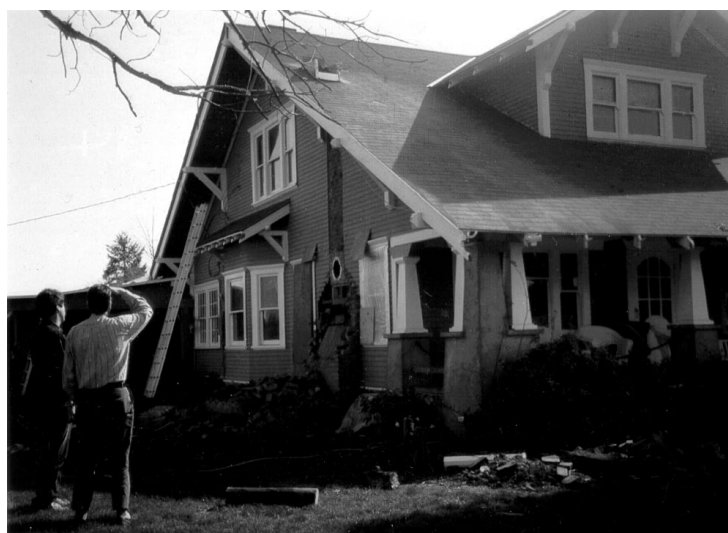
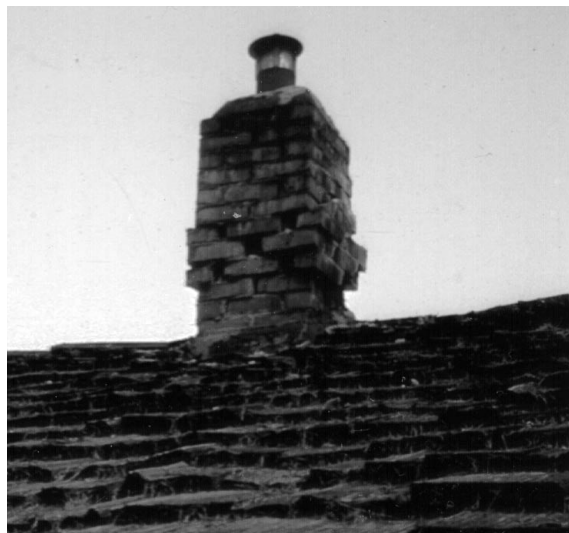
Chimneys, usually built of unreinforced masonry, show the most common type of damage caused by the 1993 Scotts Mills earthquake. Photos show house near Molalla on left and roof of authors' home near Scotts Mills (right). Photos courtesy of Doug Eaton.

Coming as a complete surprise to most people, including geologists, the M 5.6 Scotts Mills quake of 1993 was one of the strongest events in Oregon's recorded history. Because it was so unexpected, it should be seen as a warning that fu-

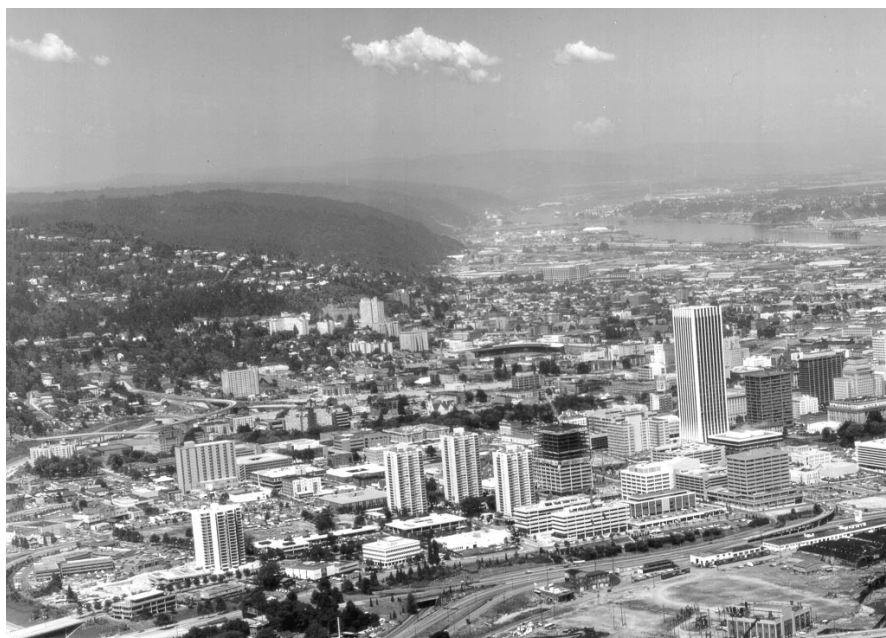
Two major north northwest-trending faults slice across Portland. The Portland Hills fault to the left is marked by the straight northeast margin of the foothills, while across the Willamette River, the parallel East Valley fault is buried beneath alluvium and fill. Photo courtesy of Delano Photographics.

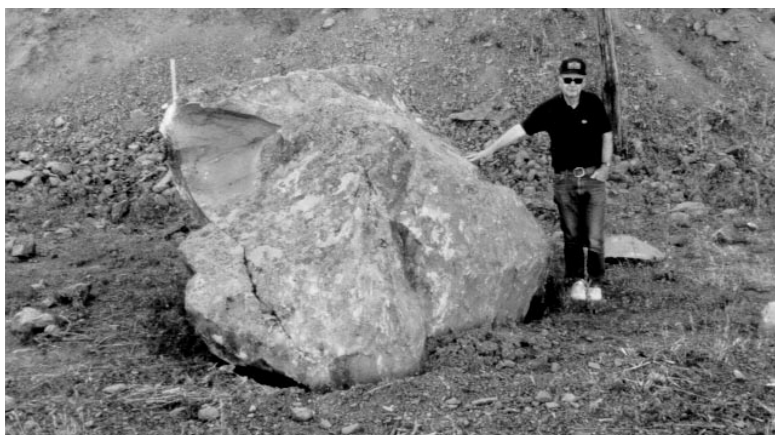
The huge boulder above was dislodged and fell on Highway 140 west of Howard Bay at Upper Klamath Lake during the 1993 Klamath Falls earthquake, which also produced a rotational slump and its associated crescent-shaped cracks in the roadbed nearby (right).

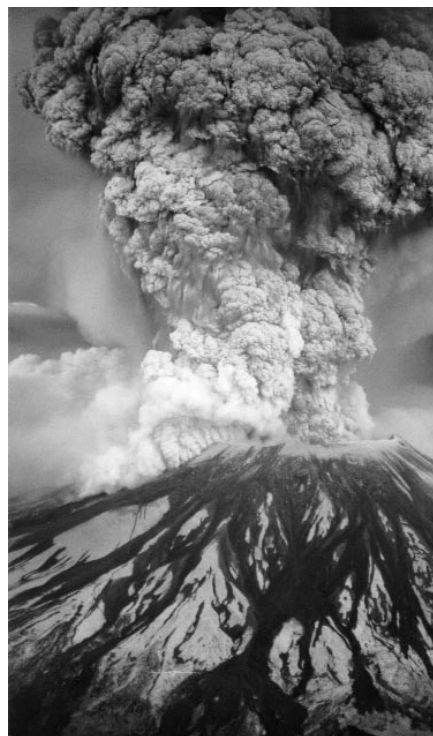
More than any other single event in this century, the May 18, 1980, eruption of Mount St. Helens brought the reality of geologic hazards to the public's awareness. Photo courtesy of U.S. Geological Survey.

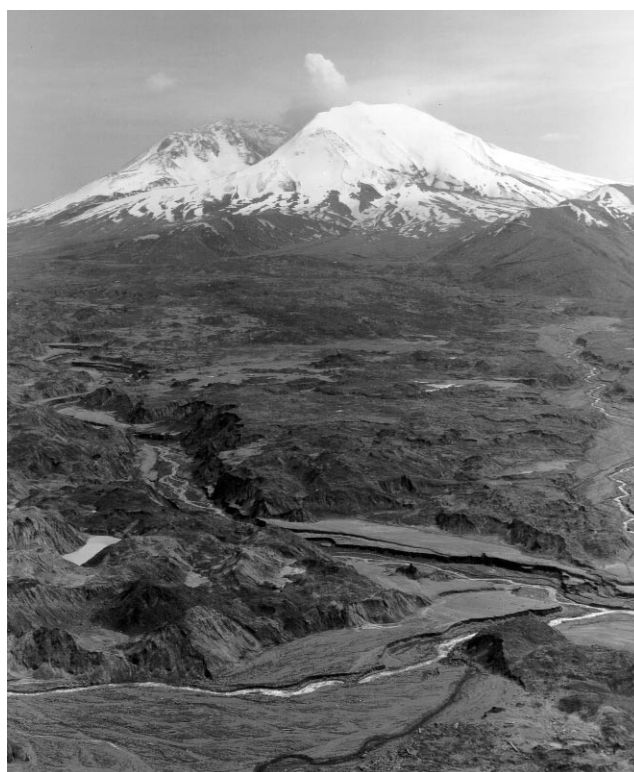
Mount St. Helens displays the debris avalanche and mudflow deposits that supplemented the blast effect of the eruption. Photo courtesy of U.S. Geological Survey.

Before the 1980 Mount St. Helens episode, the incidence and impact of lateral eruptions was poorly understood. During this event, the northeastward blast knocked down trees and increased the damage significantly. Since then, it has been found that lateral blasts are not uncommon in Cascade volcanoes. An

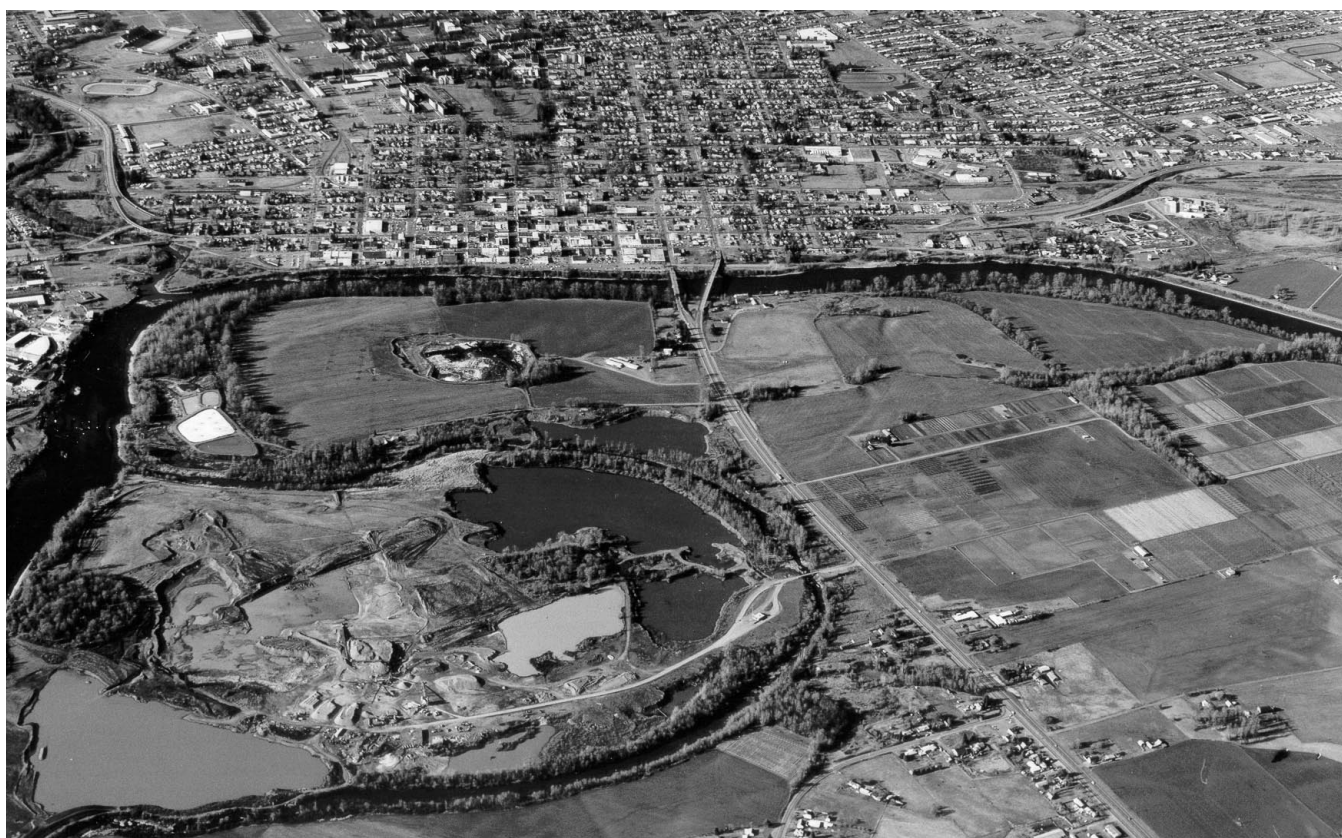
Corvallis as seen from the east. During even minor floods the entire flatland between meanders is usually under water.
