# JOHNSON CREEK LANDSLIDE RESEARCH PROJECT, LINCOLN COUNTY, OREGON

FINAL REPORT TO THE OREGON DEPARTMENT OF TRANSPORTATION

Special Paper 40  
Oregon Department of Geology and Mineral Industries  
2008

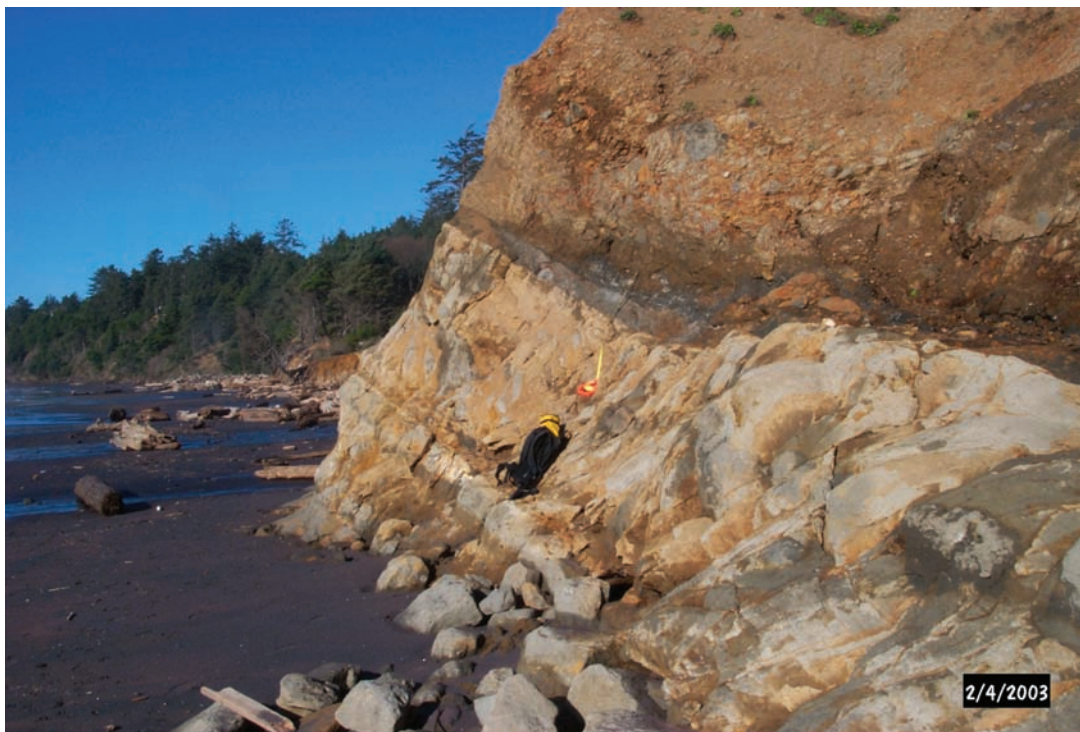
**Figure 10.** Looking north at Tertiary Astoria Formation at the toe of the Johnson Creek landslide. The smooth light tan unit is sandstone; sandy siltstone is the overlying dark orange gray unit. Black 0.8-m-long back pack is shown for scale. These units had an original dip of  $\sim 17^\circ$  E, whereas in this exposure they dip  $28^\circ$ – $37^\circ$  E from back rotation. See Figure 2 for location.

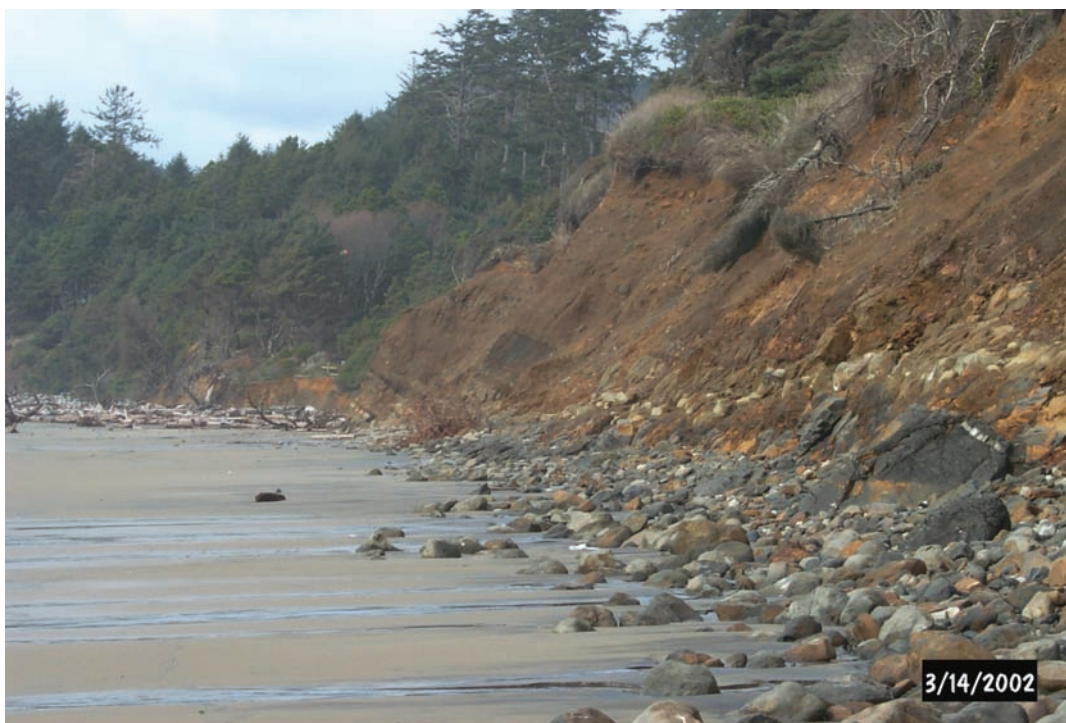
**Figure 11.** Looking north from the toe of the Johnson Creek landslide. Note light-colored marker beds that can be traced easily over the entire length of the slide toe.

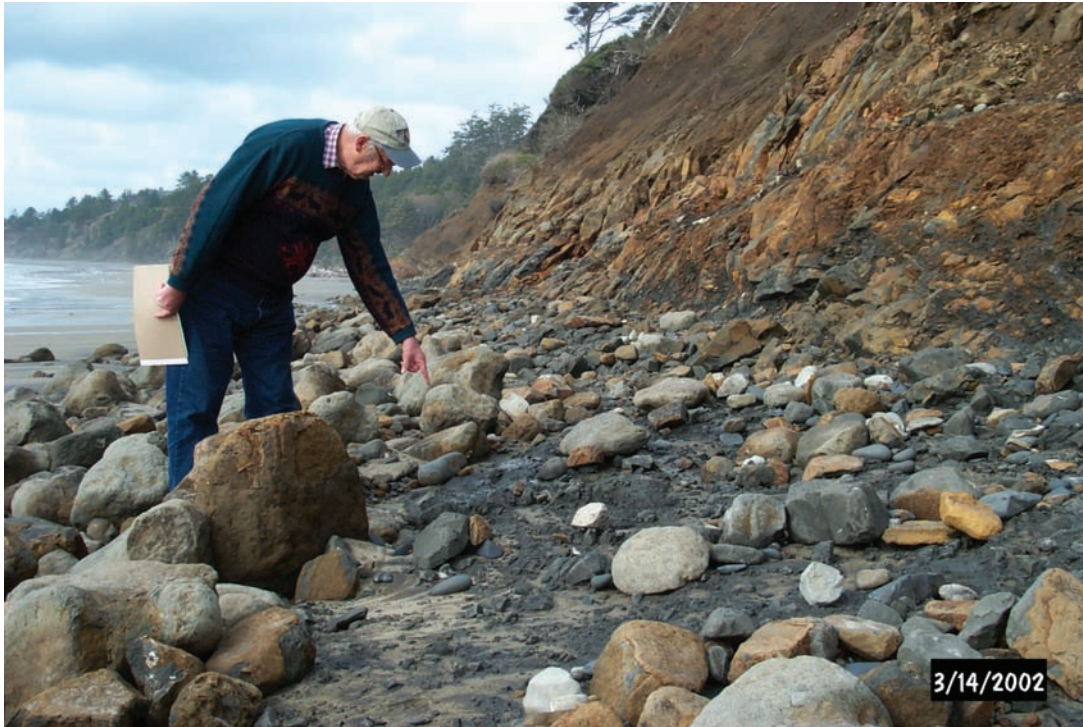
**Figure 12.** Highly sheared dark gray sandy siltstone unit at the toe of the Johnson Creek landslide. This unit underlies the tan sandstone in Figure 3. Chuck Dennison of Dennison Surveying is pointing at the unit. Slightly reworked talus from the slide partially covers the basal shear zone.

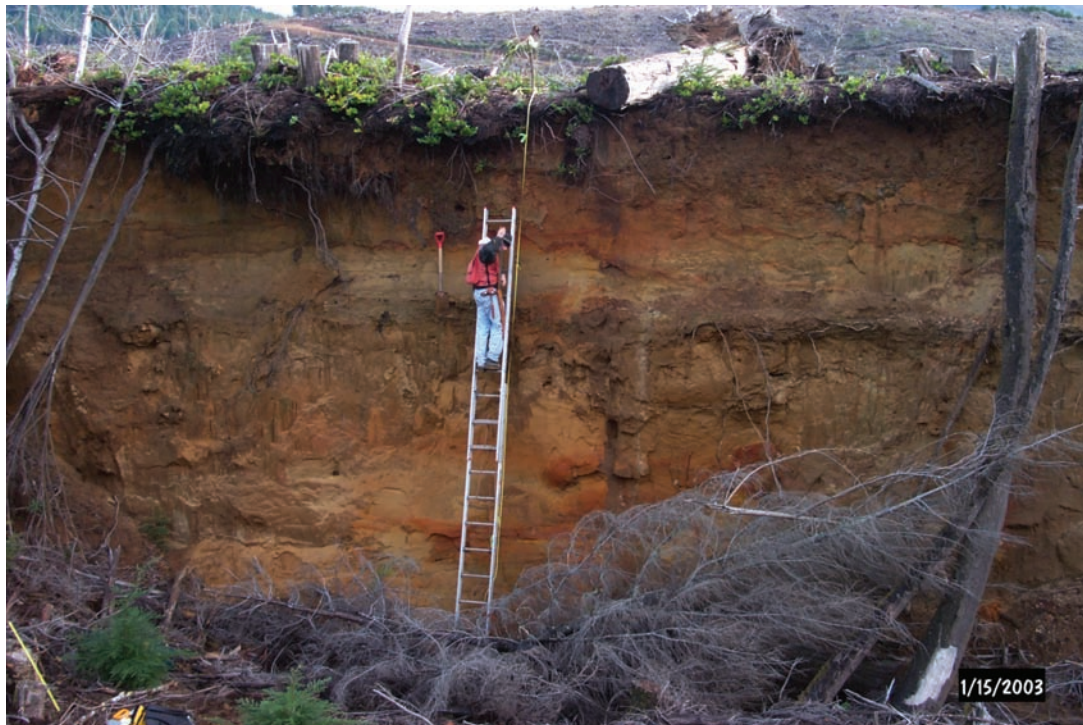
**Figure 13.** Pleistocene marine terrace sand exposed in the northeast headwall of the landslide. Jonathan Allan of DOGAMI is measuring the thickness of the unit. Note the nearly flat surface of the sand sheet. The contact with underlying Tertiary Astoria Formation is ~1 m below the base of the ladder.

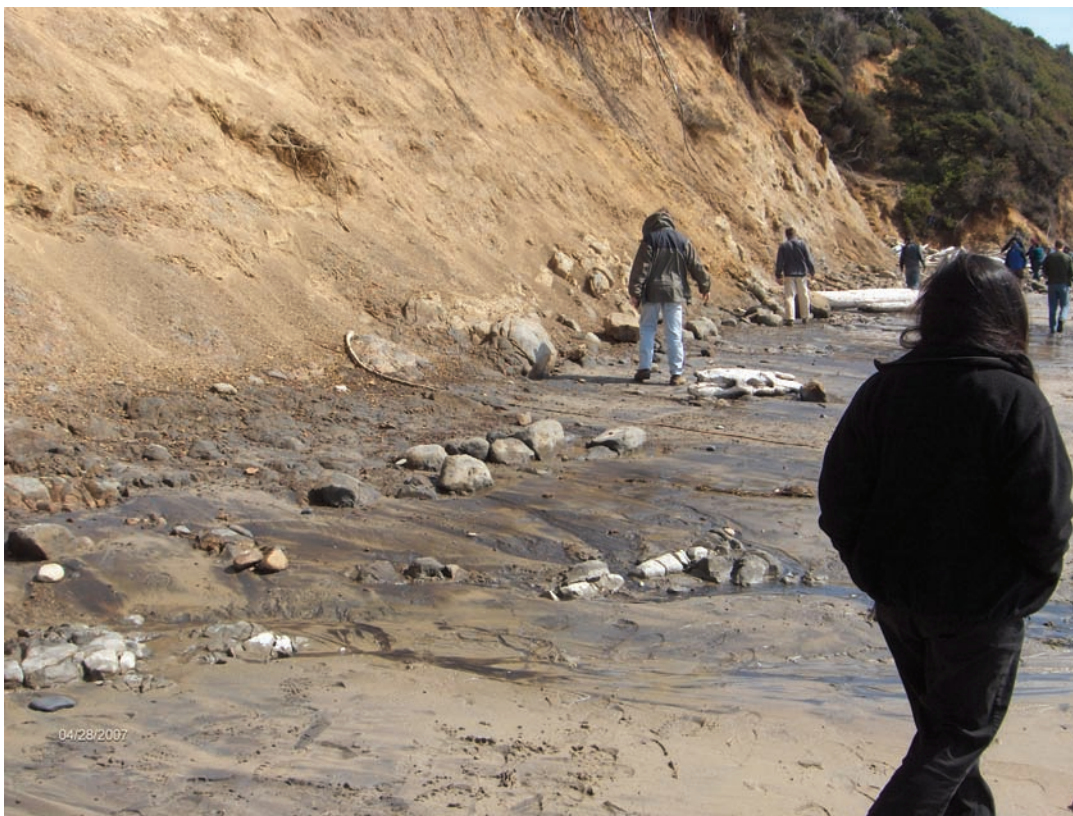
**Figure 14.** Groundwater seeping from slide breccia and gouge of sandy siltstone at the southern toe of the Johnson Creek landslide. The mouth of Johnson Creek is in the upper right where driftwood is piled up. Note that beach sand is stripped off. Wave erosion is more efficient in this part of the slide owing to a persistent rip cell embayment that carries sand offshore. Photo was taken April 28, 2007.

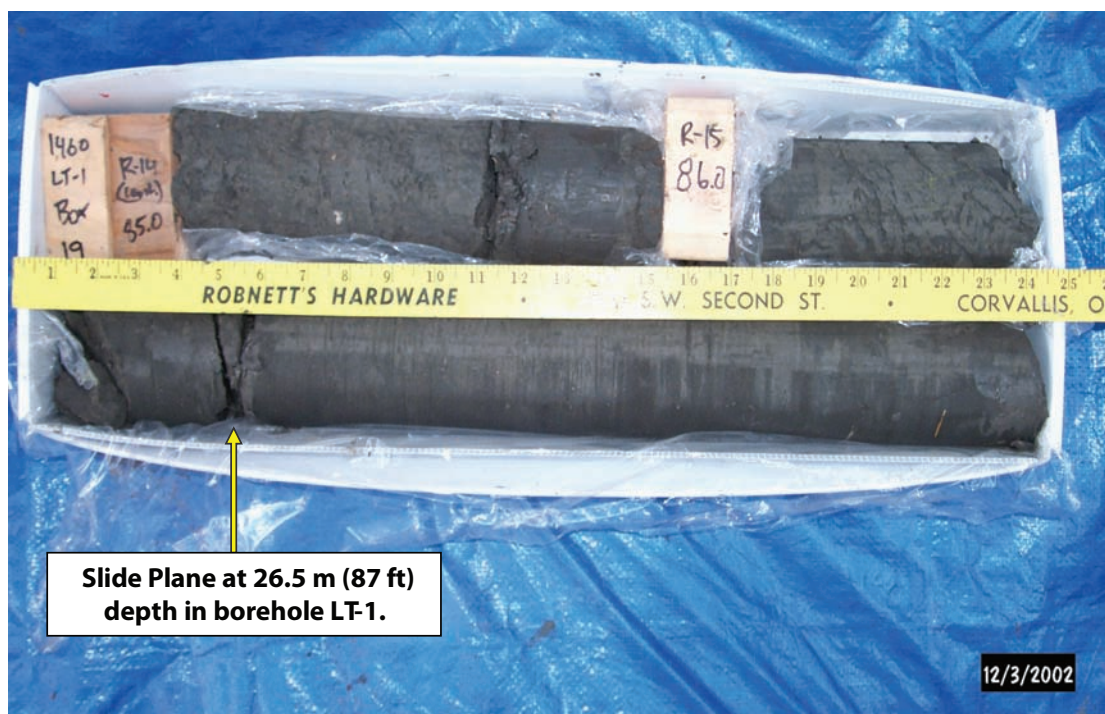
**Figure 18.** Core at the slide plane from the western (LT-1) inclinometer hole. Numerous sheared fractures occur just above the slide plane.

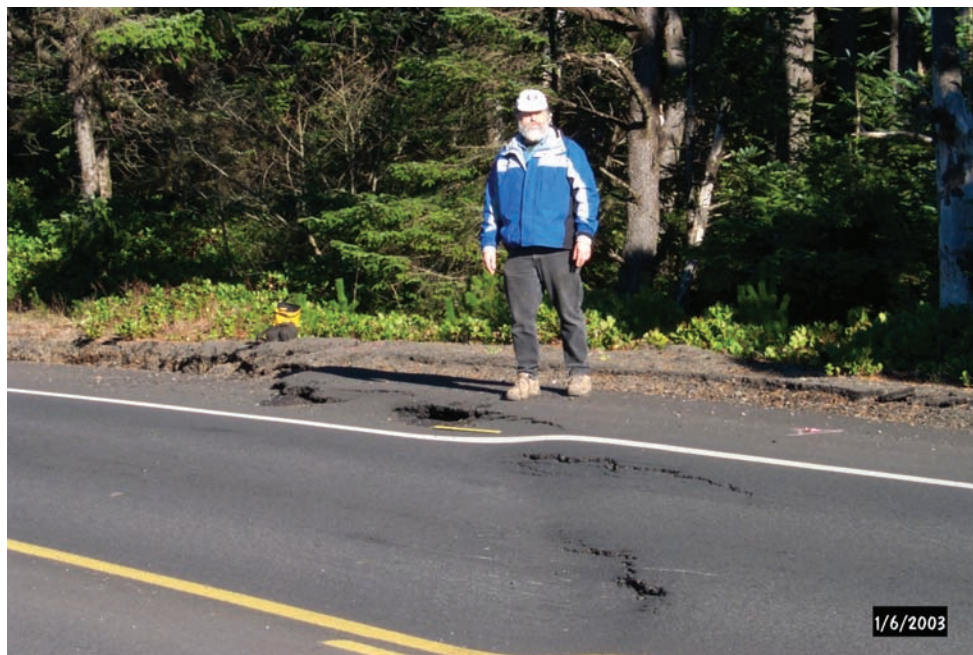
**Figure 24.** Damage to Highway 101 on the south margin of the Johnson Creek landslide immediately after a slide movement in January 2003. Maximum vertical offset is 17.8 cm down to the northwest; fissures are as wide as 5 cm. This part of the slide is south of the resurvey lines and confirms the general trend of increasing offset to the south. Roger Hart is in the background.

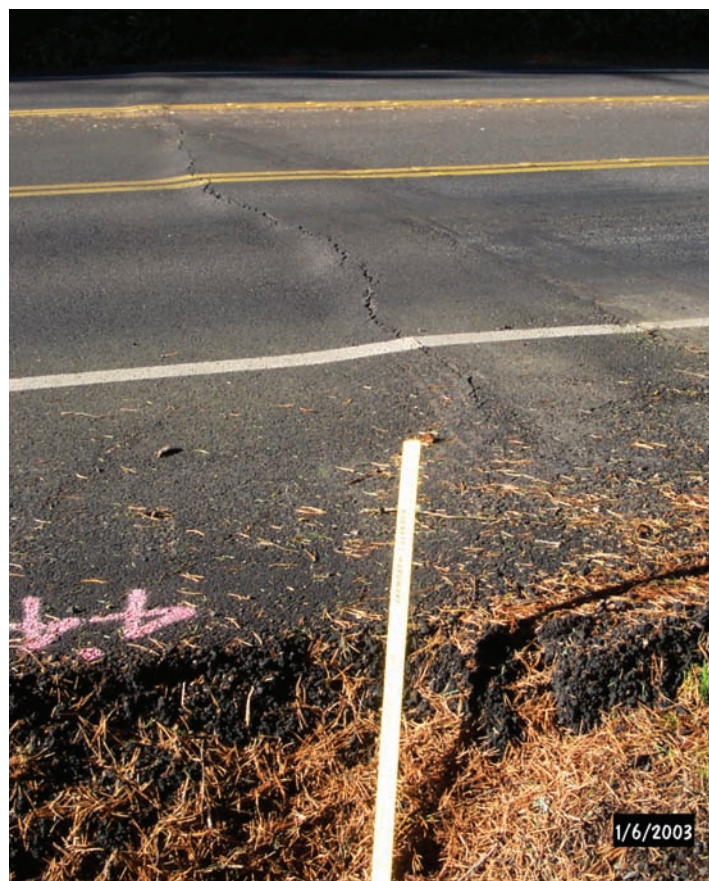
**Figure 25.** Damage to the north slide margin on Highway 101 from the same movement as in Figure 24. Note that vertical offset is only 1-2 cm.
