# JOHNSON CREEK LANDSLIDE RESEARCH PROJECT, LINCOLN COUNTY, OREGON

FINAL REPORT TO THE OREGON DEPARTMENT OF TRANSPORTATION

Special Paper 40  
Oregon Department of Geology and Mineral Industries  
2008

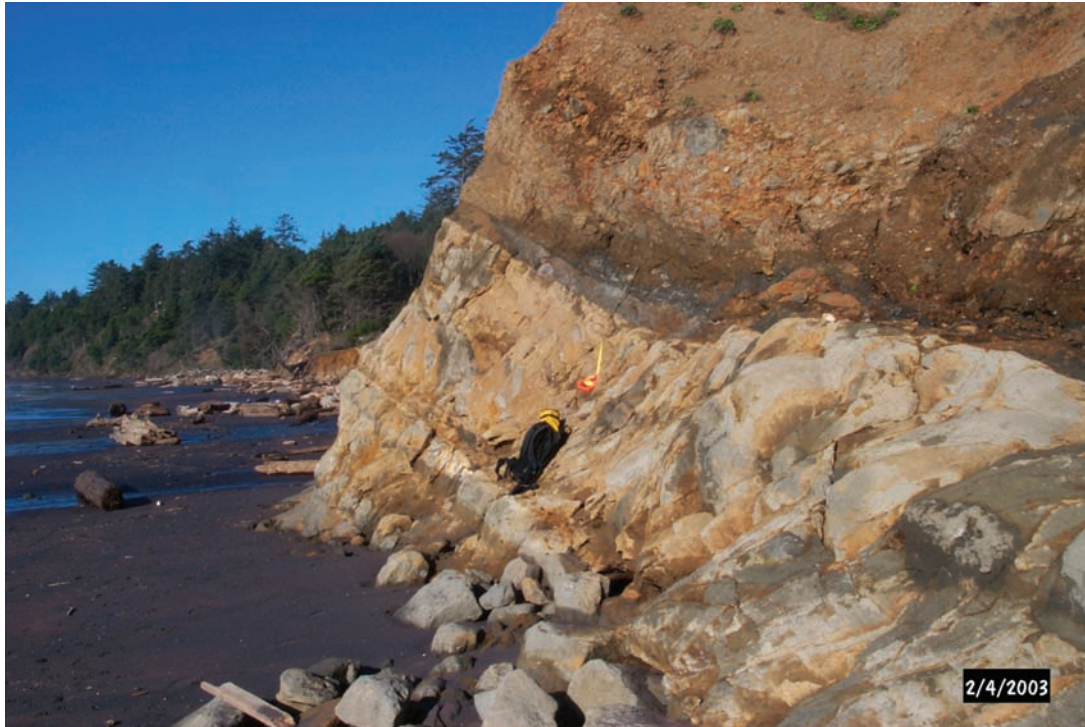
**Figure 10.** Looking north at Tertiary Astoria Formation at the toe of the Johnson Creek landslide. The smooth light tan unit is sandstone; sandy siltstone is the overlying dark orange gray unit. Black 0.8-m-long back pack is shown for scale. These units had an original dip of  $\sim 17^\circ$  E, whereas in this exposure they dip  $28^\circ$ – $37^\circ$  E from back rotation. See Figure 2 for location.

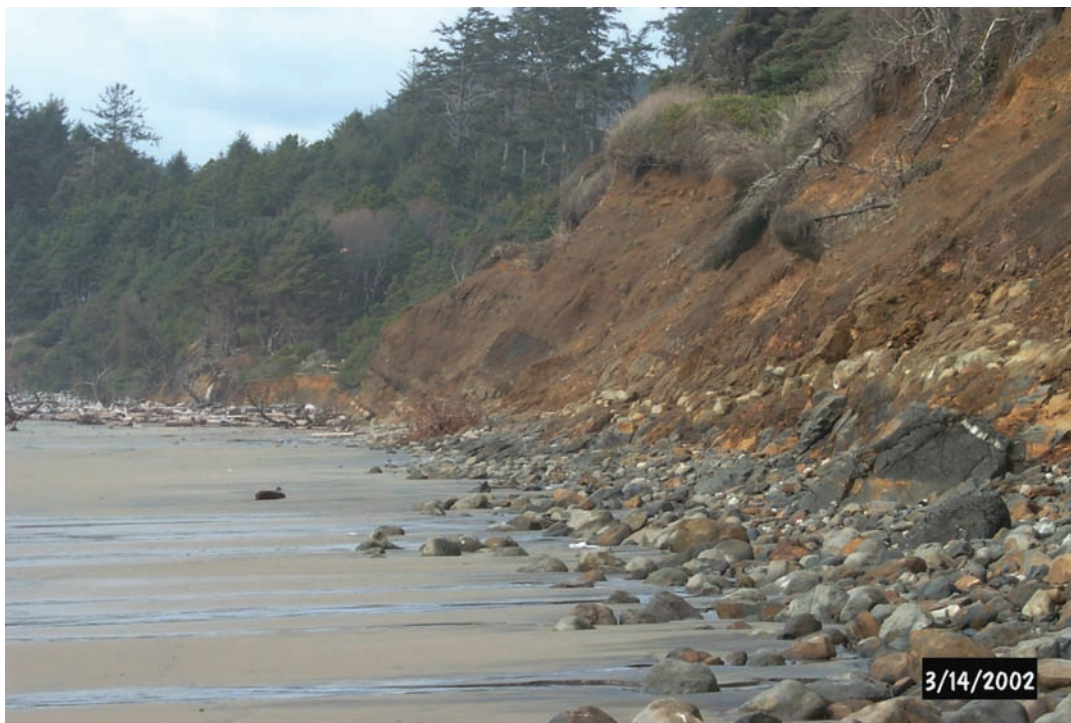
**Figure 11.** Looking north from the toe of the Johnson Creek landslide. Note light-colored marker beds that can be traced easily over the entire length of the slide toe.

The back-tilted toe block is 4 to 30 m wide and forms a 17-m-high bench that lies at the base of scarps separating it from the main translational blocks to the east (Figures 2 and 7). These scarps have about 10 m of relief and change northward from multiple scarps to one scarp. The width of the toe block increases by a factor of 2 where the scarps fuse into one. Bedding in Tertiary Astoria Formation exposed at the toe dips between 15° and 45° to the east, rotated from original west dip on the order of ~17° (Figures 4 and 10). This “back-rotation” is likely due to upward movement of slide blocks. If the basal slide zone of a translational slide rises to the surface at its toe, a passive wedge is formed where material can rotate relative to the main slide mass. Local slumps can also result in back-rotation of slide blocks, but this block is relatively coherent, as demonstrated by continuity of single marker beds (Figure 11). These marker beds are offset ~2 m down to the northeast on a fault

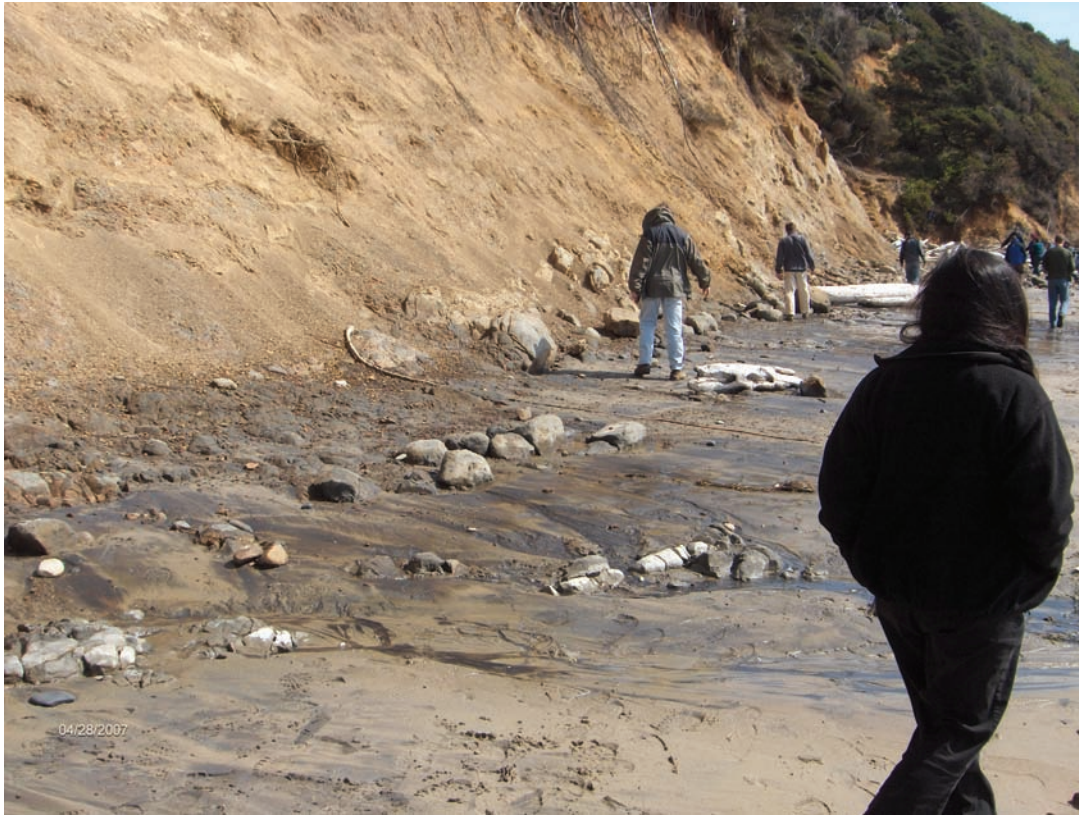
**Figure 14.** Groundwater seeping from slide breccia and gouge of sandy siltstone at the southern toe of the Johnson Creek landslide. The mouth of Johnson Creek is in the upper right where driftwood is piled up. Note that beach sand is stripped off. Wave erosion is more efficient in this part of the slide owing to a persistent rip cell embayment that carries sand offshore. Photo was taken April 28, 2007.

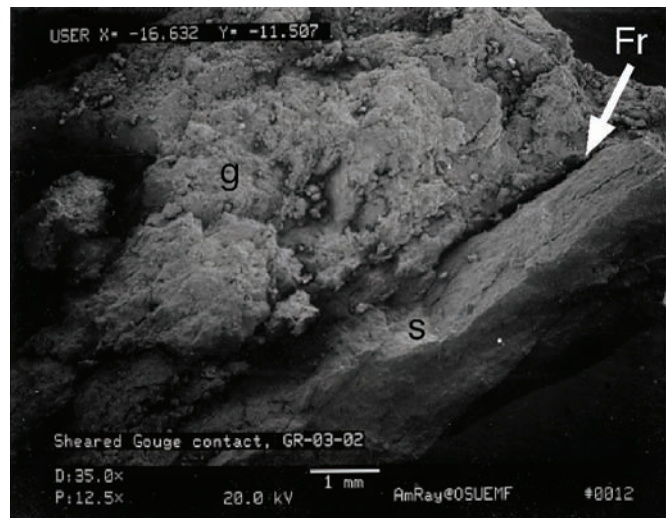
**Figure A5b.** SEM photomicrograph at low magnification (12.5x) shows a sharp smooth shear plane (labeled Fr) that appears to step across the specimen. The specimen was mounted upside-down, which places the shear gouge (g) in the upper NW half of the photograph and the unsheared siltstone (s) in the lower SE half of the photograph. The sheared gouge appears as a jumbled mass of largely subparallel (imbricated) smectite clay particles or packets. In the gouge, multiple fractures (dark lines), along which slippage has occurred, are subparallel the main shear boundary.

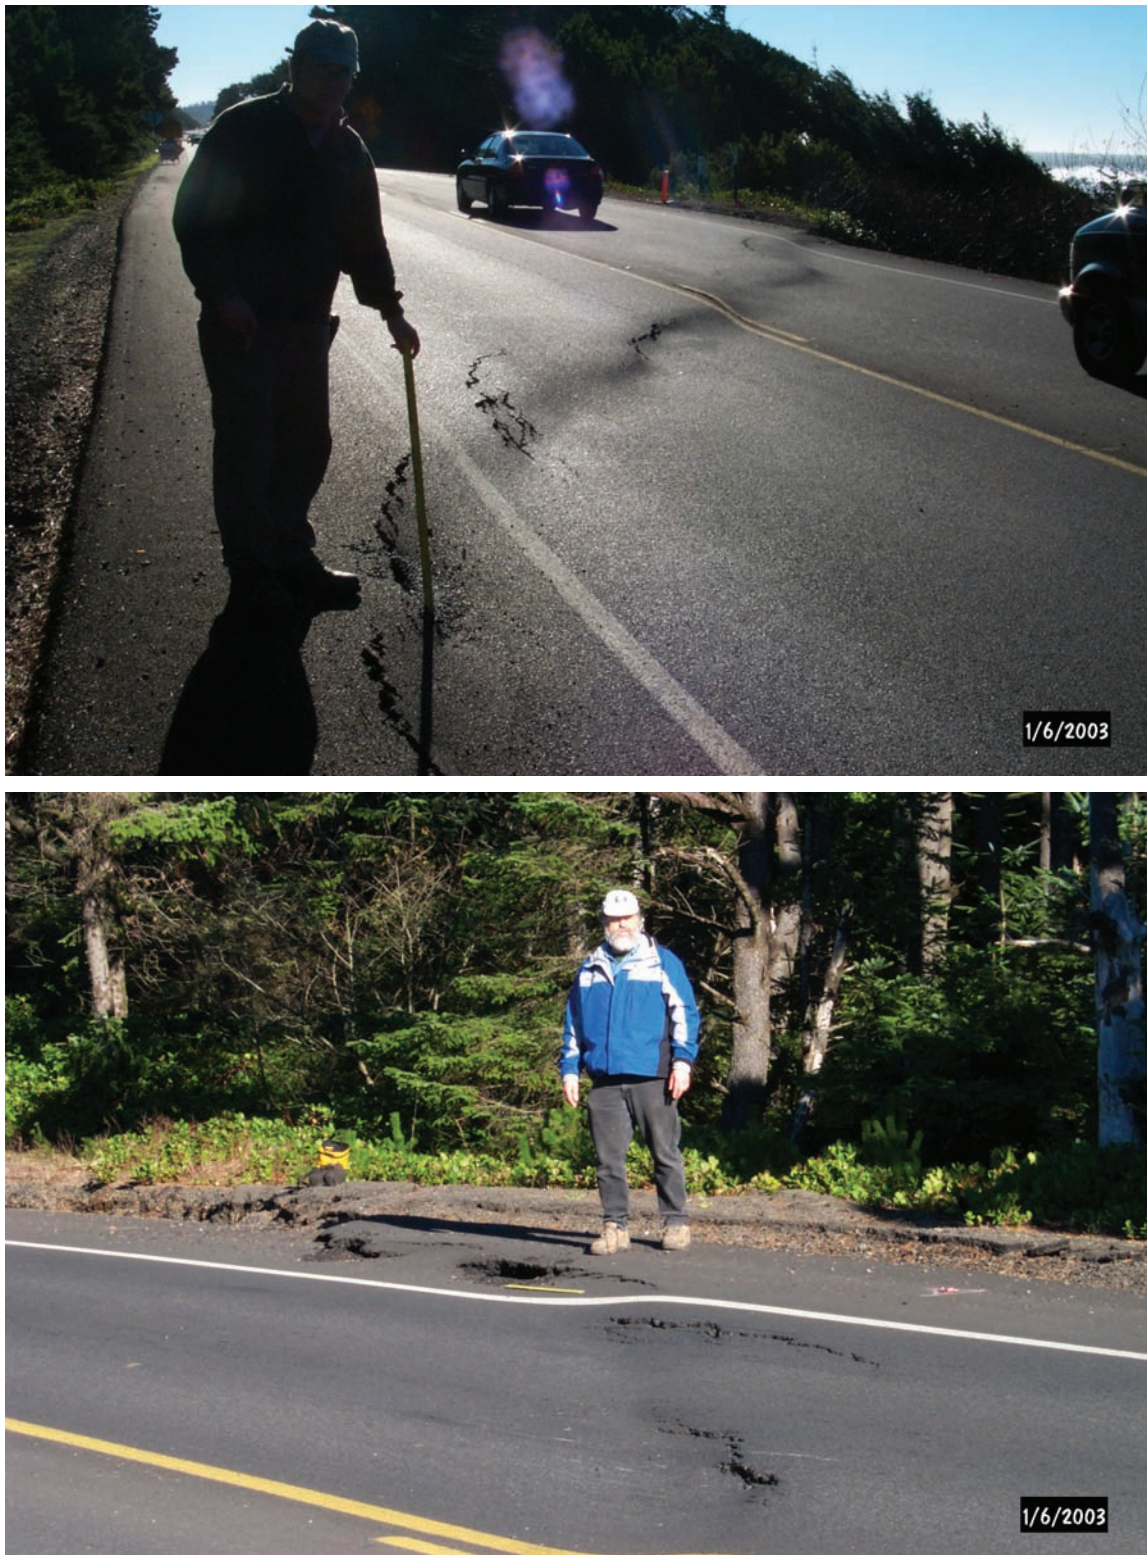
**Figure E9.** (top) Damage to Highway 101 on the south margin of the Johnson Creek landslide immediately after a slide movement in January 2003. (bottom) Maximum vertical offset is 17.8 cm down to the northwest; fissures are as wide as 5 cm. This part of the slide is south of the resurvey lines and confirms the general trend of increasing offset to the south. Roger Hart is in the background.

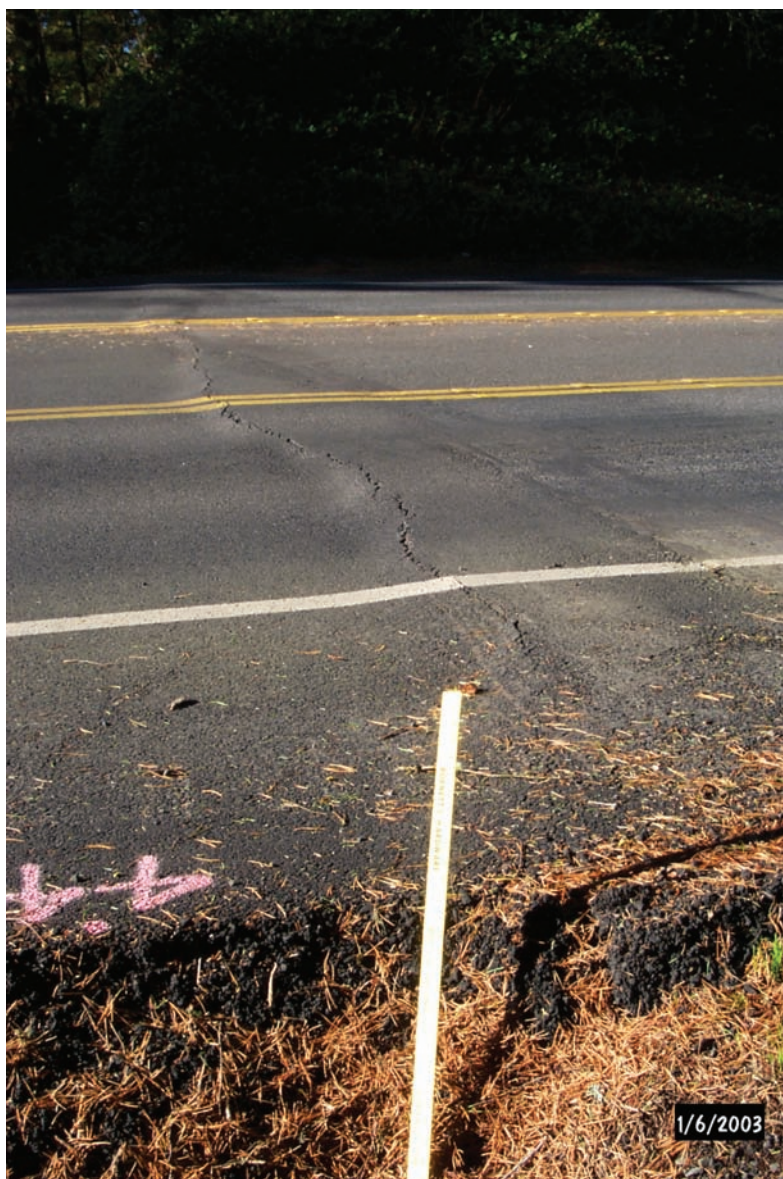
**Figure E10.** Damage to the north slide margin from the same movement as in Figure E9. Note that offset is only 1-2 cm vertical.

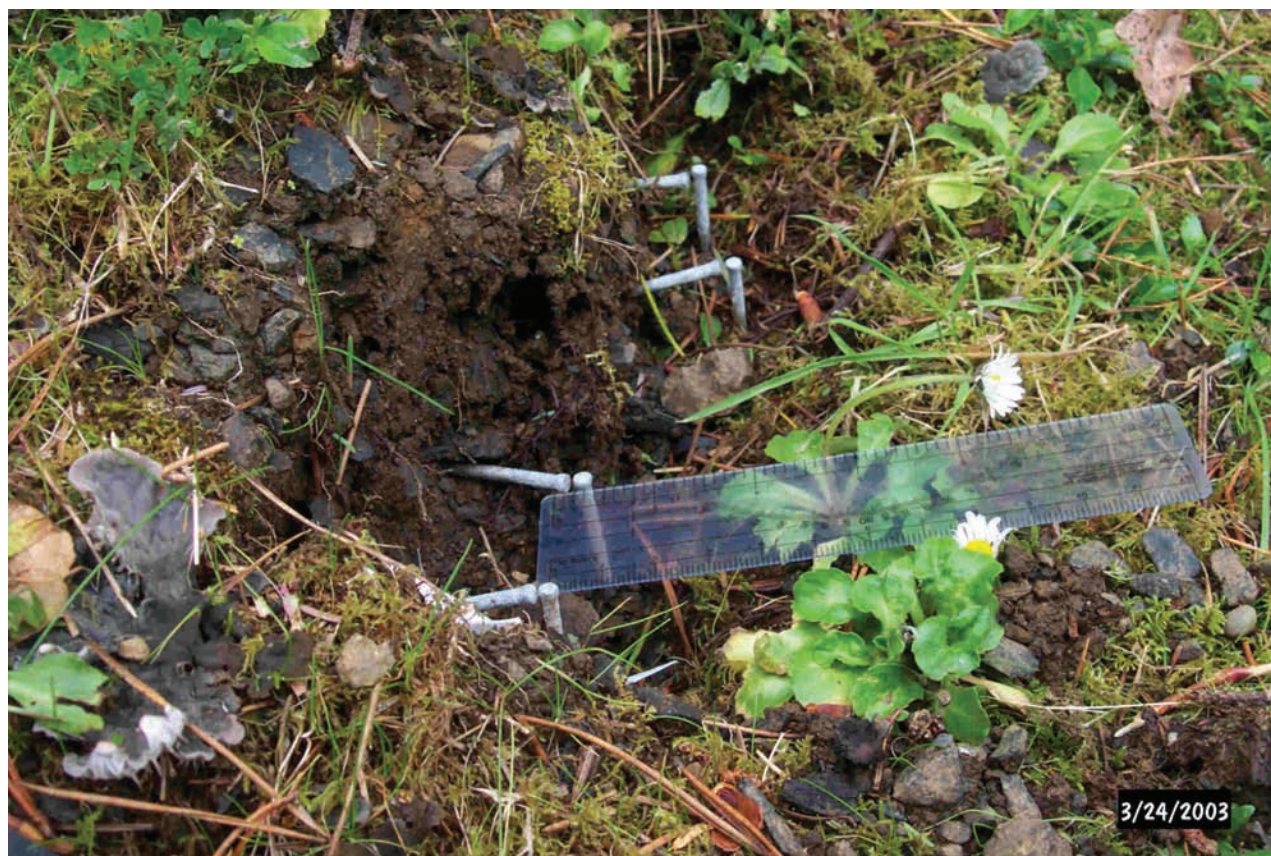
**Figure G1.** A typical marker nail site (JC-23 ); 6-in ruler used for measurements.

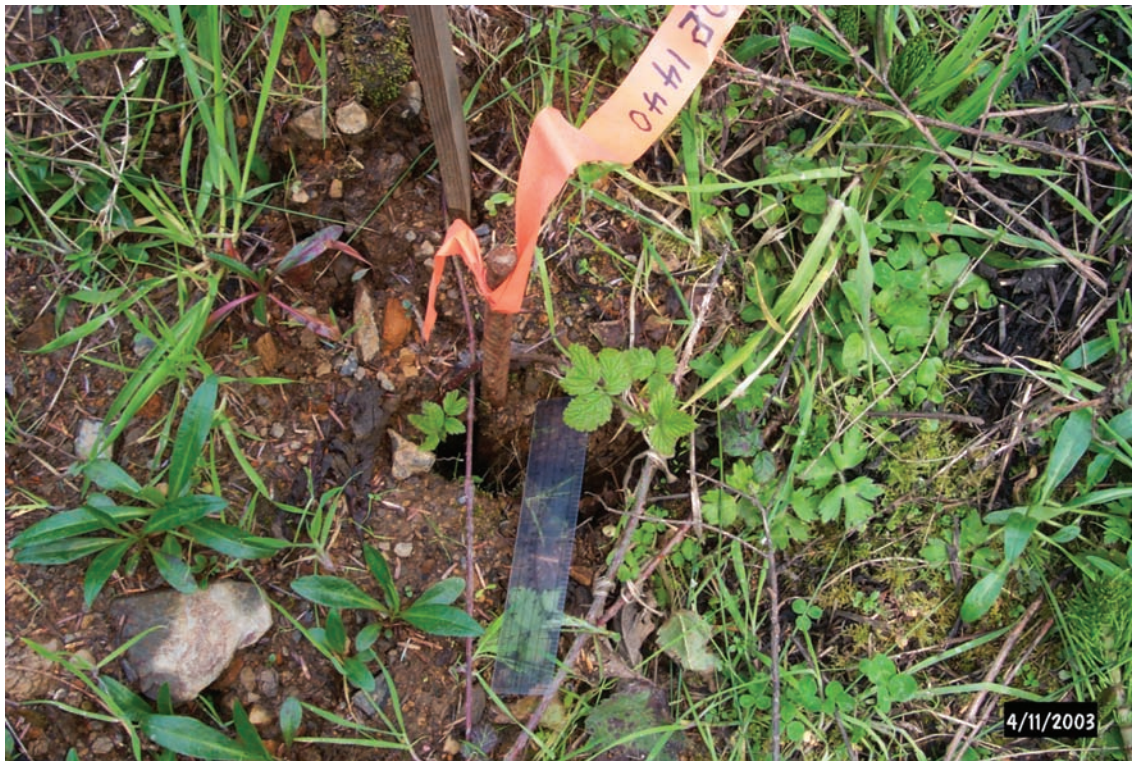
**Figure G6.** Marker nail site JC-17 with displaced steel survey marker at headscarp, looking east.  
This stake was not used in the resurvey.

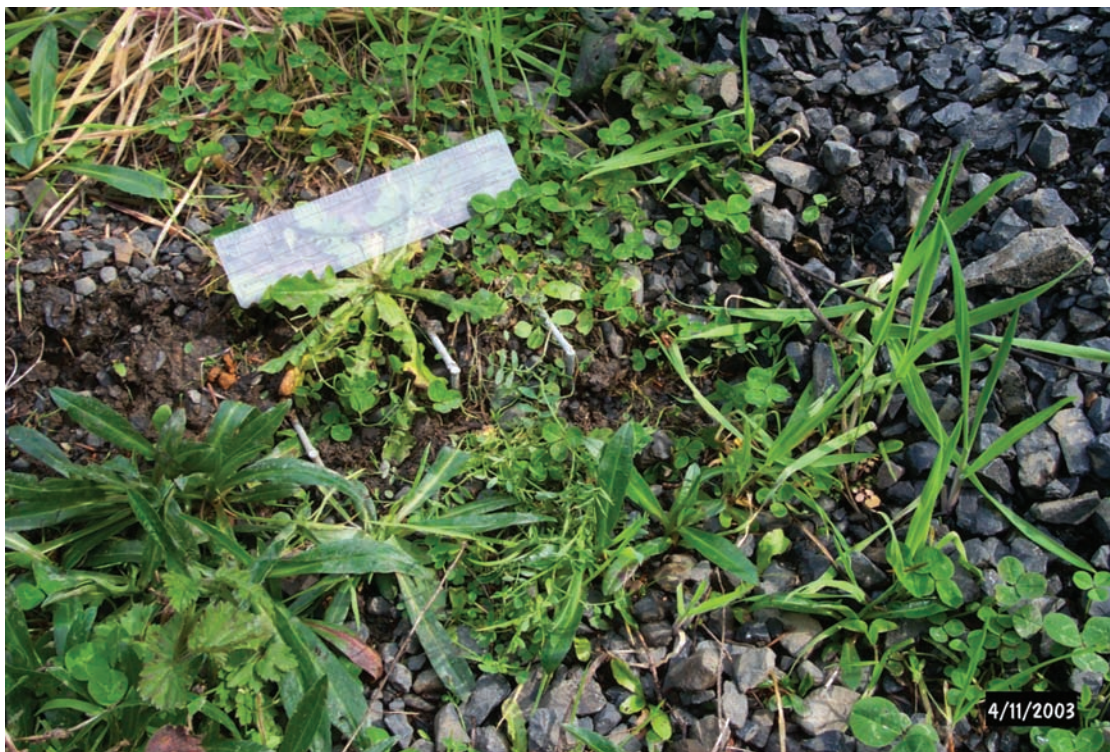
**Figure G7.** Marker nail site JC-17 showing nail locations next to forest road, looking east southeast.  
The scarp is in gravel fill from the forest road.

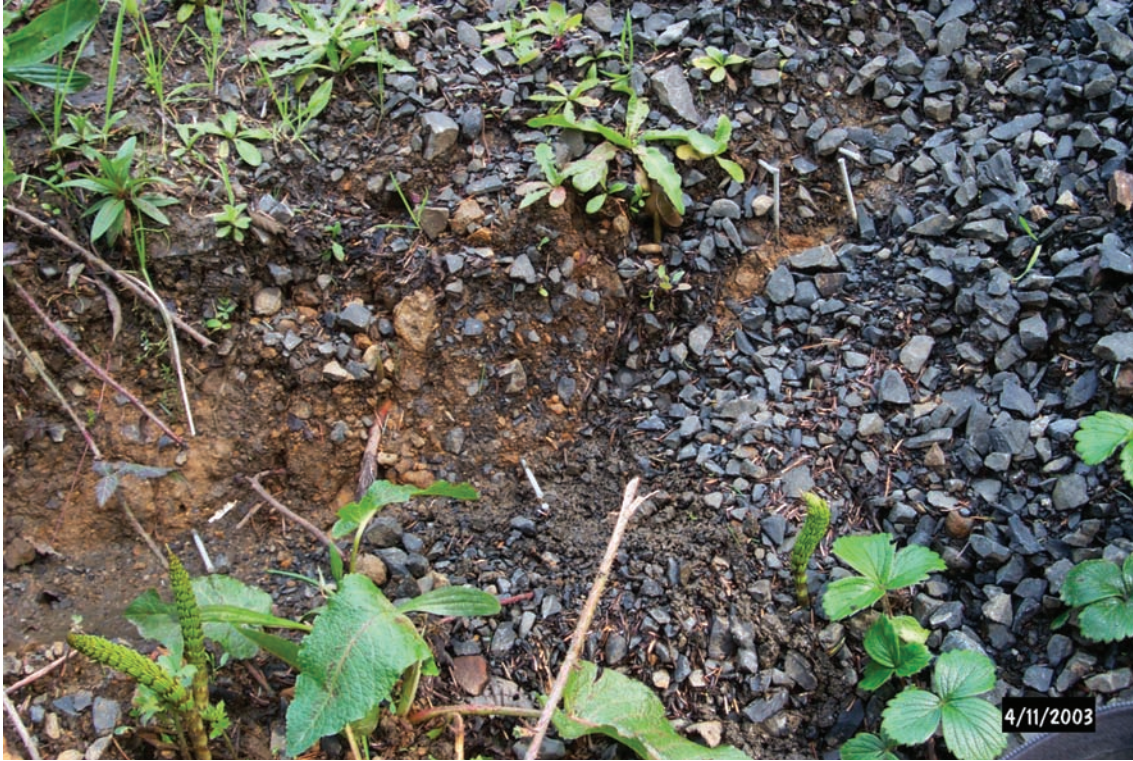
**Figure G8.** Marker nail site JC-18, looking southeast. The scarp is in gravel fill from the forest road. Exposed portions of the two vertical nails on the right are ~1.2 cm long. Note that fresh gravel dumped on the road has disturbed the nails on the right, so that measurement was not used.

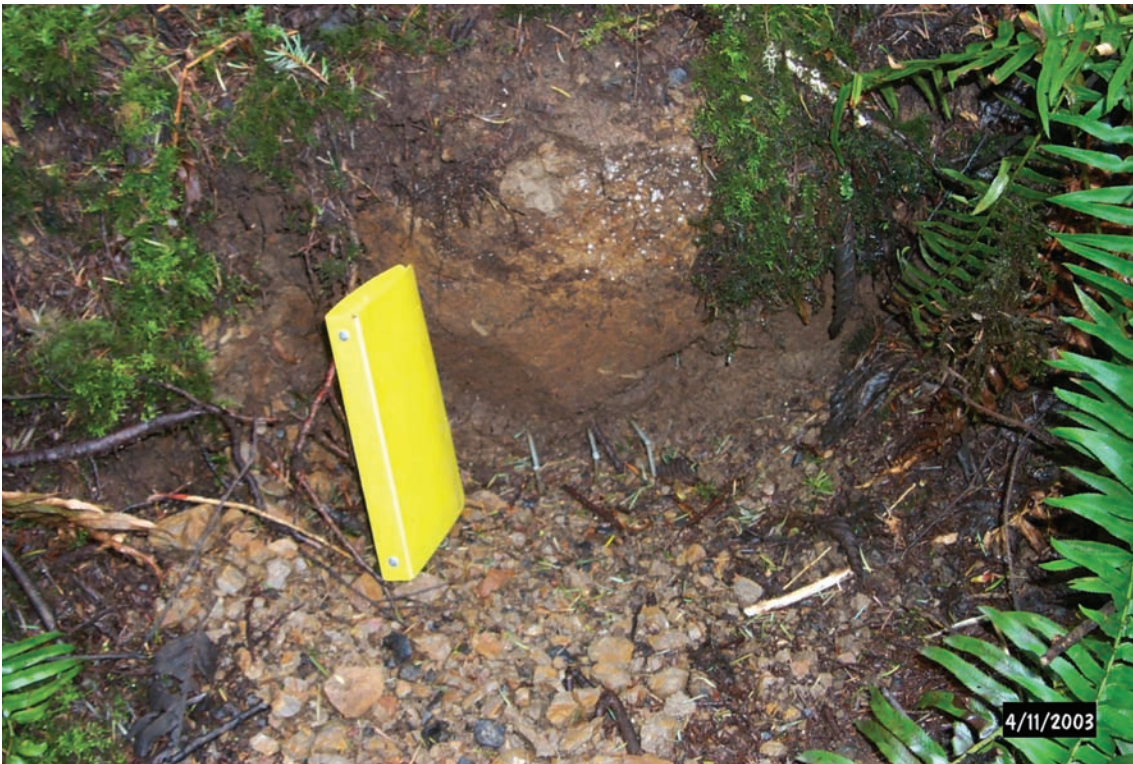
**Figure G9.** Marker nail site JC-19 looking south. Yellow field book is ~19 cm long. Note that all nail heads are still touching in this April 2003 photograph, so no significant movement occurred. Scarp is in relatively fresh Astoria Formation siltstone and sandstone with a thin covering of gravel from the Old Coast Highway.

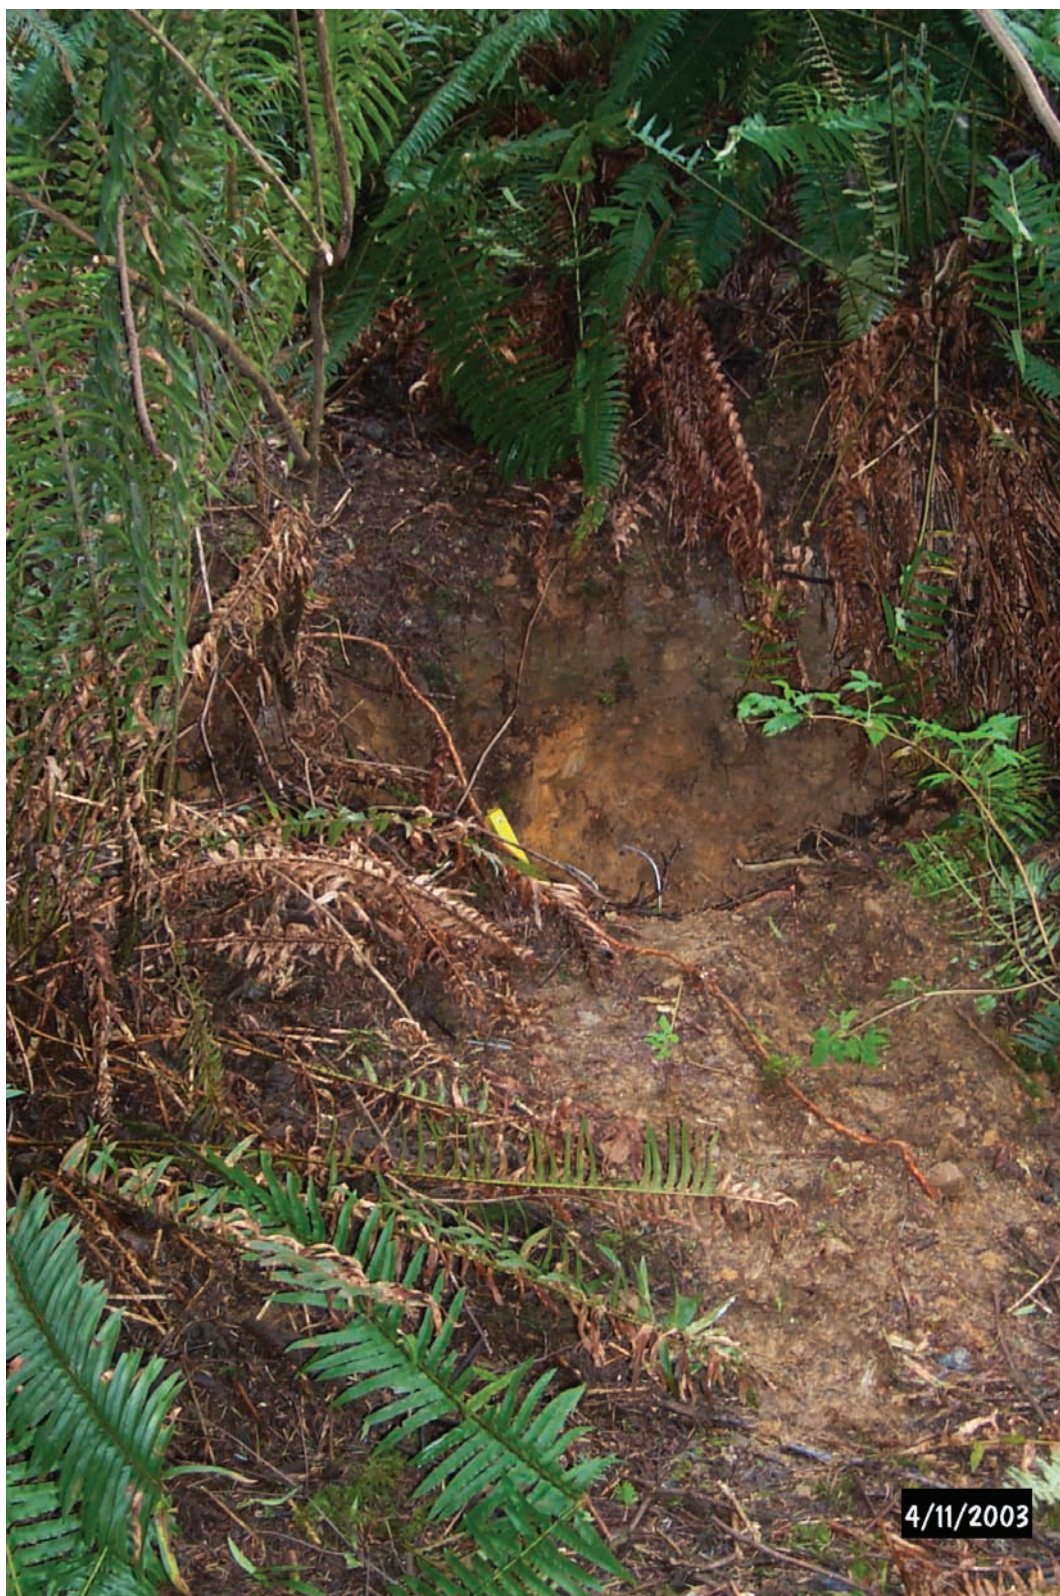
**Figure G10.** Marker nail site JC-20 looking south. Yellow field book is ~19 cm long. Scarp cuts Old Coast Highway. The scarp is in weathered Astoria Formation colluvium below the Old Coast Highway and some gravel fill from the adjacent private driveway.

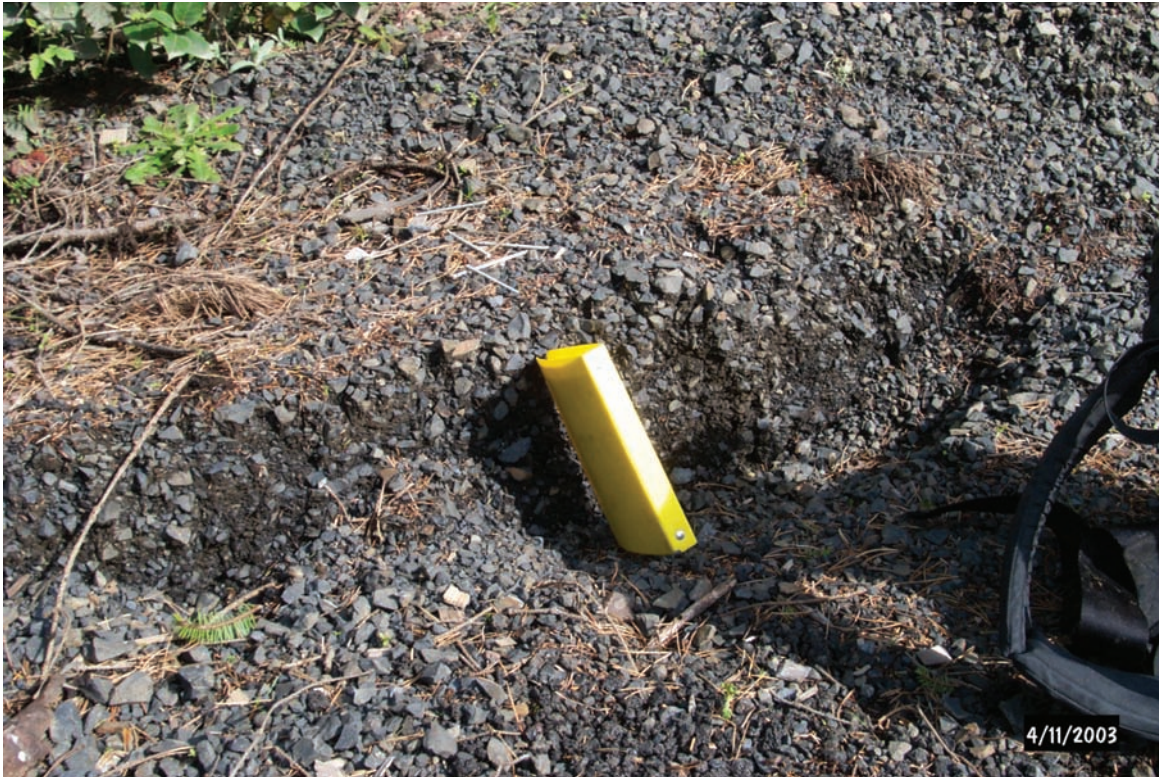
**Figure G12.** Marker nail site JC-21 looking southeast. Yellow field book is ~19 cm long. The scarp is in gravel fill from the Highway 101.

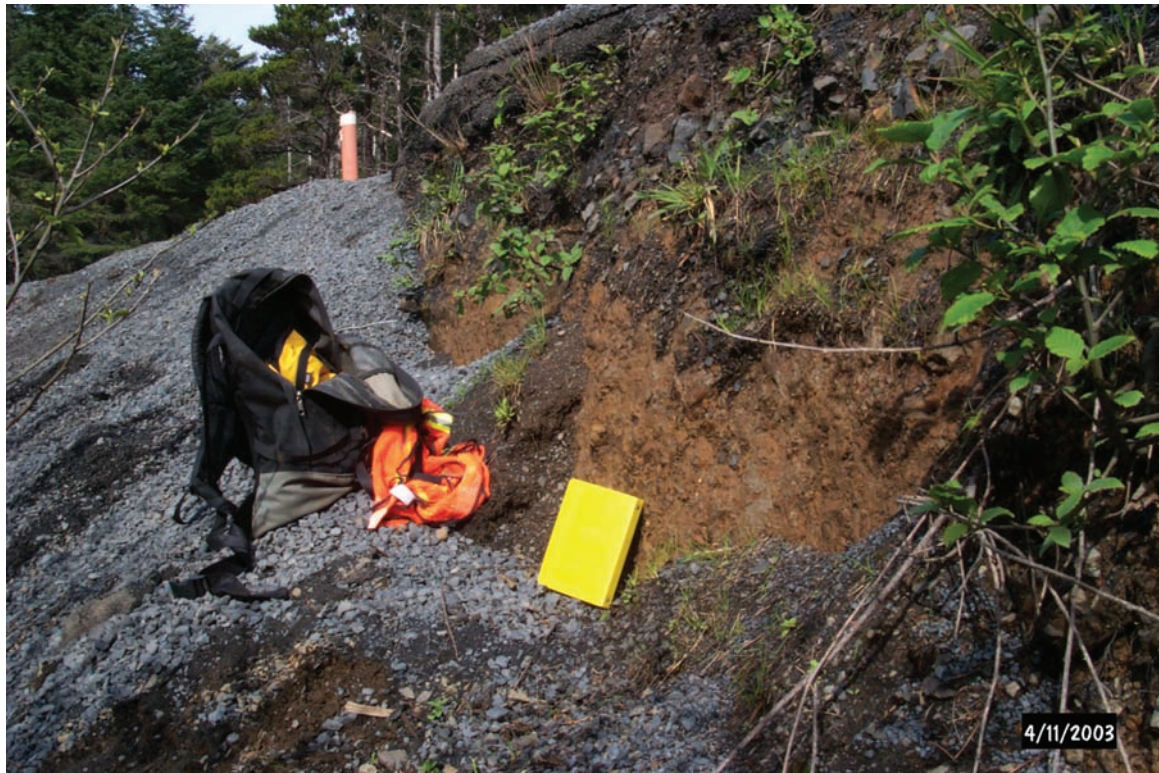
**Figure G13.** Marker nail sites JC-22 (near red highway cone at top of highway embankment) to JC-24 (to the right of the yellow field book) looking northeast parallel to the strike of the fresh headscarp (red orange fill of excavated Astoria Formation). Yellow field book is ~19 cm long. The near-vertical portion of scarp is ~1.2 m high.

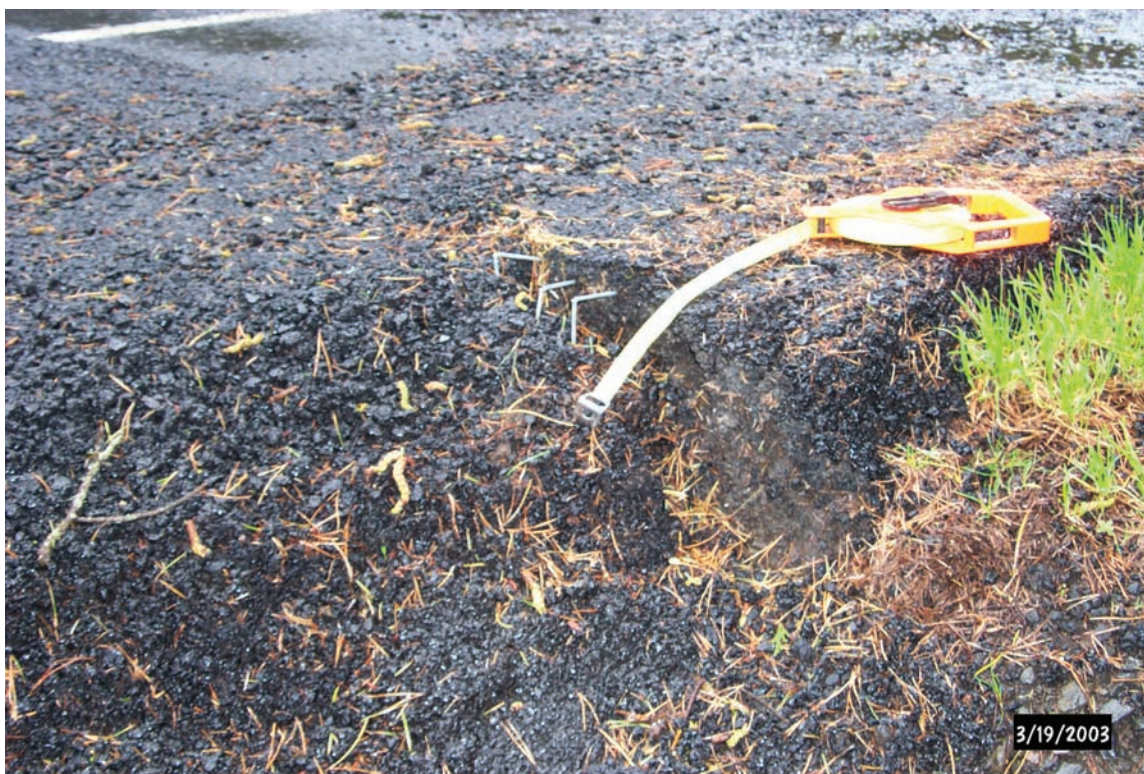
**Figure G14.** Marker nail site JC-22 looking southeast on west side of U.S. Highway 101. Scarp is asphalt and gravel.

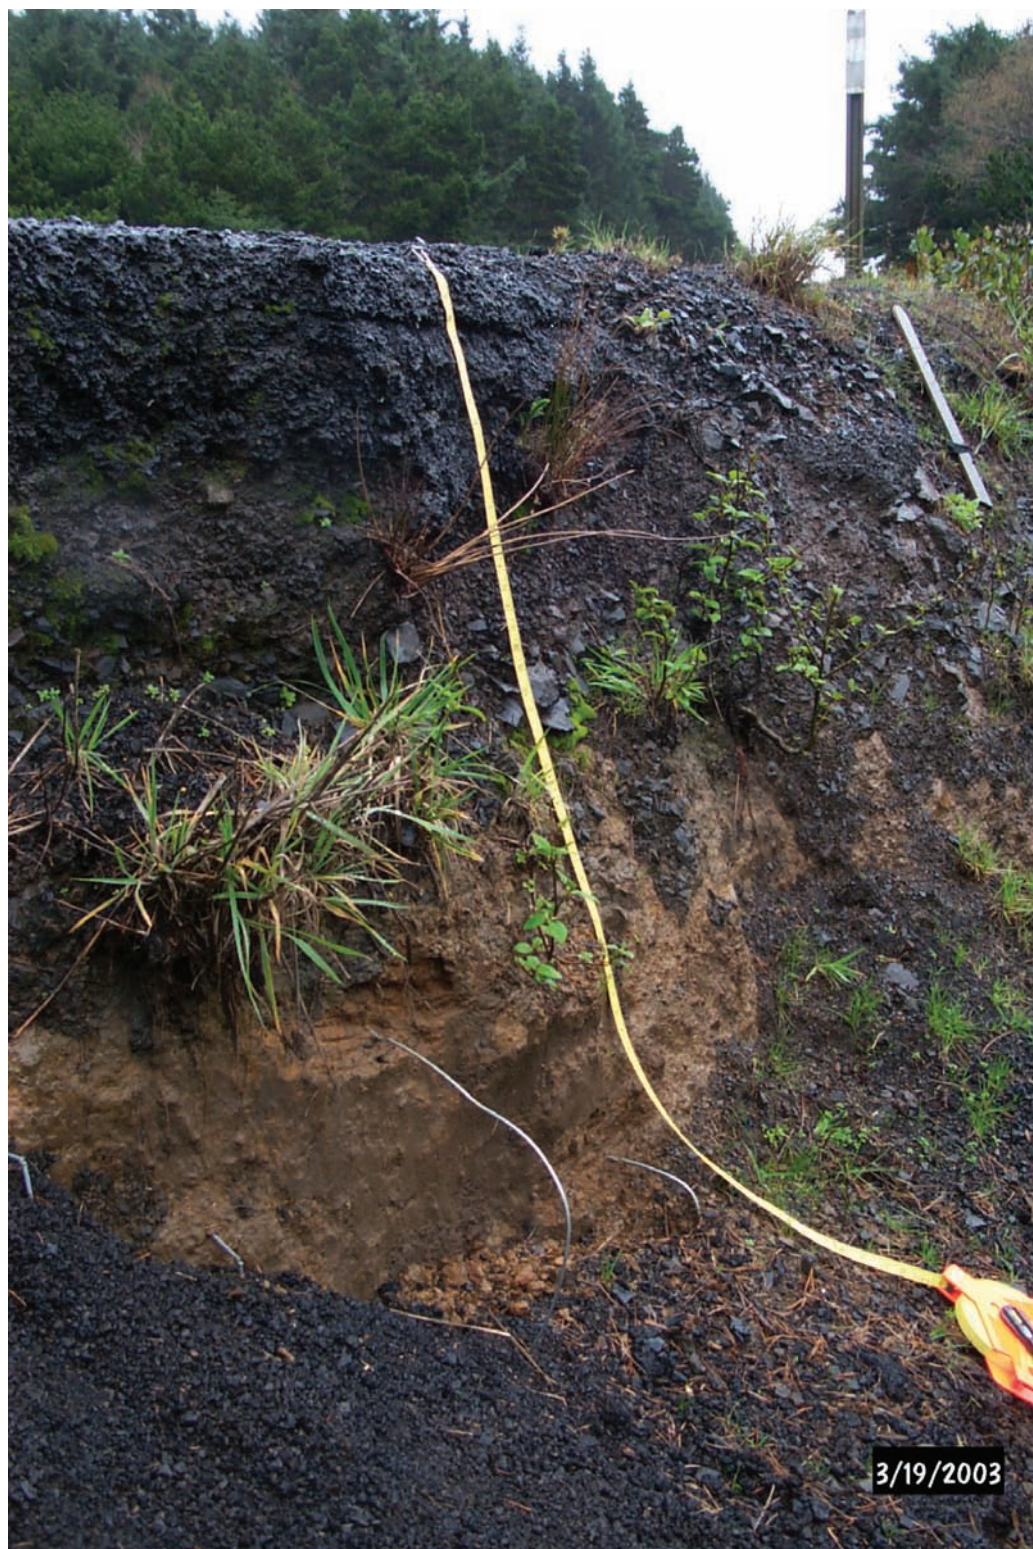
**Figure G15.** Marker nail site JC-23 with both wires and nails, looking south southeast. Scarp is in red orange fill of excavated Astoria Formation overlain by gravel and asphalt. Near vertical portion of scarp is ~1.2 m high.

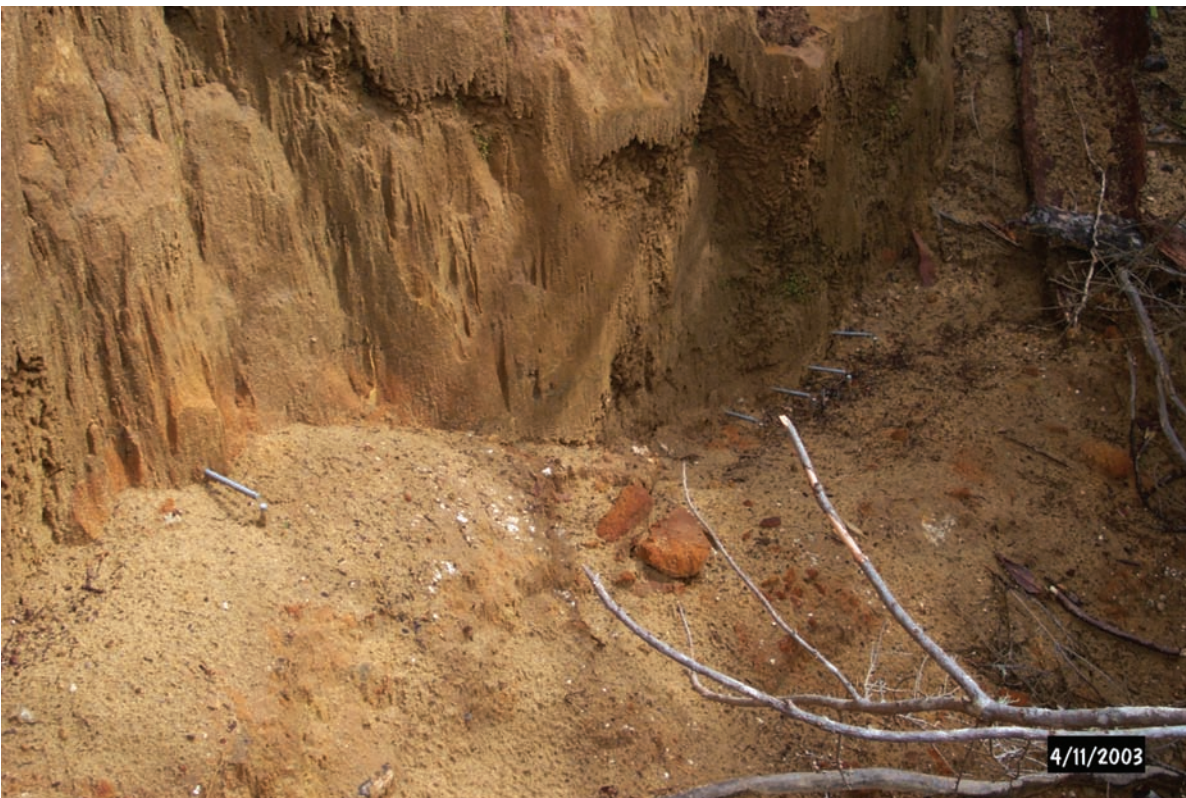
**Figure G17.** Marker nail site JC-24 looking southeast. This is the northeast headwall of the landslide. The tan unit in the near vertical escarpment is Pleistocene marine terrace sand. Talus lies along the base of the slope.
