OFR O-04-05

**GEOTECHNICAL INVESTIGATION
JOHNSON CREEK LANDSLIDE
LINCOLN COUNTY, OREGON**

Landslide Technology

2004

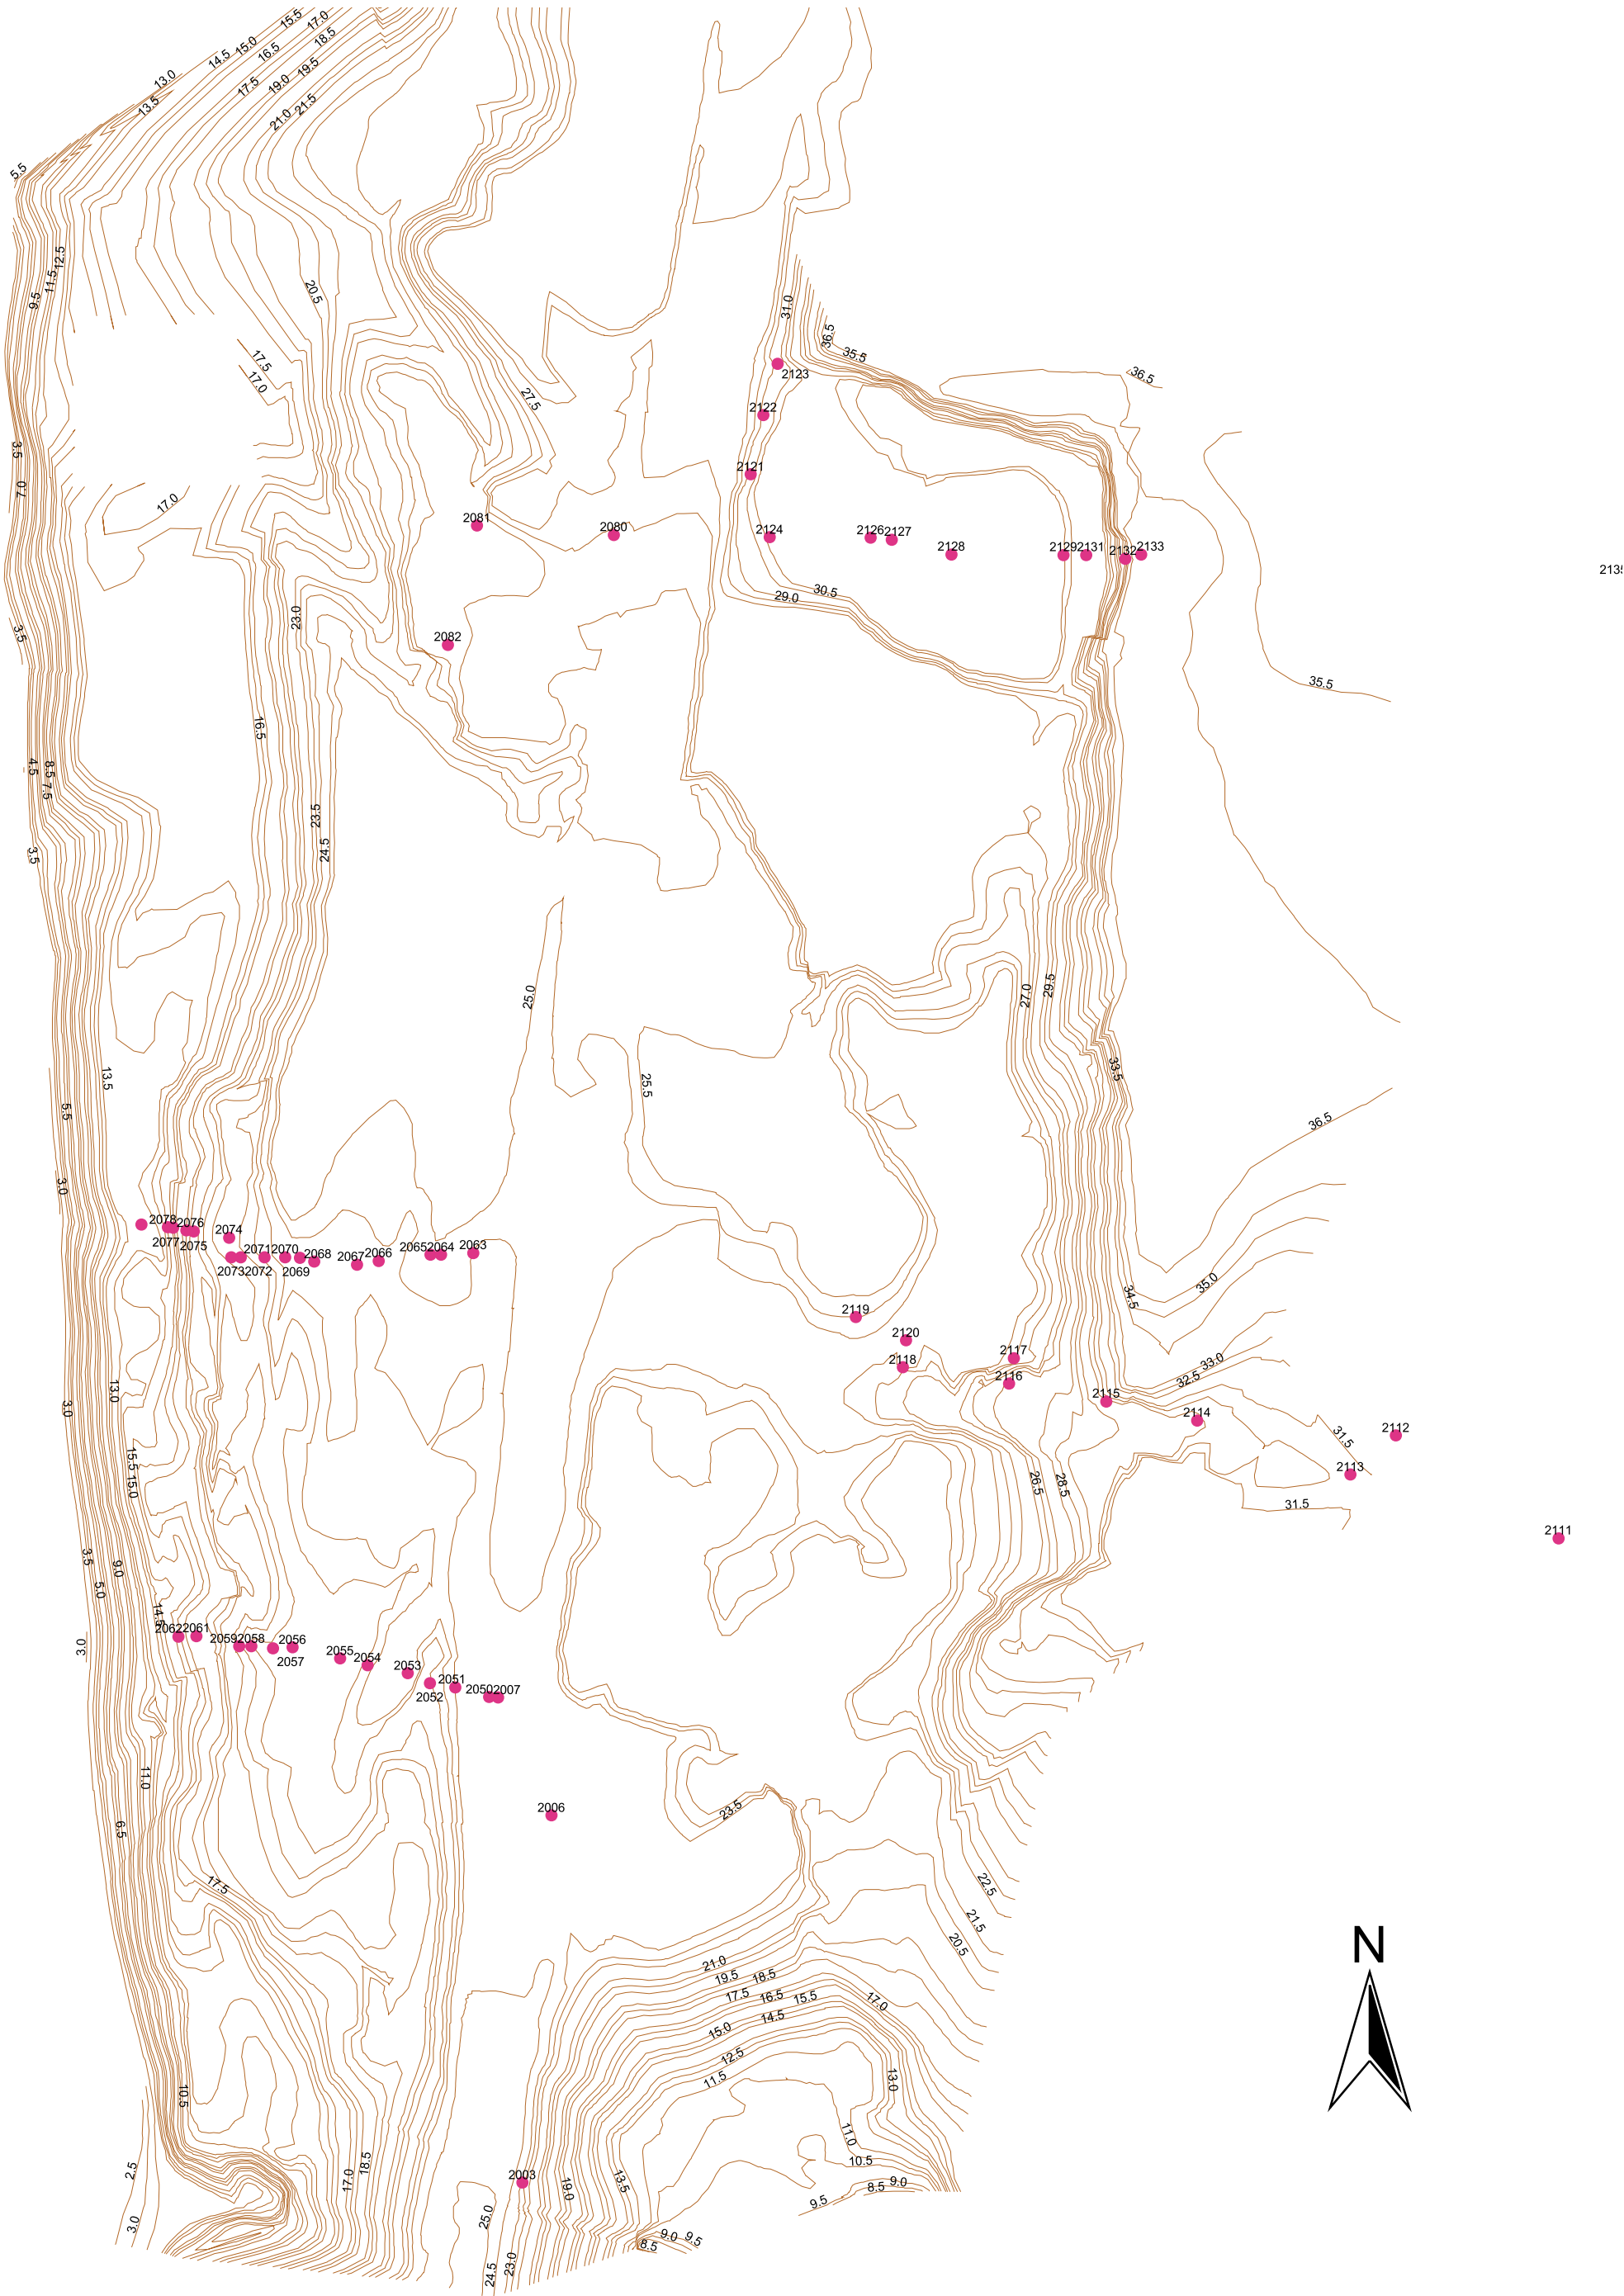
Qualitative overview of slide vectors from change in survey points between October, 2002 and April, 2003 (blue arrows). Red arrows at inclinometer holes are bearings from inclinometer data. Red arrow at south margin is qualitative displacement direction of old coast highway.
