OFR O-04-15

**REVIEW AND ANALYSIS OF THE WINSTON SLIDE
EVENT OF FEBRUARY 2, 2004**

Randy Moore and Vaughn Balzer
Oregon Department of Geology and Mineral Industries
Mineral Land Regulation and Reclamation

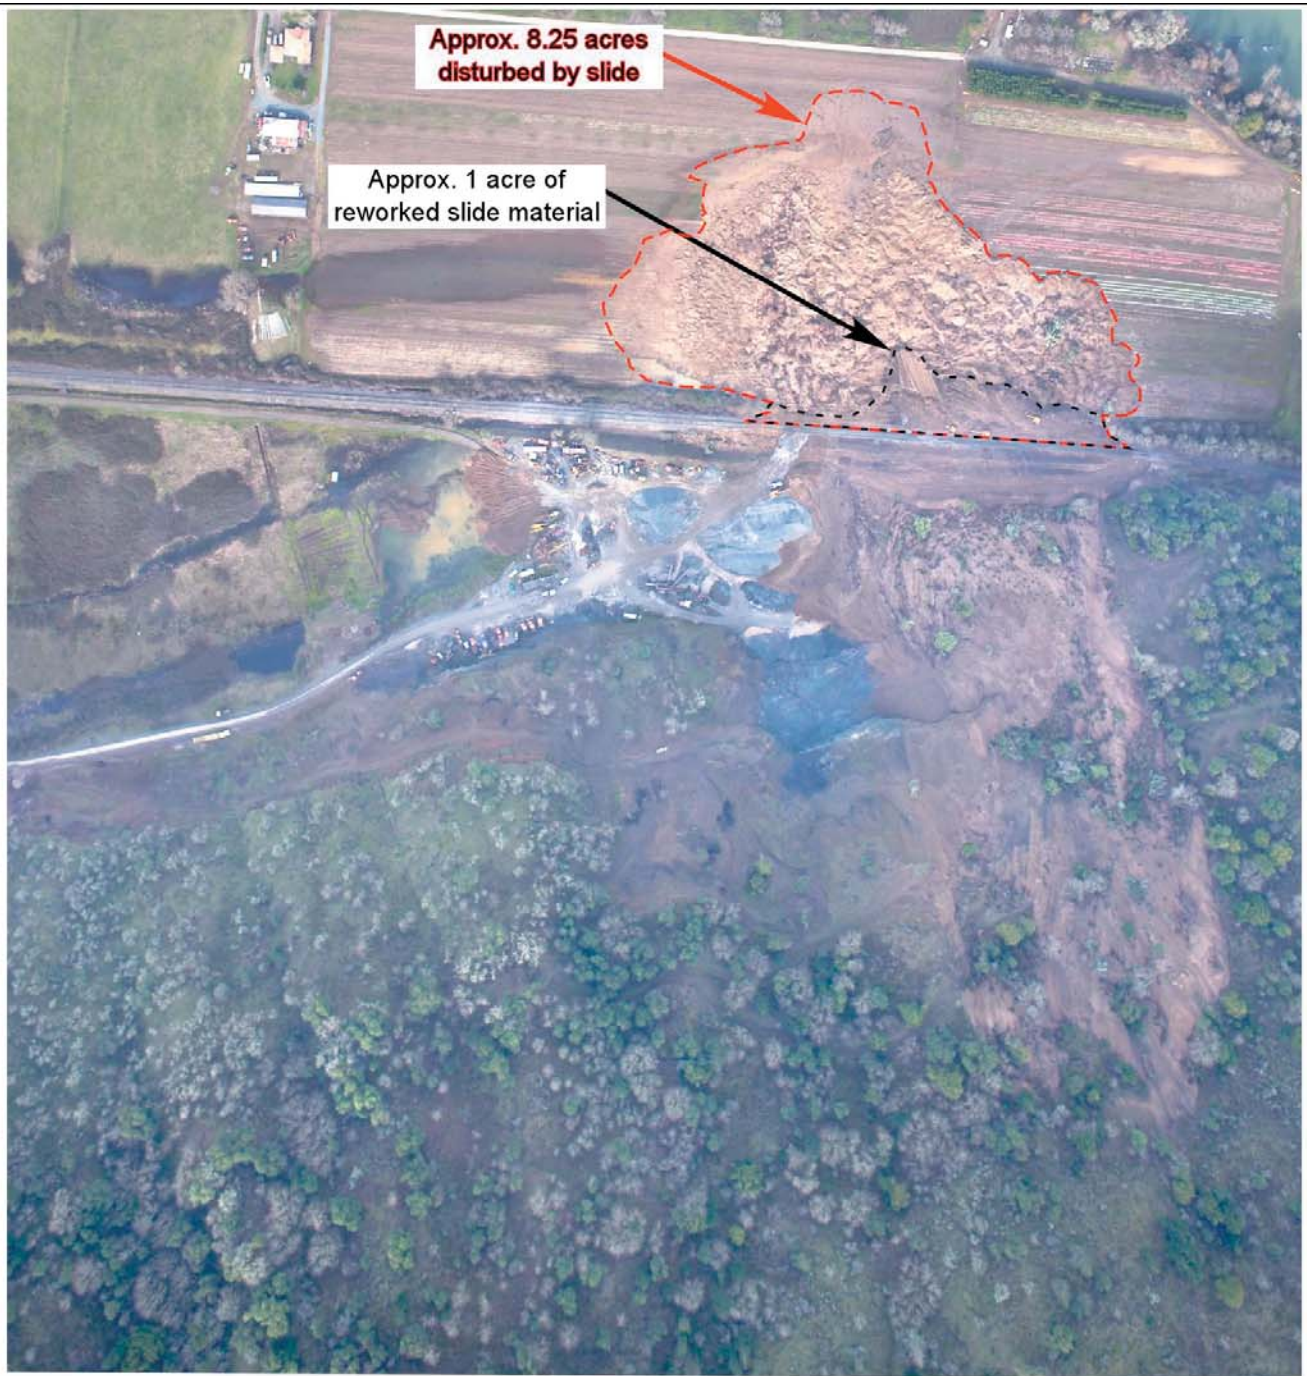
Figure 9.
 DOGAMI ID#: 10-0197
 Permittee: Sundance Rock Inc.
 Site Name: Winston
 Photo Source / Date: D. Shear / 2-5-2004
 Prepared By / Date: V. Balzer / 2-10-2004
