APPENDIX F: LINE-OF-SIGHT SURVEYS ON U.S. HIGHWAY 101

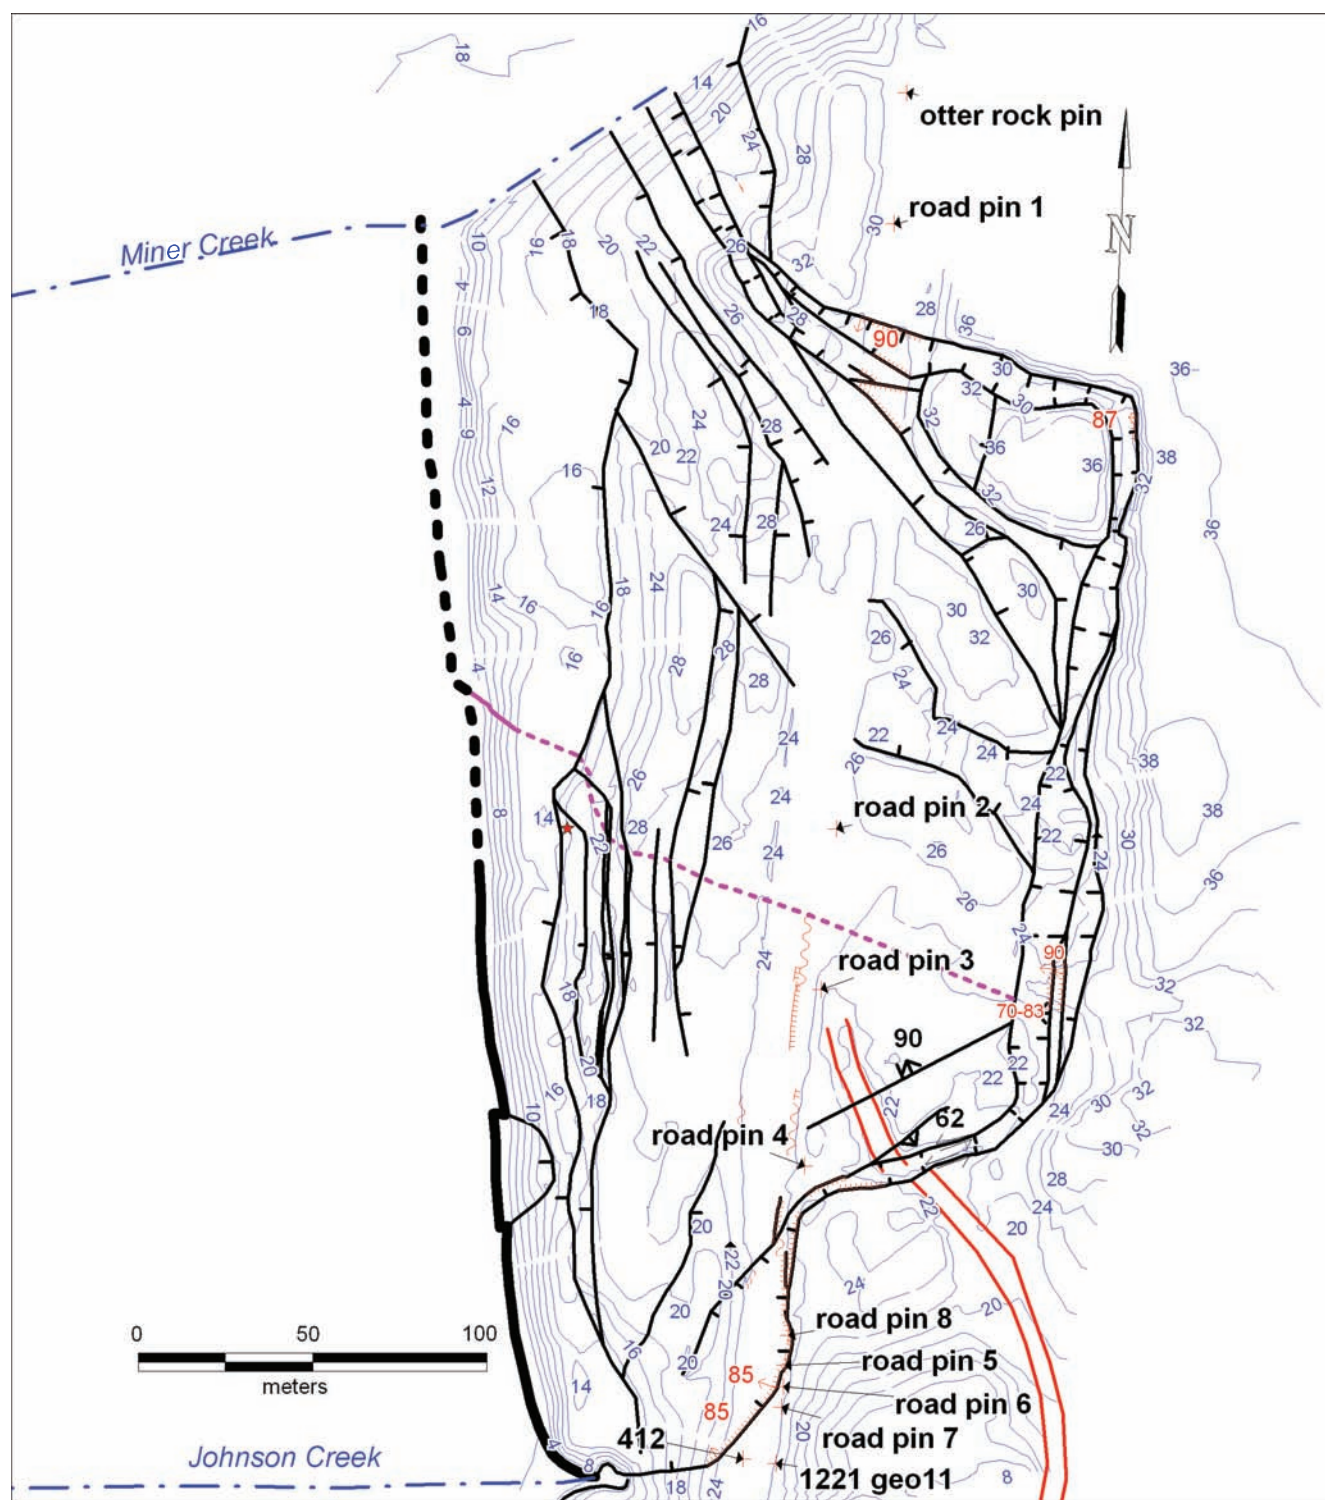
Figure F1. Location of line-of-sight survey pins. All surveys were done with a total station to subcentimeter accuracies. Black lines are mapped slide block boundaries. Solid purple line is internal slide structure or fault; dotted purple line is speculative extension of this structure across the slide to match a similar structure inferred from borehole logs. Red numbers are dips on fresh scarps (red hachured lines) where nails were installed in 2003. Blue lines are topographic contours at 2-m intervals.
