# Mined Land Reclamation Awards announced by the Oregon Department of Geology and Mineral Industries

# August 31, 2012 Mined Land Reclamation Awards

# 2011 Outstanding Reclamation— Plum Creek Timberlands, Siletz George Quarry, Lincoln County Contact: Todd West, PO Box 216, Toledo, OR 97391, 541-336-6238

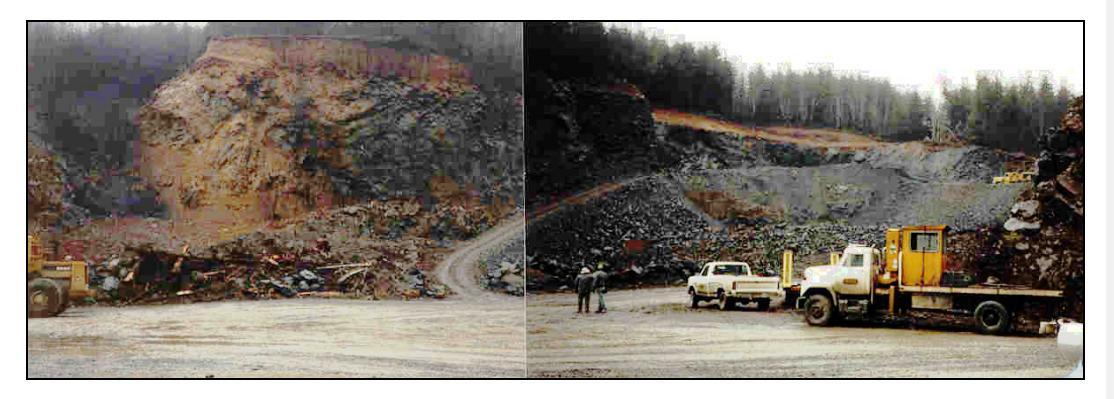
A total of six acres were disturbed by the mine operation over the years. The excavation was a side hill cut with a 20-foot-wide bench established on the 60-foot highwall. Now, red alders have established along the base of the highwall as well as on the bench. Cliff swallows have established nests in the vertical face of the highwall.

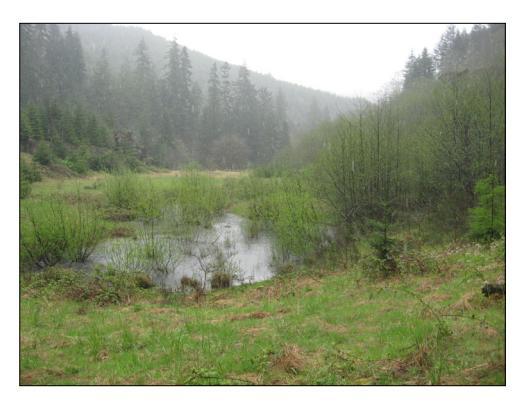
Before the quarry was established, a seasonal drainage was present on this site. Plum Creek has re-established this drainage and created a pond for wildlife habitat on the quarry floor. The drainage and pond system effectively prevents sediment from leaving the site during rain events. Wetland areas have been established where they did not exist before. Oversized material was placed along the county road to prevent entry by vehicles onto the reclaimed area.

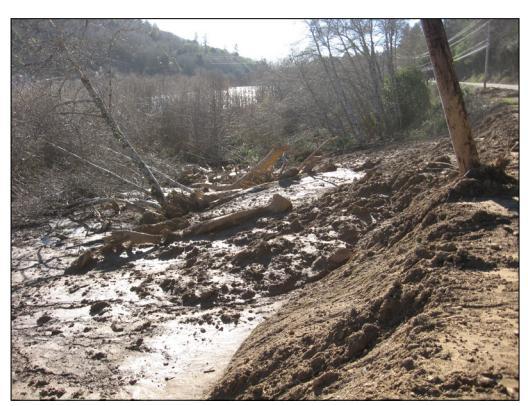
Da-Tone Rock Products obtained a DOGAMI operating permit for this upland quarry in 2003. Prior to Da-Tone, stormwater control measures at the quarry were minimal at best. As part of the DOGAMI permitting process a DEQ 1200A discharge permit was required of Da-Tone as well. A stormwater control plan is an integral part of the 1200A permit. The DOGAMI permit was issued in December 2003, and temporary stormwater control measures were immediately implemented. The following summer the approved 1200A stormwater control plan was started. This plan has been expanded and improved annually since.

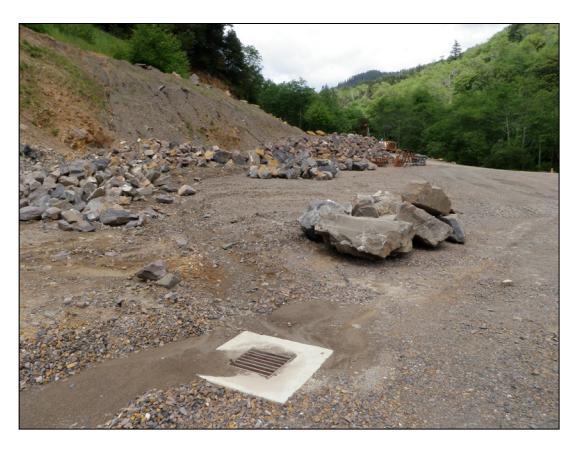
A DOGAMI inspection in December 2010 noted additional work on the stormwater control system. A subsurface drain system was constructed on the guarry floor and beneath the processing/stockpile area. A drainage ditch, excavated along the toe of the quarry highwall, intercepts any seepage and eliminates any standing water in the high-traffic areas of the quarry. A new access road was constructed that bypasses the slope failure area.

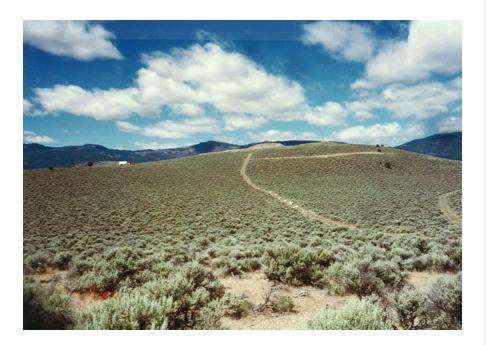
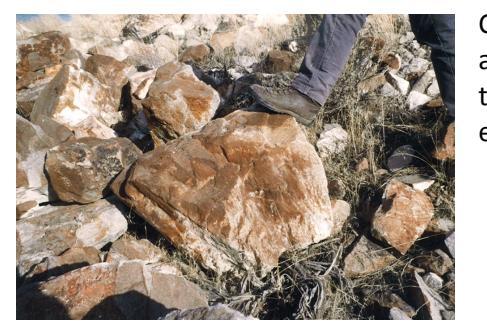
Screening of this site from public viewing areas was considered an important aspect of mine development. Leaving a topographic high along the northern permit boundary, and delaying mining in this area until the end of the project, effectively screened the site from the public highway 31. The quarry is also internally drained, thereby containing all stormwater within the confines of the excavation.

Cornerstone also treated freshly exposed perlite, a highly visible white rock, with a staining product to artificially weather the rock to a more natural earth tone.

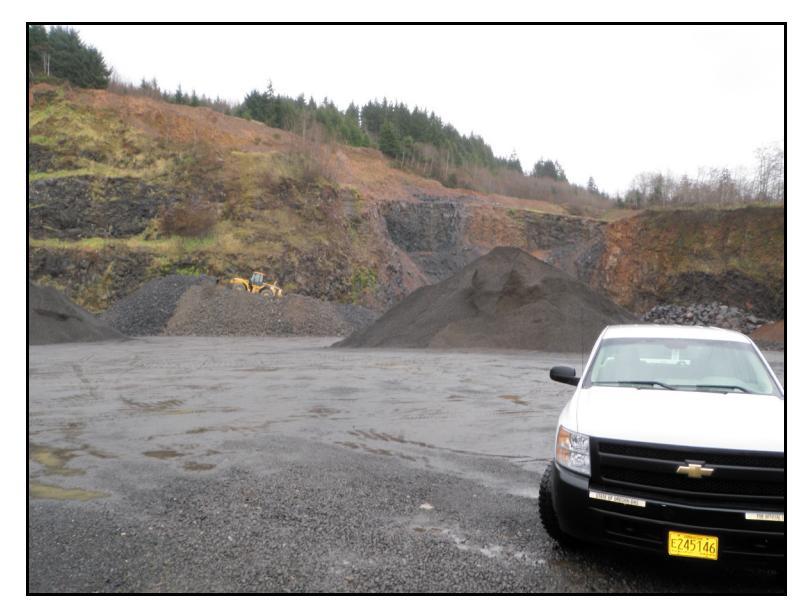
A recent DOGAMI inspection noted the extensive and unique stormwater control system on the quarry floor. Large vegetated ponds trap sediment; the overflow water is then pumped into a perforated pipe that allows the water to disperse into porous forest soils without creating overland flow. This subsurface delivery of stormwater eliminates all turbidity.
