OPEN-FILE REPORT O-01-05

Preliminary Earthquake Hazard and Risk Assessment and Water-Induced Landslide Hazard in Benton County, Oregon

By
Zhenming Wang,
Gregory B. Graham, and
Ian P. Madin

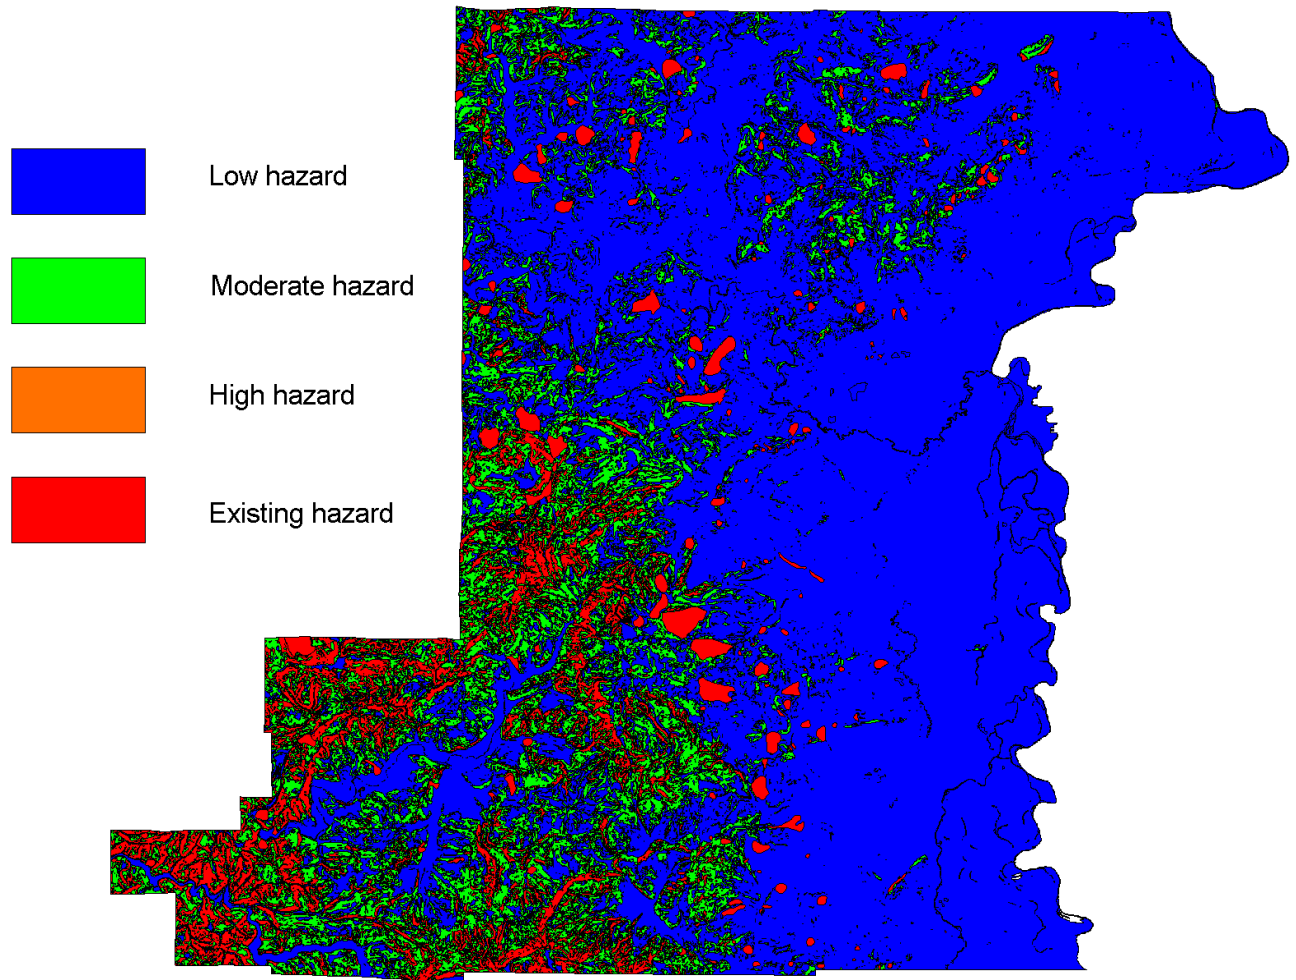
Map 4: Landslide hazard map

The landslide hazard map (Map 4) is an overlay of the three hazard layers based on factor-of-safety values from modeling, and the existing landslide layer. The hazard map delineates areas of low, moderate, and high landslide susceptibility. However, it is important to note that the hazard assignments were based on limited data and computer modeling. Cautions need to be exercised in using the maps.

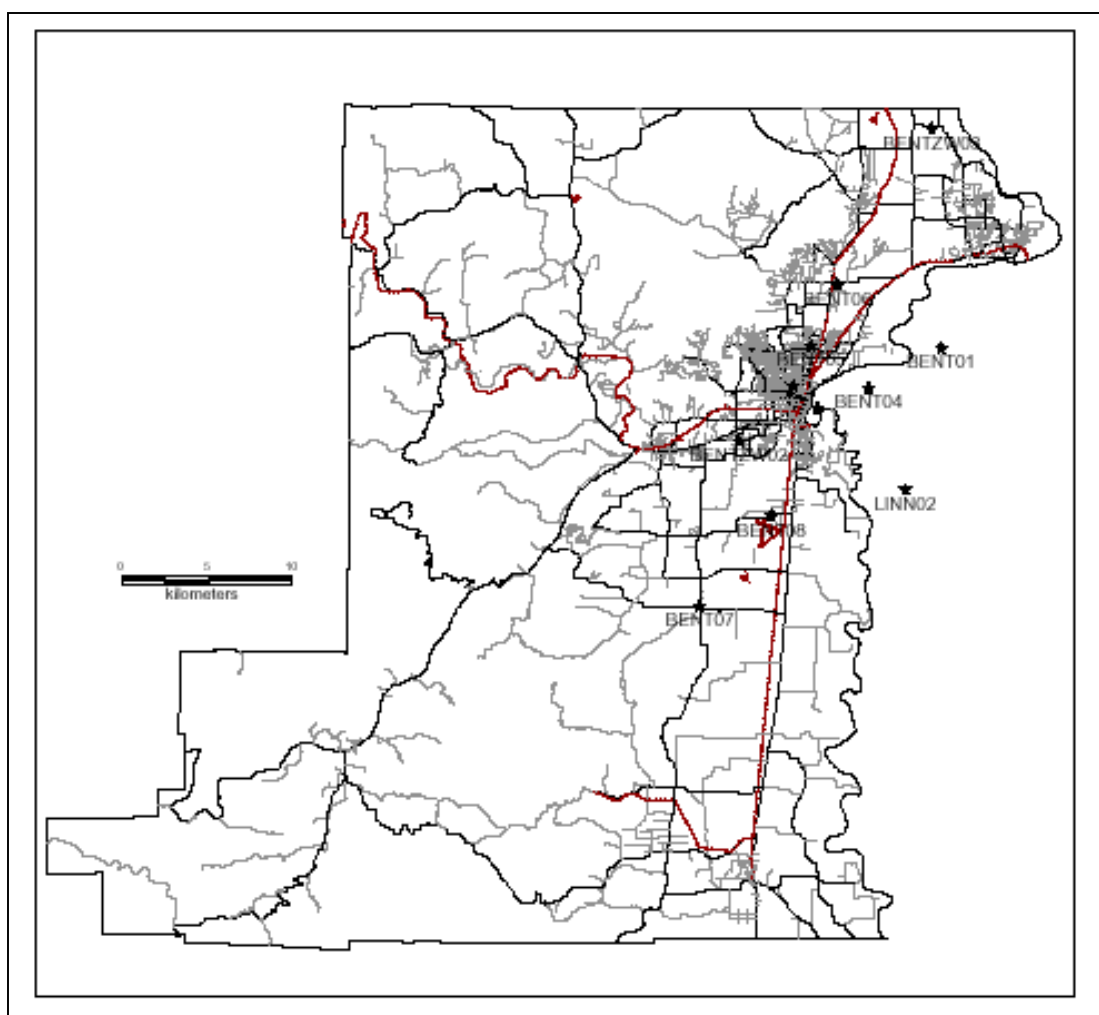
Figure A-1. Locations of geophysical investigation sites.

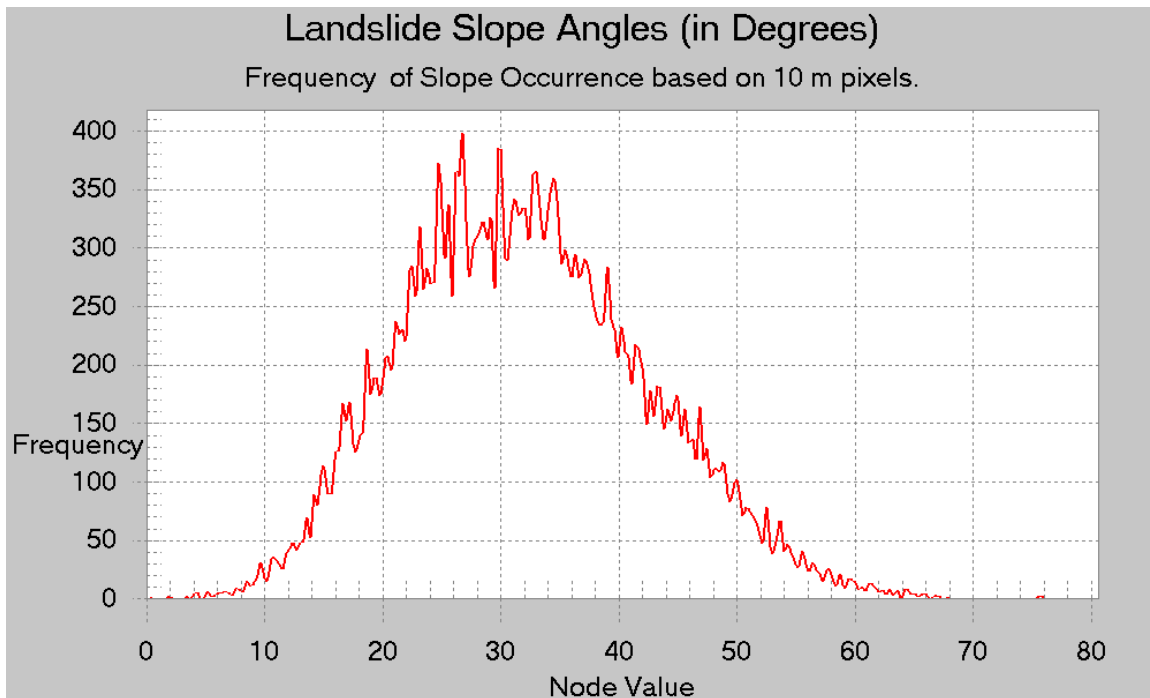
Figure 2: frequency of occurrence of slope angles

Figure 2 shows the frequency of occurrence of slopes angles within the slide areas as derived from a 10 m digital elevation model. The majority of the slides occur on slopes greater than 10 degrees, with the most common slope values above 25 degrees. The fall-off in slope values at the higher end of the histogram does not suggest that steeper slopes are less slide prone, simply that steeper slopes are less common throughout the topography. Figure 2 is a slope map of the study area derived from the 10 m Digital Elevation Model (DEM) resampled to 50 m. Clearly the majority of steep slopes are in the hills surrounding the urban growth boundaries.
